JAMES E. MCDADE CLASSICAL SCHOOL

MCDADE CLASSICAL SCHOOL
CONCEPTS + ASSESSMENT

OCTOBER 26, 2018

8801 S. Indiana Ave.
Chicago, IL 60619

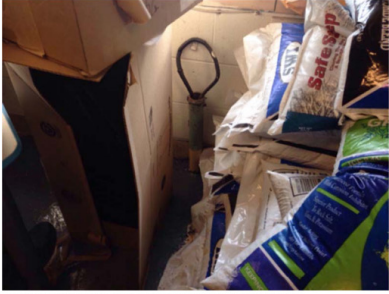
Photo 6 Evidence of UST piping noted behind fertilizer and bath tissue pallets.

Based on the scope of services, limitations, and findings of this assessment, Terracon recommends additional investigation in the form of a Ground Penetrating Radar and Electromagnetic Survey (GPR/EM) survey and environmental borings/sampling in the location of the former UST system and remaining piping.

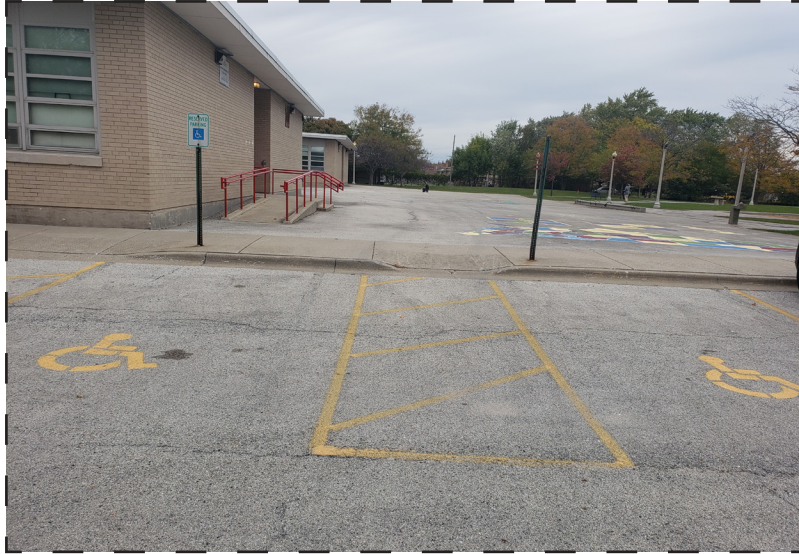
4- 2.1

Figure 4-2.1: The existing parking lot has 2 Handicap Spaces adjacent to the handicap accessible entrance at the southeast corner of the school. Based on our field observation, the slope of the parking spots appears to exceed the 2% allowable cross slope per CDOT requirements (to be verified upon receipt of the topographic survey). We recommend re-constructing this area to meet current ADA standards.

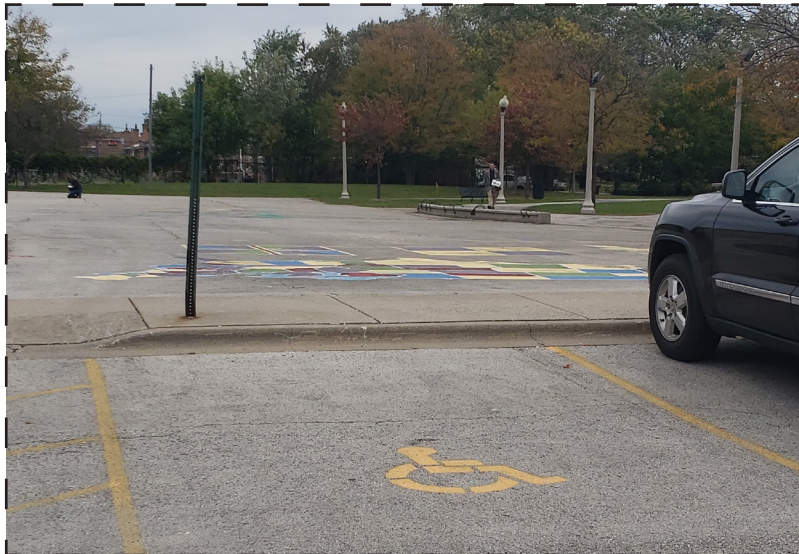
4- 2.2

Figure 4-2.2: One of the existing Handicap Spaces does not have the required ADA signage. The ADA signage should be installed.

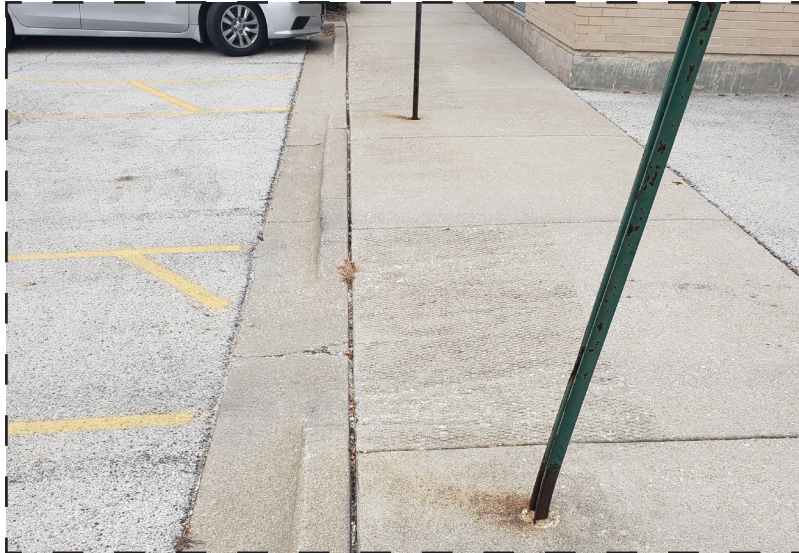
4- 3.1

Figure 4-3.1: Handicap accessibility to the southeast entrance of the school is provided along the existing sidewalk to the north of the parking lot. This sidewalk also connects to S Indiana Avenue, providing pedestrians access to the school and amenities on the east side of the school. This sidewalk does not meet current ADA standards for the pedestrians walking from Indiana Avenue. It also appears to not meet current ADA standards from the handicap parking spaces to the school (to be verified upon receipt of the topographic survey.) We recommend removing and replacing the sidewalk to meet current ADA standards.

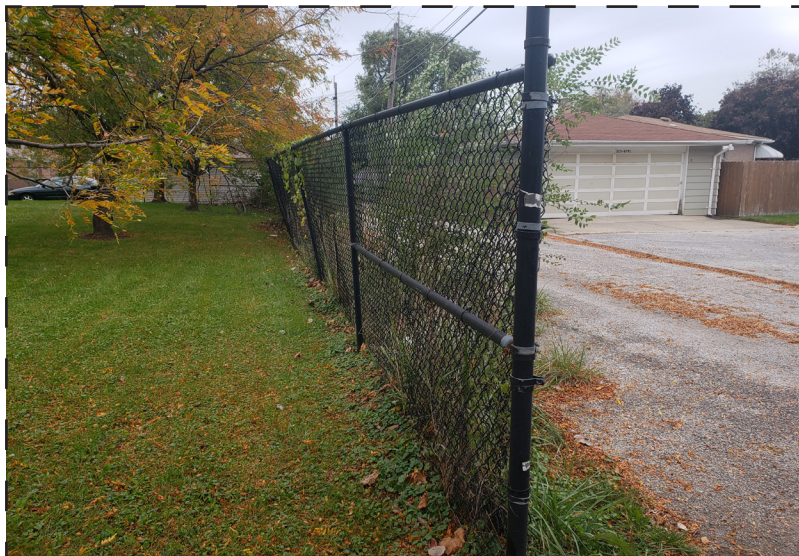
4- 3.2

Figure 4-3.2: There is an existing chain link fence along the east side of the property that is tilting over. Based on our field observation, we recommend removing and replacing or repairing approximately 100 lineal feet of the fence starting from the northeast corner.

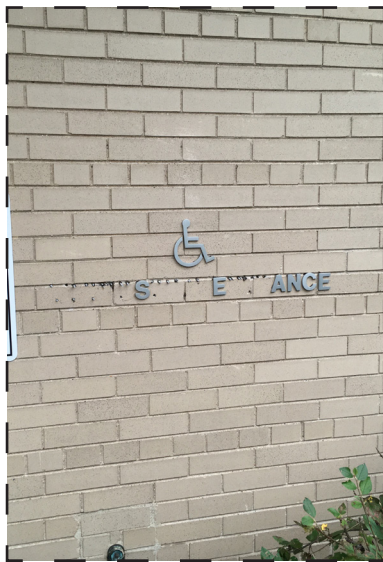
5- 2.4

Figure 5-2.4: Accessible entrance signage is broken and missing pieces.

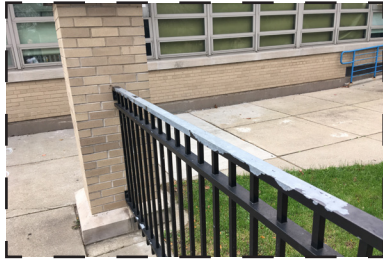
5- 3.1

Figure 5-3.1: Ornamental fence west of the north playground has chipped paint and exposed metal beneath the finish. There appears to be no structural issues but properly sanding and repainting is recommended.

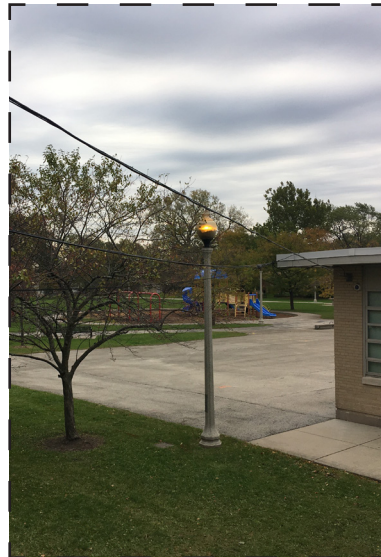
5- 3.3

Figures 5-3.2 and 3.3: Power lines extend over the north playground. Lines appear to be out of reach from current play equipment, but relocating lines is recommended.

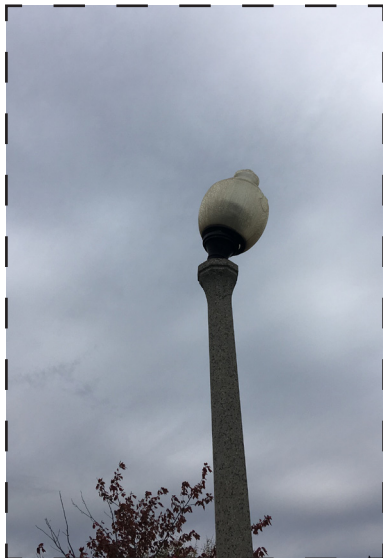
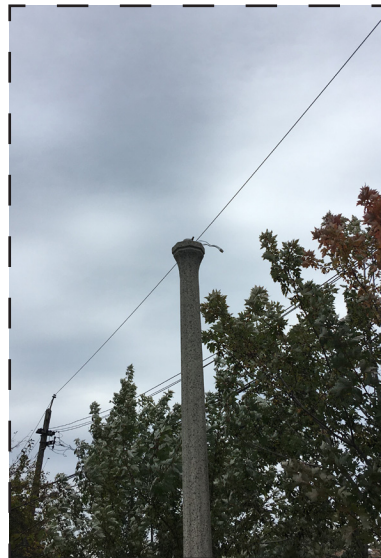
Figures 5-3.4 and 3.5: The sixteen (16) existing site lighting is in various states of disrepair with only four (4) of the lights to the south of the circulation path and one (1) to the north appear to be in good working order. Several lamps are broken (3), not working (2), or missing entirely (4). The two (2) spotlights directly west of the east playground were not on and could not be assessed if they are in working order.

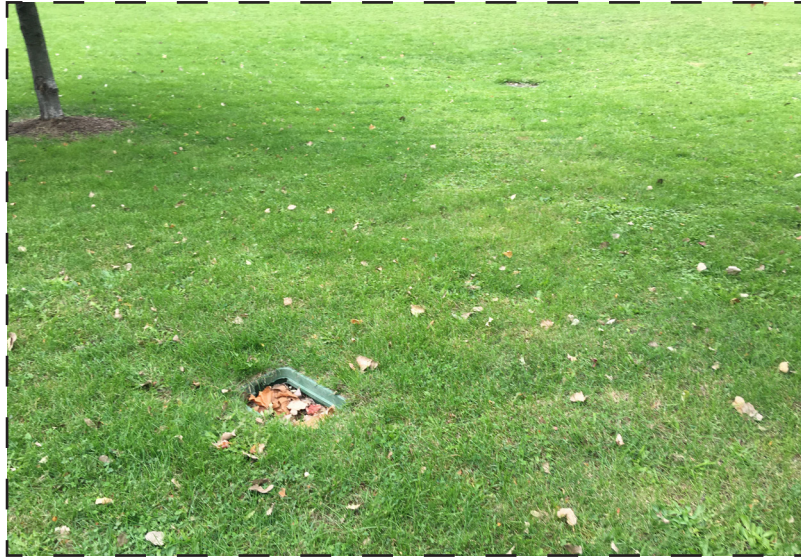
5- 4.1

Figure 5-4.1: There is a utility with a missing cover located within the east lawn near the circulation path on the east.

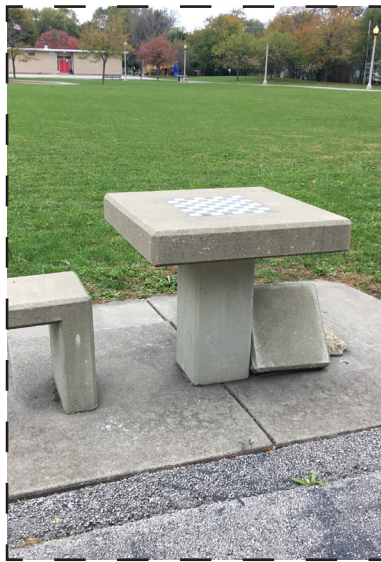
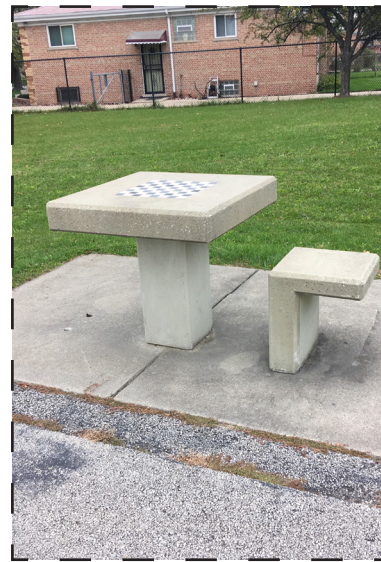
Figures 5-4.2 and 4.3: There are five (5) exterior chess tables situated around the east circulation path, all of which have broken or missing seats.

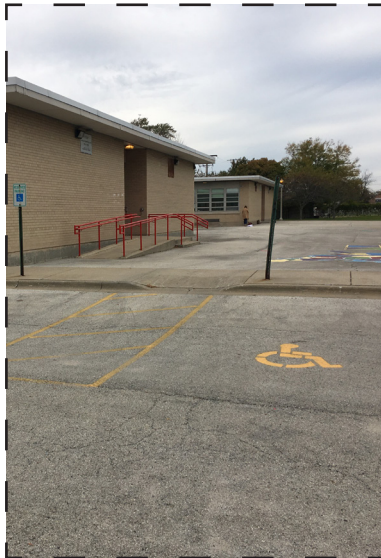
5- 5.2

Figure 5-5.2: The accessible parking spaces do not appear to meet current standards and are missing signage.

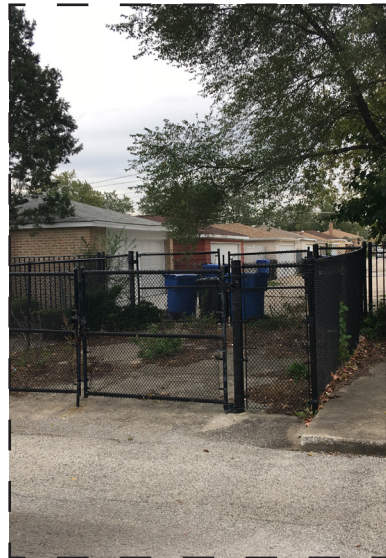
5- 5.3

Figure 5-5.3: There is an existing chain link enclosure in the middle of the parking lot on the southern edge that does not appear to be used. The space could be used for a trash enclosure if large enough to meet school needs or could be converted to landscape island in the future to meet landscape ordinance.

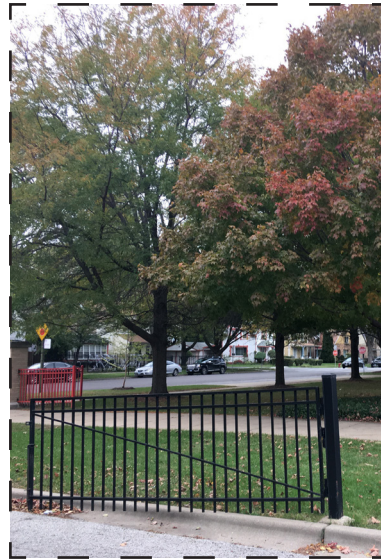
Figures 5- 6.1 and 6.2: The southern swing gate is broken off its hinges. The northern swing gate appears to lean and likely does not operate properly.

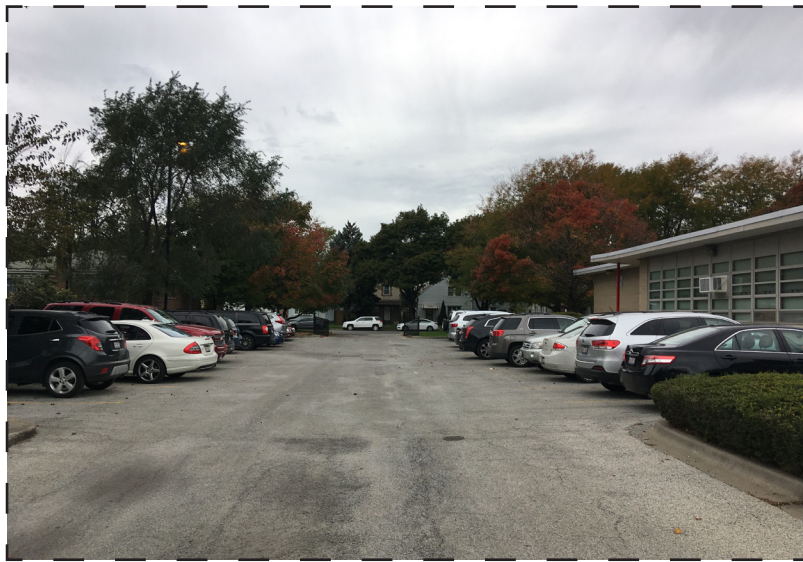
5- 6.3

Figure 5-6.3: Current parking lot does not appear to meet landscape ordinance. If new pavement is to be installed, parking lot will need to be updated to meet the ordinance.

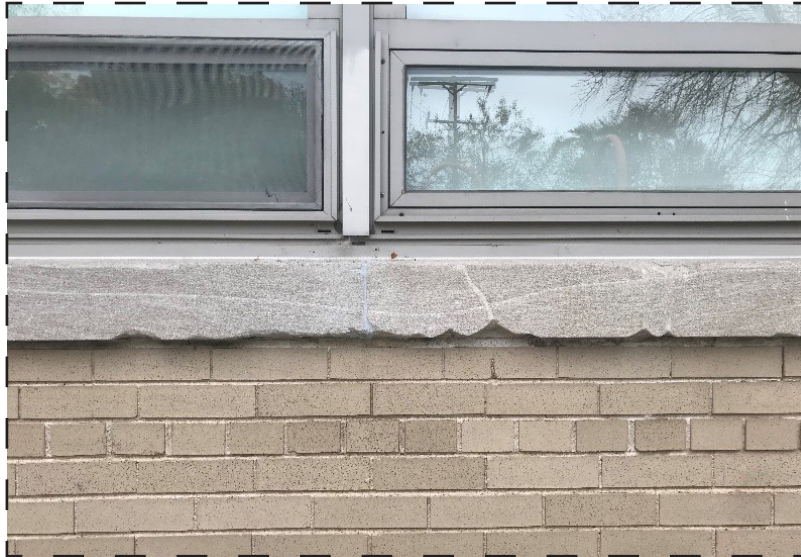
6- 2.1

Figures 6-2.1 illustrates a condition at a limestone window sill where vertical cracks have formed over time, and the bottom of the sill has spalled and broken off. This cosmetic type of deterioration of the limestone should be expected over the life of the building, and is not typical of all window sills of the building. There were no signs of water infiltration or other environmental issues with the sills. It is recommended that the cracks be packed with grout, as seen in many instances at existing cracks, with the sills being replaced if cracks appear to penetrate inwards inside the building, and/or the overall thickness of the sill has been reduced significantly.

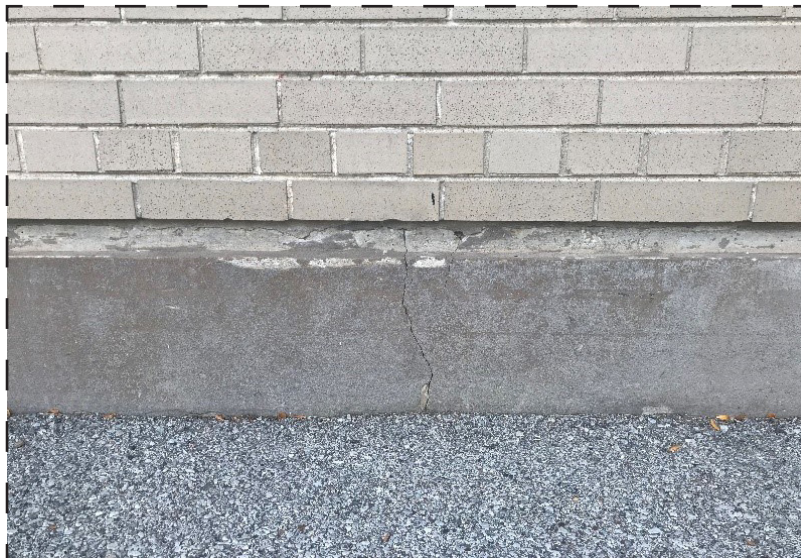
6- 2.2

Figures 6-2.2 illustrates the condition at the top of concrete foundation wall above grade. There were no signs of damage or water infiltration as a result of these hairline cracks. It is recommended that the cracks be grouted as seen in many instances around the perimeter of the building.

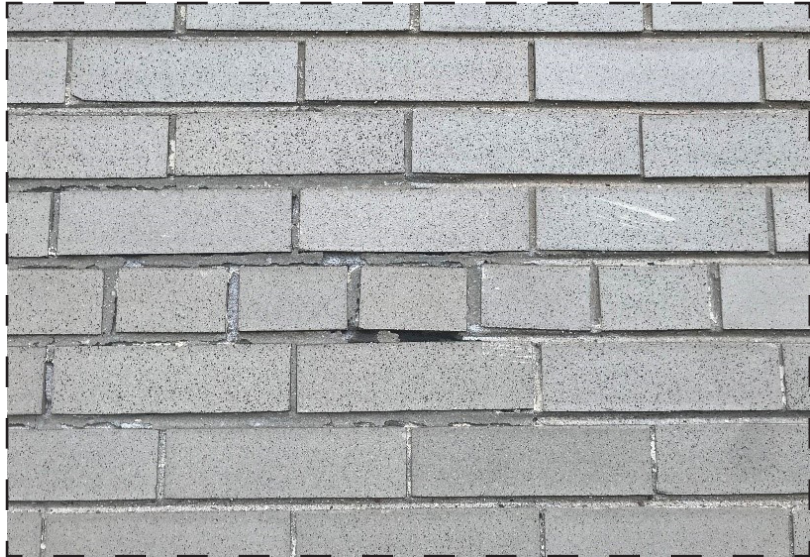
6- 3.1

Figure 6-3.1 illustrates the condition of brick veneer where mortar has been reduced, allowing the bricks to shift and develop further deterioration and cracking within the mortar beds. It is recommended that tuckpointing occur at various locations around the building where the non-structural brick veneer is shifting.

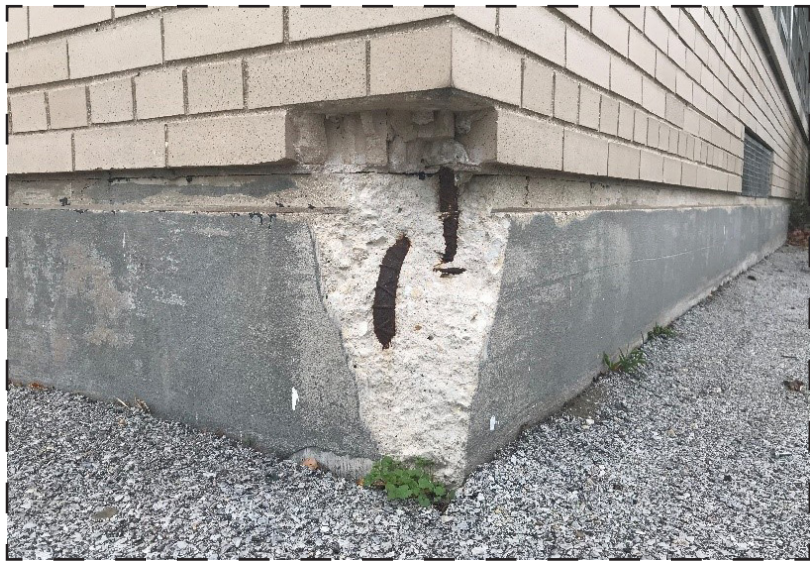
6- 3.2

Figure 6-3.2 illustrates a localized abnormality at the top of concrete foundation wall for the northeast corner of the southern half of the building. The original 90 degree corner of the wall has been damaged to the point where reinforcement is exposed to the elements, and the brick veneer has fallen off. A repair to the corner is recommended such that a portion of the wall is reconstructed on both sides of the corner. This would likely entail sawcutting or chipping away the concrete to create a clean surface, inspecting and grinding off the rust of the exposed reinforcement, forming a new portion of the concrete wall to match the original extents and to resupport the brick masonry veneer above.

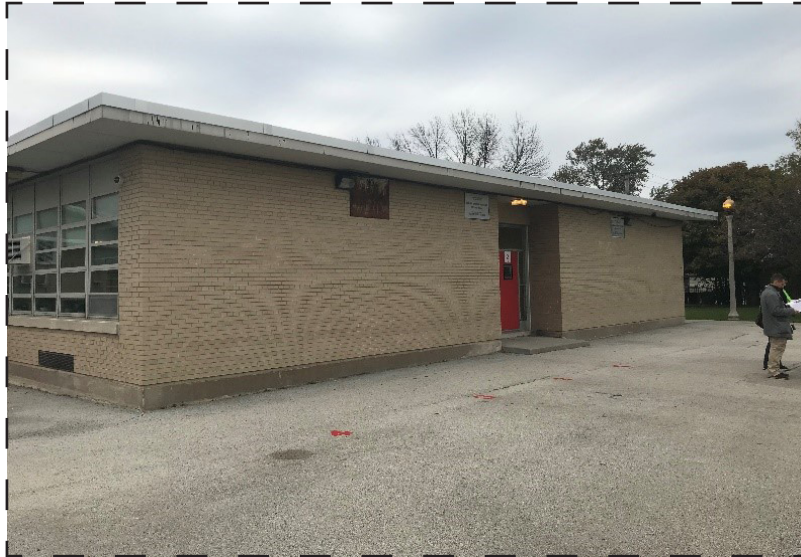
6- 4.1

Figure 6-4.1 illustrates the east façade on the north half of the building where the proposed annex is planned to connect. There are no observable structural issues at the existing exterior wall to preclude the annex to be positioned adjacent to the façade. Partial demolition of non-structural items along this façade is likely to be acceptable.

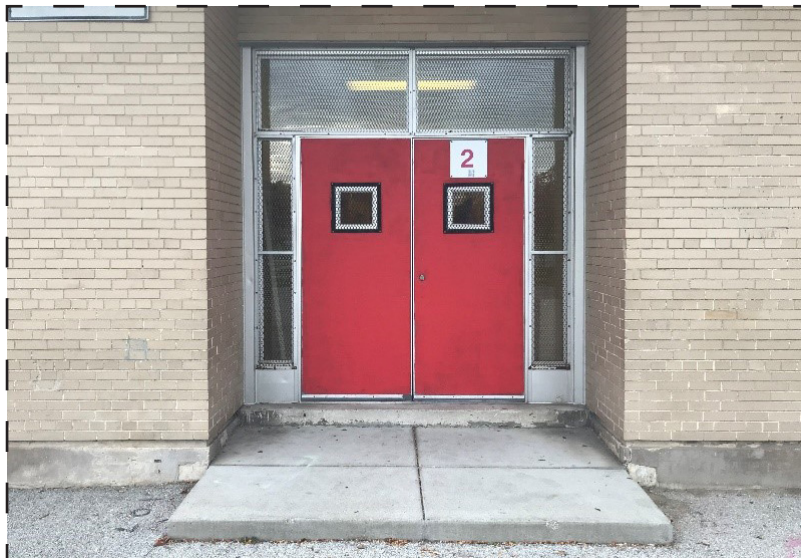
6- 4.2

Figure 6-4.2 illustrates the existing exit (Exit #2) that is proposed to be demolished to create a continuous corridor through the existing building and into the new annex. The structural opening in the masonry load bearing wall creating the framed out door appears to be in excellent condition, allowing removal of the architectural double-door, windows, and concrete stoop to be easily removed without impacted the structural integrity of the wall. The existing steel lintel above the door appears to be in excellent condition – no signs of corrosion, deflection, bending, out-of-plumbness. It is recommended that this be left in place as is unless the opening size needs to be increased.

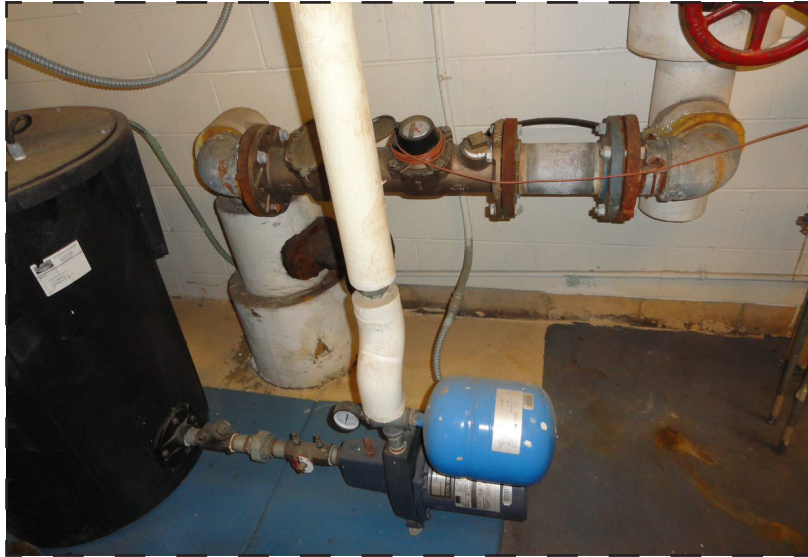
9- 2.1

Existing incoming water service. Recommend reworking service entry by replacing main gate valve and installed domestic water meter. Also recommend installing dual check back flow preventer. Asbestos abatement will be required.

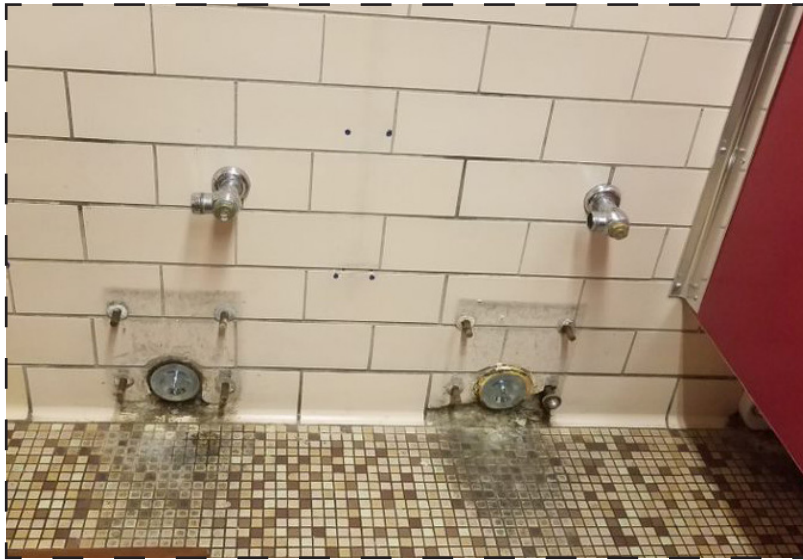
9- 3.2

Existing girls toilet room; fixtures were removed and capped to accommodate “ADA”

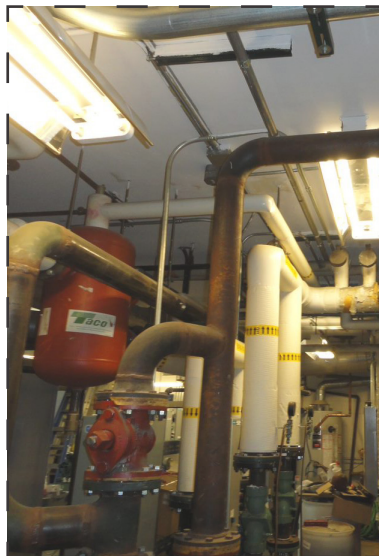
10- 2.3

Figure 10-2.3: Heating hot water pumps and supply main header. Should the existing plant be upgraded, a new header may be required, or the existing header would need to be increased. The existing distribution would remain, but an additional branch to serve the new Annex would be required. Existing pump performance is 165 GPM, 40 ft HD, and 3 HP. Pump size to be evaluated and replaced as necessary based on boiler plant upgrades.

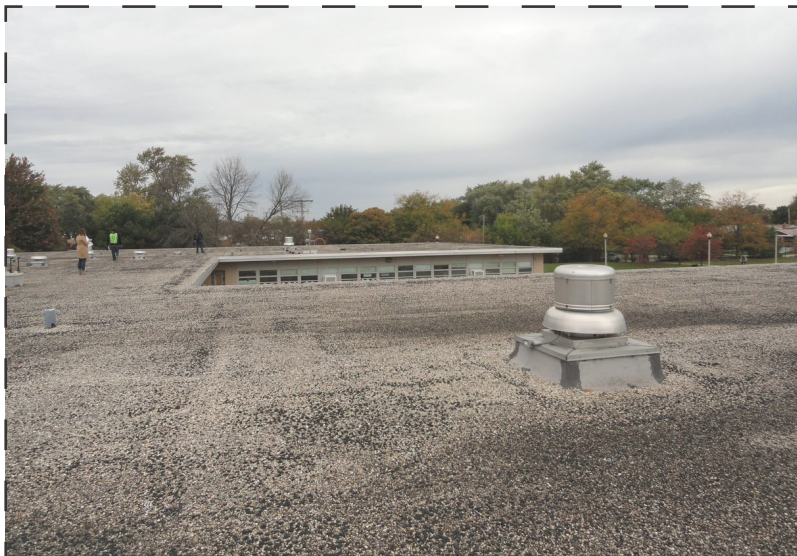
10- 4.3

Figure 10-4.3: Existing roof mounted exhaust fan serving boys toilet room. Recommended to replace the fan with along with the renovation of the toilet room (same for girl's toilet room).

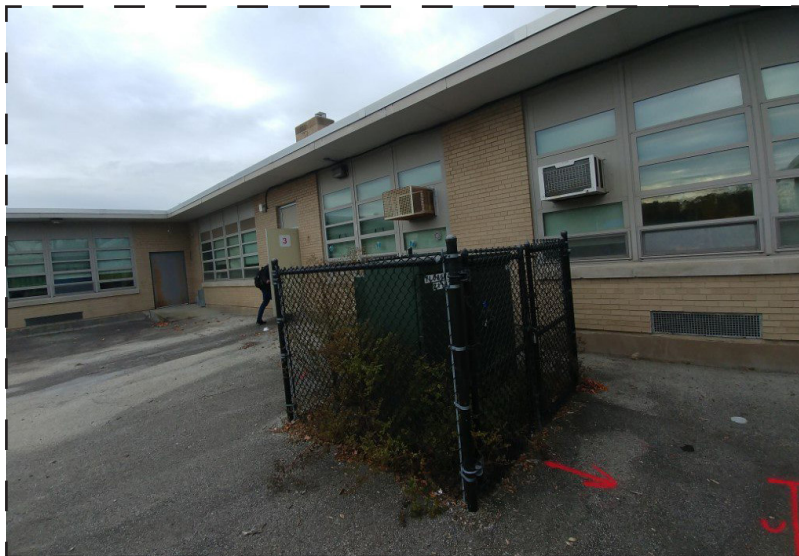
11- 1.2

Figure 11-1.2: Existing 75 kVA pad-mounted transformer. With a 68kVA power draw, it has insufficient capacity to serve the existing building as well as the new annex and warming kitchen. A transformer upgrade and/or additional service transformer (for the annex) will be required and shall be coordinated with ComEd.

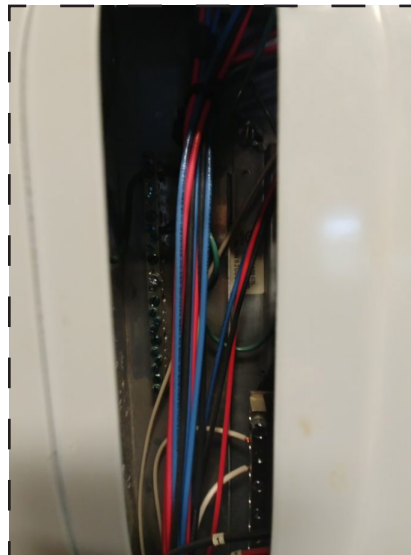
11- 2.2

Figure 11-2.2: Mechanical room panel does not appear to have any grounding with its branch feeders, although one is brought with the incoming feeders. While use of raceway is generally permitted for the grounding, it is generally not recommended. CPS should consider whether its feeders should be replaced to include equipment grounding conductors on newer equipment.

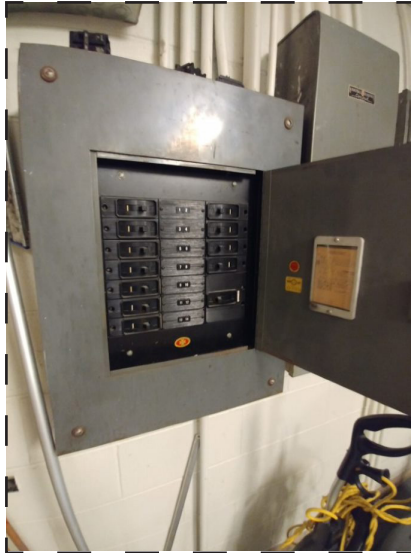
11- 3.1

Figure 11-3.1: Typical older power panel. these panels are significantly old and likely use cloth wiring and have no equipment grounding conductors. Phased replacement for panels and associated incoming and branch feeders (with grounding) is recommended for planning of the building's long-term.

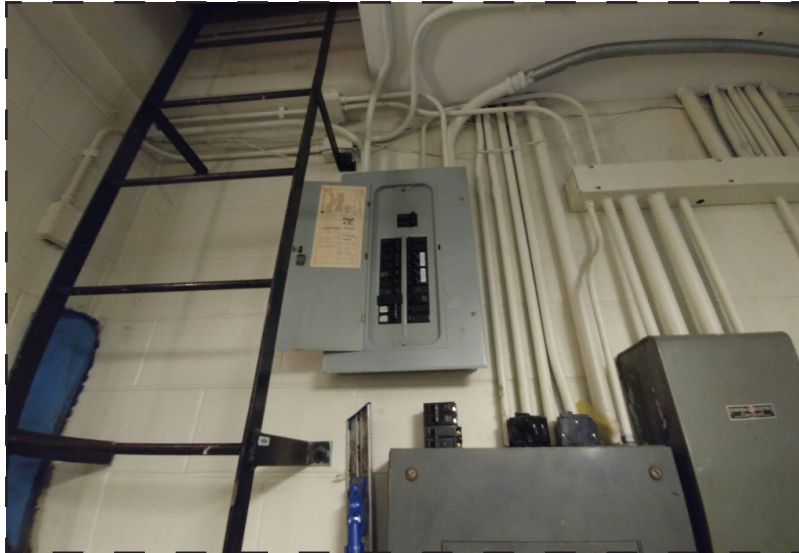
11- 4.1

Figure 11-4.1: Panelboard that is only operable by climbing a ladder within the mechanical room. This is a serious code violation and should be replaced and relocated elsewhere in the mechanical room. It should be noted that this panel appears to serve the emergency loads of the building (along with other loads); however, this panel is directly served by the main distribution and is not fed via the transfer switch. Refer to commentary of the emergency power for more information.

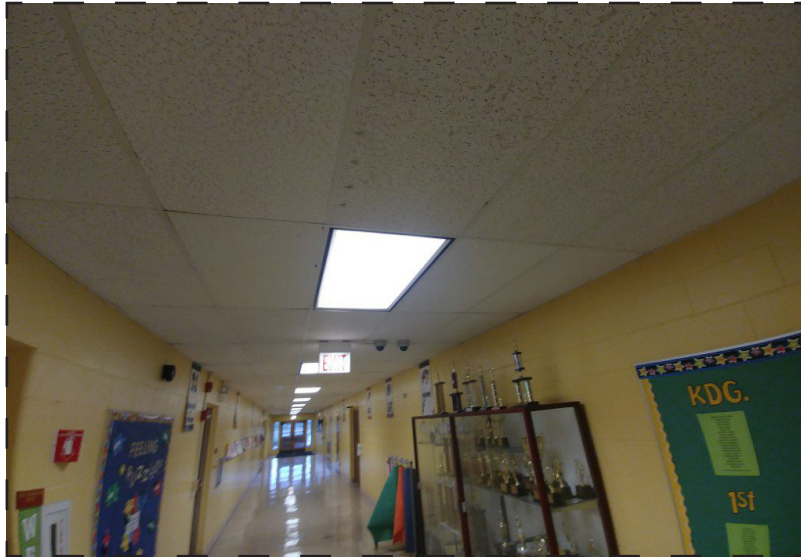
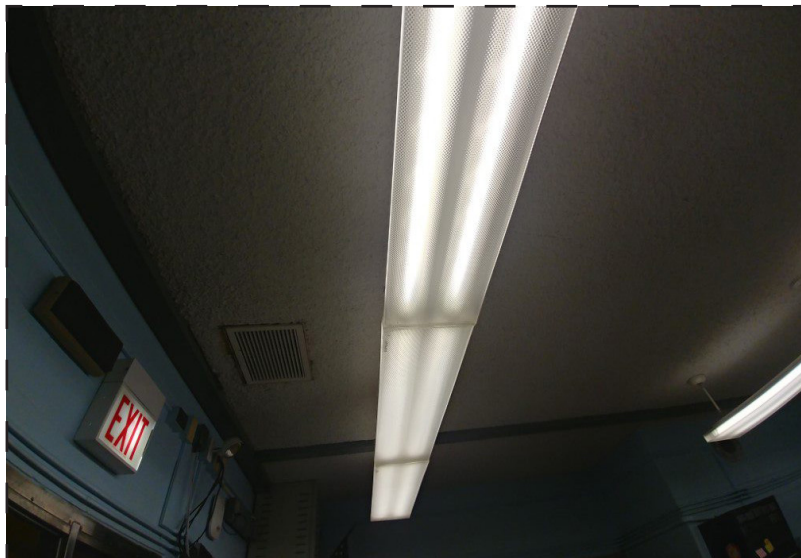
Figure 11- 8.1 and 8.2: Typical existing lights within the building. Generally, the lights are fluorescent (T8). There are time clocks installed for the building, but no other advanced lighting controls. To provide a common lighting standard to the building in coordination with the new annex construction, we recommend replacement of the existing lights with new LED-type of a standard CPS fixture, along with the installation of lighting controls in line with current energy codes and standards.

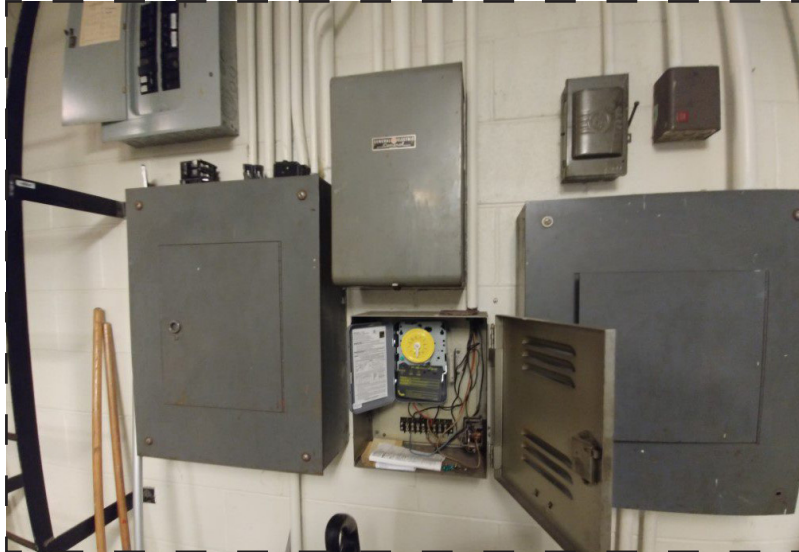
11- 9.1

Figure 11-9.1: Time clocks to provide controls to hallway lights and exterior lights. When CPS performs a phased replacement of the existing building's lighting, we strongly recommend the replacement of the lighting controls to be more in-line with current energy codes.

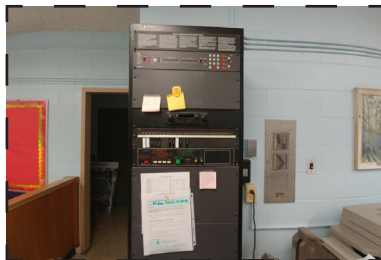
11- 12.3

Figure 11-12.3: Existing PA head-in equipment. Per conversation with building staff, the PA system is old and the sound output is very poor. Its replacement is strongly recommended to provide better sound and capacity to serve the new annex along with the existing building.

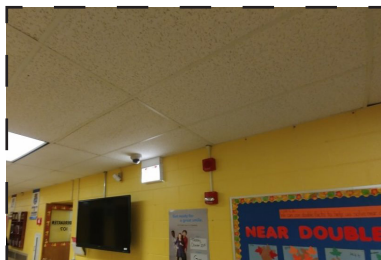
11- 12.4

Figure 11-12.4: Typical security camera. The quantities and locations appear to be adequate. Some changes will likely be required in line with the annex construction.

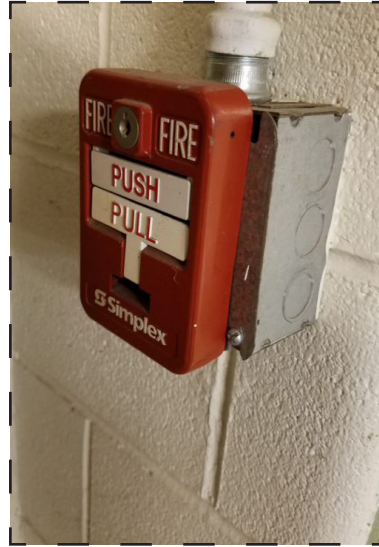
11- 16.2

Figure 11-16.2: Existing conventional manual pull-station. Under our proposed upgrades these would be replaced with addressable devices throughout the building. Same shall be performed for other initiating devices (e.g. smoke/heat detectors).

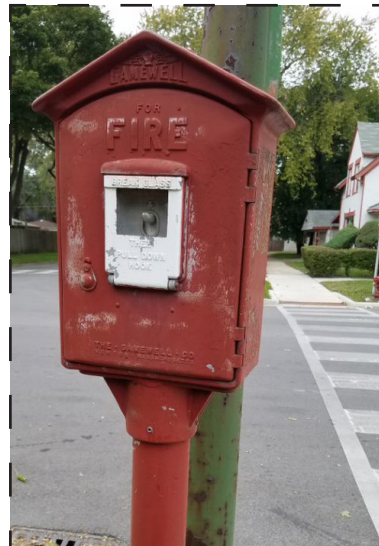
11- 16.4

Figure 11-16.4: Existing Gamewell City-tie Master Box. It is located approximately 50 feet from the main entrance. According to the building engineer, the city tie box is inoperable. Should it be required, it will need to be replaced.
