# EXHIBIT M – TEST PIT INVESTIGATION REPORT

**Re: Test Pit Investigation  
Proposed Engine Company 115 – Site B  
Northwest Corner of W. 119<sup>th</sup> St. & S. Morgan St.  
Chicago, Illinois 60643**

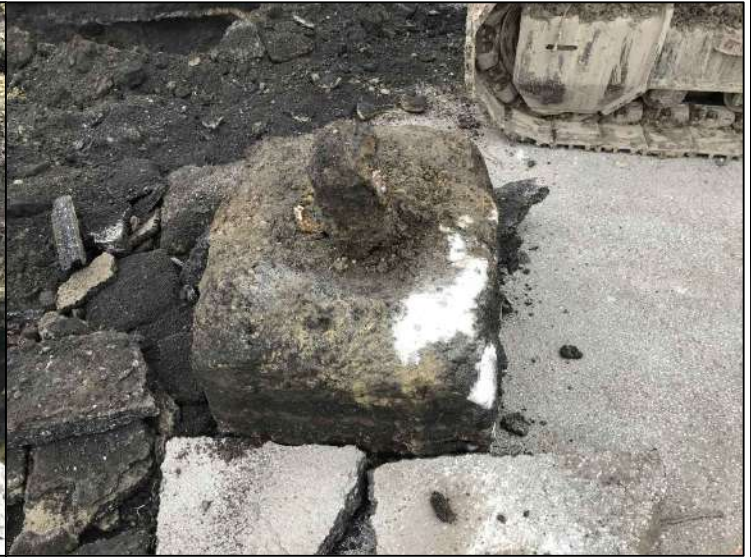
Test Pit	Anomaly	Size	GPS Location*	Observations
1	Southern EMI Zone	3.5' East-West 15' North-South ~5' depth	41 40.679 N -87 38.872 W 41 40.682 N -87 38.871 W	Approximately 6" asphalt underlain with black silty CLAY with light brown SAND at 3.5'. Large metal post support encountered at 2.5'. No noticeable odors.
2	Southern EMI Zone	3.5' East-West 15' North-South ~5' depth	41 40.685 N -87 38.866 W 41 40.683 N -87 38.869 W	Approximately 6" asphalt underlain with black silty CLAY with light brown SAND at 3.5'. No anomalies encountered. No noticeable odors.
3	Southern EMI Zone	3.5' East-West 15' North-South ~5' depth	41 40.677 N -87 38.845 W 41 40.674 N -87 38.849 W	Approximately 6" asphalt underlain with black silty CLAY with light brown SAND at 3.5'. No anomalies encountered. No noticeable odors.
4	Southern EMI Zone	3.5' East-West 15' North-South ~5.5' depth	41 40.676 N -87 38.810 W 41 40.679 N -87 38.815 W	Approximately 6" asphalt underlain with black silty CLAY with light brown SAND at 3.5'. Brick fragments encountered at 2'. No noticeable odors.

2: TP-1, obstruction

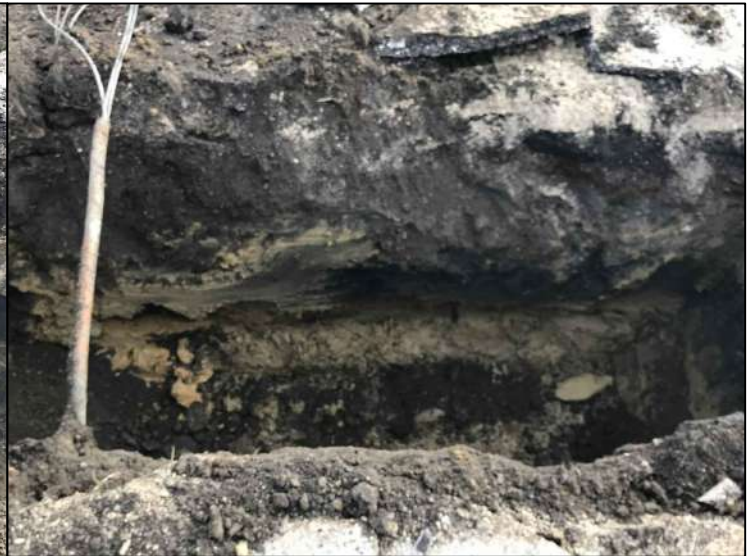
5	Southern EMI Zone	3.5' East-West 15' North-South ~5.5' depth	41 40.691 N -87 38.870 W 41 40.695 N -87 38.869 W	Approximately 6" asphalt underlain with black silty CLAY with light brown SAND at 3.5'. Relic utility line exposed at 1'. Broken foundation/brick fragments at 2'. No noticeable odors.
6	Southern EMI Zone	3.5' East-West 15' North-South ~5' depth	41 40.699 N -87 38.871 W 41 40.701 N -87 38.871 W	Approximately 6" asphalt underlain with black silty CLAY with light brown SAND at 3.5'. Broken foundation/brick fragments at 2'. No noticeable odors.
7	Southern EMI Zone	3.5' East-West 20' North-South ~5' depth	41 40.713 N -87 38.849 W 41 40.706 N -87 38.850 W	Approximately 6" asphalt underlain with black silty CLAY with light brown SAND at 3.5'. Broken foundation/brick fragments at 2'. No noticeable odors.
8	Southern EMI Zone	3.5' East-West 15' North-South ~5' depth	41 40.722 N -87 38.873 W 41 40.713 N -87 38.873 W	Approximately 6" asphalt underlain with black silty CLAY with light brown SAND at 3.5'. No anomalies encountered. No noticeable odors.

6: TP-5, with abandoned utility wire, view east

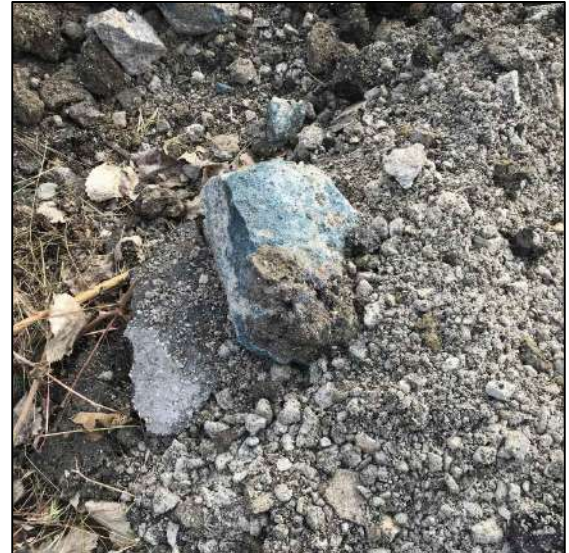
10	GPR East Zone	3.5' East-West 15' North-South ~5' depth	41 40.717 N -87 38.837 W 41 40.720 N -87 38.836 W	Approximately 6" asphalt underlain with black silty CLAY with light brown SAND at 3'. Broken blue stained concrete at 2'. No noticeable odors.
11	GPR East Zone	3.5' East-West 20' North-South ~5' depth	41 40.720 N -87 38.832 W 41 40.723 N -87 38.824 W	Approximately 6" asphalt underlain with black silty CLAY with light brown SAND at 3'. Broken blue stained concrete at 2'. No noticeable odors.
12	GPR East Zone	3.5' East-West 30' North-South ~5' depth	41 40.724 N -87 38.823 W 41 40.723 N -87 38.818 W	Approximately 6" asphalt underlain with black silty CLAY with light brown SAND at 3'. Broken brick at 2'. No noticeable odors.
13	GPR West Zone	3.5' East-West 40' North-South ~5.5' depth	41 40.732 N -87 38.875 W 41 40.834 N -87 38.862 W	Approximately 6" asphalt underlain with black silty CLAY with light brown SAND at 3'. Wood flooring and brick debris at 2-3, with perched water'. 6-9" metal pipe (possible relic water main) running perpendicular to trench at north end. No noticeable odors.

12: TP-10, stained concrete rubble

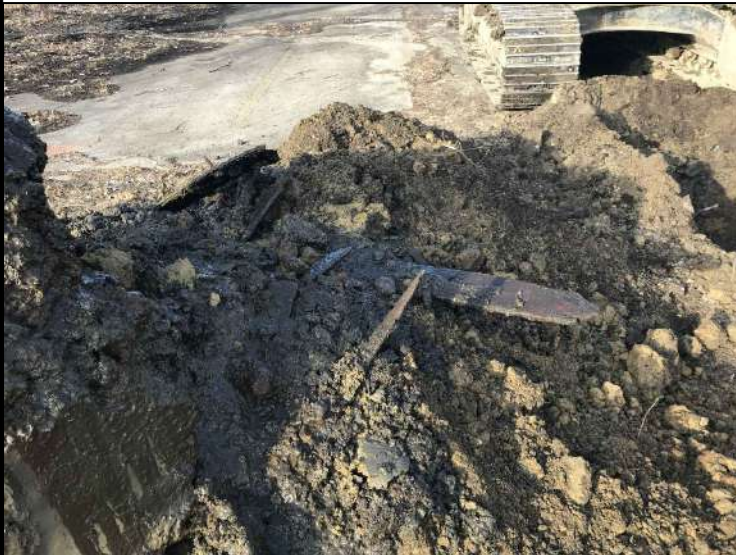
15: TP-13, building debris

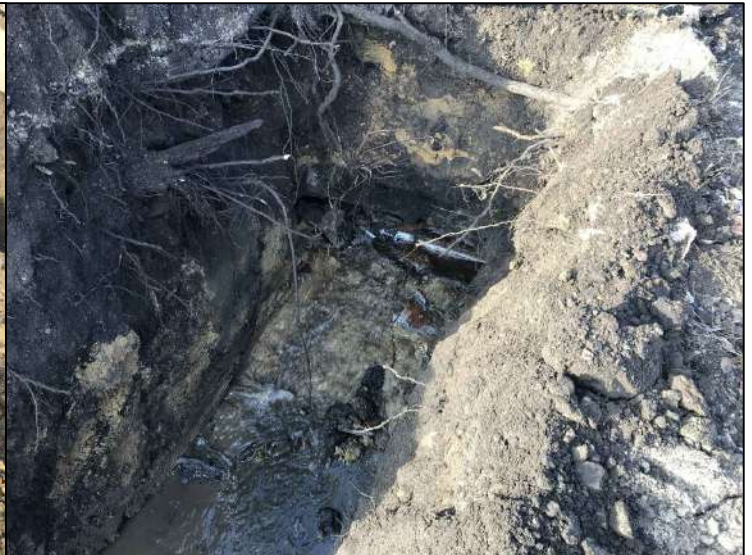
16: TP-13, probable abandoned water main, view north

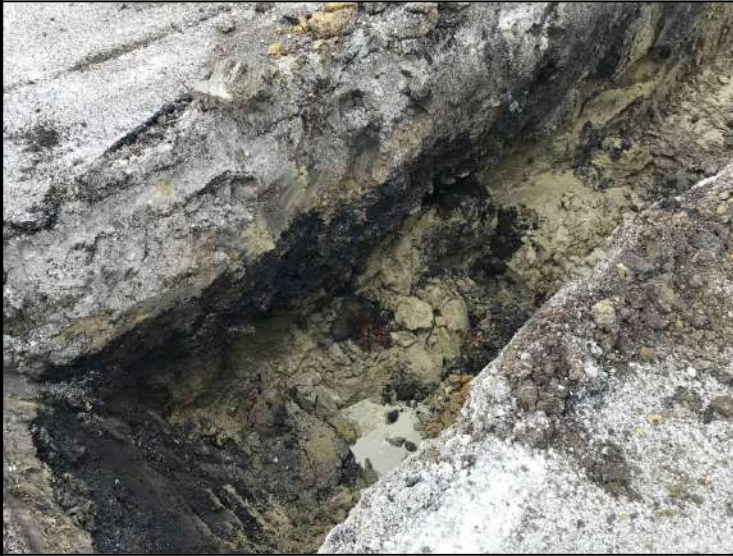
14	GPR West Zone	3.5' East-West 40' North-South ~5.5' depth	41 40.726 N -87 38.871 W 41.40.742 N -87 38.871 W	Approximately 6" asphalt underlain with black silty CLAY with light brown SAND at 3'. Brick foundation at 2-3' with perched water. No noticeable odors.
15	Northern EMI Zone	3.5' East-West 20' North-South ~5' depth	41 40.740 N -87 38.827 W 41 40.743N -87 38.828 W	Approximately 6" asphalt underlain with black silty CLAY with light brown SAND at 3'. Broken brick at 2'. No noticeable odors.
16	Northern EMI Zone	3.5' East-West 15' North-South ~5' depth	41 40.758 N -87 38.862 W 41 40.771 N -87 38.864 W	Approximately 6" asphalt underlain with black silty CLAY with light brown SAND at 3'. No anomalies encountered. No noticeable odors.
17	Northern EMI Zone	3.5' East-West 15' North-South ~5' depth	41 40.746 N -87 38.856 W 41 40.746 N -87 38.859 W	Approximately 6" asphalt underlain with black silty CLAY with light brown SAND at 3'. No anomalies encountered. No noticeable odors.

**17: TP-14, view west**

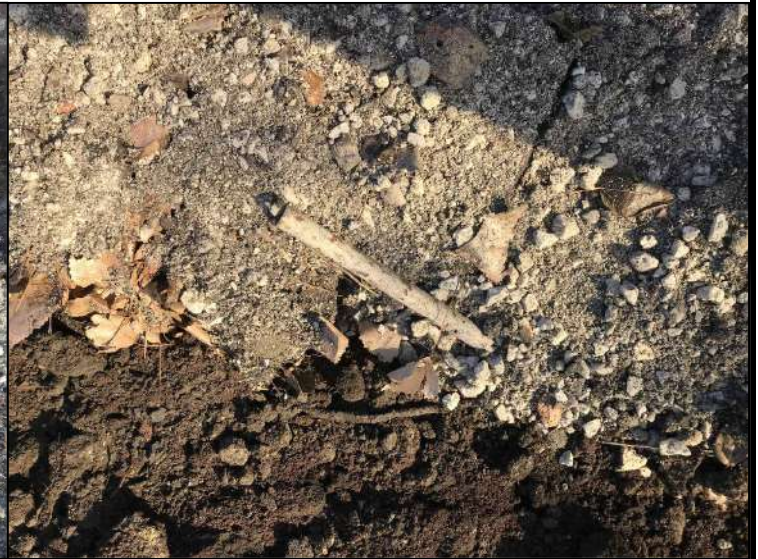
26: TP-22, metal debris

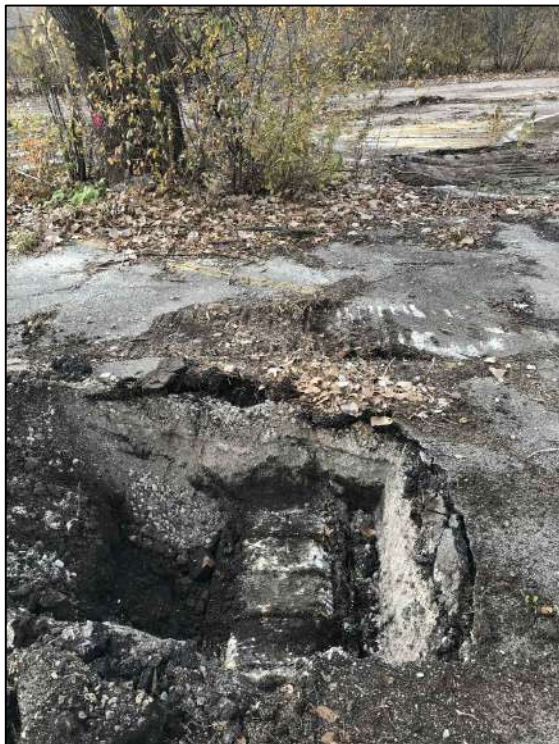
27: TP-22A, wall footing, view west

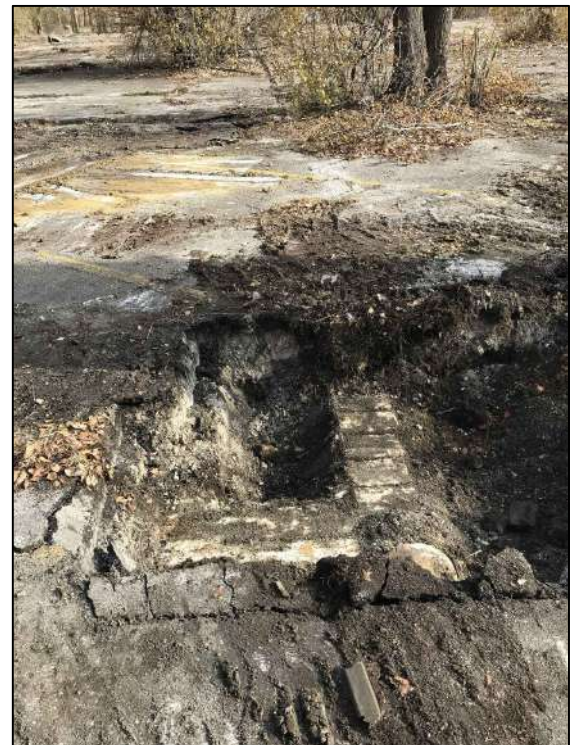
31	Northern EMI Zone	3.5' East-West 20' North-South ~5.5' deep	41 40.764 N -87 38.824 W 41 40.770 N -87 38.827 W	Approximately 6" asphalt underlain with black silty CLAY with light brown SAND at 3'. Concrete wall footing at south end. 1' wide, 18' bgs. 3.5' depth with base at ~5 bgs. No noticeable odors.
22A	Northern EMI Zone	3.5' East-West 3.5' North-South ~2' deep	41 40.754 N -87 38.864 W	Approximately 6" asphalt underlain with black silty CLAY with light brown SAND at 3'. Concrete wall footing located. No noticeable odors.
22B	Northern EMI Zone	3.5' East-West 3.5' North-South ~2' deep	41 40.752 N -87 38.873 W	Approximately 6" asphalt underlain with black silty CLAY with light brown SAND at 3'. Southwest corner concrete wall footing located. No noticeable odors.

28: TP-22B, corner wall footing, view east

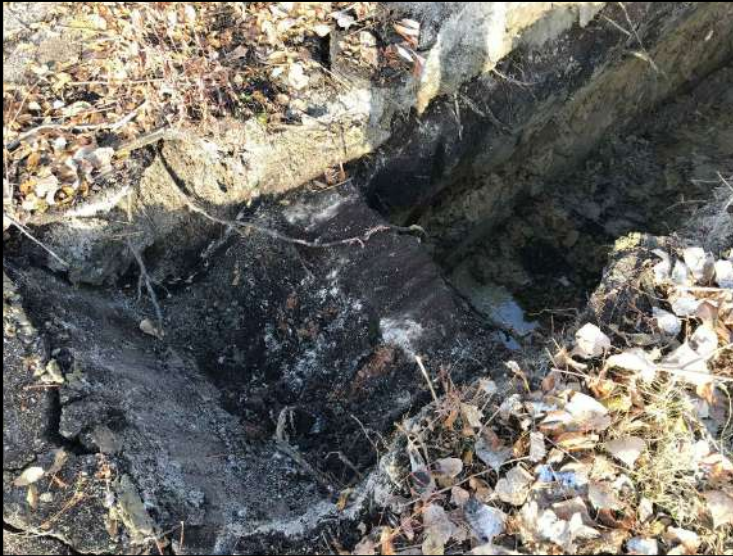
23	Northern EMI Zone	3.5' East-West 25' North-South ~5.5' deep	41 40.756 N -87 38.850 W 41 40.756 N -87 38.846 W	Approximately 6" asphalt underlain with black silty CLAY with light brown SAND at 3'. Concrete wall footing at south end. 1' wide, 18' bgs. 3.5' depth with base at ~5 bgs. No noticeable odors.
24	Northern EMI Zone	3.5' East-West 35' North-South ~5' deep	41 40.759 N -87 38.841 W 41.40.759 N -87 38.840 W	Approximately 6" asphalt underlain with black silty CLAY with light brown SAND at 3'. No anomalies encountered. Red sandy layer at 2' at south end. No noticeable odors.
25	Northern EMI Zone	3.5' East-West 15' North-South ~5.5' deep	41 40.761 N -87 38.832 W 41 40.761 N -87 38.835 W	Approximately 6" asphalt underlain with black silty CLAY with light brown SAND at 3'. Loose foundation pier at north end. Top of pier is ~2 bgs; pier is 12x12", approximately 3' south of north end. No noticeable odors.

29: TP-23, wall footing, view west

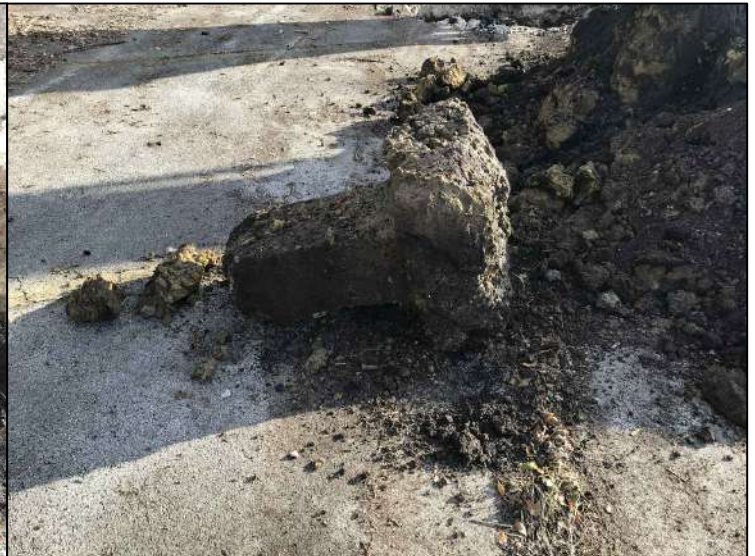
32: TP-25, foundation pier

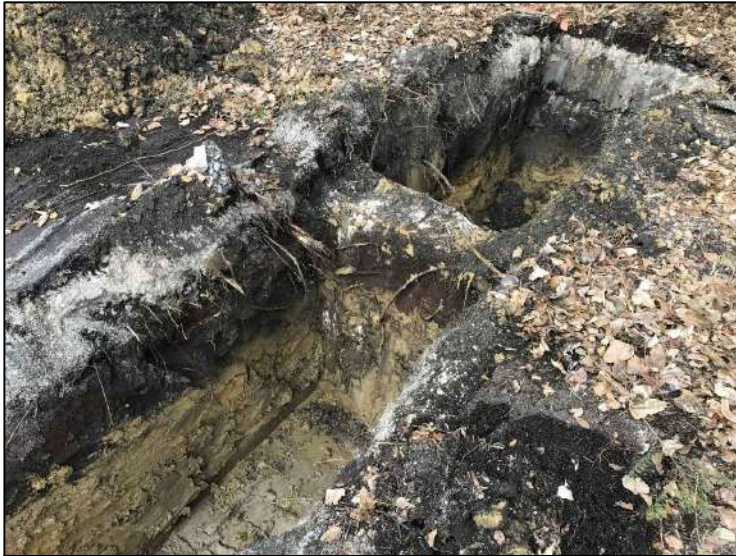
26	Northern EMI Zone	3.5' East-West 30' North-South ~5' deep	41 40.760 N -87 38.863 W 41 40.766 N -87 38.862 W	Approximately 6" asphalt underlain with black silty CLAY with light brown SAND at 3'. Concrete wall footing at north end. 1' wide, 18' bgs. 3.5' depth with base at ~5 bgs. No noticeable odors.
27	Northern EMI Zone	3.5' East-West 15' North-South ~5' deep	41 40.761 N -87 38.854 W 41 40.766 N -87 38.849 W	Approximately 6" asphalt underlain with black silty CLAY with light brown SAND at 3'. No anomalies encountered. Red sandy layer at 2' at south end. No noticeable odors.

33: TP-26, wall footing, view west

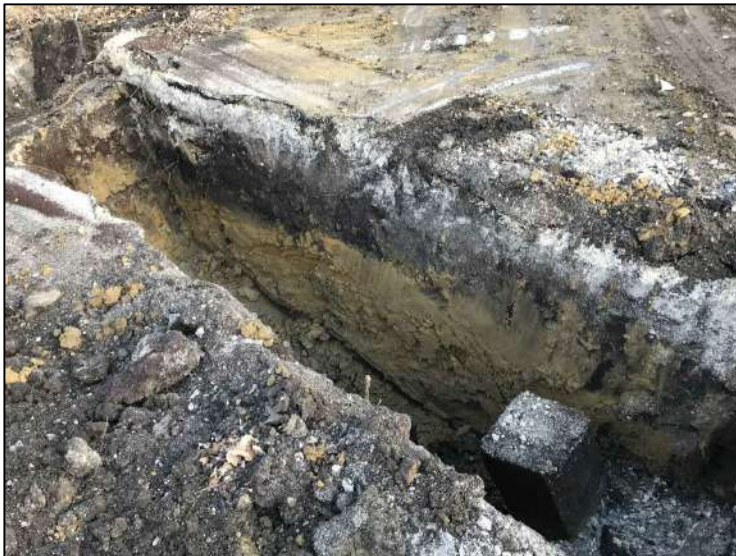
28	Northern EMI Zone	3.5' East-West 20' North-South ~5' deep	41 40.764 N -87 38.844 W 41 40.765 N -87 38.844 W	Approximately 6" asphalt underlain with black silty CLAY with light brown SAND at 3'. Concrete wall footing at north end. 1' wide, 18' bgs. 3.5' depth with base at ~5 bgs. Foundation pier at south end. Top of pier is ~2 bgs; pier is 12x12", approximately 2' north of south end. No noticeable odors.
29	Northern EMI Zone	3.5' East-West 20' North-South ~5' deep	41 40.767 N -87 38.844 W 41 40.767 N -87 38.843 W	Approximately 6" asphalt underlain with black silty CLAY with light brown SAND at 3'. Concrete wall footing at north end. 1' wide, 18' bgs. 3.5' depth with base at ~5 bgs. No noticeable odors.
30	Northern EMI Zone	3.5' East-West 15' North-South ~5' deep	41 40.762 N -87 38.831 W 41 40.766 N -87 38.829 W	Approximately 6" asphalt underlain with black silty CLAY with light brown SAND at 3'. Concrete wall footing at north end. 1' wide, 18' bgs. 3.5' depth with base at ~5 bgs. 6" drainage pipe south of foot wall approximately 2' bgs. Relic utility wire at south end approximately 2' bgs. No noticeable odors.

35: TP-28, foundation pier, view east

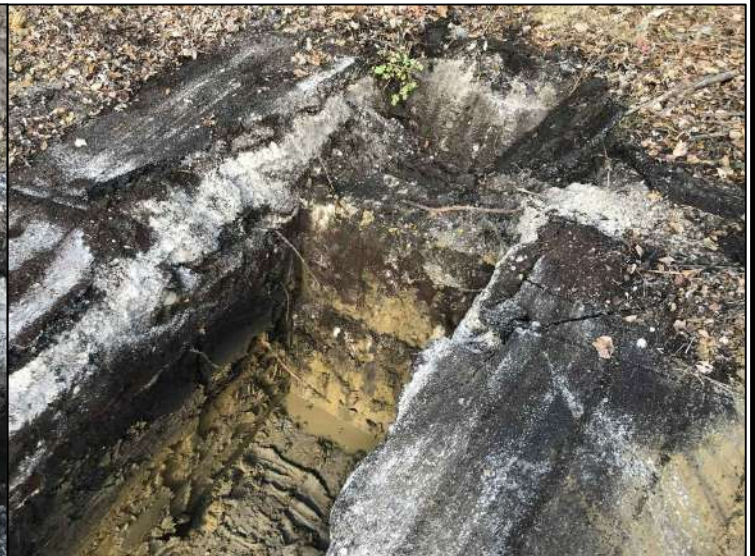
36: TP-28, foundation wall, view west

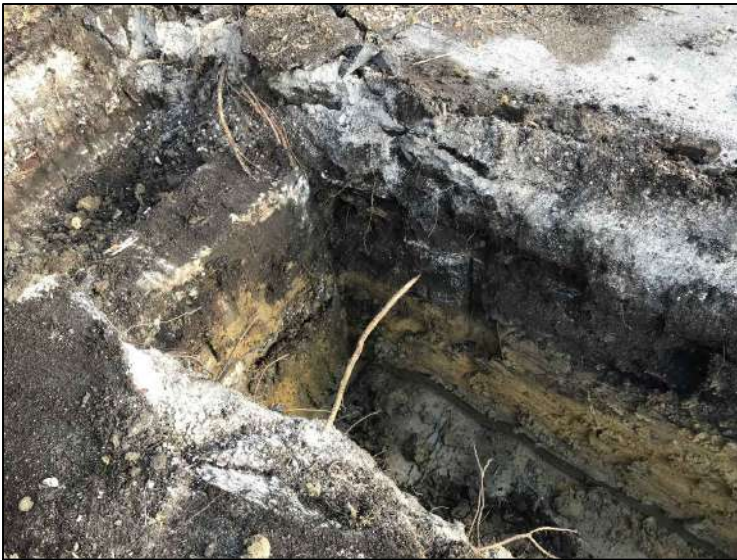
**37: TP-29, wall footing, view east**

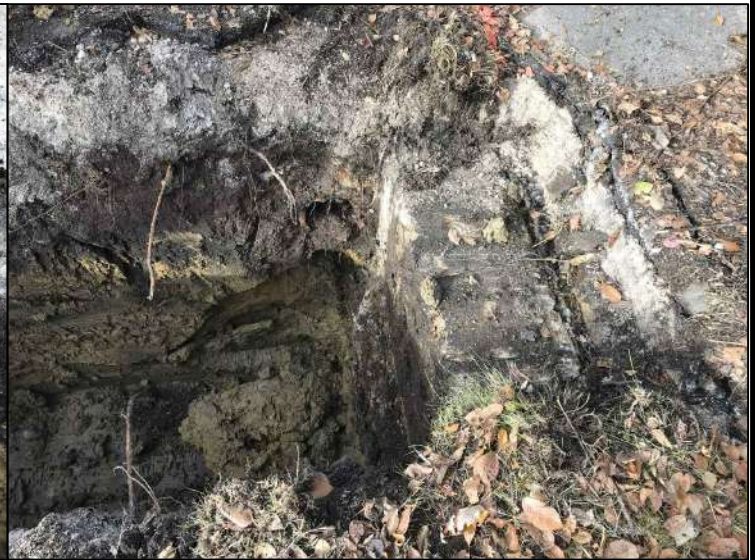
**38: TP-30, wall footing, view west**

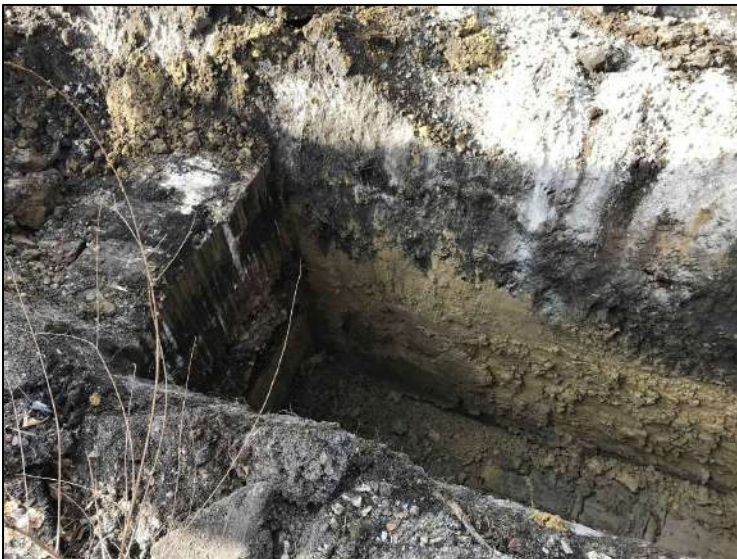
**39: TP-31, wall footing, view east**
