EXHIBIT M – TEST PIT INVESTIGATION REPORT

**Re: Test Pit Investigation
Proposed Engine Company 115 – Site B
Northwest Corner of W. 119th St. & S. Morgan St.
Chicago, Illinois 60643**

Exhibit I: Test Pit Location Map
Proposed Engine Company 115 - Site B
Northwest Corner of W. 119th St. & S. Morgan St.
Chicago, Illinois 60643

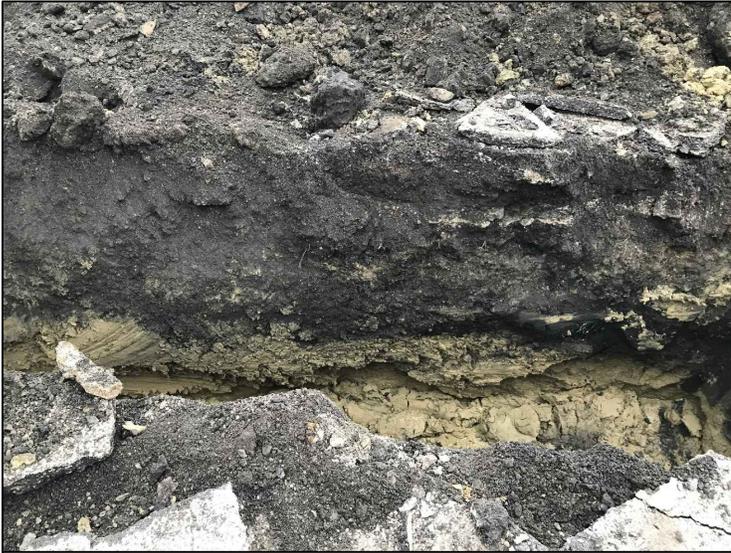
1: TP-1, view east

| Test Pit | Anomaly | Size | GPS Location* | Observations |
|---|---|--|--|---|
| 1 | Southern EMI Zone | 3.5' East-West 15' North-South ~5' depth | 41 40.679 N -87 38.872 W 41 40.682 N -87 38.871 W | Approximately 6" asphalt underlain with black silty CLAY with light brown SAND at 3.5'. Large metal post support encountered at 2.5'. No noticeable odors. |

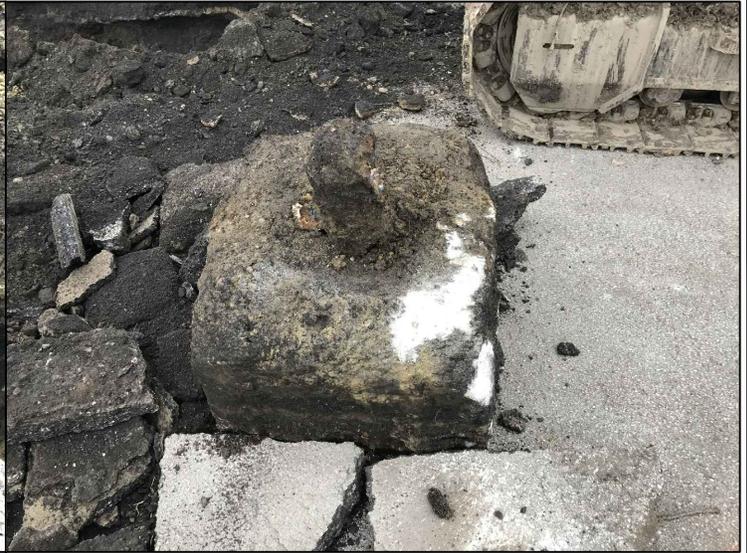
2: TP-1, obstruction

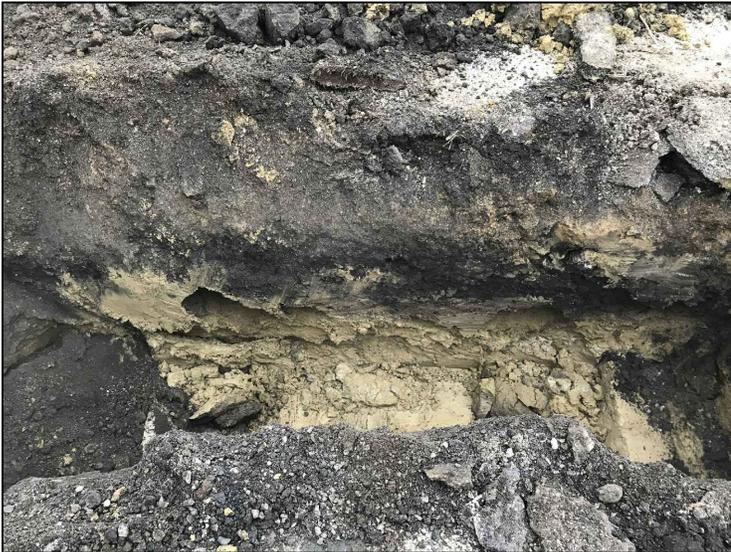
3: TP-2, view east

| Test Pit | Anomaly | Size | GPS Location* | Observations |
|---|---|--|--|---|
| 2 | Southern EMI Zone | 3.5' East-West 15' North-South ~5' depth | 41 40.685 N -87 38.866 W 41 40.683 N -87 38.869 W | Approximately 6" asphalt underlain with black silty CLAY with light brown SAND at 3.5'. No anomalies encountered. No noticeable odors. |

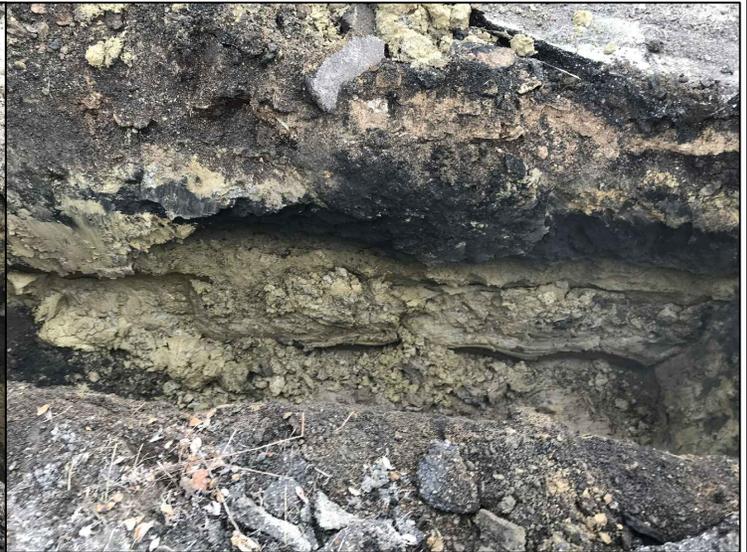
4: TP-3, view east

| Test Pit | Anomaly | Size | GPS Location* | Observations |
|---|---|--|--|---|
| 3 | Southern EMI Zone | 3.5' East-West 15' North-South ~5' depth | 41 40.677 N -87 38.845 W 41 40.674 N -87 38.849 W | Approximately 6" asphalt underlain with black silty CLAY with light brown SAND at 3.5'. No anomalies encountered. No noticeable odors. |

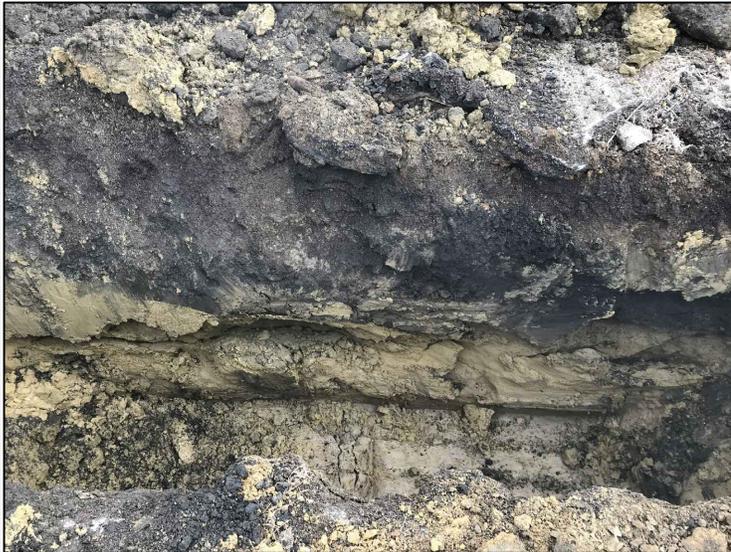
5: TP-4, view east

| Test Pit | Anomaly | Size | GPS Location* | Observations |
|---|---|--|--|---|
| 4 | Southern EMI Zone | 3.5' East-West 15' North-South ~5.5' depth | 41 40.676 N -87 38.810 W 41 40.679 N -87 38.815 W | Approximately 6" asphalt underlain with black silty CLAY with light brown SAND at 3.5'. Brick fragments encountered at 2'. No noticeable odors. |

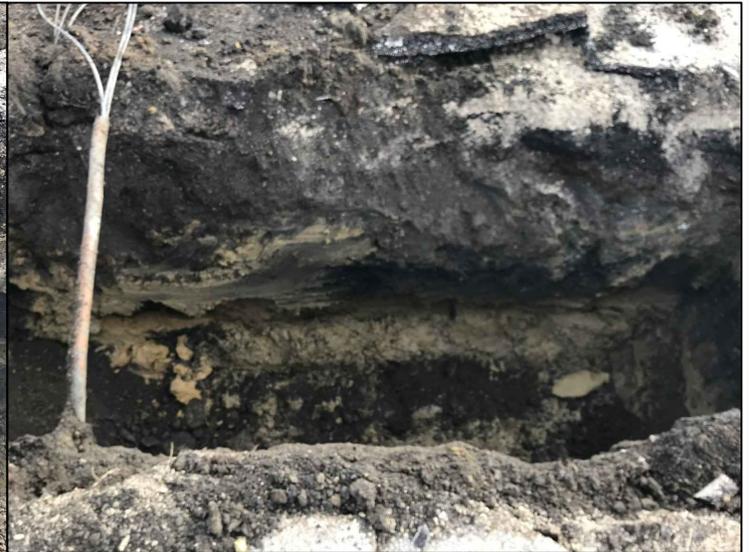
| Test Pit | Anomaly | Size | GPS Location* | Observations |
|---|---|--|--|---|
| 5 | Southern EMI Zone | 3.5' East-West 15' North-South ~5.5' depth | 41 40.691 N -87 38.870 W 41 40.695 N -87 38.869 W | Approximately 6" asphalt underlain with black silty CLAY with light brown SAND at 3.5'. Relic utility line exposed at 1'. Broken foundation/brick fragments at 2'. No noticeable odors. |

6: TP-5, with abandoned utility wire, view east

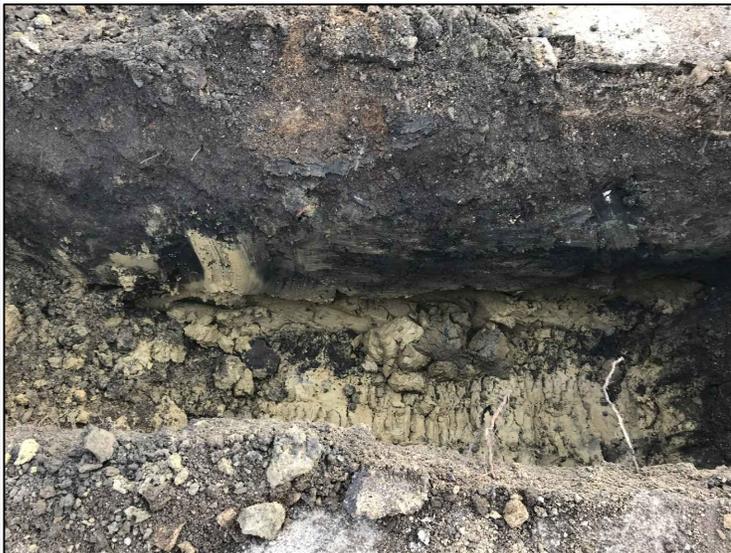
7: TP-6, view east

| Test Pit | Anomaly | Size | GPS Location* | Observations |
|---|---|--|--|---|
| 6 | Southern EMI Zone | 3.5' East-West 15' North-South ~5' depth | 41 40.699 N -87 38.871 W 41 40.701 N -87 38.871 W | Approximately 6" asphalt underlain with black silty CLAY with light brown SAND at 3.5'. Broken foundation/brick fragments at 2'. No noticeable odors. |

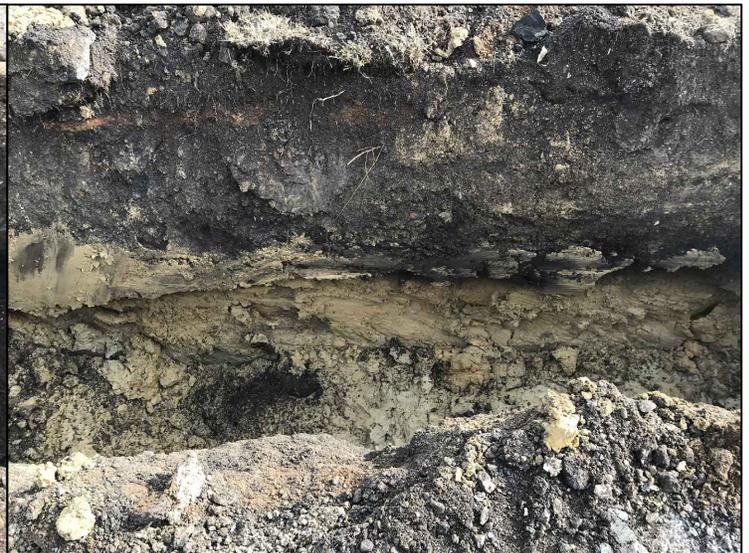
8: TP-7, view east

| Test Pit | Anomaly | Size | GPS Location* | Observations |
|---|---|--|--|---|
| 7 | Southern EMI Zone | 3.5' East-West 20' North-South ~5' depth | 41 40.713 N -87 38.849 W 41 40.706 N -87 38.850 W | Approximately 6" asphalt underlain with black silty CLAY with light brown SAND at 3.5'. Broken foundation/brick fragments at 2'. No noticeable odors. |

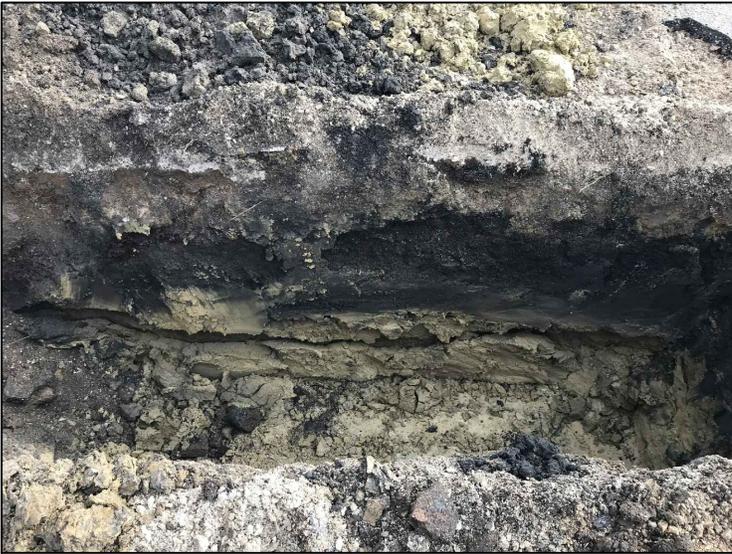
9: TP-8, view east

| Test Pit | Anomaly | Size | GPS Location* | Observations |
|---|---|--|--|---|
| 8 | Southern EMI Zone | 3.5' East-West 15' North-South ~5' depth | 41 40.722 N -87 38.873 W 41 40.713 N -87 38.873 W | Approximately 6" asphalt underlain with black silty CLAY with light brown SAND at 3.5'. No anomalies encountered. No noticeable odors. |

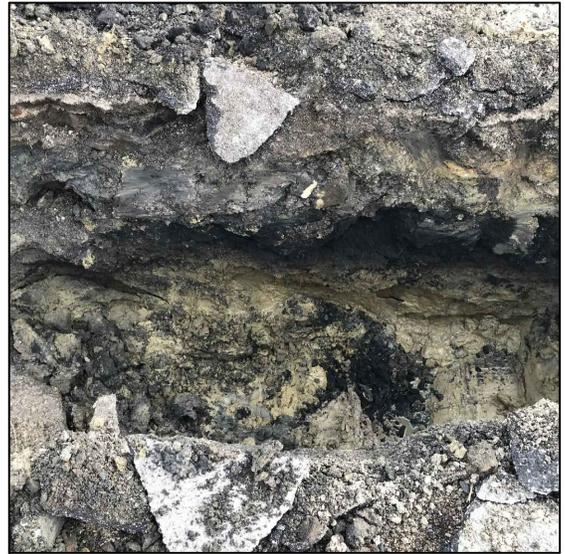
10: TP-9, view east

| Test Pit | Anomaly | Size | GPS Location* | Observations |
|---|---|--|--|---|
| 9 | Southern EMI Zone | 3.5' East-West 15' North-South ~5' depth | 41 40.712 N -87 38.878 W 41 40.714 N -87 38.852 W | Approximately 6" asphalt underlain with black silty CLAY with light brown SAND at 3'. Broken foundation material and storm drain found at 3'. No noticeable odors. |

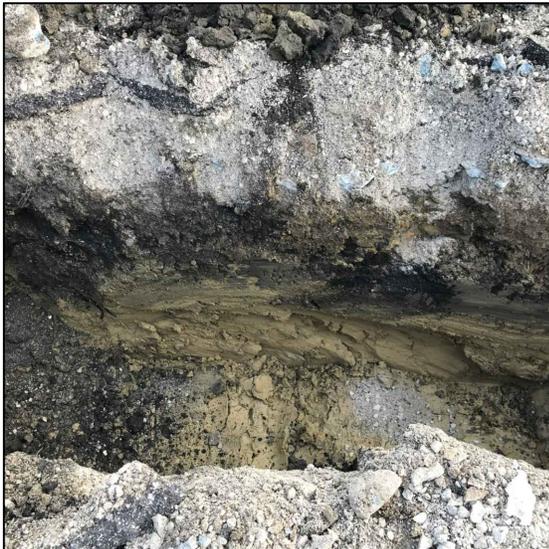
11: TP-10, view east

| 10 | GPR East Zone | 3.5' East-West 15' North-South ~5' depth | 41 40.717 N -87 38.837 W 41 40.720 N -87 38.836 W | Approximately 6" asphalt underlain with black silty CLAY with light brown SAND at 3'. Broken blue stained concrete at 2'. No noticeable odors. |

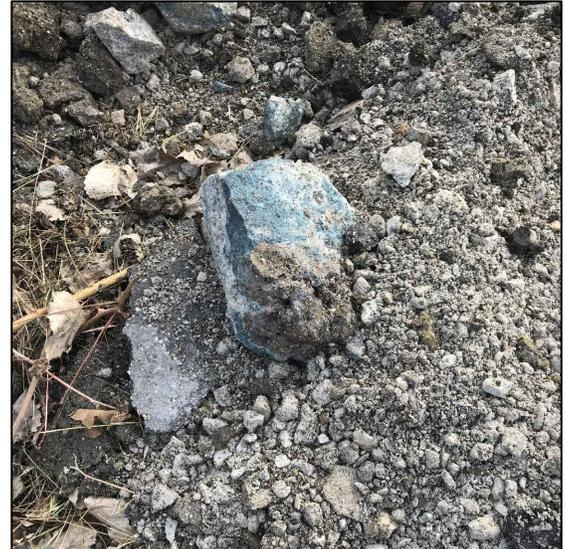
12: TP-10, stained concrete rubble

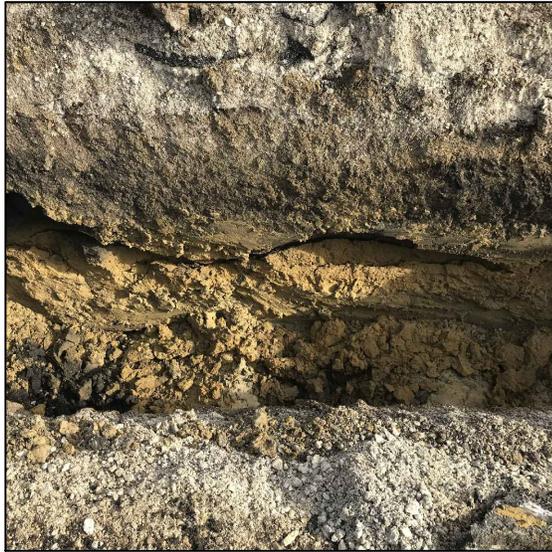
13: TP-11, view east

| 11 | GPR East Zone | 3.5' East-West 20' North-South ~5' depth | 41 40.720 N -87 38.832 W 41 40.723 N -87 38.824 W | Approximately 6" asphalt underlain with black silty CLAY with light brown SAND at 3'. Broken blue stained concrete at 2'. No noticeable odors. |

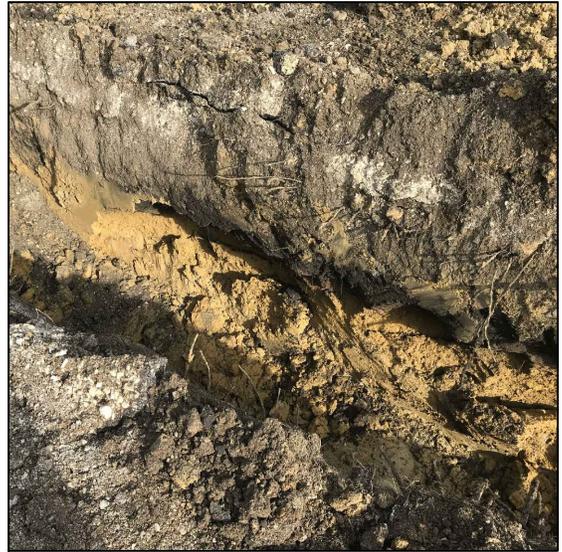
14: TP-12, view east

| 12 | GPR East Zone | 3.5' East-West 30' North-South ~5' depth | 41 40.724 N -87 38.823 W 41 40.723 N -87 38.818 W | Approximately 6" asphalt underlain with black silty CLAY with light brown SAND at 3'. Broken brick at 2'. No noticeable odors. |

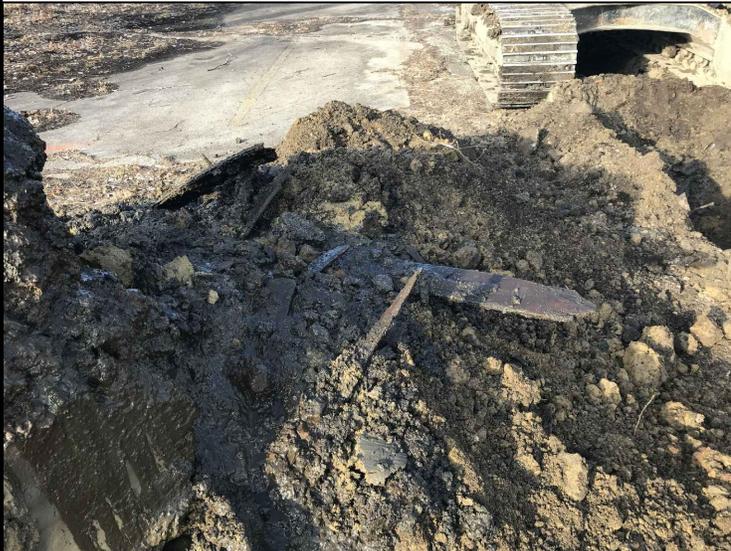
| 13 | GPR West Zone | 3.5' East-West 40' North-South ~5.5' depth | 41 40.732 N -87 38.875 W 41 40.834 N -87 38.862 W | Approximately 6" asphalt underlain with black silty CLAY with light brown SAND at 3'. Wood flooring and brick debris at 2-3, with perched water'. 6-9" metal pipe (possible relic water main) running perpendicular to trench at north end. No noticeable odors. |

15: TP-13, building debris

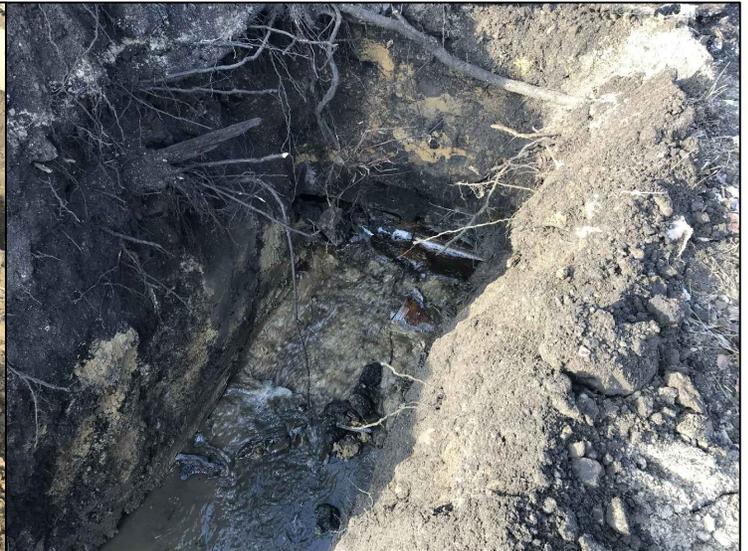
16: TP-13, probable abandoned water main, view north

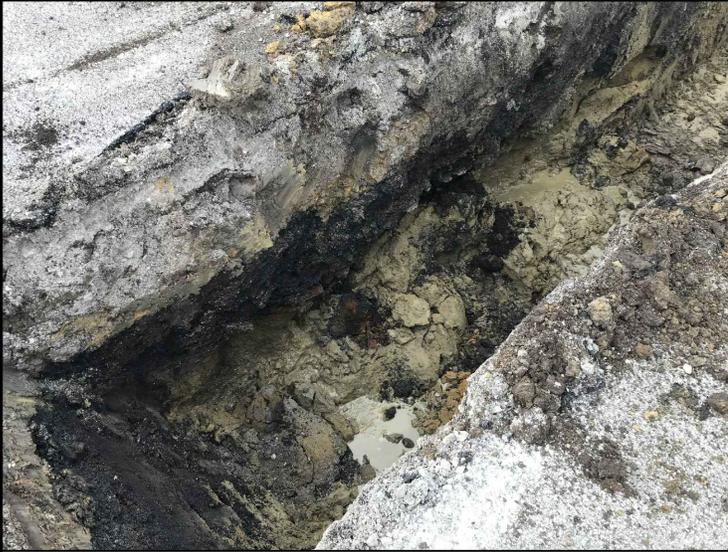
17: TP-14, view west

| 14 | GPR West Zone | 3.5' East-West 40' North-South ~5.5' depth | 41 40.726 N -87 38.871 W 41.40.742 N -87 38.871 W | Approximately 6" asphalt underlain with black silty CLAY with light brown SAND at 3'. Brick foundation at 2-3' with perched water. No noticeable odors. |

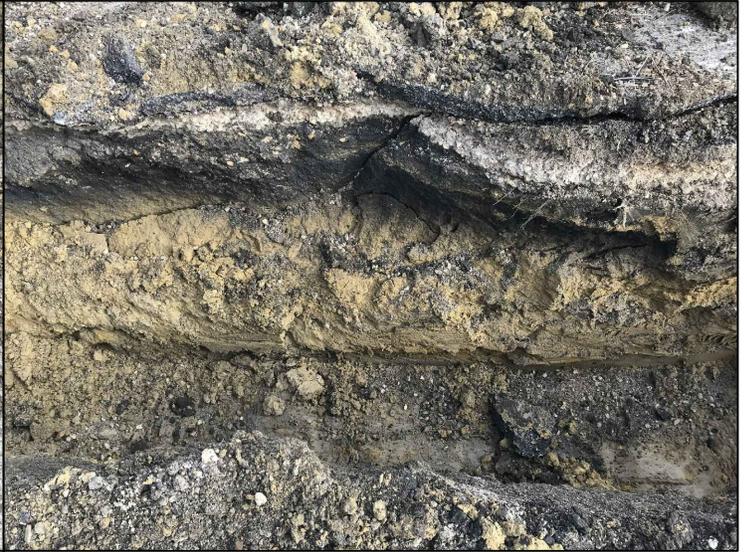
18: TP-15, view east

| 15 | Northern EMI Zone | 3.5' East-West 20' North-South ~5' depth | 41 40.740 N -87 38.827 W 41 40.743N -87 38.828 W | Approximately 6" asphalt underlain with black silty CLAY with light brown SAND at 3'. Broken brick at 2'. No noticeable odors. |

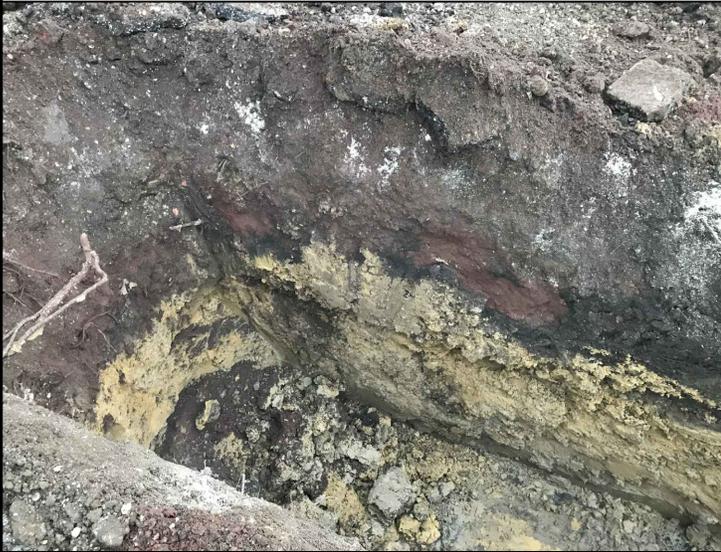
21: TP-18, view west

| 18 | Northern EMI Zone | 3.5' East-West 15' North-South ~5.5' depth | 41 40.748 N -87 38.872 W 41 40.749 N -87 38.874 W | Approximately 6" asphalt underlain with black silty CLAY with light brown SAND at 3'. No anomalies encountered. Red sandy layer at 2' on north end. No noticeable odors. |

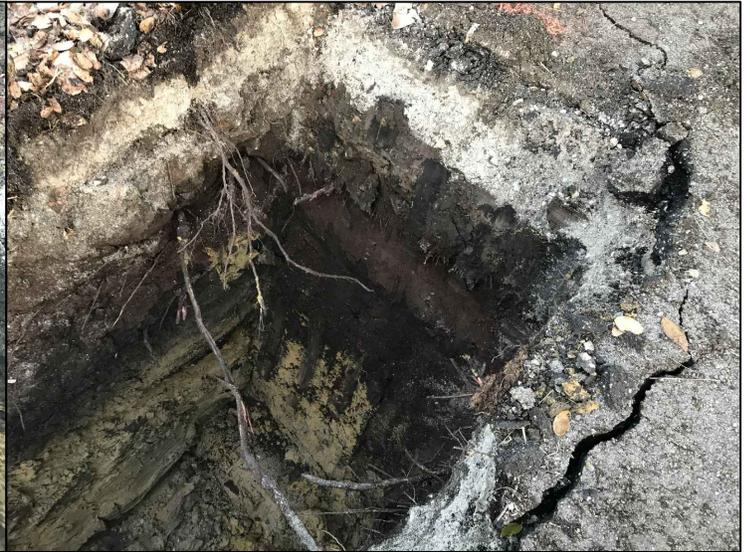
22: TP-19, view east

| 19 | Northern EMI Zone | 3.5' East-West 15' North-South ~5.5' deep | 41 40.750 N -87 38.869 W 41 40.751 N -87 38.867 W | Approximately 6" asphalt underlain with black silty CLAY with light brown SAND at 3'. No anomalies encountered. Red sandy layer at 2' at north end. No noticeable odors. |

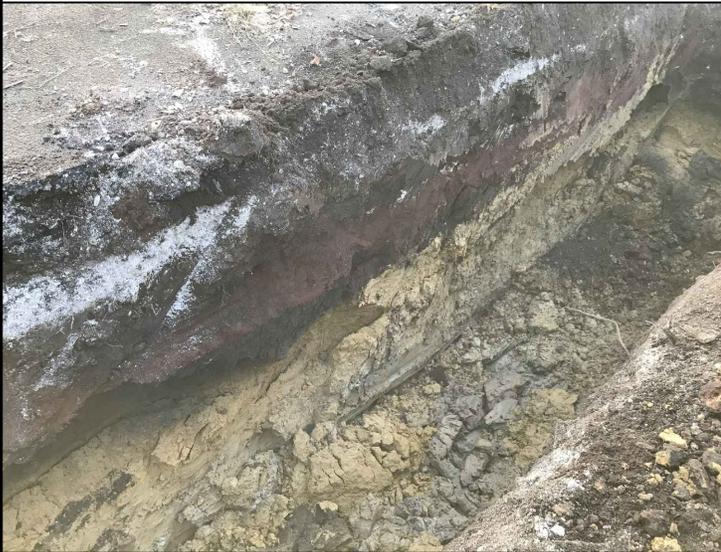
23: TP-20, view east

| 20 | Northern EMI Zone | 3.5' East-West 20' North-South ~5.5' deep | 41 40.760 N -87 38.873 W 41 40.761 N -87 38.875 W | Approximately 6" asphalt underlain with black silty CLAY with light brown SAND at 3'. No anomalies encountered. Red sandy layer at 2' at south end. No noticeable odors. |

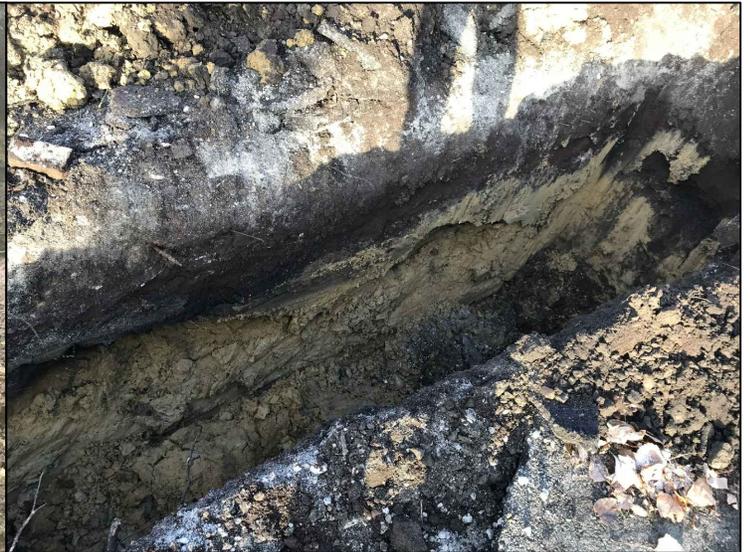
24: TP-21, view east

| 21 | Northern EMI Zone | 3.5' East-West 20' North-South ~5.5' deep | 41 40.750 N -87 38.870 W 41 40.756 N -87 38.868 W | Approximately 6" asphalt underlain with black silty CLAY with light brown SAND at 3'. Red sandy layer and some bricks at 2' at south end. No noticeable odors. |

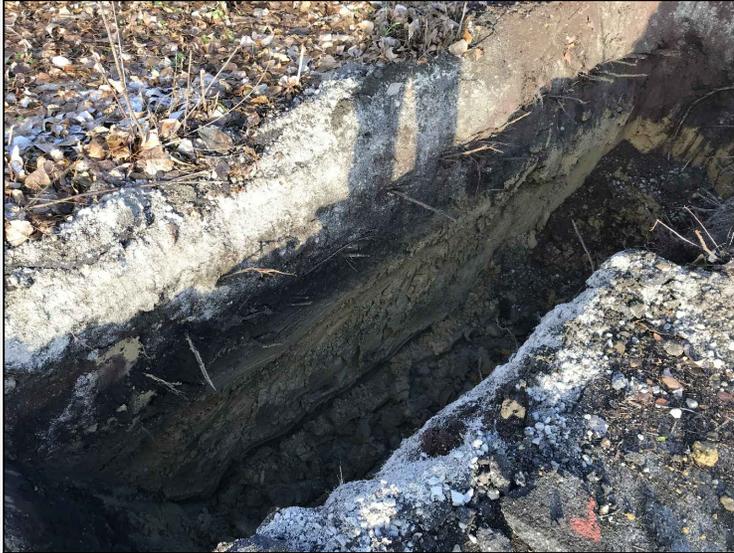
25: TP-22, view west

| 22 | Northern EMI Zone | 3.5' East-West 17.5' North-South ~5.5' deep | 41 40.752 N -87 38.860 W 41 40.753 N -87 38.860 W | Approximately 6" asphalt underlain with black silty CLAY with light brown SAND at 3'. Loose metal pipe at ~2'. Red sandy layer at 2' at south end. No noticeable odors. |

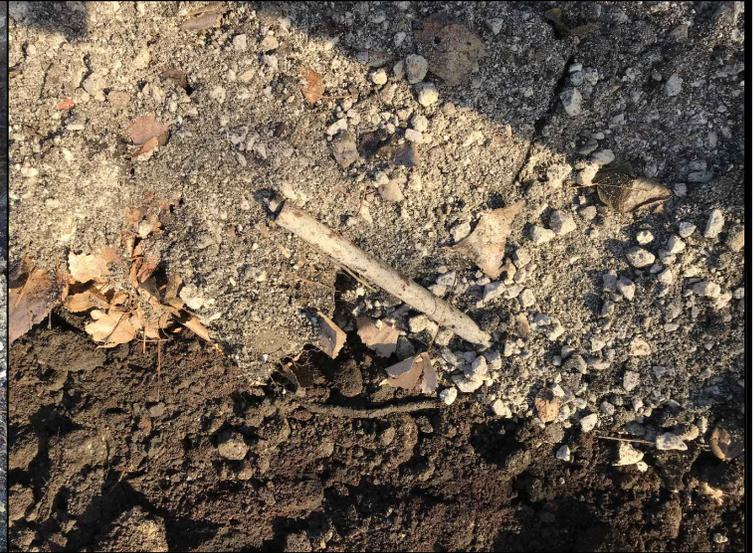
26: TP-22, metal debris

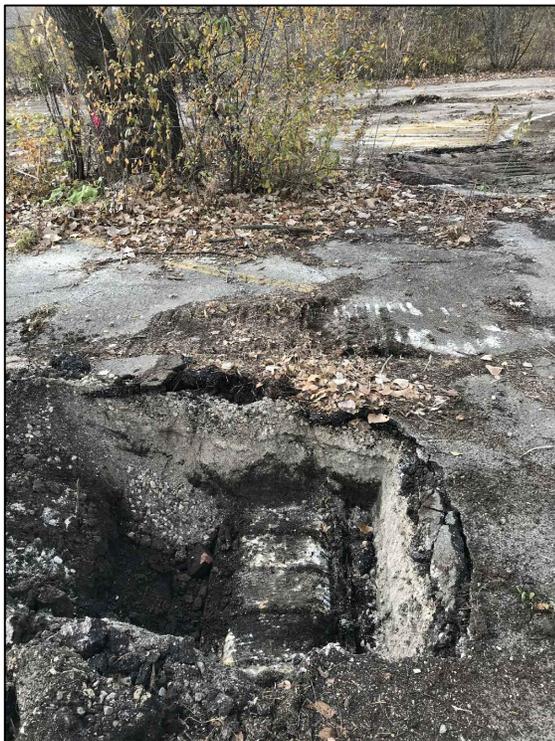
| 22A | Northern EMI Zone | 3.5' East-West 3.5' North-South ~2' deep | 41 40.754 N -87 38.864 W | Approximately 6" asphalt underlain with black silty CLAY with light brown SAND at 3'. Concrete wall footing located. No noticeable odors. |

27: TP-22A, wall footing, view west

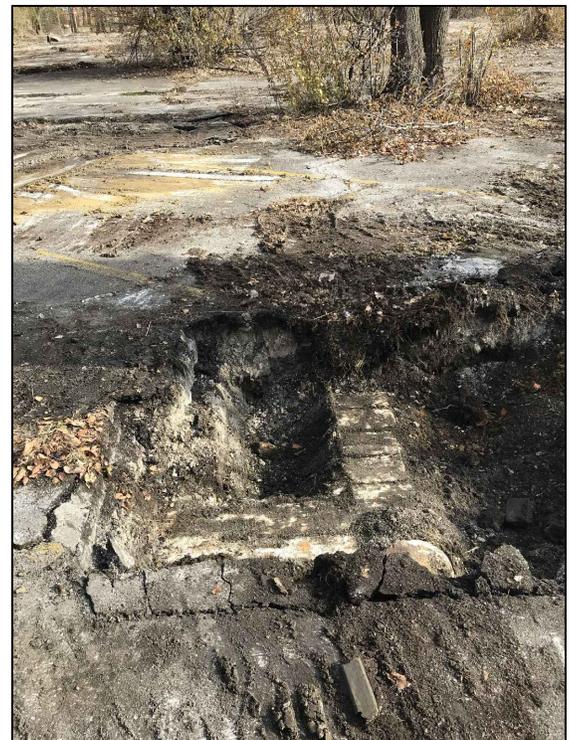
| 22B | Northern EMI Zone | 3.5' East-West 3.5' North-South ~2' deep | 41 40.752 N -87 38.873 W | Approximately 6" asphalt underlain with black silty CLAY with light brown SAND at 3'. Southwest corner concrete wall footing located. No noticeable odors. |

28: TP-22B, corner wall footing, view east

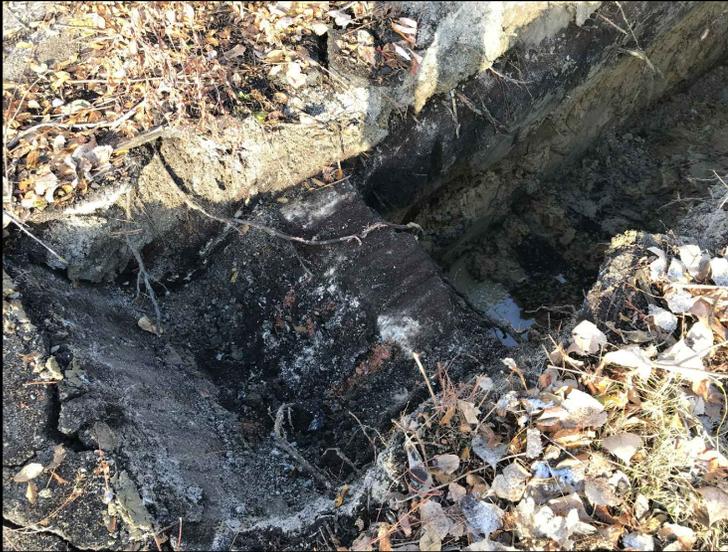
| 23 | Northern EMI Zone | 3.5' East-West 25' North-South ~5.5' deep | 41 40.756 N -87 38.850 W 41 40.756 N -87 38.846 W | Approximately 6" asphalt underlain with black silty CLAY with light brown SAND at 3'. Concrete wall footing at south end. 1' wide, 18' bgs. 3.5' depth with base at ~5 bgs. No noticeable odors. |

29: TP-23, wall footing, view west

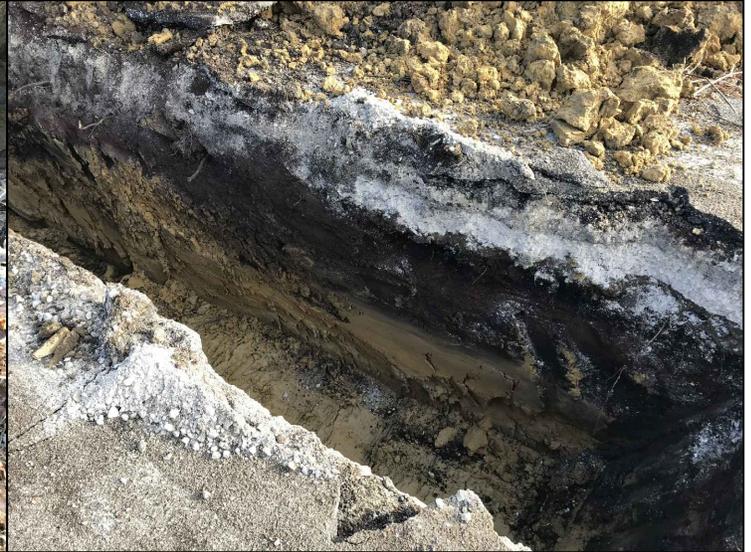
30: TP-24, view east

| 24 | Northern EMI Zone | 3.5' East-West 35' North-South ~5' deep | 41 40.759 N -87 38.841 W 41.40.759 N -87 38.840 W | Approximately 6" asphalt underlain with black silty CLAY with light brown SAND at 3'. No anomalies encountered. Red sandy layer at 2' at south end. No noticeable odors. |

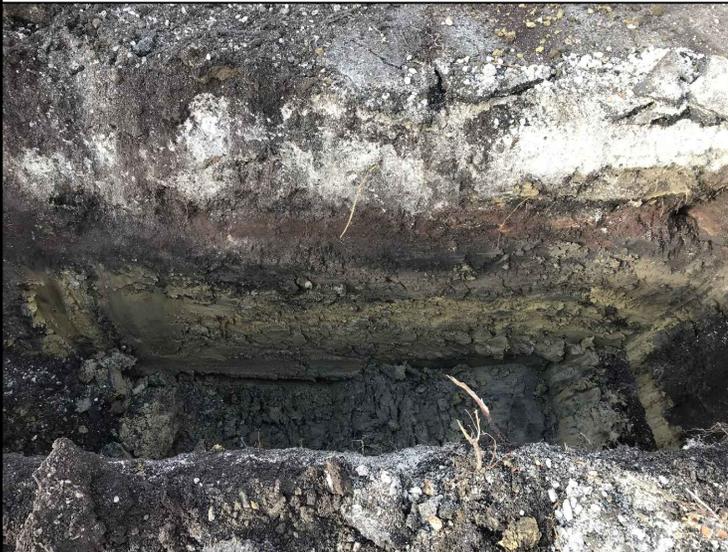
31: TP-25, view east

| 25 | Northern EMI Zone | 3.5' East-West 15' North-South ~5.5' deep | 41 40.761 N -87 38.832 W 41 40.761 N -87 38.835 W | Approximately 6" asphalt underlain with black silty CLAY with light brown SAND at 3'. Loose foundation pier at north end. Top of pier is ~2 bgs; pier is 12x12", approximately 3' south of north end. No noticeable odors. |

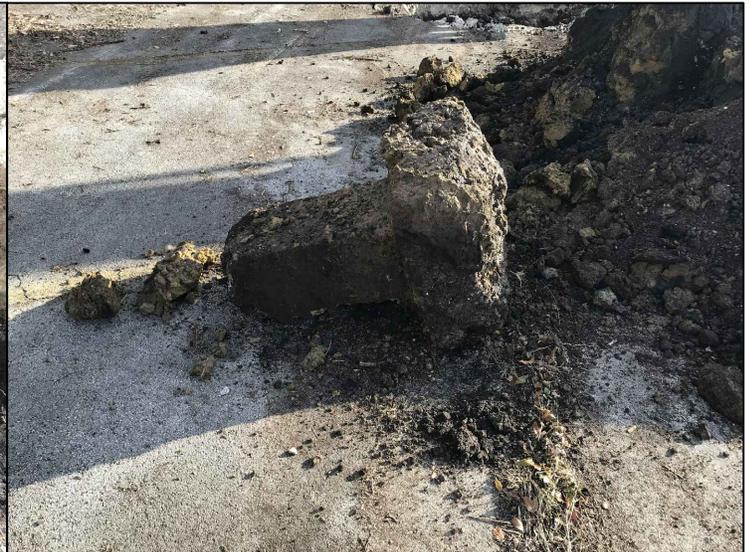
32: TP-25, foundation pier

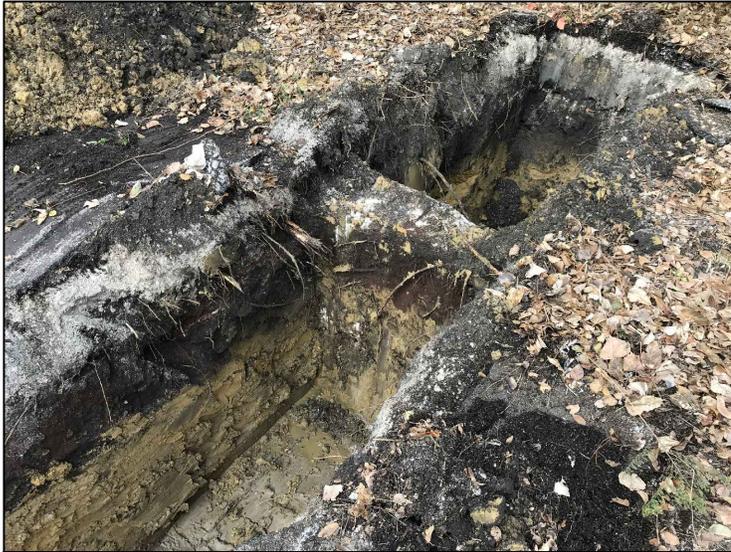
| 26 | Northern EMI Zone | 3.5' East-West 30' North-South ~5' deep | 41 40.760 N -87 38.863 W 41 40.766 N -87 38.862 W | Approximately 6" asphalt underlain with black silty CLAY with light brown SAND at 3'. Concrete wall footing at north end. 1' wide, 18' bgs. 3.5' depth with base at ~5 bgs. No noticeable odors. |

33: TP-26, wall footing, view west

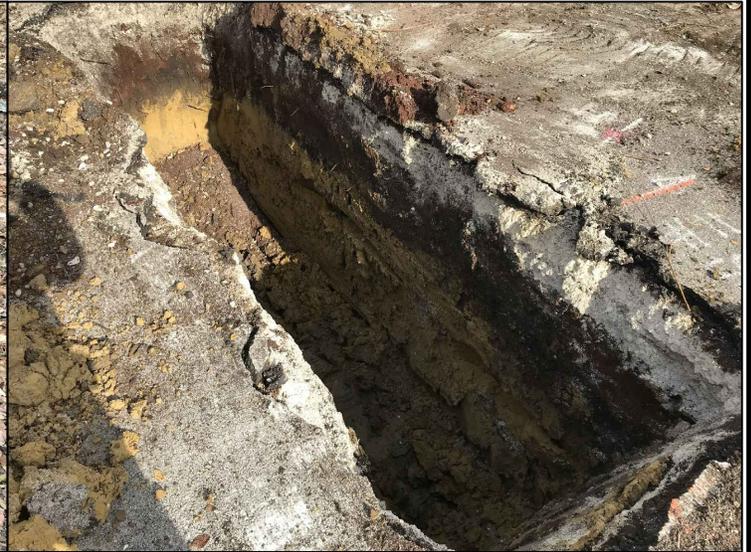
34: TP-27, view west

| 27 | Northern EMI Zone | 3.5' East-West 15' North-South ~5' deep | 41 40.761 N -87 38.854 W 41 40.766 N -87 38.849 W | Approximately 6" asphalt underlain with black silty CLAY with light brown SAND at 3'. No anomalies encountered. Red sandy layer at 2' at south end. No noticeable odors. |

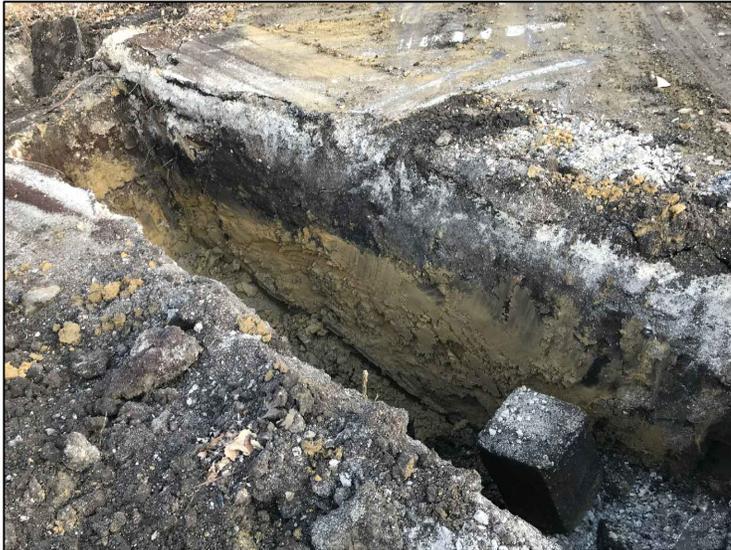
| 28 | Northern EMI Zone | 3.5' East-West 20' North-South ~5' deep | 41 40.764 N -87 38.844 W 41 40.765 N -87 38.844 W | Approximately 6" asphalt underlain with black silty CLAY with light brown SAND at 3'. Concrete wall footing at north end. 1' wide, 18' bgs. 3.5' depth with base at ~5 bgs. Foundation pier at south end. Top of pier is ~2 bgs; pier is 12x12", approximately 2' north of south end. No noticeable odors. |

35: TP-28, foundation pier, view east

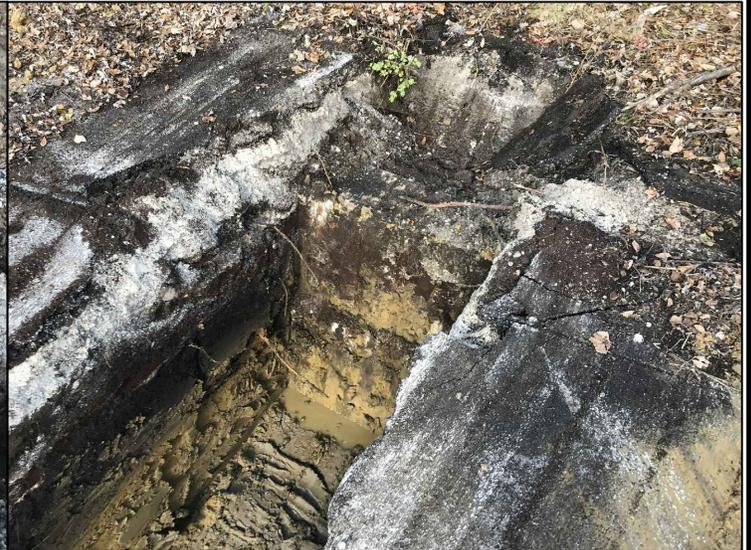
36: TP-28, foundation wall, view west

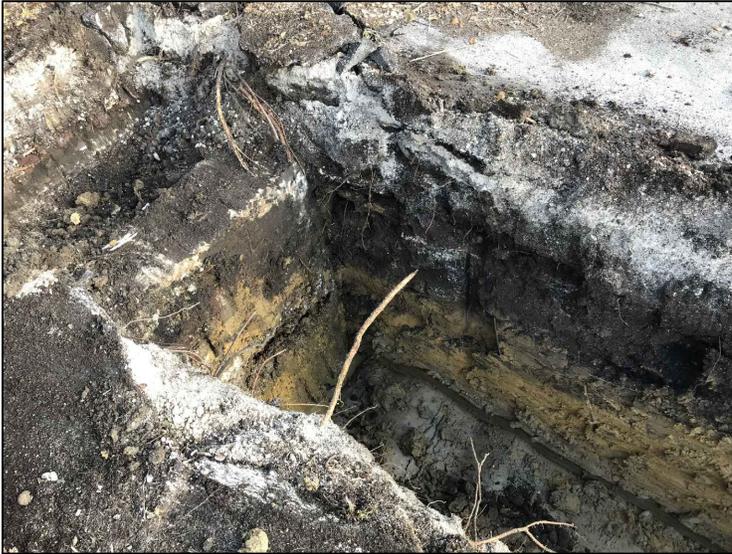
| 29 | Northern EMI Zone | 3.5' East-West 20' North-South ~5' deep | 41 40.767 N -87 38.844 W 41 40.767 N -87 38.843 W | Approximately 6" asphalt underlain with black silty CLAY with light brown SAND at 3'. Concrete wall footing at north end. 1' wide, 18' bgs. 3.5' depth with base at ~5 bgs. No noticeable odors. |

37: TP-29, wall footing, view east

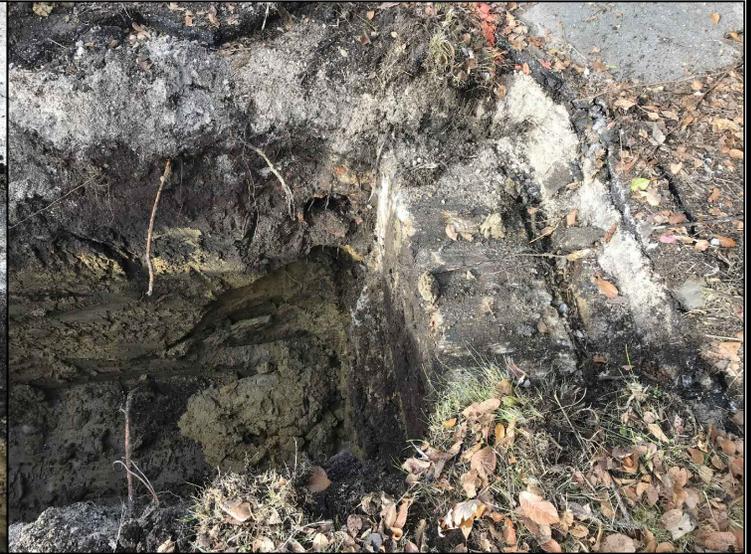
| 30 | Northern EMI Zone | 3.5' East-West 15' North-South ~5' deep | 41 40.762 N -87 38.831 W 41 40.766 N -87 38.829 W | Approximately 6" asphalt underlain with black silty CLAY with light brown SAND at 3'. Concrete wall footing at north end. 1' wide, 18' bgs. 3.5' depth with base at ~5 bgs. 6" drainage pipe south of foot wall approximately 2' bgs. Relic utility wire at south end approximately 2' bgs. No noticeable odors. |

38: TP-30, wall footing, view west

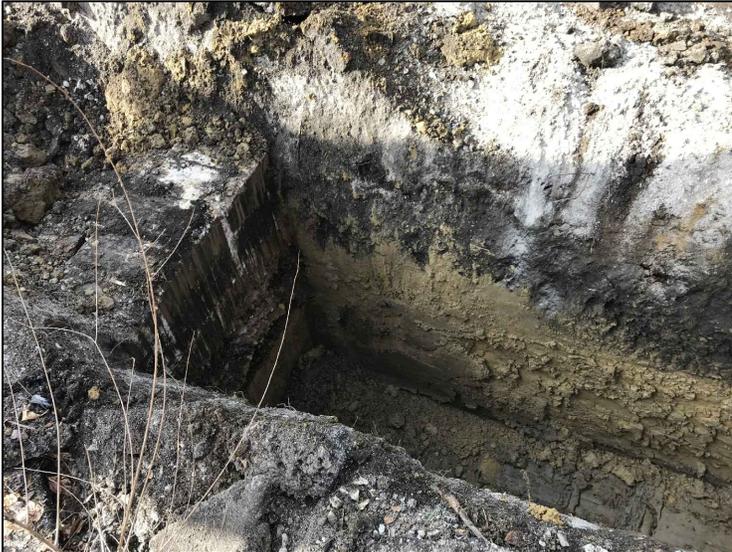
| 31 | Northern EMI Zone | 3.5' East-West 20' North-South ~5.5' deep | 41 40.764 N -87 38.824 W 41 40.770 N -87 38.827 W | Approximately 6" asphalt underlain with black silty CLAY with light brown SAND at 3'. Concrete wall footing at south end. 1' wide, 18' bgs. 3.5' depth with base at ~5 bgs. No noticeable odors. |

39: TP-31, wall footing, view east
