XXXXXXXXXX- Juvenile Detention Center Upgrades

Project Address: 3900 S California Ave., Chicago Illinois

Investigation – HVAC, ELECTRICAL, PLUMBING, FIRE PROTECTION & FIRE ALARM AND
TELECOMMUNICATION

OBSERVATIONS AND CONCLUSIONS OF OBSERVED

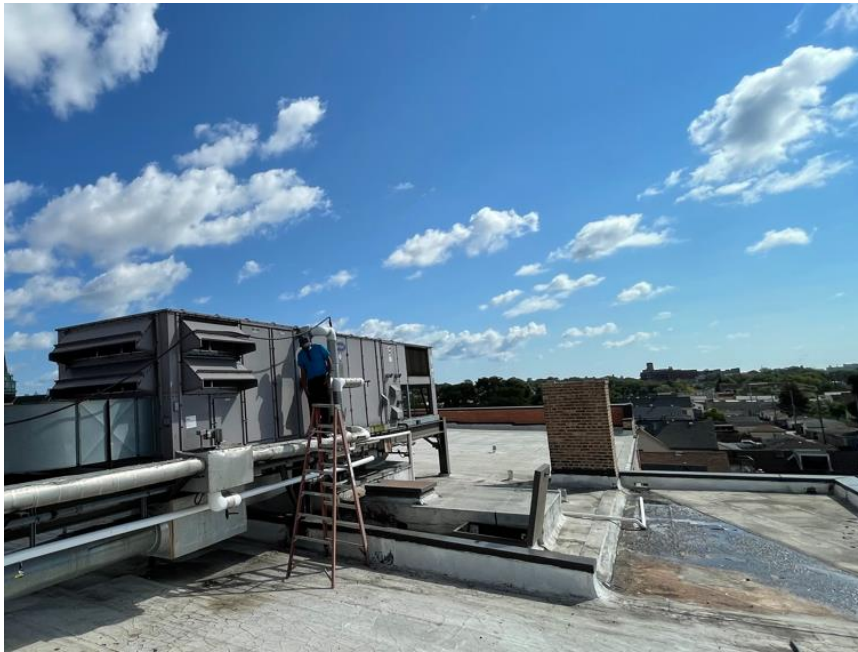
The Roof top unit (RTU-1), located on the roof is reaching its service life. It becomes unreliable and costly to maintain. The unit is DDC controlled. RTU was design for DX cooling coils, but is replaced with water cooled because of the code issue of using old refrigerant. The gas fired Heater of this unit is out of service for two years, due to controls connection. This unit has a return fan. The supply fans for these roof top unit is VFD driven.

Existing RTU-1

Replace RTU-1 with a new package system with efficient cooling and gas-fired heating capabilities. Provide a walking pad around the equipment for maintenance and include safety railings. Consider improving the redundancy of hydronic heating system.

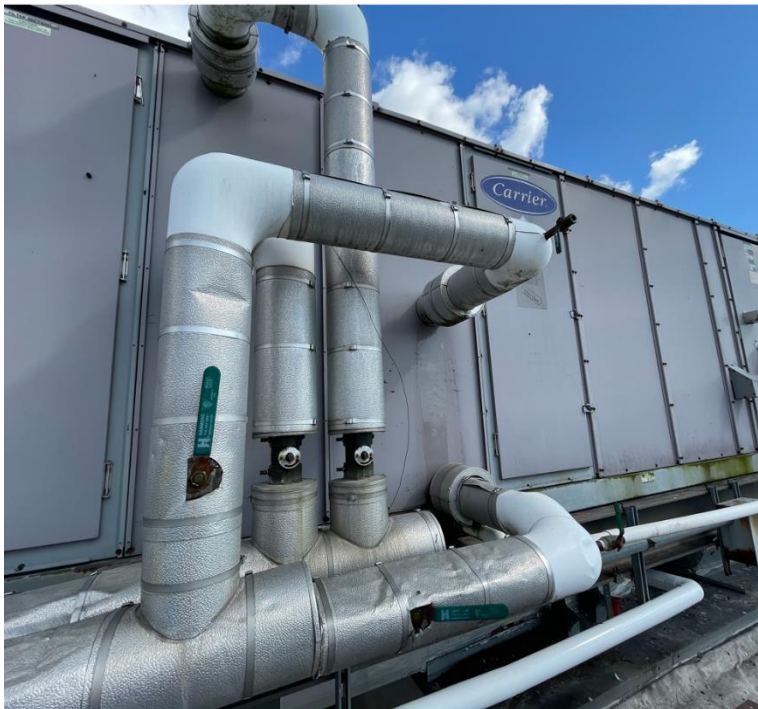
Existing RTU-1 Cooling coil leaking

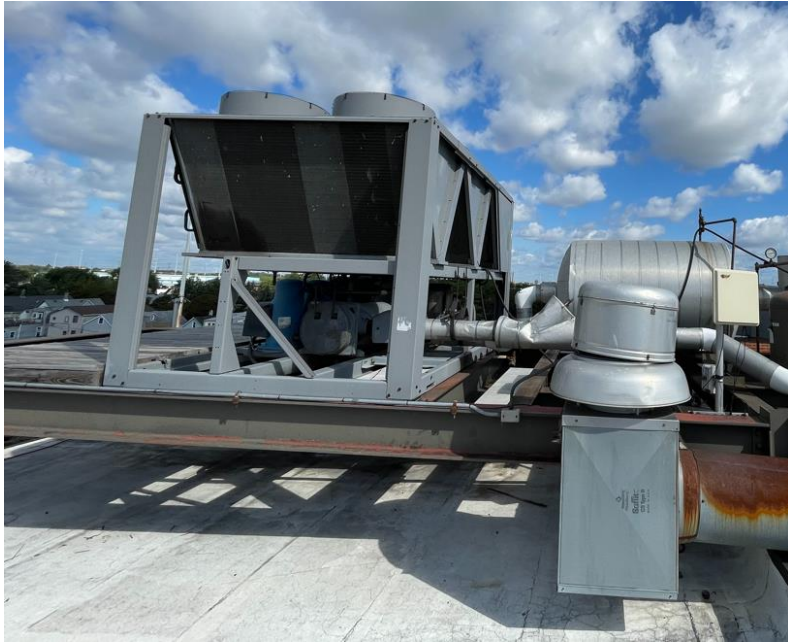
The air-cooled chiller (CH-1) located within the roof level, is also reaching its service life.

Existing Air-cooled chiller system CH-1

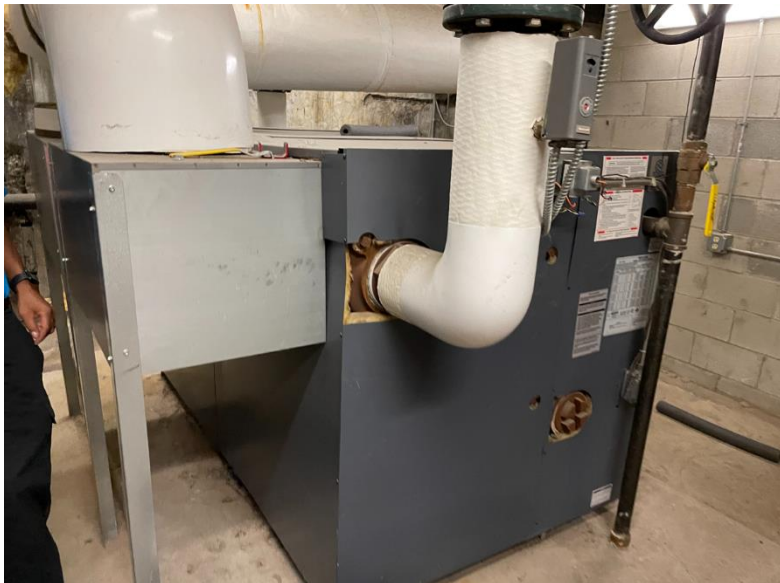
The Existing boiler is new and is currently serving the building heating load, since the heating of RTU is not working. The only issue with the heating system is lack of redundancy.

Existing Hot water boiler B-1

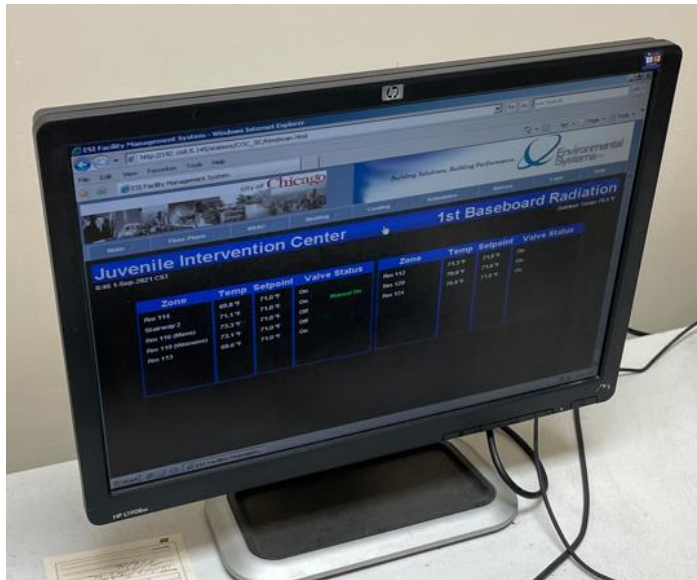
The exiting BAS by Environmental System Inc. has limited capability in terms of monitoring and control to the other systems in the building.

Existing BAS System

Upgrade the existing BAS system to a GBMS to improve building management, field devices should be replaced and modified for its compatibility.

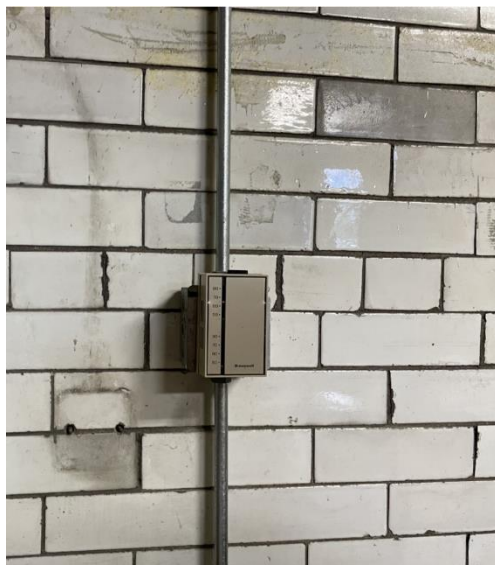
The heating, ventilation, and air-conditioning (HVAC) systems uses a DDC to controls the valve and damper actuators. Thermostats are working and connected to the existing BAS.

Existing Thermostat

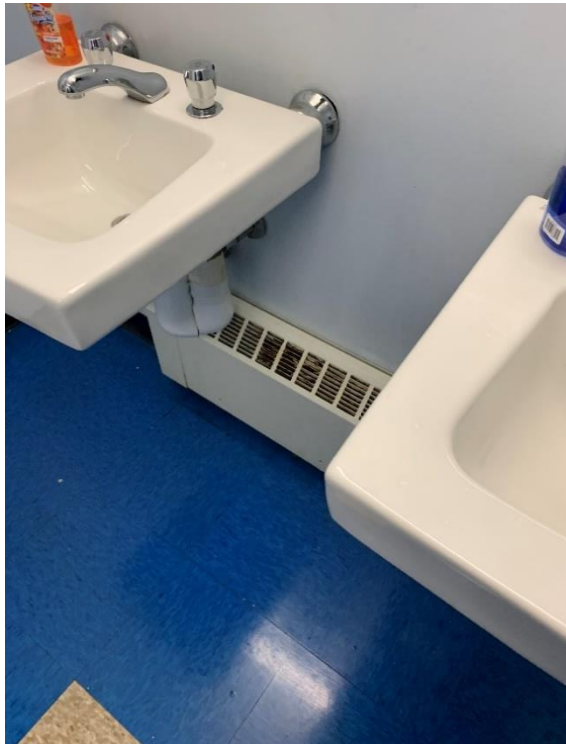
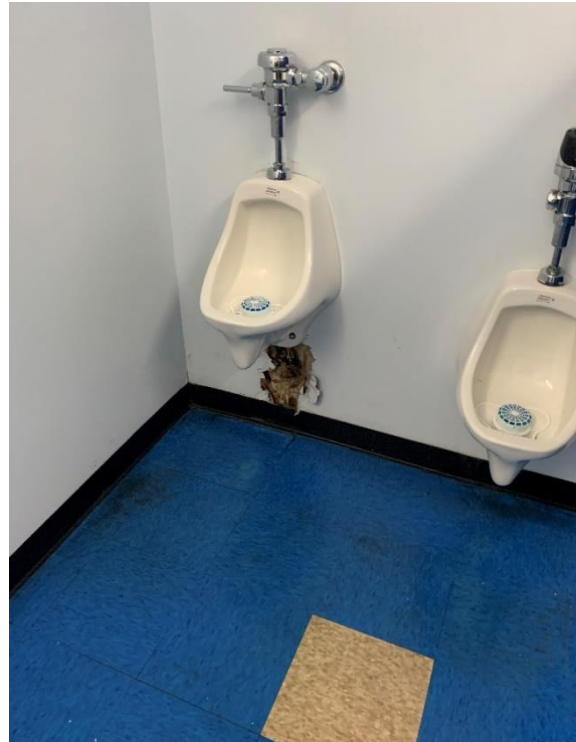
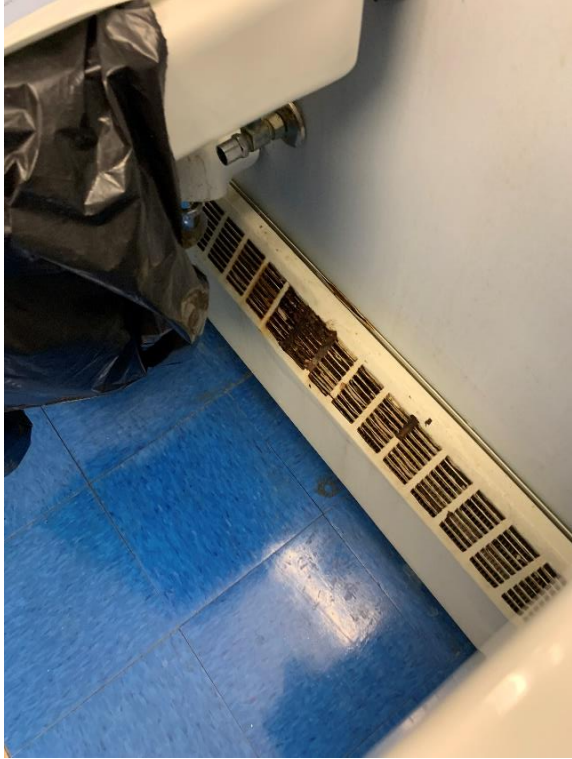
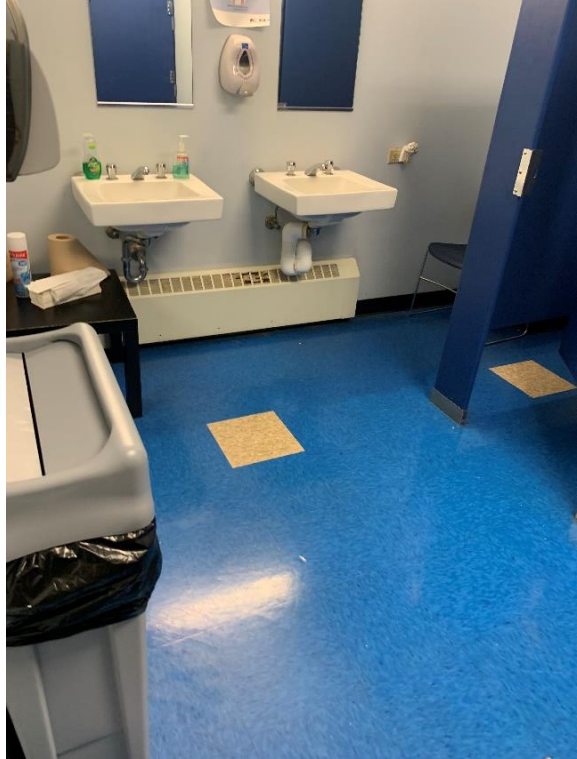
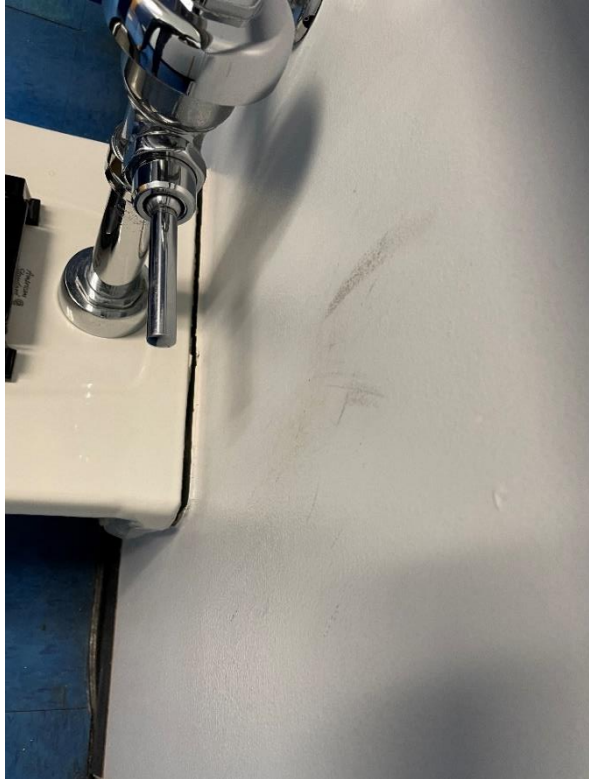
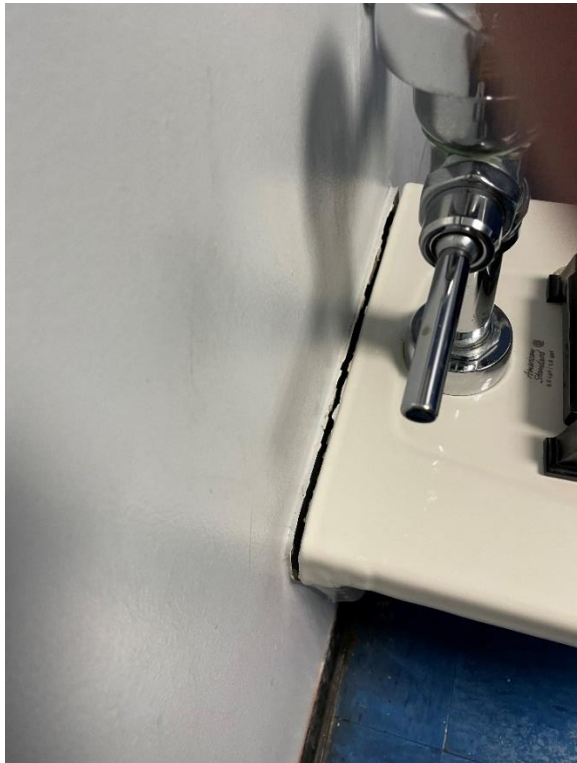
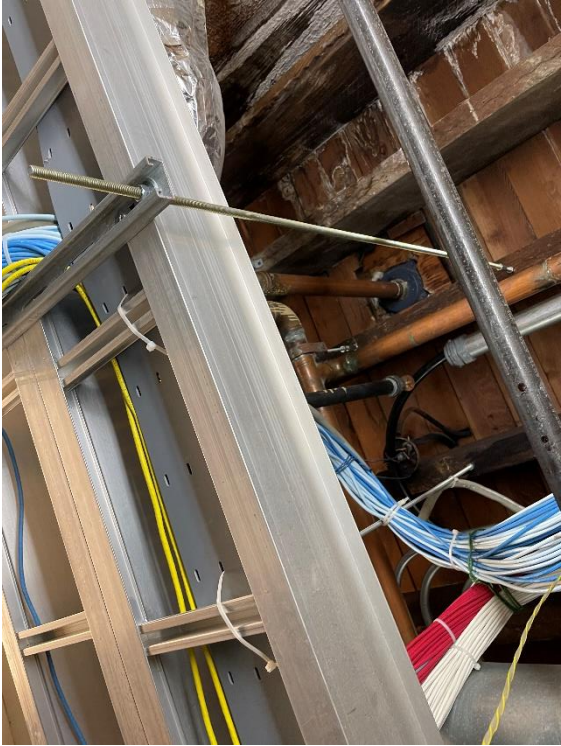
PHOTOS(Damages on Bathrooms)

No Plumbing scope required on this project. But during the meeting they bring to attention the leaked on the plumbing fixtures. It damages the baseboard heaters and walls. An in-house repair resolved this problem. No engineering design work required.

Water closets are not properly secured this requires proper installation detail. Resulting plumbing work will be required.

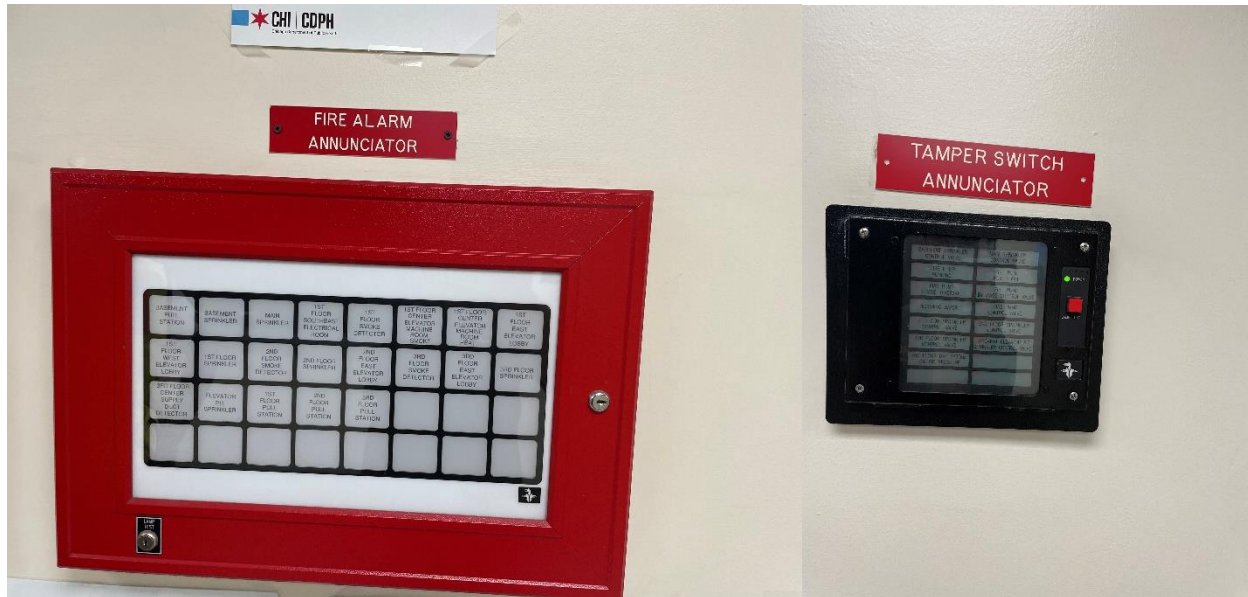
PHOTOS(Fire alarm)

The facility is equipped with Fire protection system and fire alarm systems. That are inspected and tested periodically. It is in good condition and working properly, no work required.
