Management Report

The HOH Group, Inc.
Juvenile Intervention Center
3900 South California Avenue, Chicago, IL

Prepared For
The HOH Group, Inc.

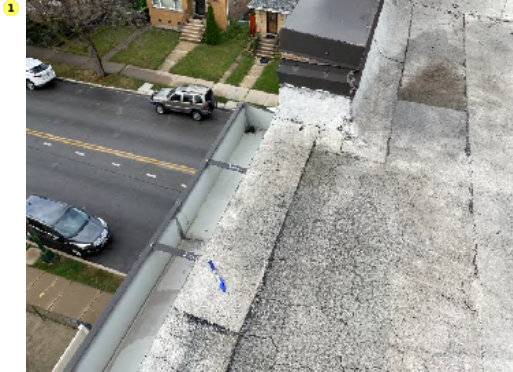
Modified Bitumen - Sheet Metal- Gutter straps (Emergency)

The gutter straps are not installed properly. They should not be installed on the roof under the roof membrane.

This deficiency needs to be monitored and repaired as needed.

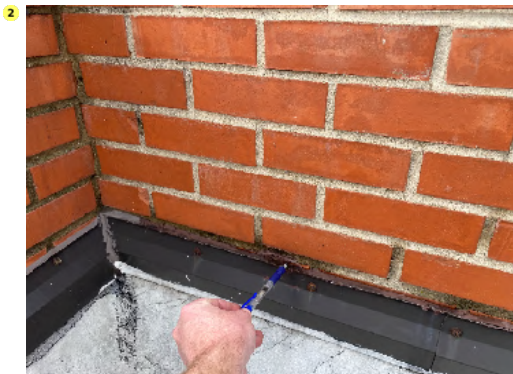
Modified Bitumen - Caulk- Caulking failure (Emergency)

The caulking has failed.

New caulking will be installed .

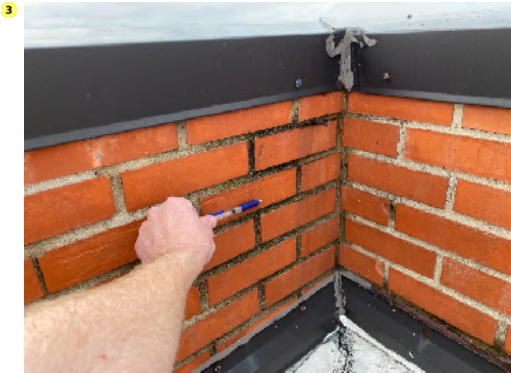
General - Masonry- Masonry defective (Emergency)

The masonry on the parapet walls are absorbing water and infiltrating the roof system.

The roof membrane should wrap completely over the top of the parapet walls.

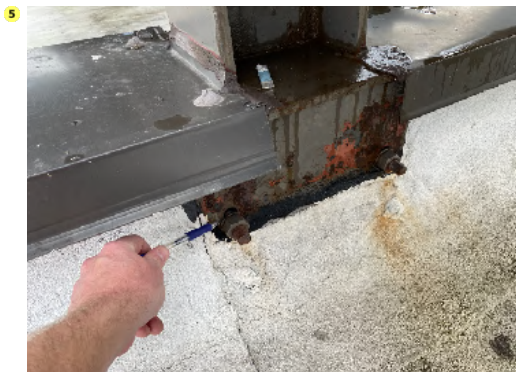
Modified Bitumen - Penetration- Improper Pipe Penetration Flashing (Emergency)

The pipe penetration has not been properly sealed.

The pipes will be sealed using a urethane liquid flashing material.

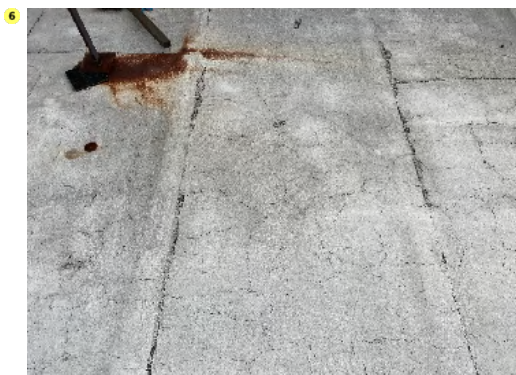
Modified Bitumen - Membrane- Membrane wrinkling and cracking (Emergency)

Membrane is beginning to crack.

The cracking will eventually lead to failure of the roof membrane.

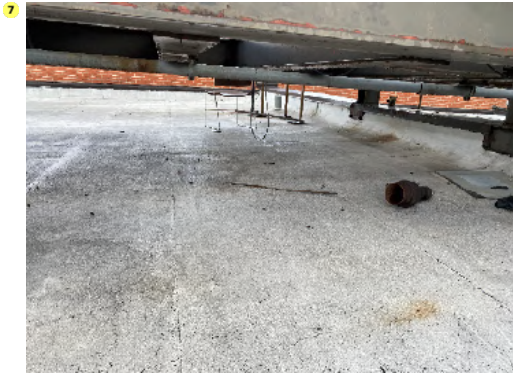
Modified Bitumen - Loose Debris (Emergency)

Loose debris has a high probability of blowing around on the roof and causing damage to the waterproofing membrane.

Remove loose debris from roof area.

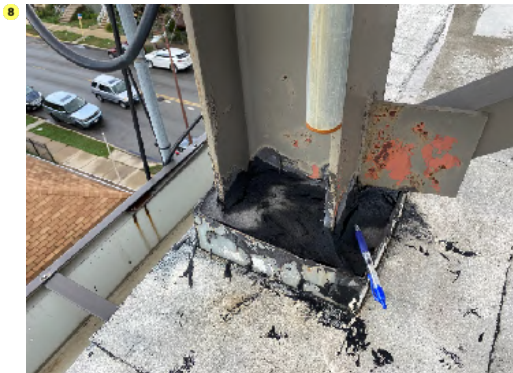
Modified Bitumen - Penetration- Pitch Pan (Emergency)

The pitch pan around the pipe penetration needs to be refilled.

The pitch pan will be refilled to prevent water leakage.

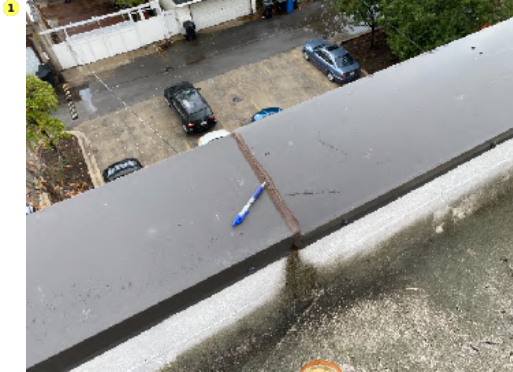
Sheet Metal - Sheet metal- coping joint. (Emergency)

The sheet metal coping joint caulking has failed.

The coping joint will be recaulked.

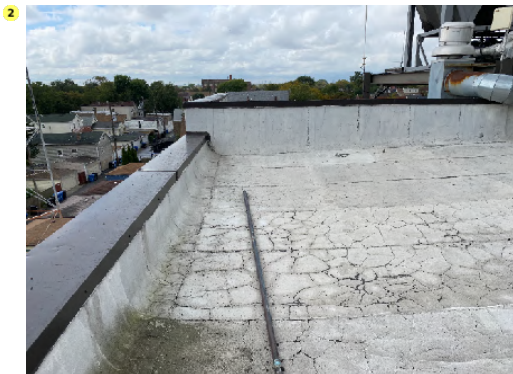
Modified Bitumen - Loose Debris (Emergency)

Loose debris has a high probability of blowing around on the roof and causing damage to the waterproofing membrane.

Remove loose debris from roof area.

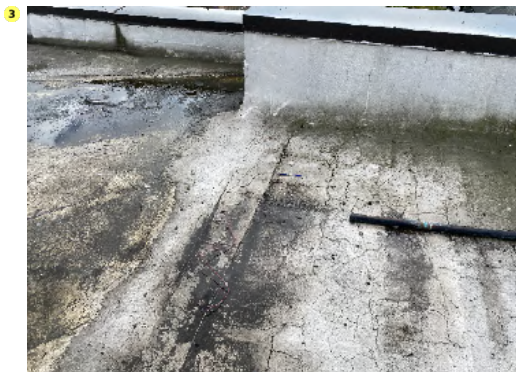
Modified Bitumen - Membrane- Puncture or Tear in Membrane (Emergency)

A tear has been discovered in the roof membrane.

The tear may have been due to a lack of an expansion joint at the stairway addition. An expansion joint should be installed.

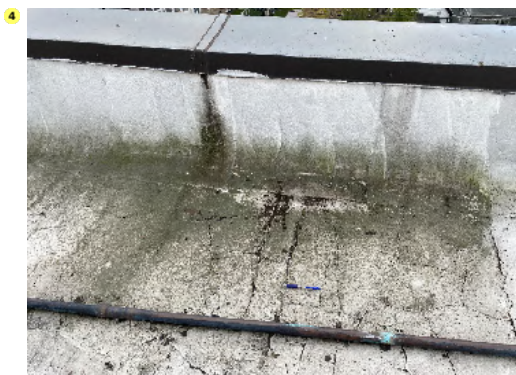
Modified Bitumen - Membrane- Membrane wrinkling and cracking (Emergency)

Membrane is beginning to crack.

The cracking will eventually lead to failure of the roof membrane.

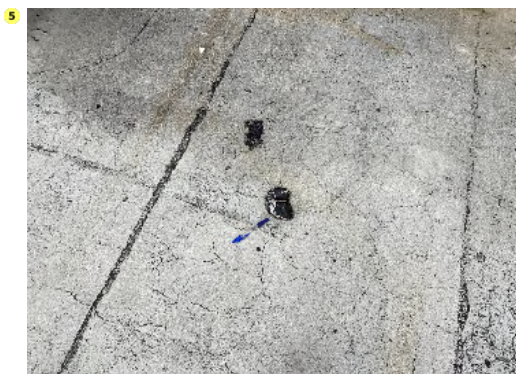
Modified Bitumen - Membrane- Puncture or Tear in Membrane (Emergency)

A puncture or tear has been discovered in the roof membrane.

The area surrounding the deficiency will be cleaned. A proper repair will be performed using compatible materials for the roof membrane type.

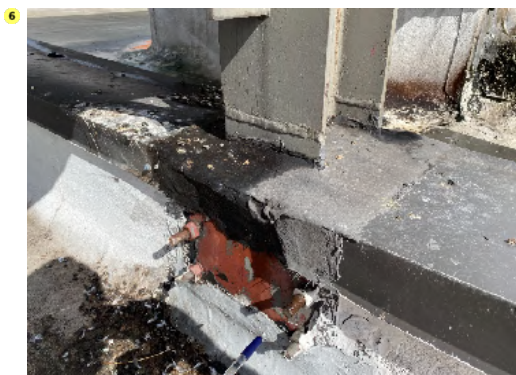
Modified Bitumen - Penetration- Improper Pipe Penetration Flashing (Emergency)

The pipe penetration has not been properly sealed.

The pipes will be sealed using a urethane liquid flashing material.

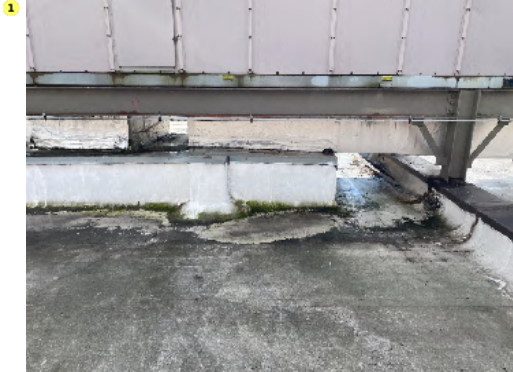
Modified Bitumen - Membrane- Ponding (Emergency)

Ponding of water on the roof.

Ponding will lead to the premature failure of the roof membrane. This area needs to be monitored for deterioration.

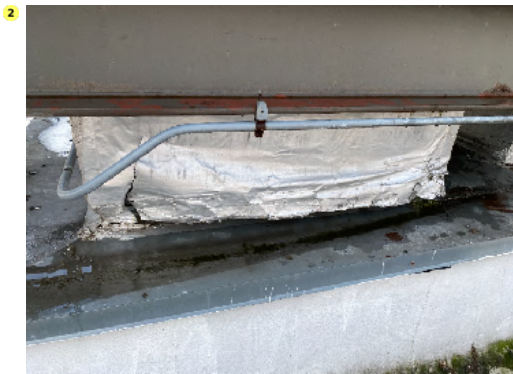
General - Flashing- Open Flashing (Emergency)

The ductwork flashings are open and are not watertight.

The ductwork flashings should be sealed.

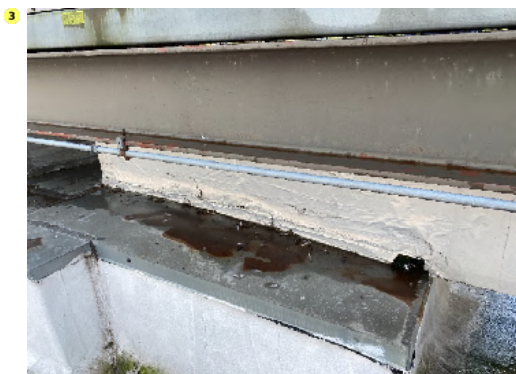
General - Oxidation or Rust (Emergency)

As the galvanized coating breaks down and the metal is exposed to the elements, oxidation or rust will take over and reduce the materials integrity.

Depending upon the level of corrosion, the metal may be able to be restored. A rust-inhibiting paint should be utilized.

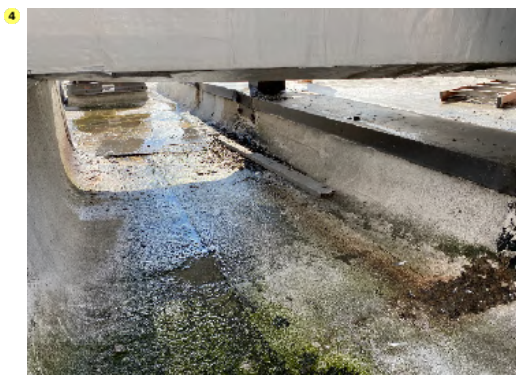
Modified Bitumen - Loose Debris (Emergency)

Loose debris has a high probability of blowing around on the roof and causing damage to the waterproofing membrane.

Remove loose debris from roof area.

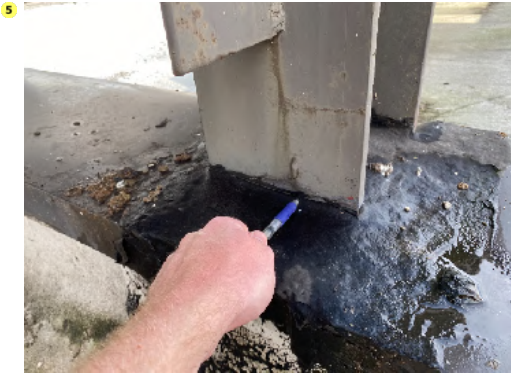
Modified Bitumen - Penetration- Improper Pipe Penetration Flashing (Emergency)

The pipe penetration has not been properly sealed.

The pipes will be sealed using a urethane liquid flashing material.

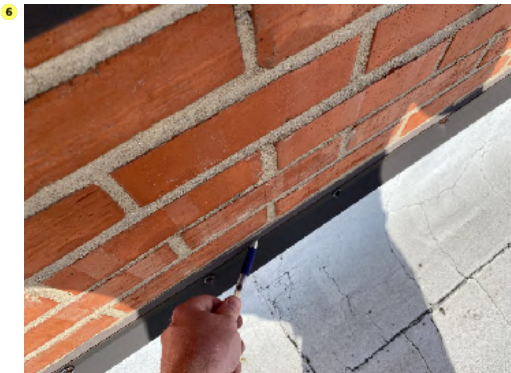
Modified Bitumen - Caulk- Caulking failure (Emergency)

The caulking has failed.

New caulking will be installed .

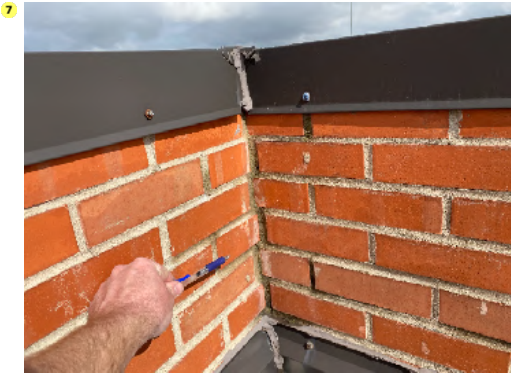
General - Masonry- Masonry defective (Emergency)

The masonry on the parapet walls are beginning to deteriorate.

The roof flashing membrane should wrap up over the top of the parapet walls to stop water infiltration.

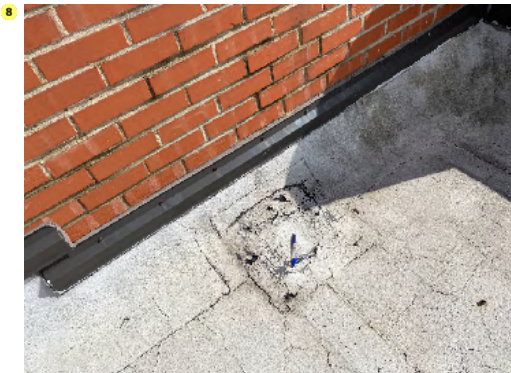
Modified Bitumen - Membrane-Defective patch (Emergency)

The membrane patch has failed.

The defective patch will be replaced.

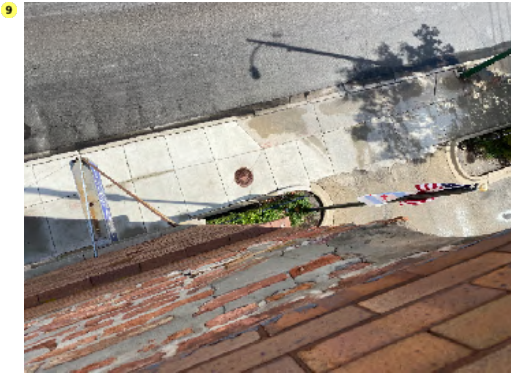
General - Masonry- Masonry defective (Emergency)

The masonry on the exterior walls are deteriorated and need to be repaired. Portions of the walls have exposed wood beams which may have originally been part of a sign structure.

Remove the exposed wood and repair the walls.

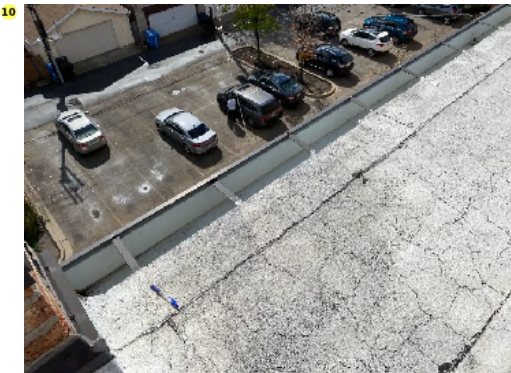
Modified Bitumen - Sheet Metal- Gutter straps (Emergency)

The gutter straps are not installed properly. They should not be installed on the roof under the roof membrane.

This deficiency needs to be monitored and repaired as needed.

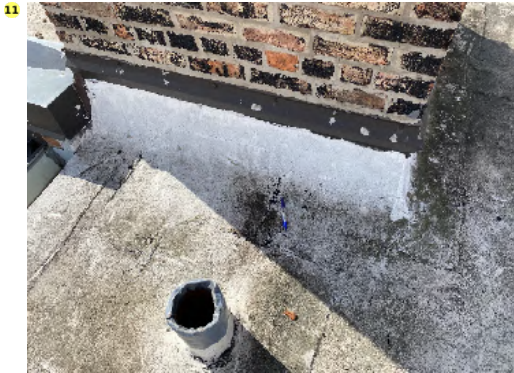
Modified Bitumen - Membrane- Membrane seam open (Emergency)

The seam on the membrane is open.

The seam will be patched with compatible materials to make the seam watertight.

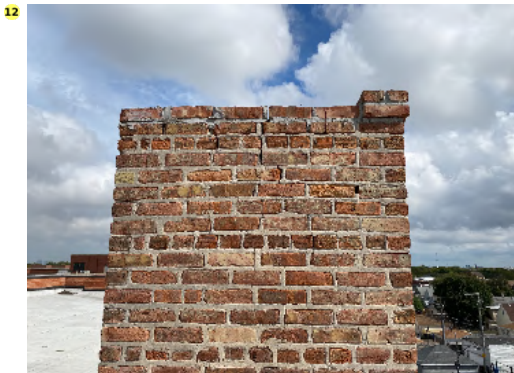
General - Masonry- Masonry defective (Emergency)

The masonry at the chimney is deteriorated and needs to be repaired. No chimney cap is present.

Re-build unsound portions of the chimney. Tuckpoint the remaining portions of the chimney. Install a cap.

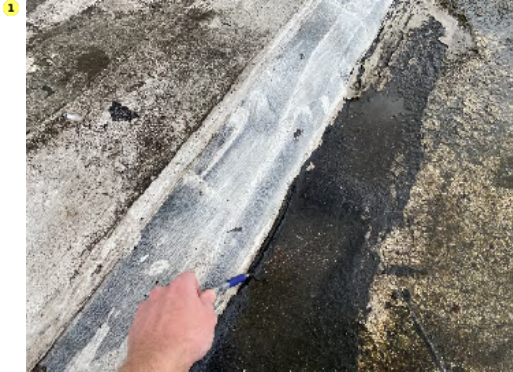
Modified Bitumen - Flashing- Open Flashing (Emergency)

The flashings are open and are not watertight.

The flashings will be sealed.

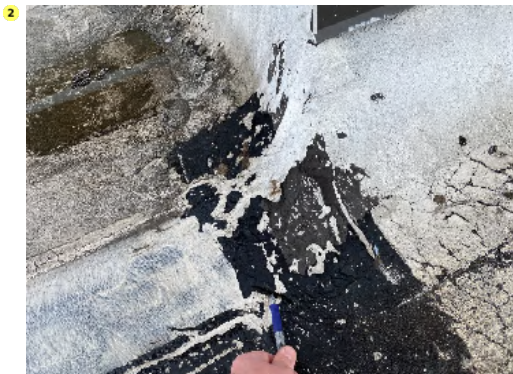
Modified Bitumen - Flashing- Open flashing corner (Emergency)

The membrane flashing corner is open.

The corner will be repaired to make the flashing watertight.

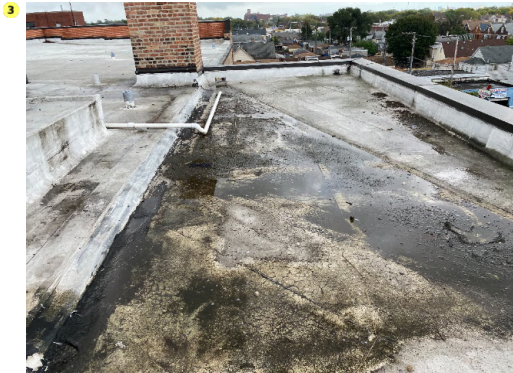
Modified Bitumen - Membrane- Ponding (Emergency)

Ponding of water on the roof.

Ponding has lead to the premature failure of the roof membrane.

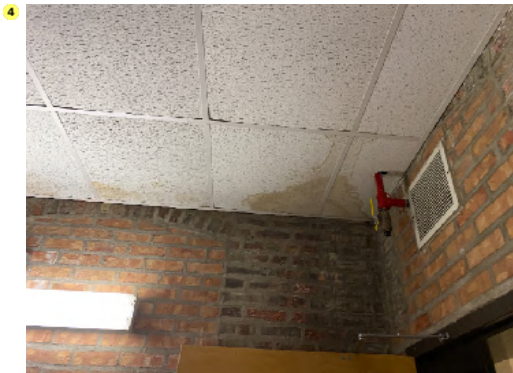
General - Leaking Area (Emergency)

The roof is leaking in this area.

The roof will be inspected in this area and deficiencies repaired as needed.

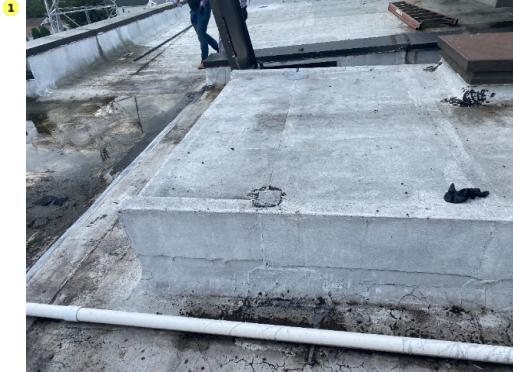
Modified Bitumen - Sheet Metal- Gravel stop missing. (Emergency)

The gravel stop is missing.

The gravel stop will be installed where missing.
