HOH Project # 5438:

2021-F687-SIT CIP-Juvenile Det. Center Building Upgrades

Project Address: 3900 S California Ave Chicago, Illinois

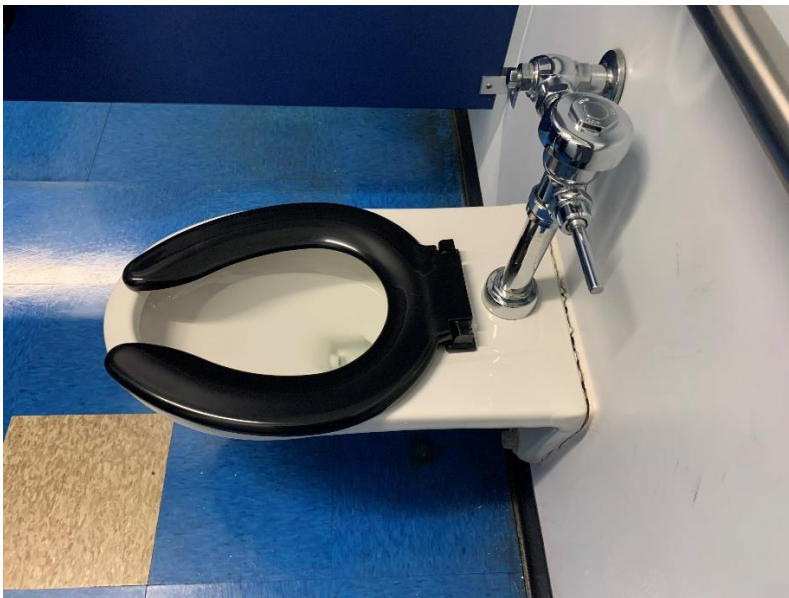
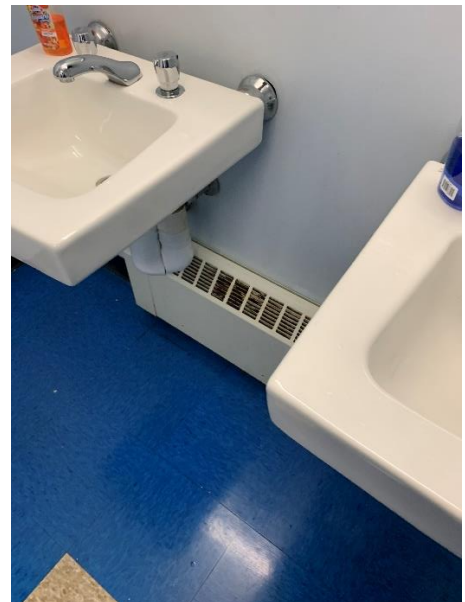
All restrooms were observed, and they show wear and tear damage.

All wall-hung toilets show the same damage, and they need to be removed and replaced. The connection to the wall seems to be failing. The joint between the wall and the wall hung toilet is enlarging at all locations. This condition needs to be repaired with a detail that will ensure wall hung toilet to be appropriately fastened to wall to ensure no deflection.

Lavatories are also reaching the end of their lives and need to be removed and replaced.

Photos 1 & 2: Damaged toilets and lavatories to be removed and replaced.

All plumbing fixtures need to be removed and replaced.

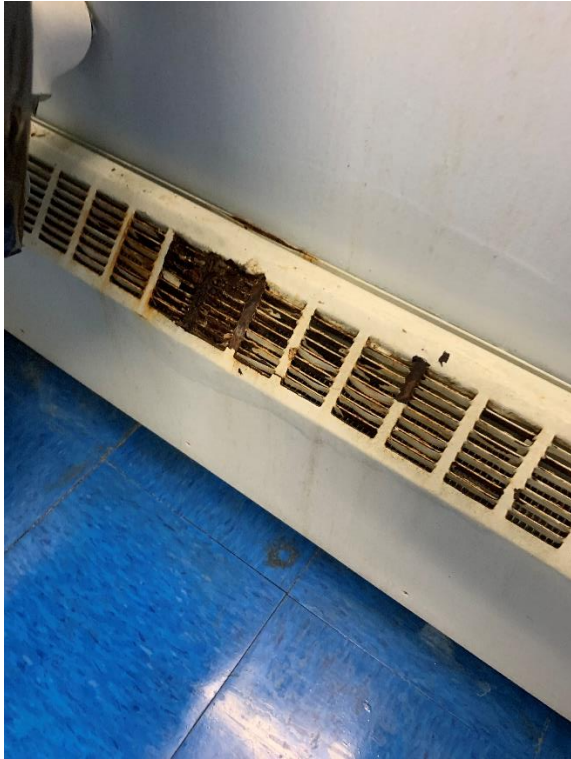
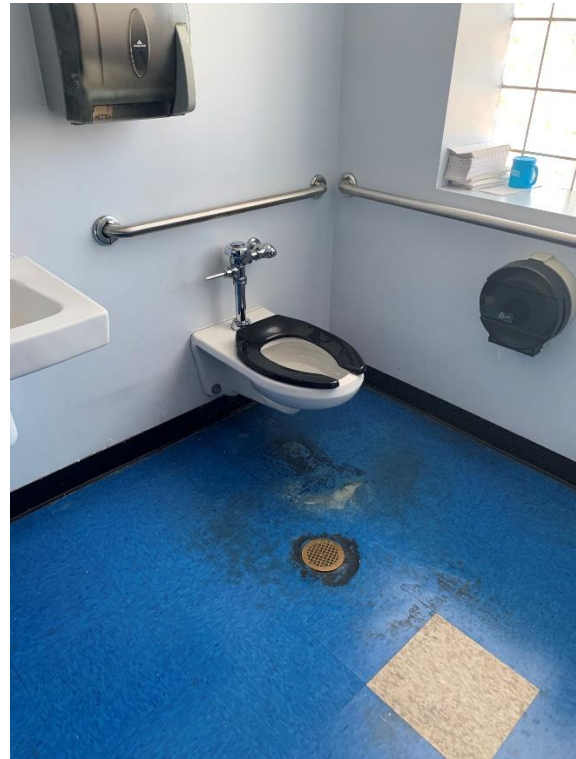
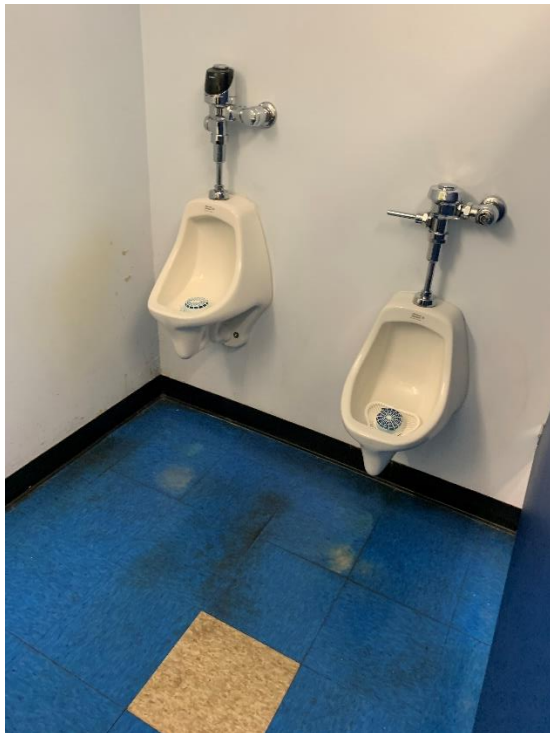
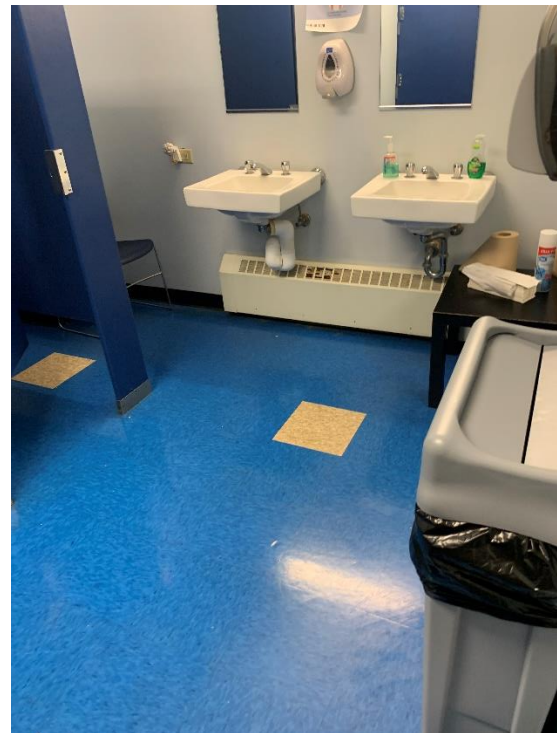
Photos 3, 4, 5 & 6: Damaged urinals, base board heaters and finishes to be removed and replaced.

All interior finishes in restrooms need to be removed and replaced.

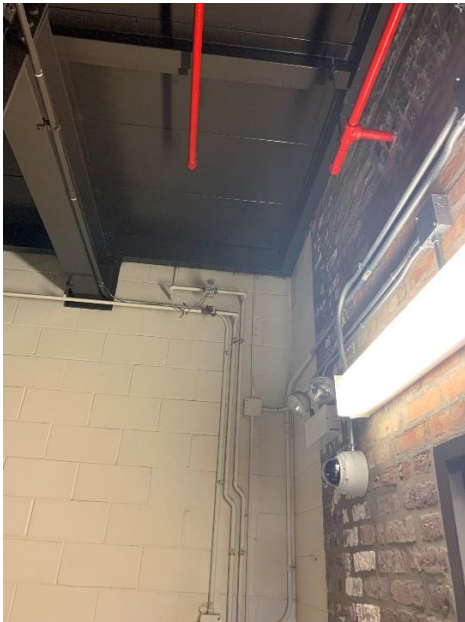
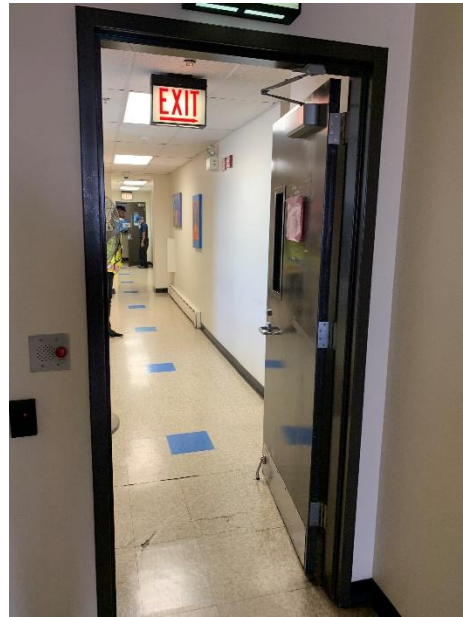
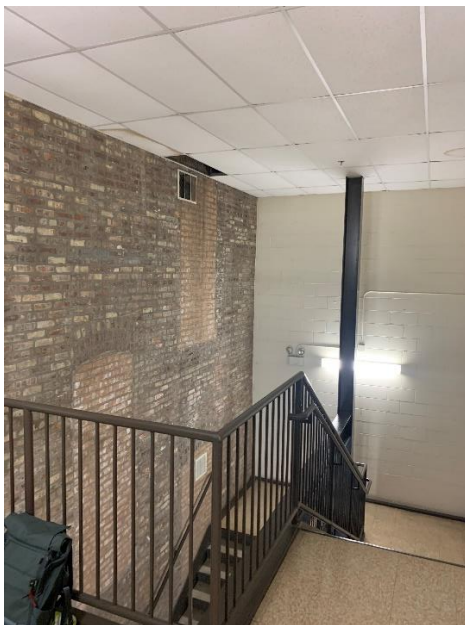
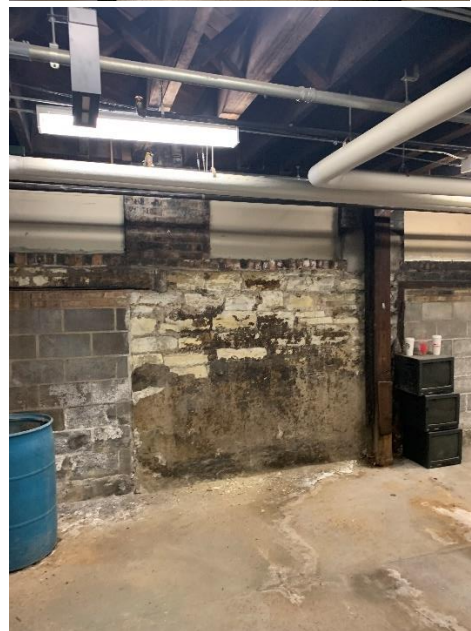
Photos 7, 8, 9 & 10: Fluorescent lighting and fixtures to be removed and replaced with LED.

After site visits AOR recommends removing and replacing all fluorescent lighting fixtures with LED lighting and LED lighting fixtures all throughout.

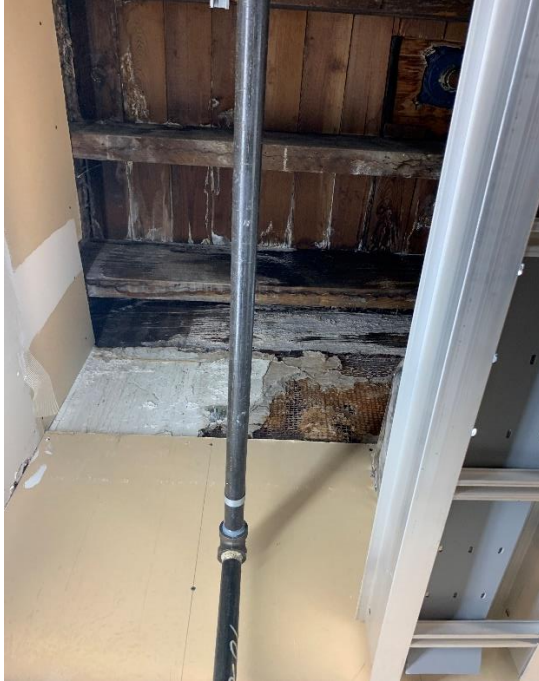
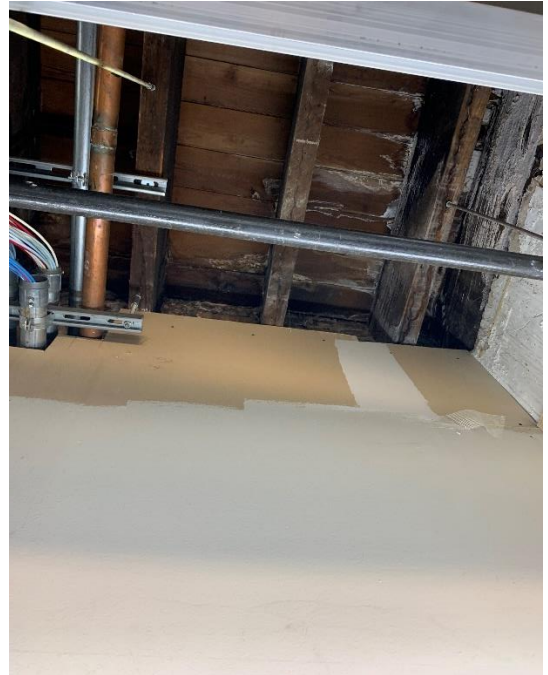
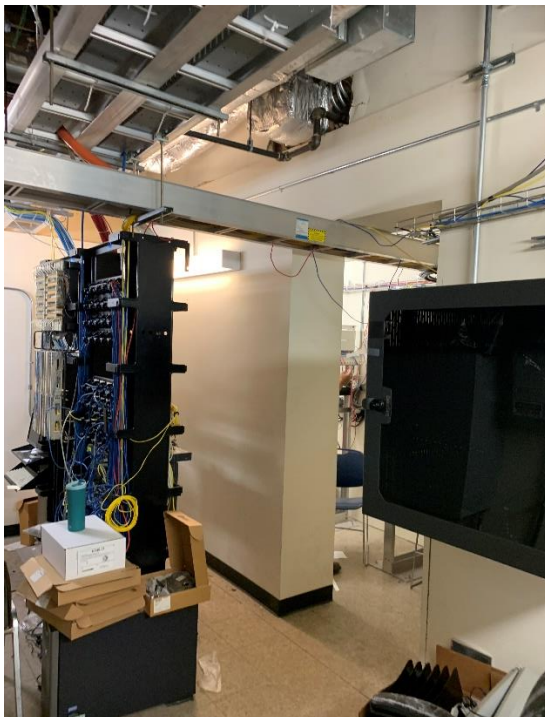
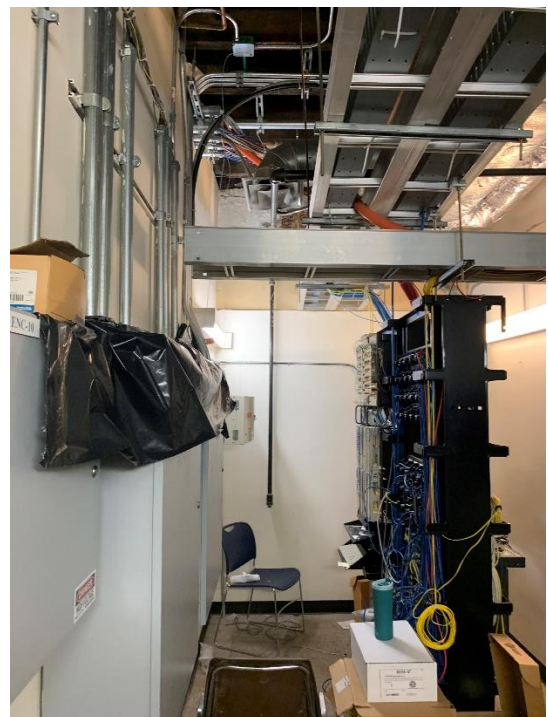
Server Room shows exposed structure above with a lot of roof leak damage falling directly above and to the side walls.

Photos 11, 12, 13 & 14: Roof leak damage on brick walls showing efflorescence getting into wood structure. Need to repair roof. Then provide 2 layers of 5/8" gyp board for 2-hour enclosure of server room.

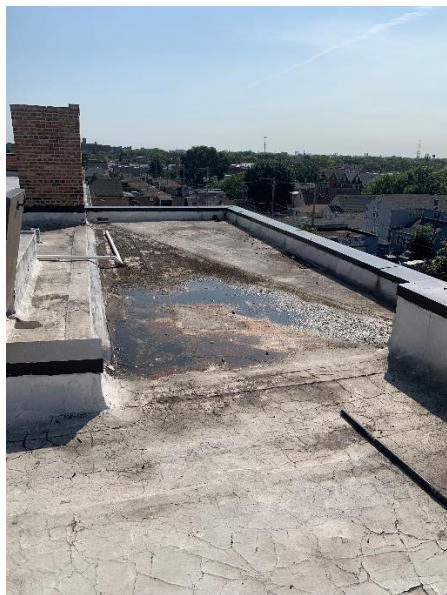
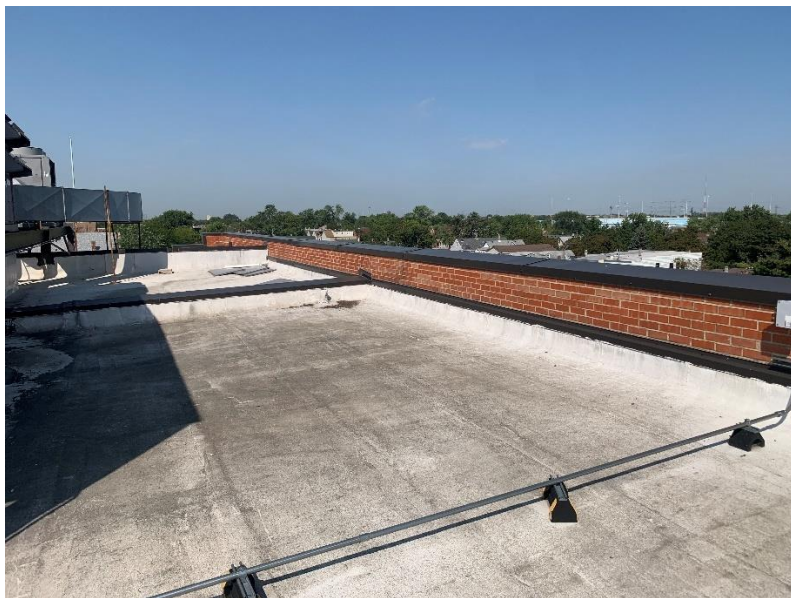
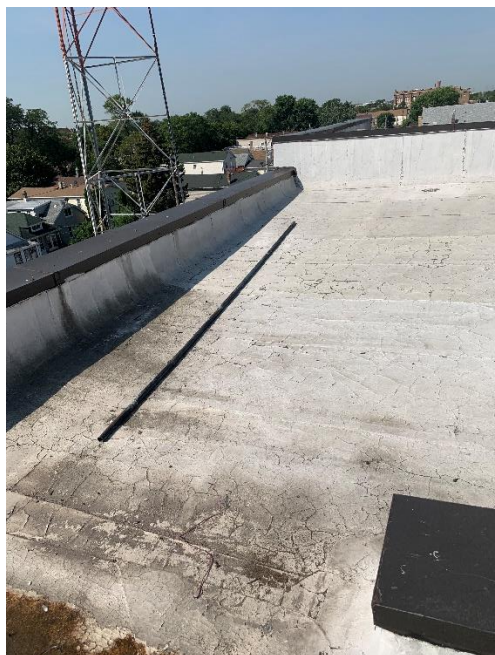
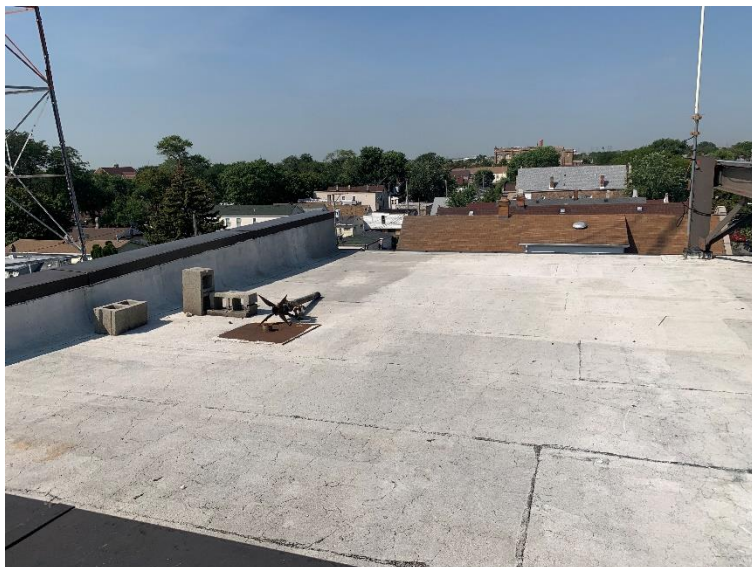
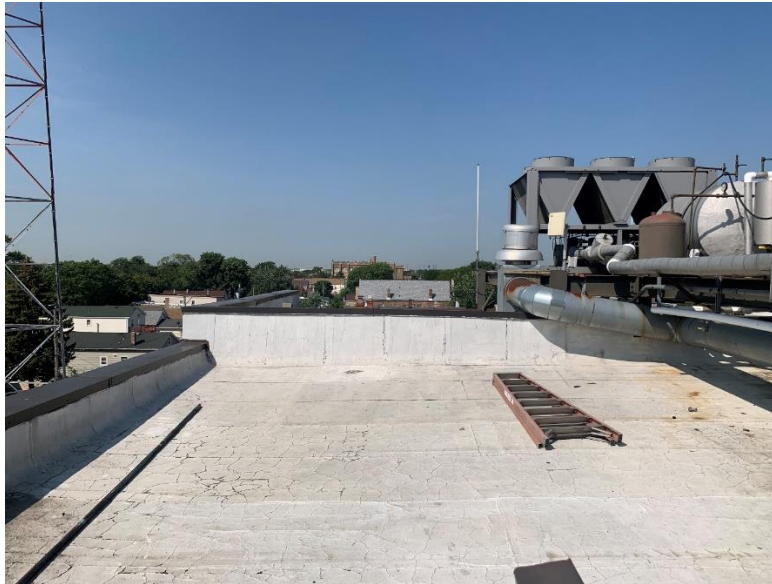
Photos 15, 16, 17, 18 & 19: The roof was reported to have been leaking from snow melt and is not properly pitched to drain. The modified bit roof is showing evidence of ponding. Remove existing membrane, investigate condition of roof components, and provide new tapered insulation and roof membrane.

Recommendation: Remove existing roofing system and replace with new system. Provide proper slopes and roof drainage. Roof leak damage to be repaired in exterior envelope: parapet walls, upper floor lintels and miscellaneous roof system accessories. Repair of interior damage caused by roof leaks shall be executed: remove and replace some acoustical ceiling tiles, gypsum board walls and ceilings and patch, prepare and paint accordingly. Once the AOR and roofing consultant visit the site and perform core samples and provide lab results to verify and confirm visual observations the assessment is to remove existing roofing system and replace with new system to be determined by owner. TPO is the recommended system to be used. The access to roof needs to be improved with a new ship ladder and new roof hatch as well as a more appropriate location to be determined with project design team.

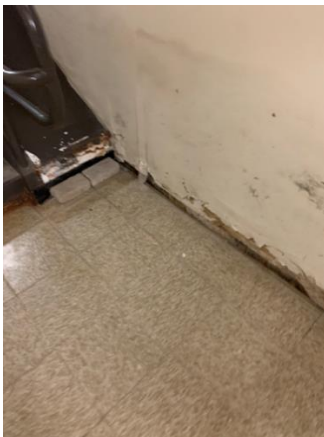
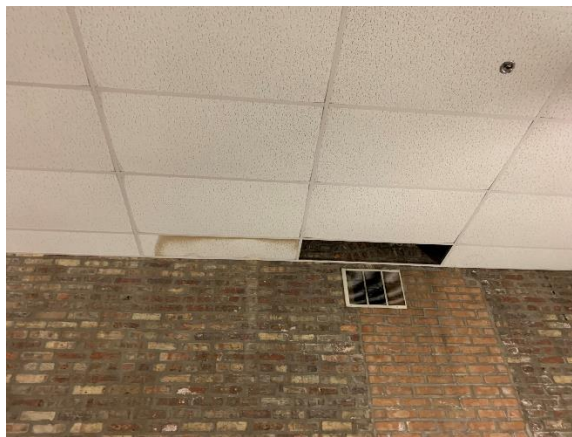
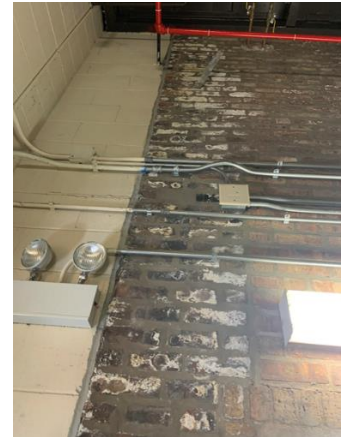
Photos 20, 21 & 22: The roof leak damage has caused acoustical ceiling tiles and drywall damage.

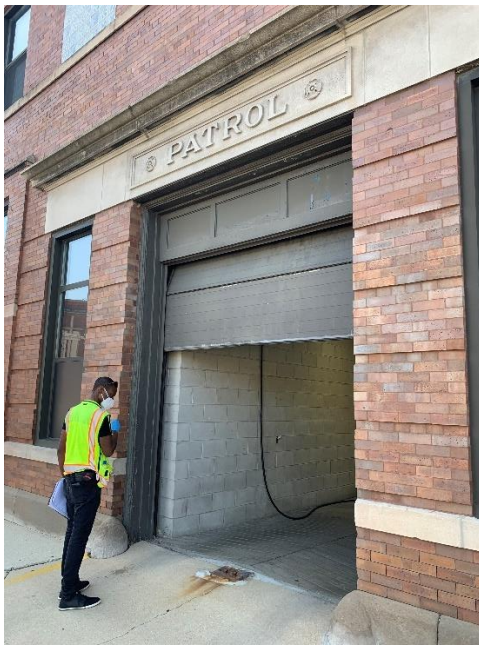
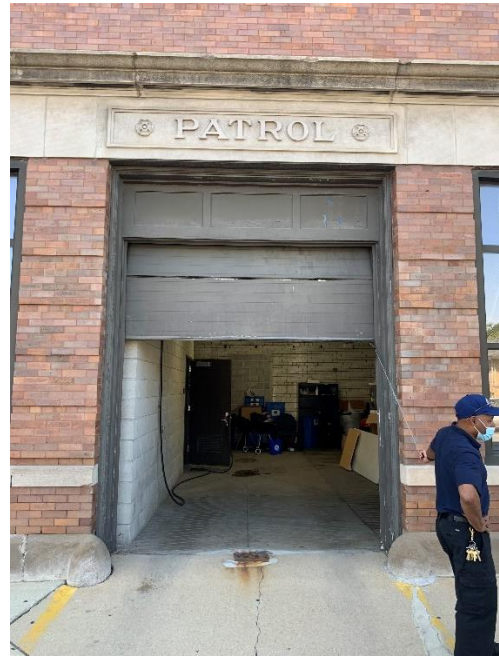
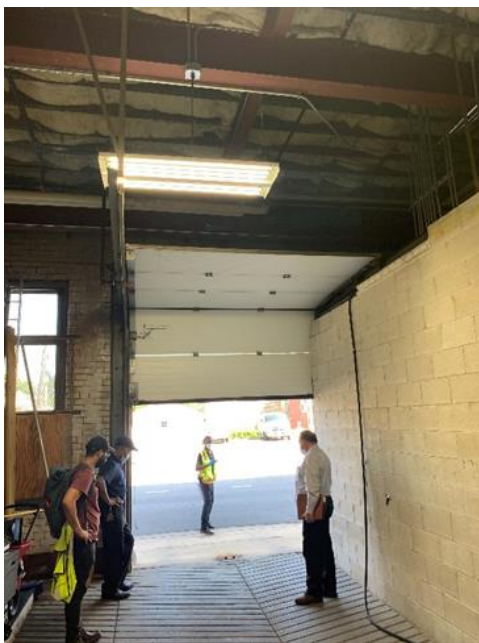
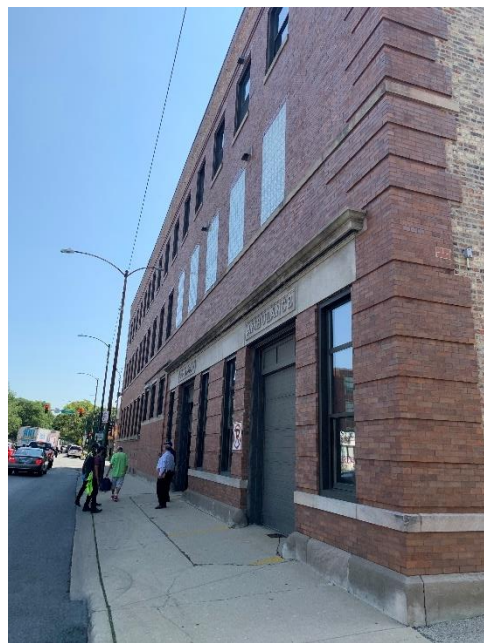
Overhead Garage Door: North exterior door showing signs of wear and tear that are going beyond repair.

Photos 23, 24, 25 & 26: Garage door and frame show signs of wear and tear above repair.

Recommendation: Remove and replace frame, door and hardware.

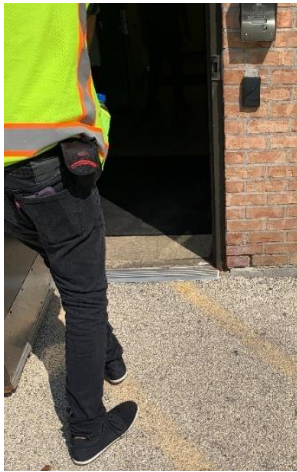
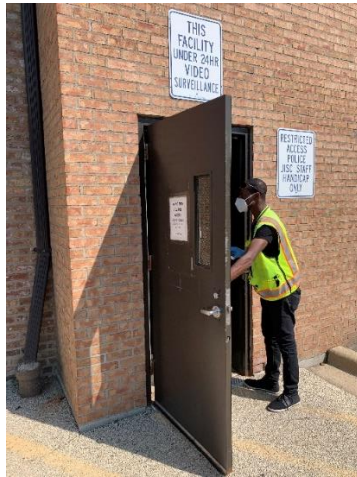
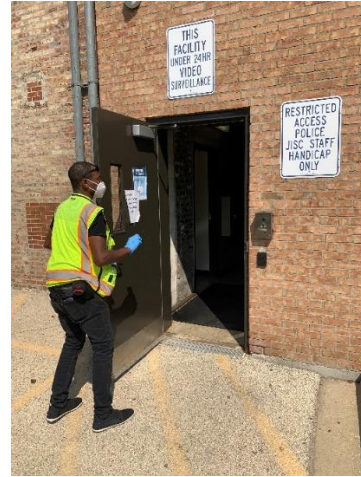
South Entry Door: It has been problematic with temperature changes.

Photos 27, 28 & 29: South exterior door showing signs of wear and tear that are going beyond repair.

Recommendation: Remove and replace frame, door and hardware.

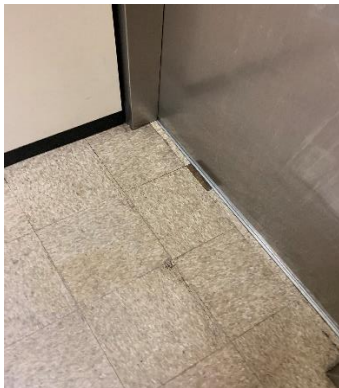
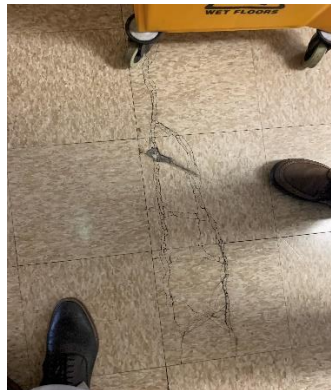
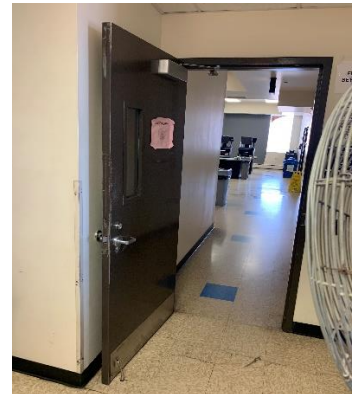
Corridors Finish Flooring: It was observed that the vinyl finish flooring at corridors is worn out and needs replacement at different areas.

Photos 30, 31 & 32: Vinyl flooring at all corridors needs removal and replacement.

Recommendation: Remove and replace in kind with new vinyl flooring all corridors in first, second and third floors. Provide new substrate at areas where repair is needed: 10% of total corridor area.

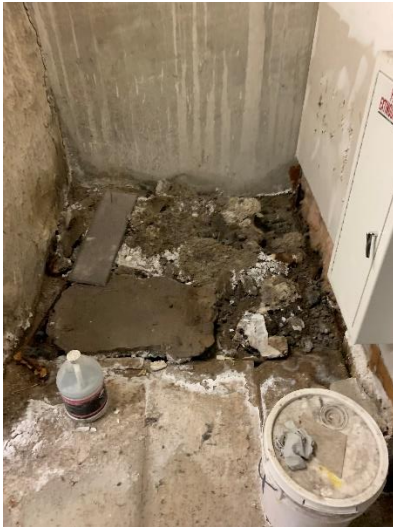
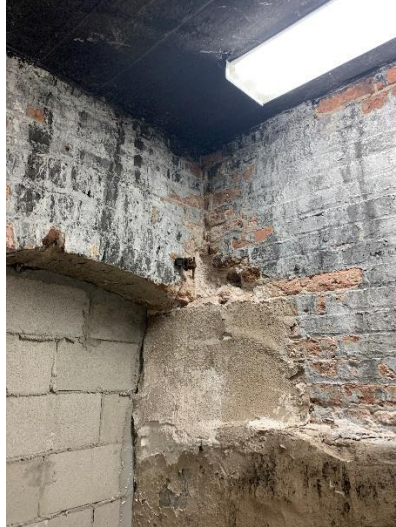
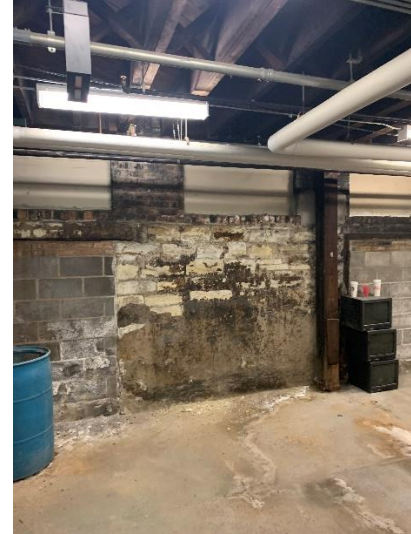
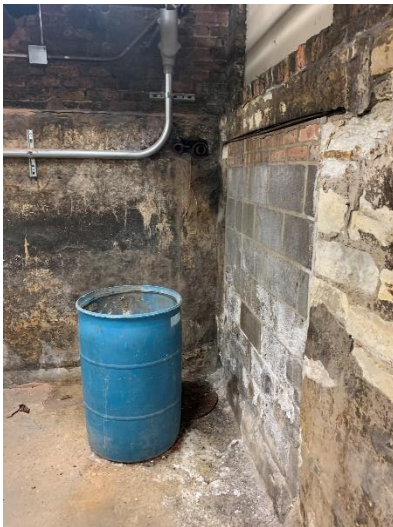
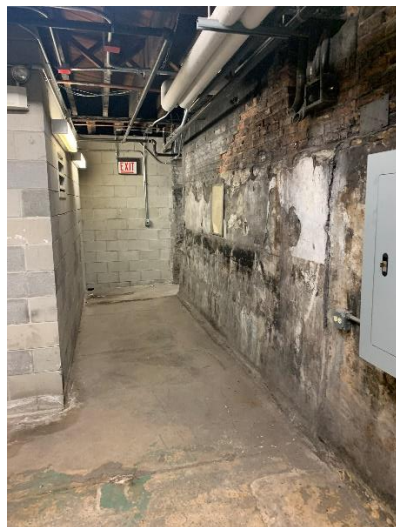
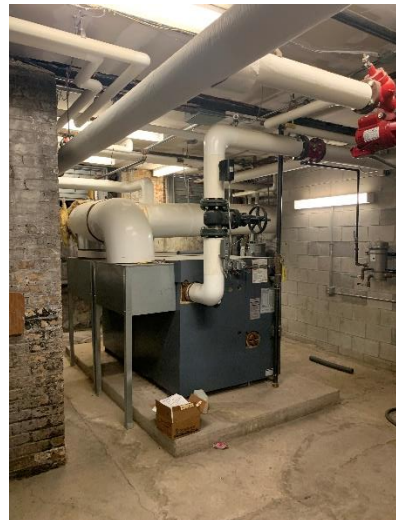
Basement Roof Leaks and Moisture Damage: The building engineer has reported roof leak damage and potential plumbing leaks and sump pump issues.

Photos 33, 34, 35, 36, 37 & 38: Roof Leak and moisture damage at basement level is deteriorating the building materials. Sump pump may have issues as reported by building engineer.

Recommendation: Remove and clean off thoroughly efflorescence from brick, mortar and masonry and dispose off properly. Identify plumbing damage, remove, and replace in kind. Sump pump damaged parts to be repaired. If damaged beyond repair, then remove and replace with new.

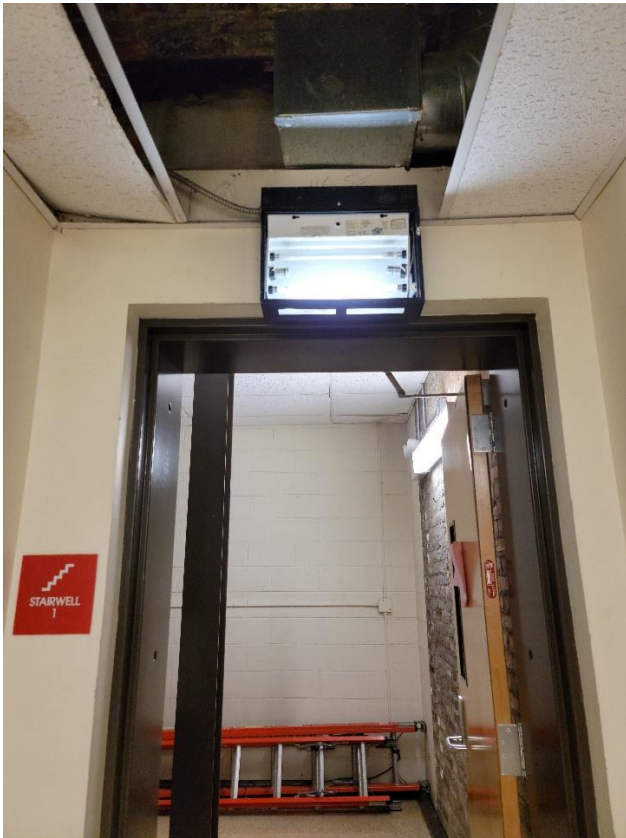
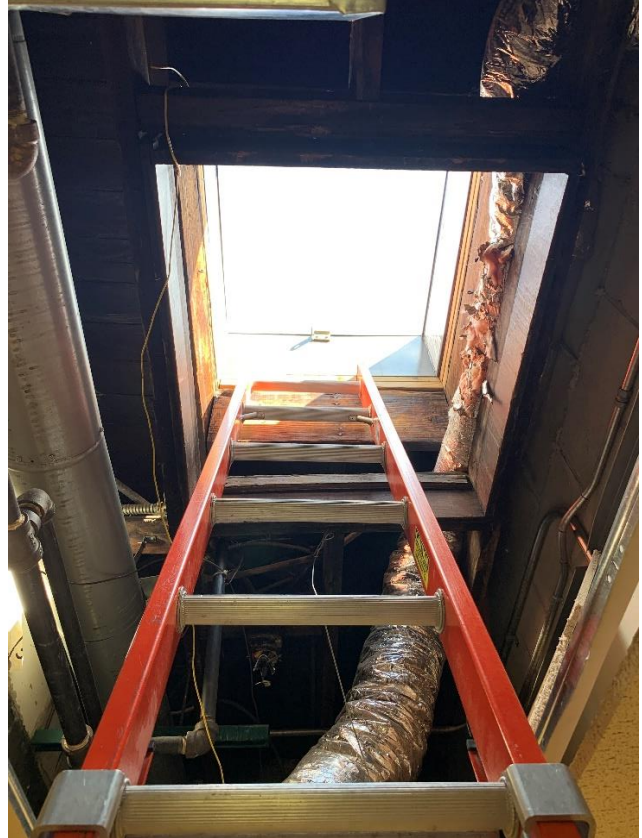
Roof Hatch and Ladder: The roof needs proper access and away from public corridor. The existing roof hatch is located at the corridor in front of the elevator.

Photos 39 & 40: Roof access with movable ladder in corridor.

Recommendation: Remove and replace roof hatch and provide new structural system to cover opening and ceiling finish to match existing. Provide new roof hatch and new metal ladder at stair enclosure landing

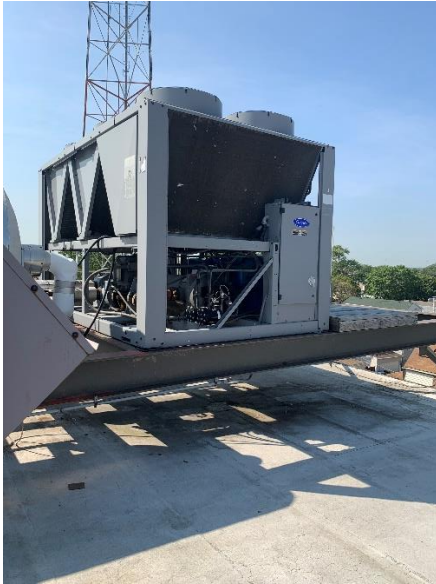
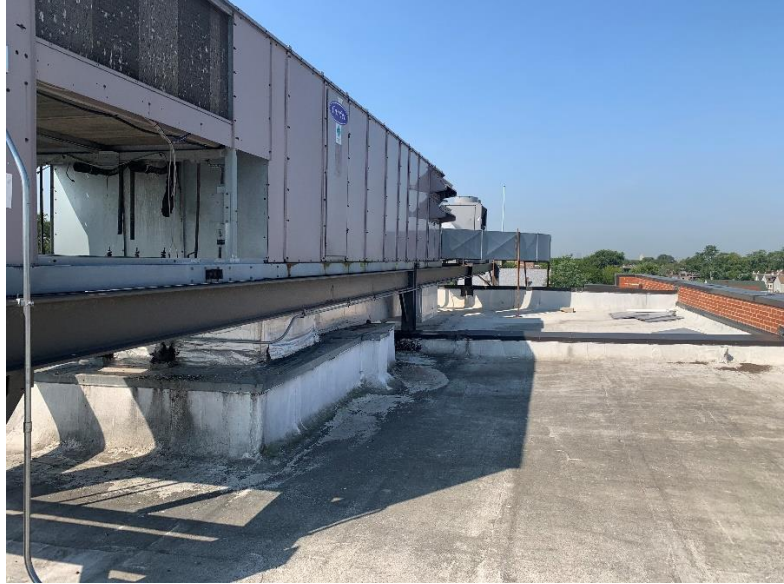
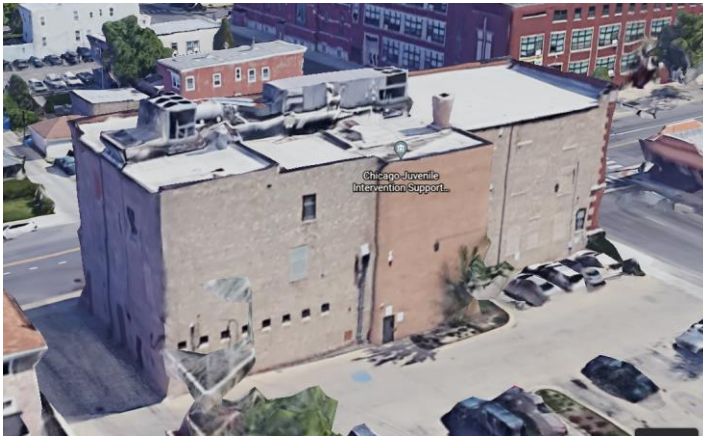
Mechanical roof equipment on steel structure safety rail: Roof mechanical units are to be serviced and they lack a safety rail next to west end of the building.

Photos 41, 42 & 43: Roof mechanical equipment shows no safety rails nor maintenance traffic pads.

Recommendation: Provide safety rails at the west end as well as traffics pads around mechanical equipment for maintenance.
