PERSHING ROAD BUILDING
1769 W Pershing Ave, Chicago, IL 60609
Facility Evaluation Report 07/09/2021

HARDING MODE JOINT VENTURE

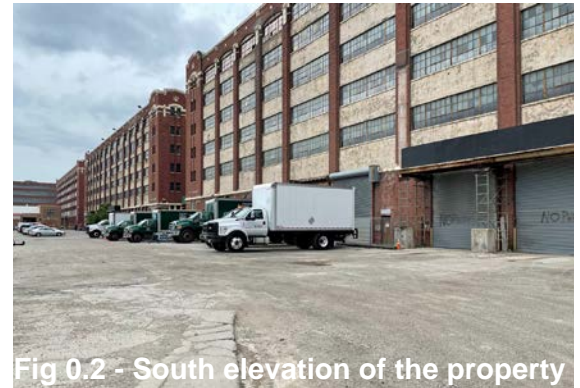
Fig 0.2 - South elevation of the property

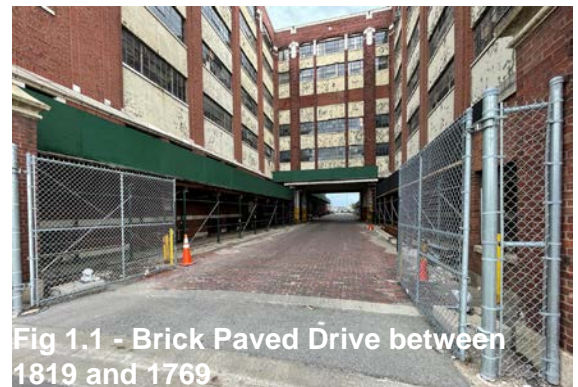
Fig 1.1 - Brick Paved Drive between 1819 and 1769

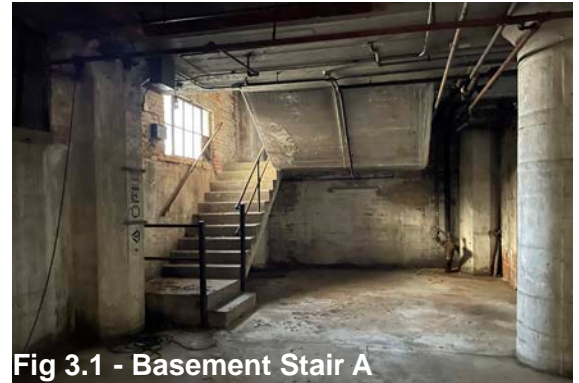
Fig 3.1 - Basement Stair A

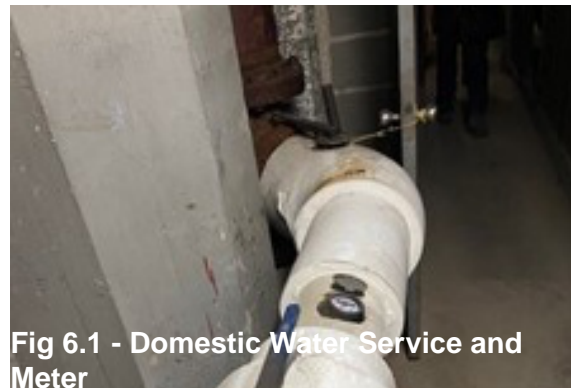
Fig 6.1 - Domestic Water Service and Meter

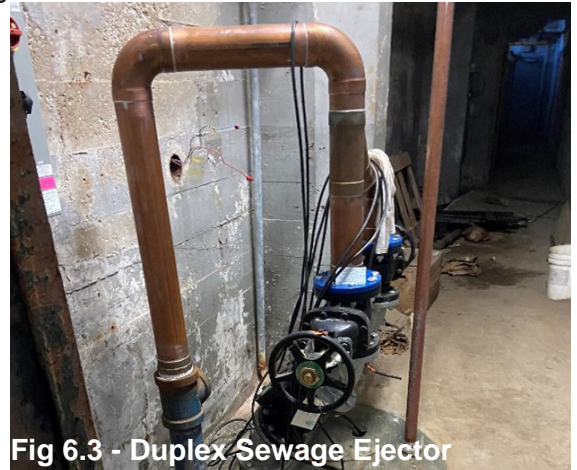
Waste and vent piping was observed to the extent feasible when exposed. Only a small sample was viewed. No official determination can be made to the overall condition. Waste and vent observed at the basement level ceiling appeared to be in poor condition with visible exterior pipe corrosion. The existing ejector pump and pit was observed to be in new to newer condition (fig 6.3). All electrical connections have been cut from the panel.

Fig 6.3 - Duplex Sewage Ejector

- Recommendations
 - Reconnect electrical power and controls to ejector pumps. Confirm pump and high-water alarm/switch operation. Pumps to be activated and operational during building vacancy. No recommendation to replace any waste and vent piping as the building is to remain vacant.

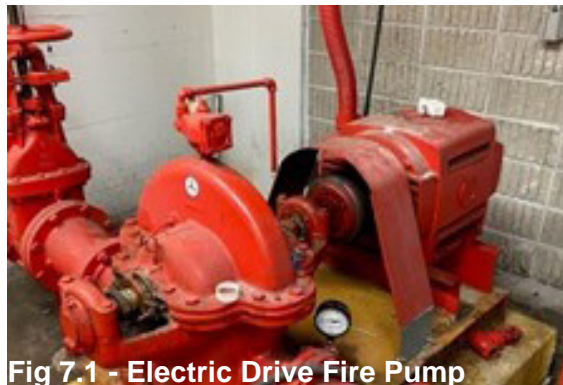
Fig 7.1 - Electric Drive Fire Pump

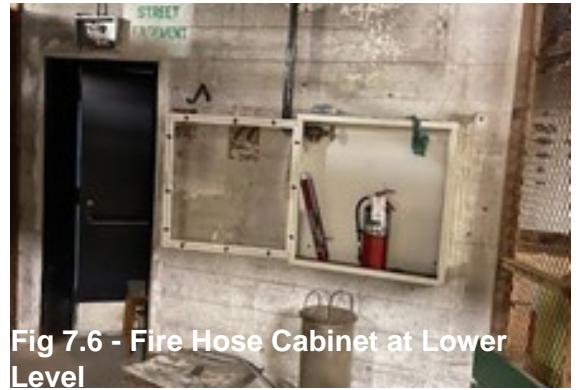
Standpipes are not installed. The existing building, when occupied, was protected by a wet pipe sprinkler system and 1-1/2" hose valves.

Fig 7.6 - Fire Hose Cabinet at Lower Level

- Recommendations:
 - No recommendations for providing standpipes with 2-1/2" valves as building is to remain vacant.

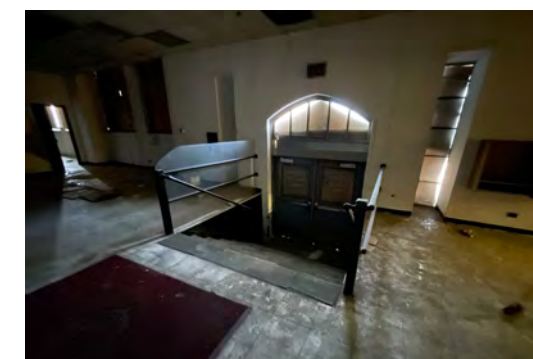
G - Center entrance to Pershing Road obstructed with plywood

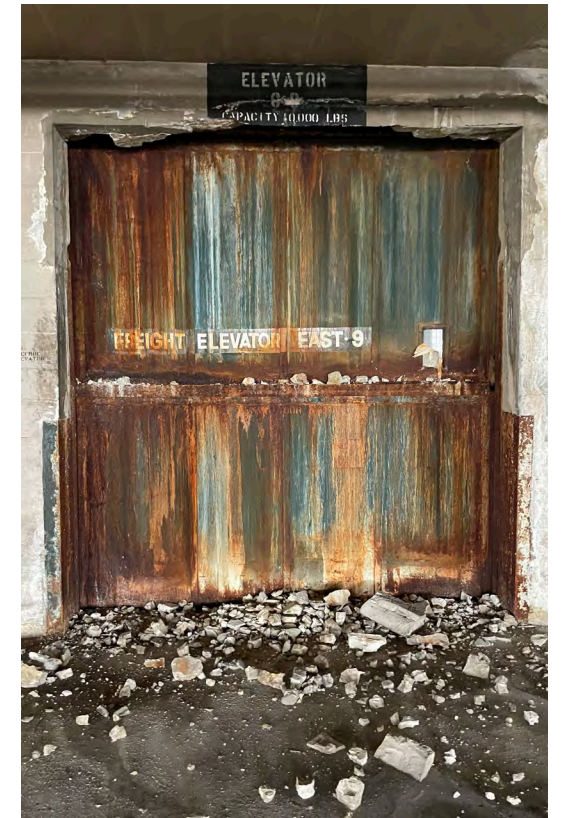
C - Deteriorated Lintel Elevator 9

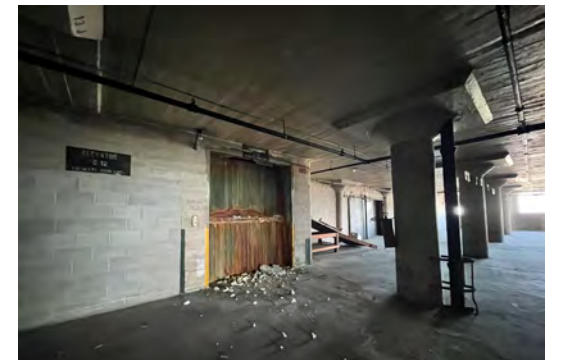
D - Elevator Lintel Deterioration

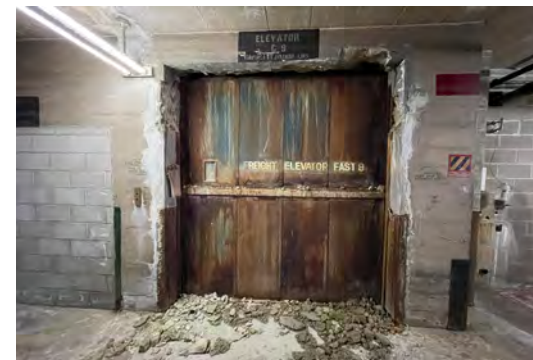
E - Elevator Lintel Deterioration

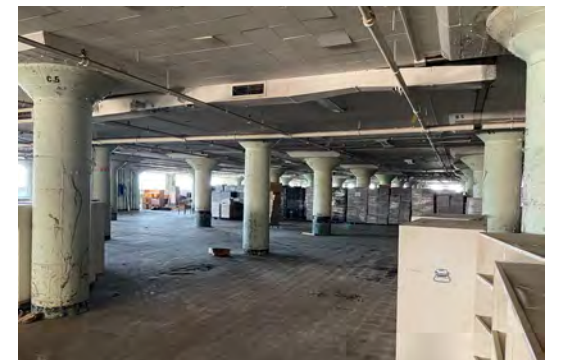
F - BOE storage at north side of floor

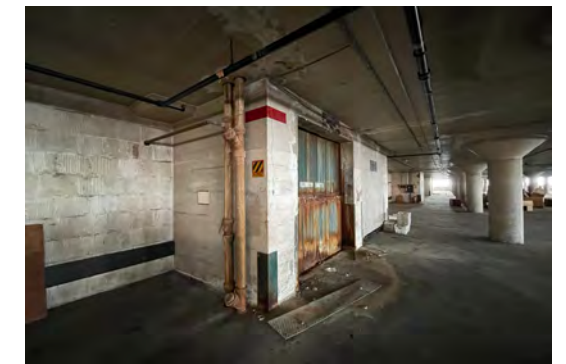
B - Damaged elevator

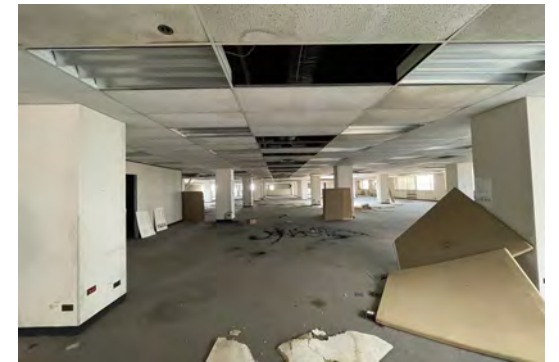
B - Interior build-outs and damaged materials

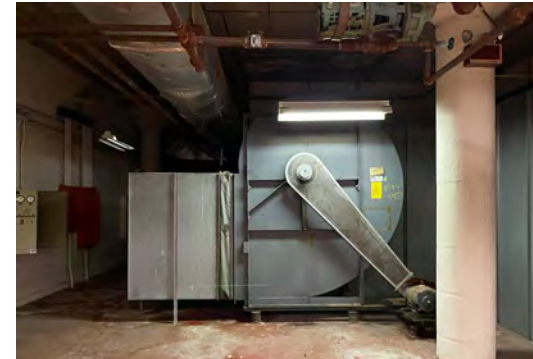
C - Abandoned mechanical units

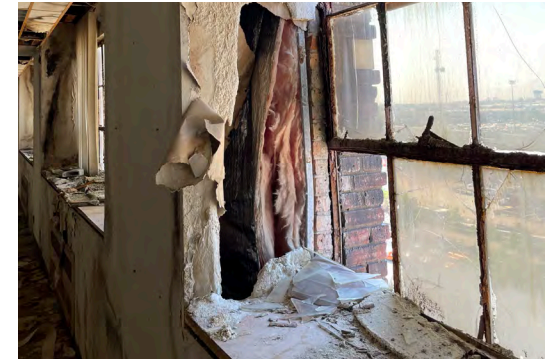
D - Deteriorated wall assembly

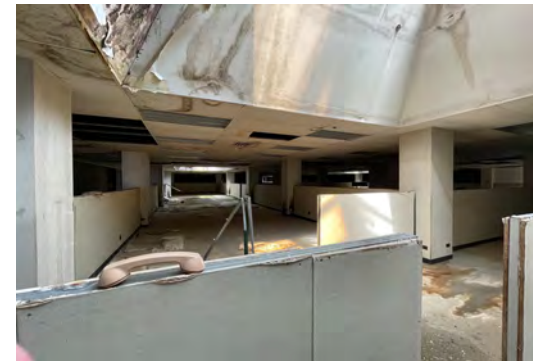
E - Partition and buildout, abandoned equipment

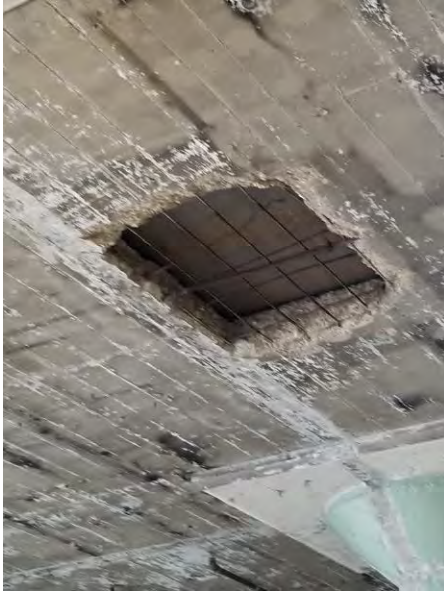
The building structure was generally in good condition. On Level 6, we observed a hole in the roof concrete slab, where the concrete had been removed, but the rebar was still intact and visible. We also observed a concrete beam above the Elevator B-6 opening that appeared to have been cut. Some of the bottom bar reinforcement and stirrups in the cut beam were visible. Generally, on Level 6, we observed several locations of concrete spalling and exposed, rusted rebar. Typically, when reinforcing is exposed to water and rusts it expands. The forces that result from the rusting cracks and eventually spalls the concrete cover. The majority of the locations of rusted rebar and spalled concrete were around skylights. It appeared that there had been leaks in the past, which caused the rebar to rust and concrete to spall. At the time of our visit, we did not observe any leaks, possibly the roof and skylights had been repaired and the water damage rusting and spalling occurred some time ago.

Cut Slab Near Column M.2

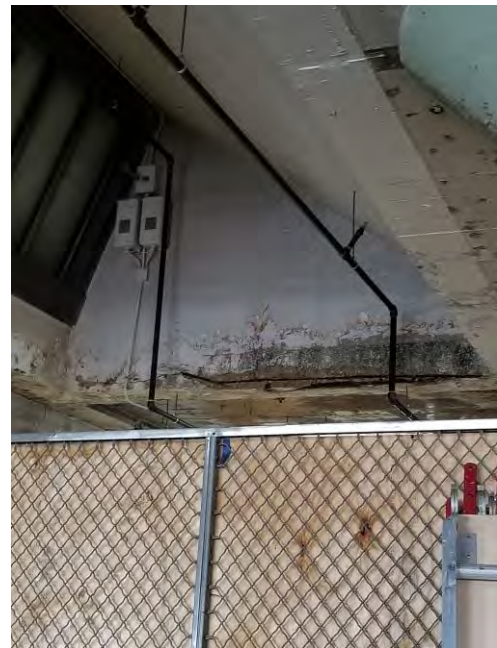
Exposed Rebar around Skylight

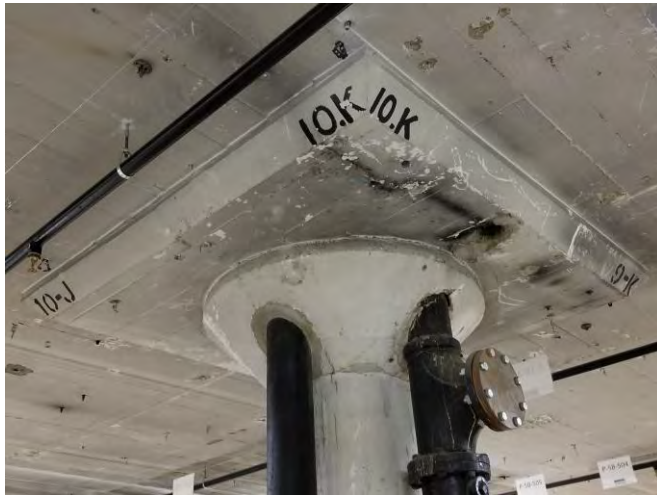
Levels 1 to 5 of 1869 W. Pershing were in relatively good condition. There were many existing cores through the concrete structure for plumbing and other utilities. Some cores occurred through column capitals. The cores reduce the strength of the concrete slabs. Cores through the column capitals and drop panels reduces the shear and flexural strength of the slab/column connection. We observed several locations where there were cracks in the floors. We did not see these cracks telegraphing through to the underside of slab in the locations we checked. There are many causes for concrete surface cracks, such as initial shrinkage cracks that enlarged over time due to overloading of the slab by heavy equipment, or long-term deflection of the slab due to creep. The surface damage cracks may also have occurred from the forklifts and equipment that were driven over the slab.

Pipes Through Column Capital

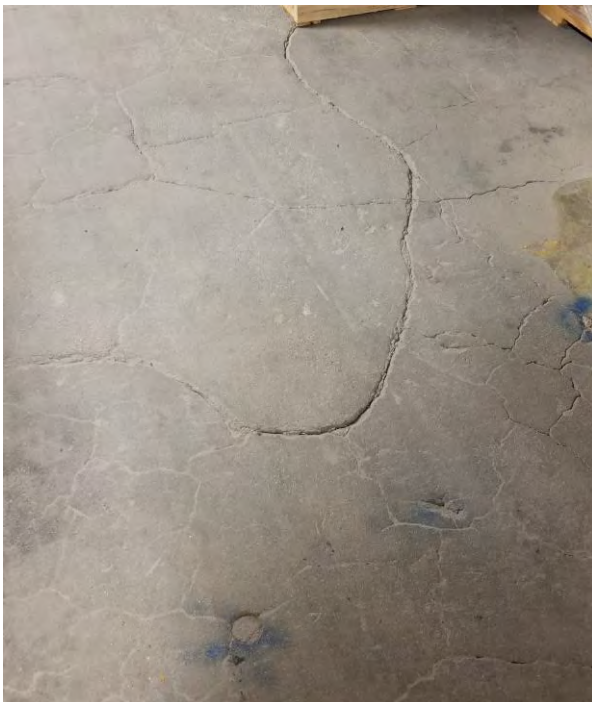
Floor Cracks at Level 5

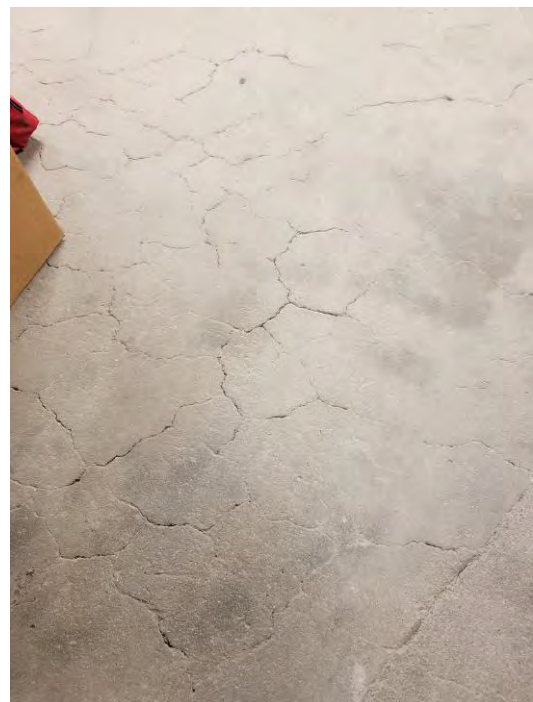
Floor Cracks at Level 5

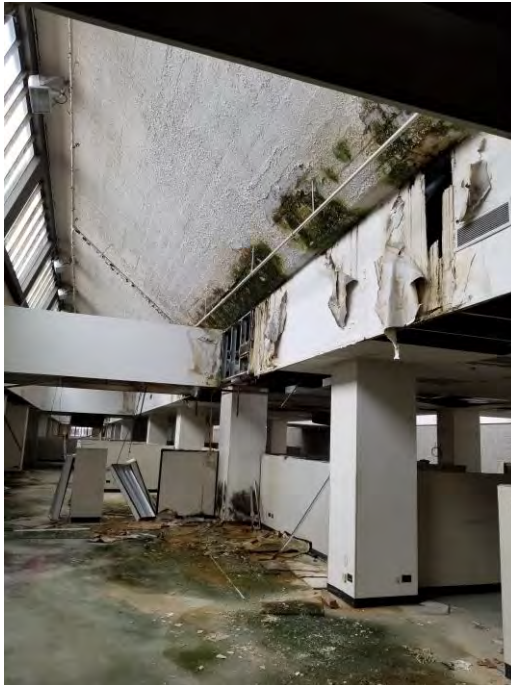
At Level 6, there was extensive visible damage due to water infiltration. There was visible water leaking through the roof structure, and there was mold and water damage throughout the floor. The majority of the substantial leaks were occurring at the skylights. There were many areas where the concrete structure around the skylight was covered with mold, and there was visible rusted rebar. The majority of the structure around the skylights will need to be repaired or replaced. There were other leaks in the roof away from the skylights that could result in damage to the reinforcing and concrete. There were approximately 10 locations of leaks and possible water damage in other locations away from the skylights.

Water Damage at Skylights

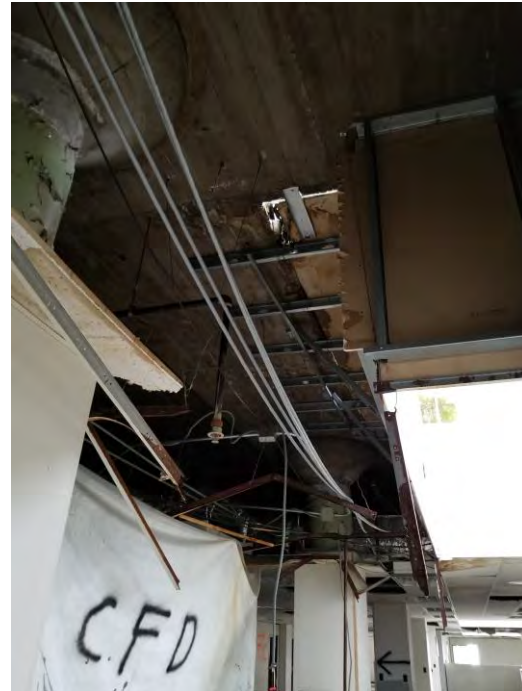
Water Damage at Skylights

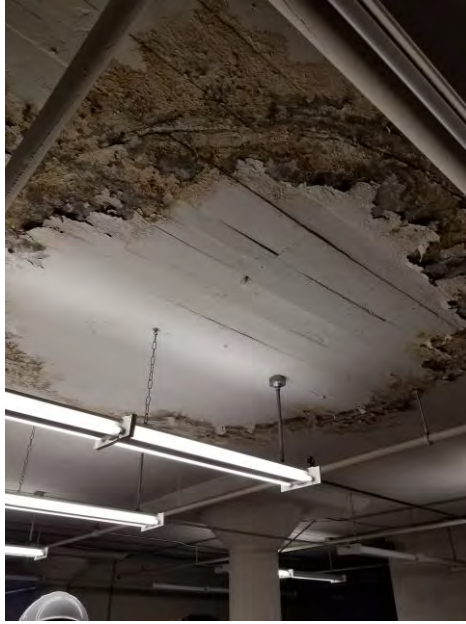
Level 5 Water Damage

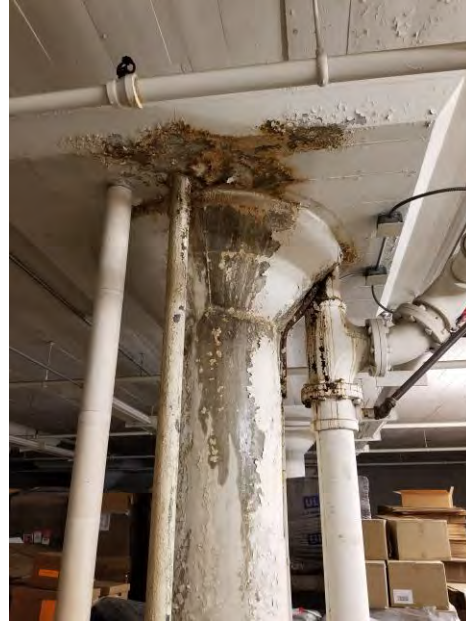
Water Damage at Column

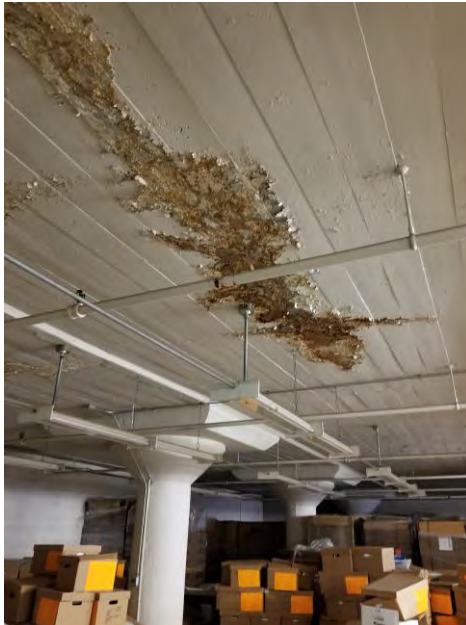
Level 5 Water Damage

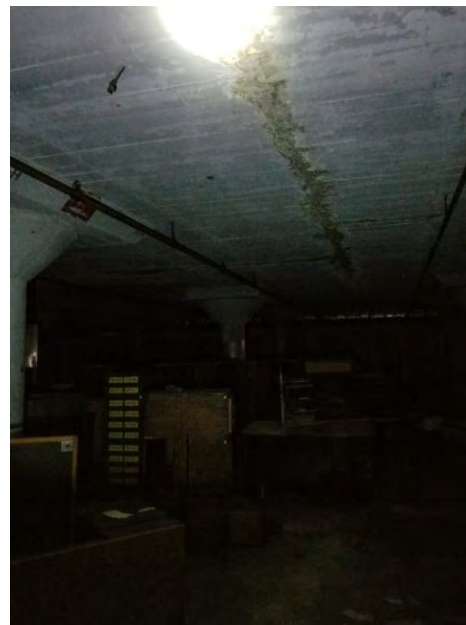
At the ground floor and 2nd floor, the condition of the structure was generally good. We observed thin continuous cracks on the underside of the floor slab in the midspan of several bays. The cracks were similar to those that had been observed on the upper floors, but there was no water infiltrating these cracks at the time of our visit.

Continuous Crack at Slab Underside

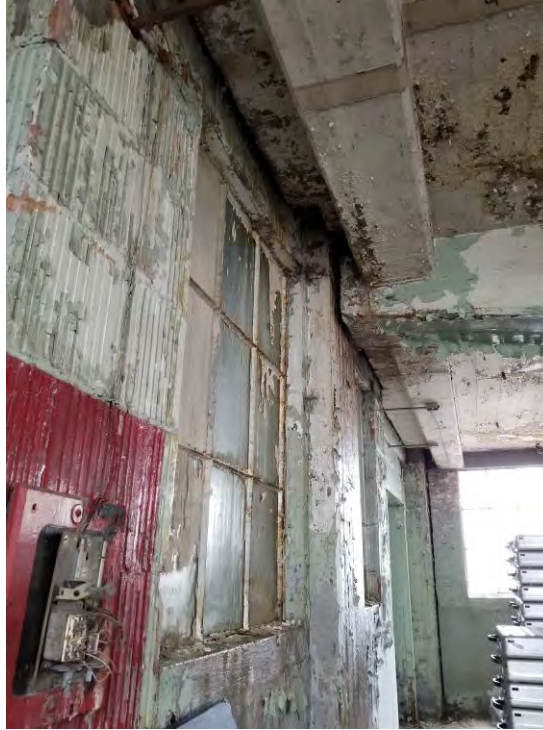
At Level 3, in the interconnecting bridge building, we observed water dripping through the building expansion joints on each side. There was some deterioration of the structure due to water damage.

***Water Damage at Expansion Joint between
Main Building and Interconnecting Bridge***

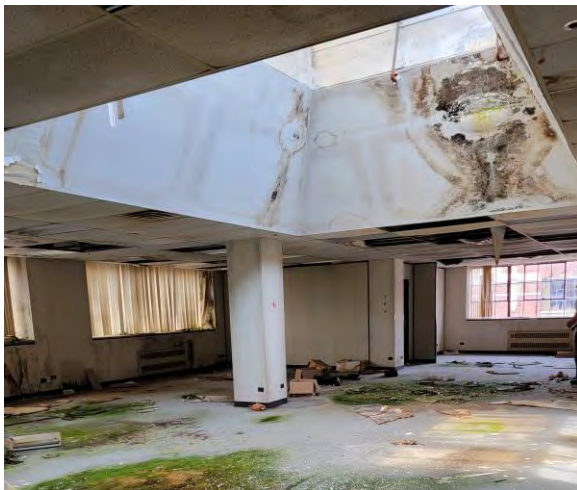
There was widespread water damage to the roof slab of the 1769 W. Pershing building. There were active leaks at all skylight locations. At least 1/3 of the bays observed across the entire roof structure had some sort of active leak or visible corrosion. There were other areas of the roof that were not visible due to a dropped ceiling. There was extensive mold across the 6th floor, with moss and plants growing under the skylights where there was direct sunlight. Much of the carpeted floor was moist, so much of the concrete slab below is constantly being exposed to moisture.

Mold and Corrosion @ Skylight

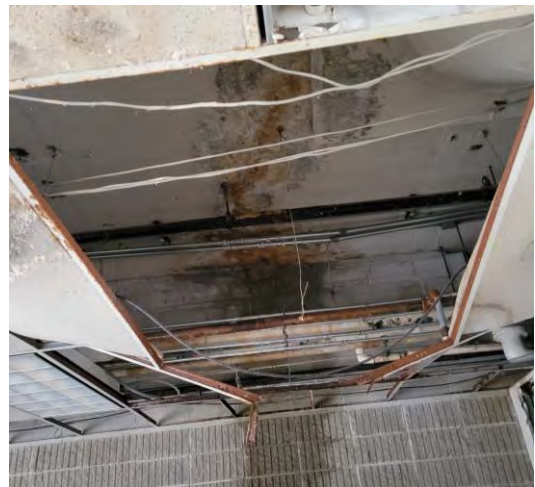
Water Damage and Cracking in Roof Slab

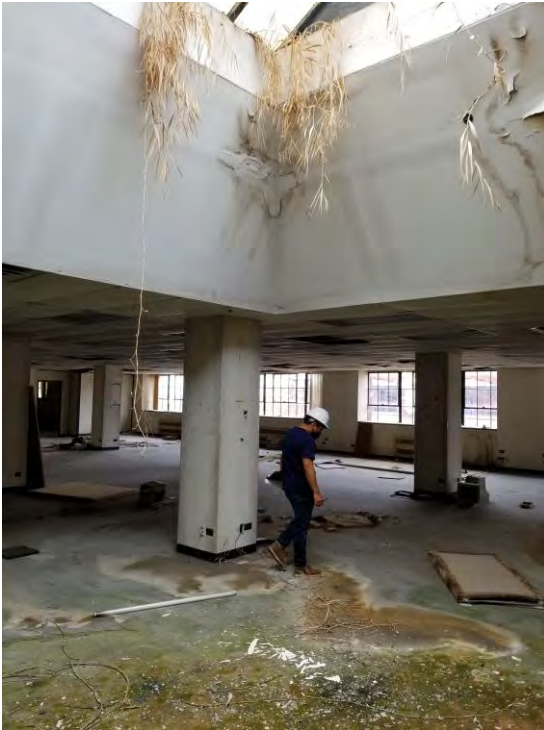
Plant growth at skylight areas

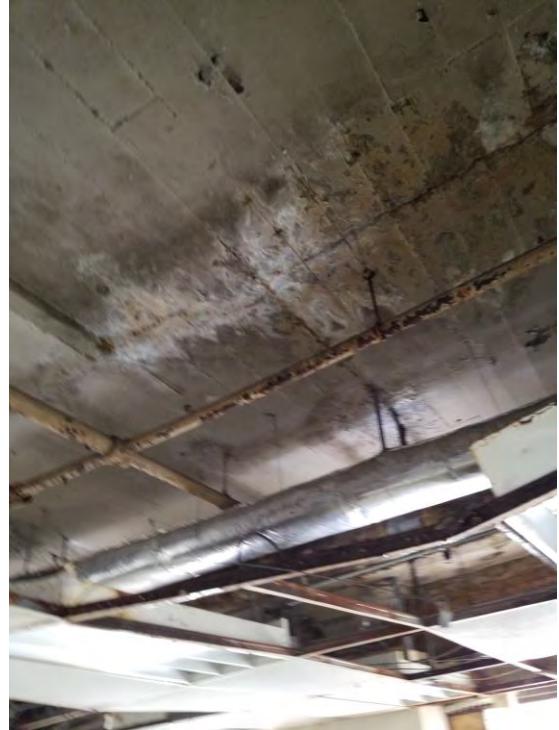
***Corrosion visible on underside of
Roof slab***

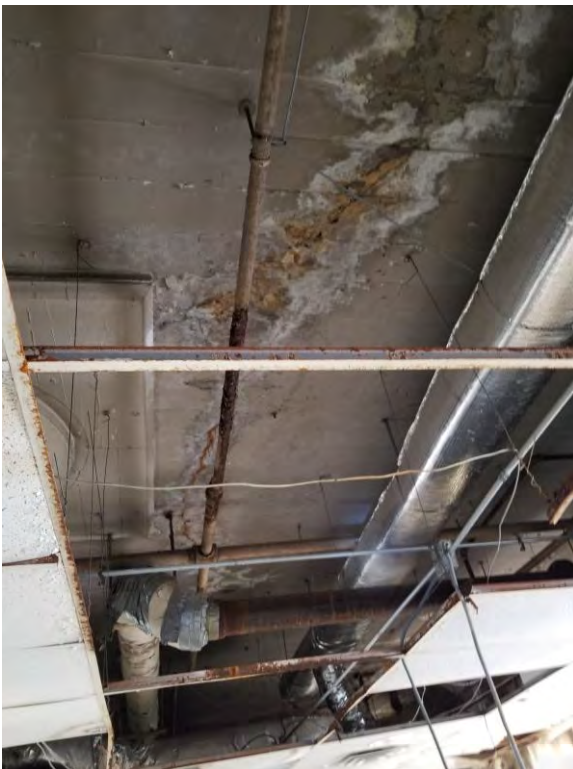
***Corrosion visible on underside of
Roof slab***

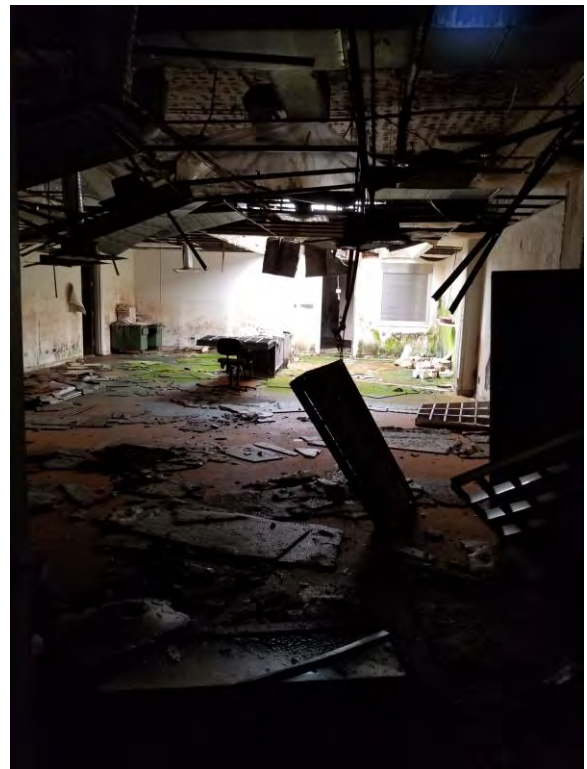
***Overall condition of all elements on
Level 6***

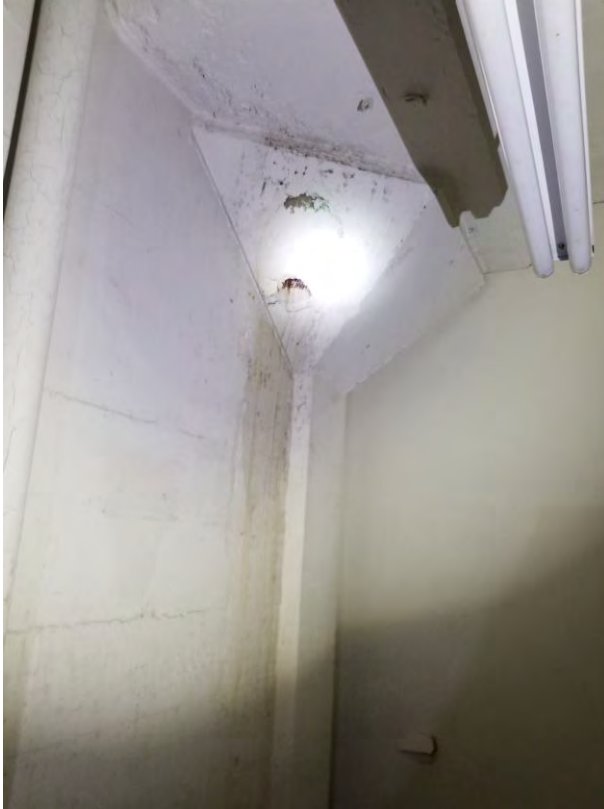
On Level 5, there were at least 10 locations observed throughout the building where there were active leaks with signs of concrete deterioration. Most of these were small cracks that ranged from within one bay to several bays in length. There was also a location where water was leaking through a column capital, indicating possible corrosion of reinforcing within the column. A good portion of the concrete structure on this level is concealed by dropped ceilings, but judging from locations of water leaks on the floors below, there could be up to 10 more locations where active leaks are occurring through the 6th floor slab. In addition to the cracks through the floor, there is also deterioration around the freight elevators, and in other locations where plumbing penetrates the floor structure.

Active leak through column capital

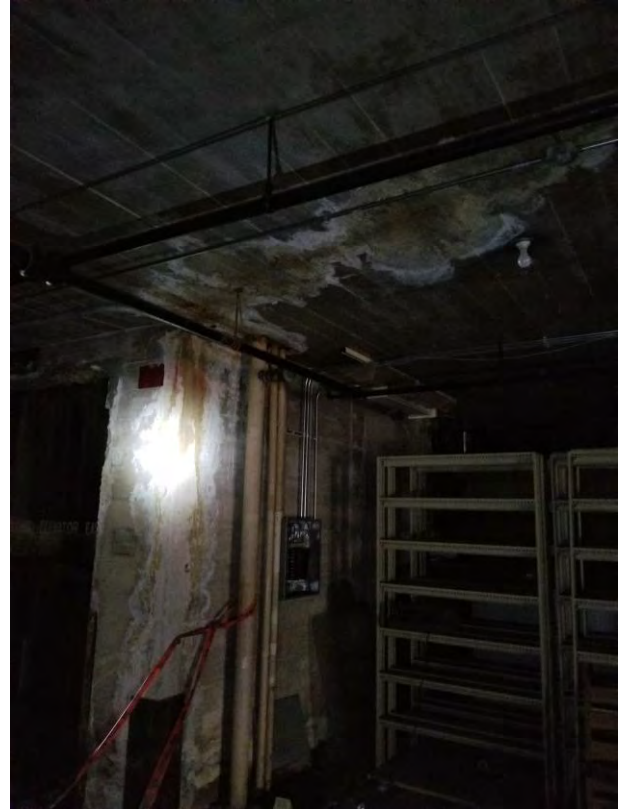
***Corrosion of slab surrounding the
freight elevator shaft***

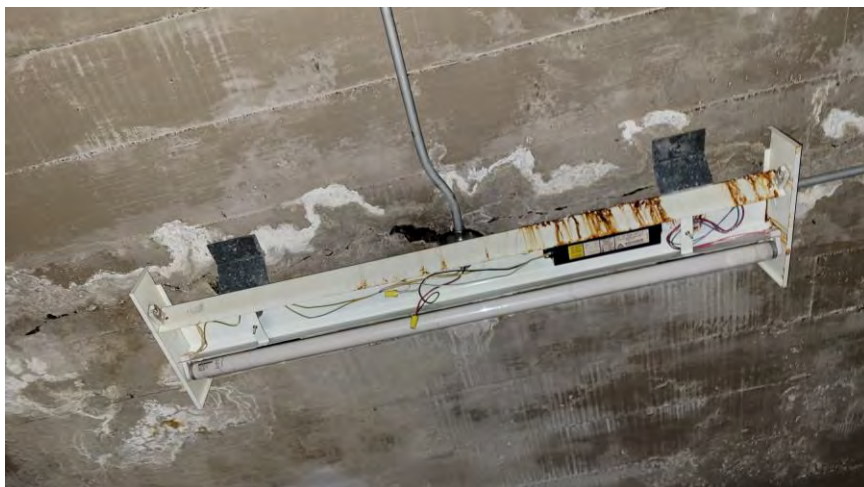
Cracking @ Water Infiltration in Floor Slab

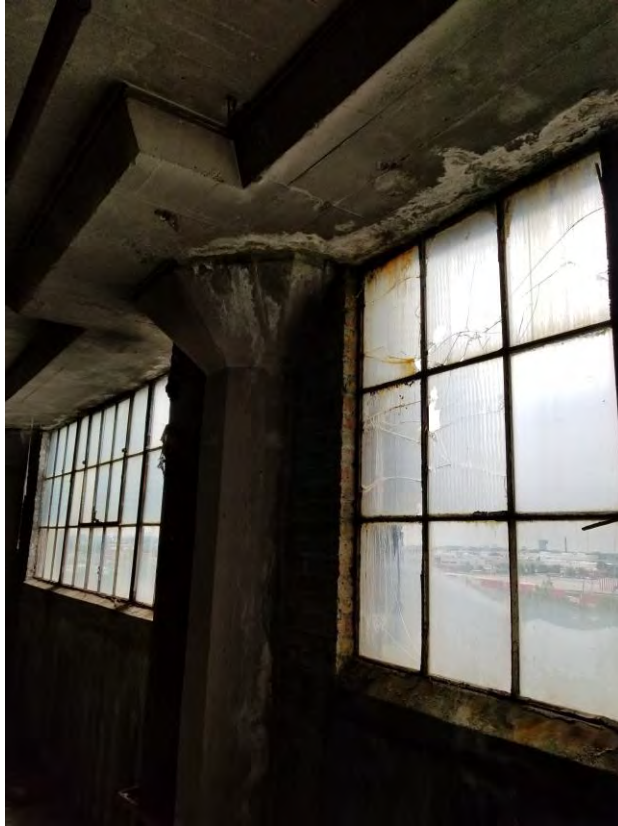
***Deterioration of spandrel beam on
north side of building***

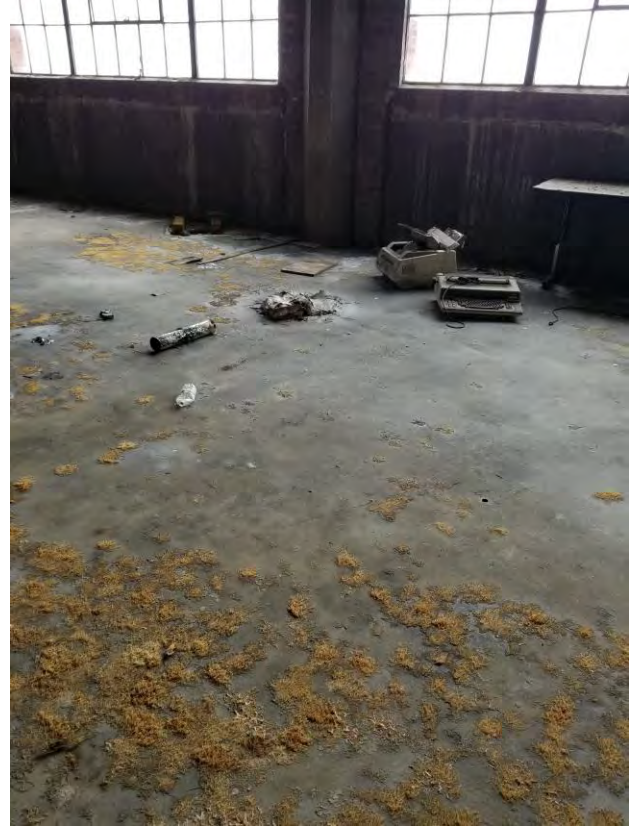
***Life forms growing on surface of
5th floor slab***

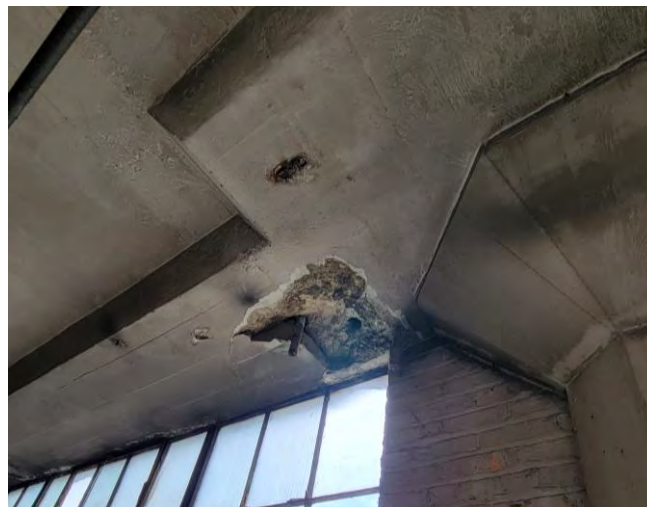
On Level 4, there were 18 observed locations of concrete deterioration around cracks. More locations were observed on this level than on the upper levels because there were no dropped ceilings, so all concrete structure was visible for inspection. Most of these locations were discoloration or efflorescence, but at 4 of the locations there were active leaks. A good length of the spandrel beam at the north wall was deteriorated, and there was also some corrosion visible along the south wall, particularly at one of the columns.

Spalling at North Spandrel Beam

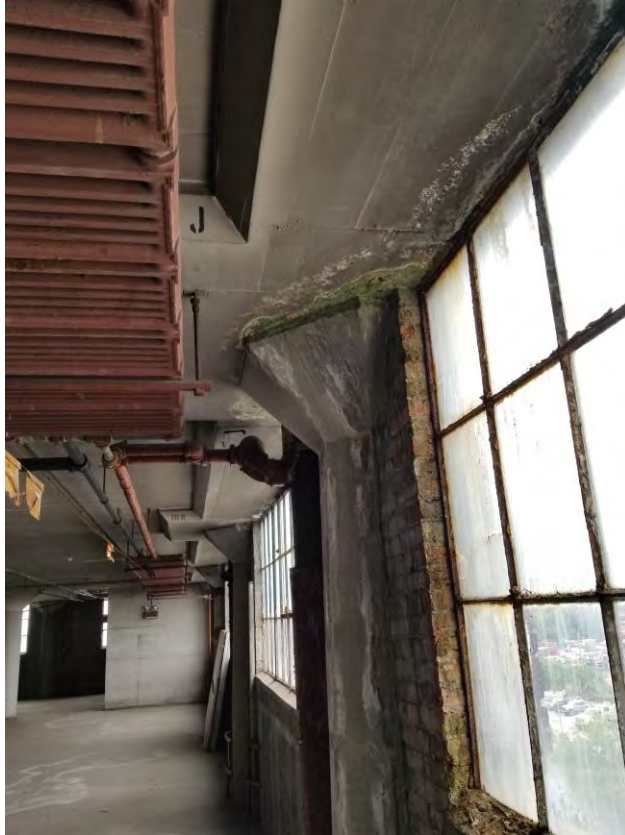
***Deterioration of spandrel beam on
north side of building***

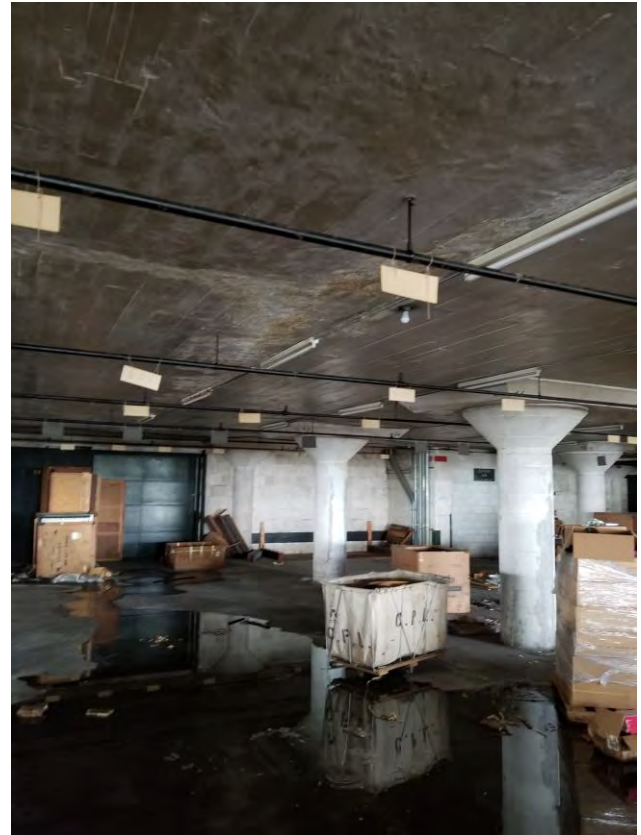
***Crack running through multiple
bays, with corrosion***

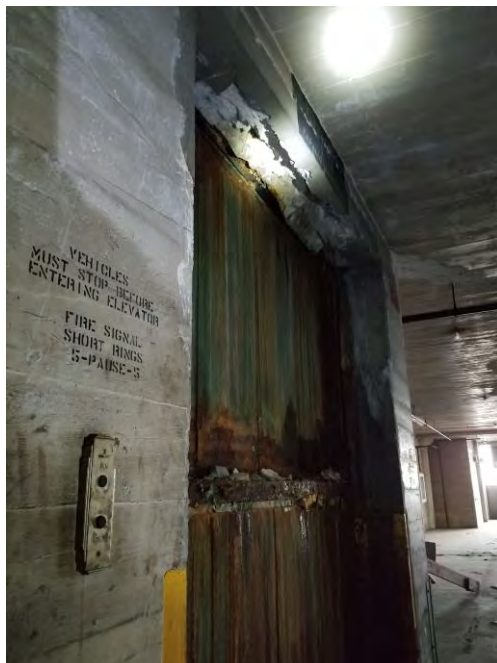
At Level 3 of the 1769 W. Pershing building, the condition of the structure was generally good with a few isolated areas of water leaks located within the interior areas of the floor plan. There were several locations at the elevator doors that had visible water leaking. Additionally, there were large pieces of spalled concrete from the beam above the elevator opening. Based on the color of the concrete, it appeared that these beams had been patched at some time in the past. The patched concrete was spalling in large pieces, and were on the floor slab below the opening. This could have been attributed to the patches applied without wire or pins, for a positive mechanical connection to the original base concrete. This issue is recurring on the other levels of this building at the 4 interior freight elevator shafts.

Elevator 13 Concrete Beam Deterioration

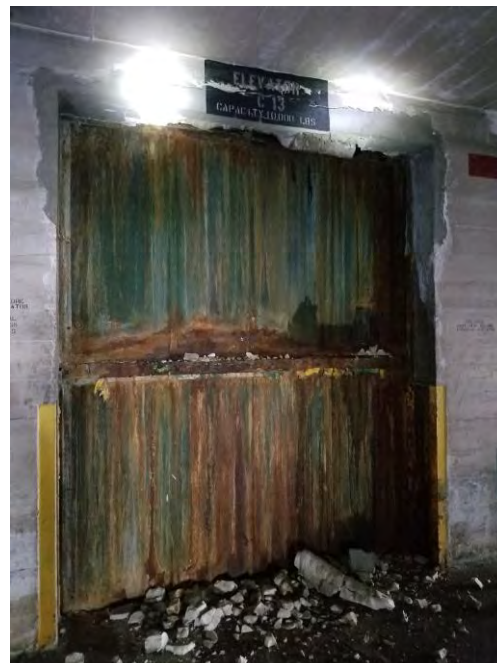
Elevator 13 Spalled Concrete

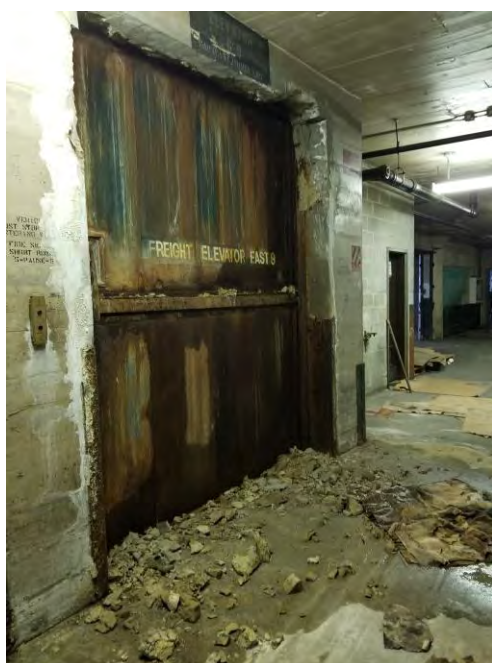
Elevator 9 South Door

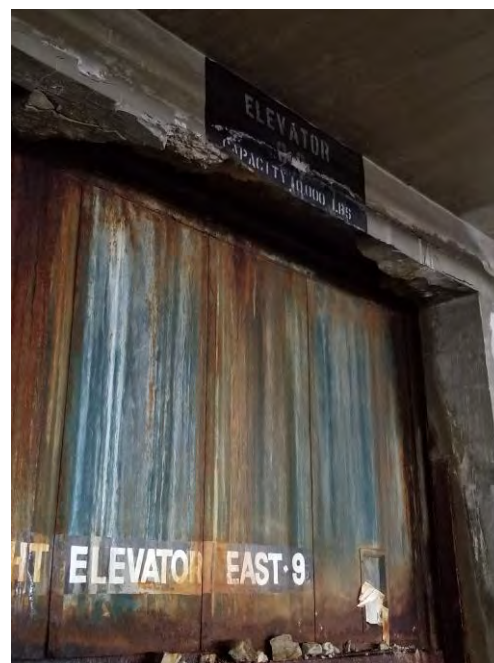
Elevator 9 North Door

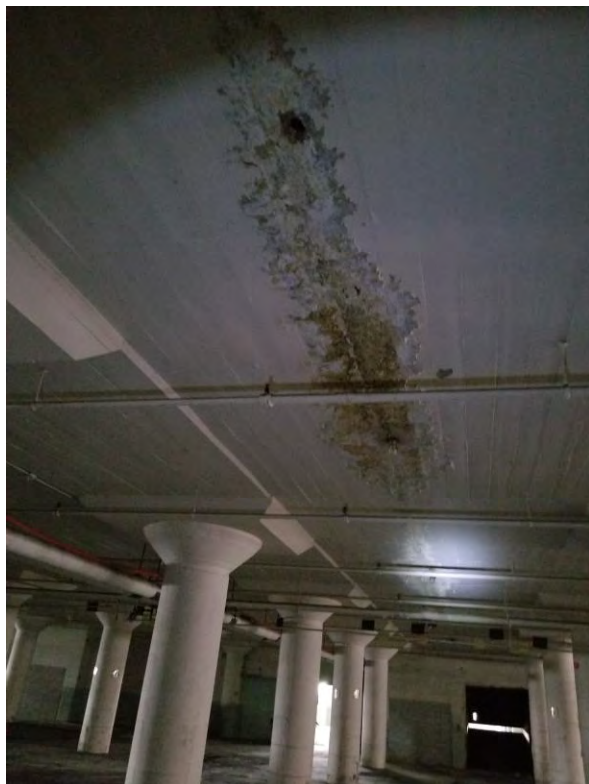
At the levels below the 3rd floor, the deterioration was minor, mainly in the form of efflorescence at some of the cracks. There were very few locations of active leaking, except at the freight elevator shafts and some of the adjacent pipe penetrations.

***Corrosion visible on underside of
3rd floor slab***

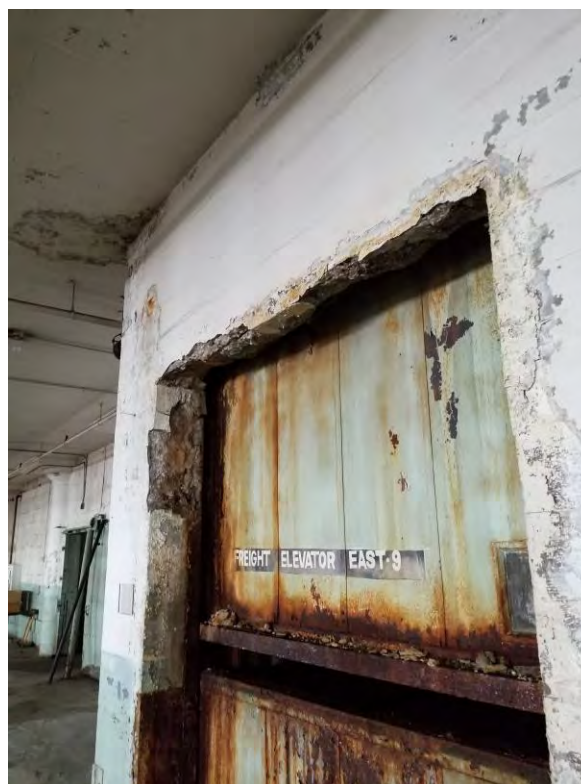
***Deteriorated beam at freight elevator,
and corrosion in adjacent 3rd floor slab***

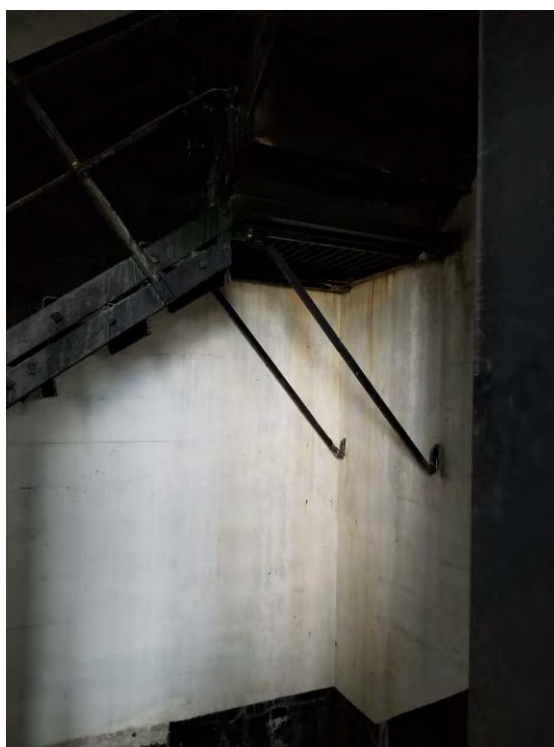
We also observed the condition of a metal stair, possibly cast iron, in the 1769 W. Pershing building. This stair had more visible rust, including on the face of the stair shaft walls.

Rust from Metal Stair Structure

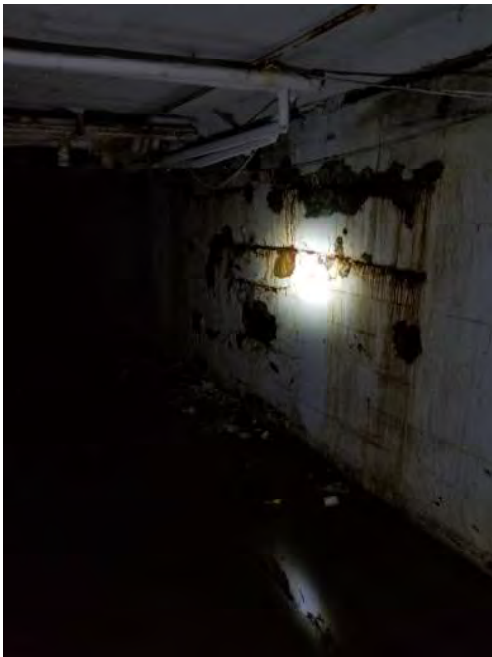
In the basement of 1869 W. Pershing, at the tunnel area beneath the loading docks, we observed spalled concrete and exposed, rusted rebar from water damage that was occurring at the joint in the building basement wall and the pavement slab above the tunnel. There was damage in the concrete wall under the exterior face of the building above, and there were some areas of the tunnel slab that were deteriorated and may need replacement.

Deteriorated Rebar in West Building Tunnel

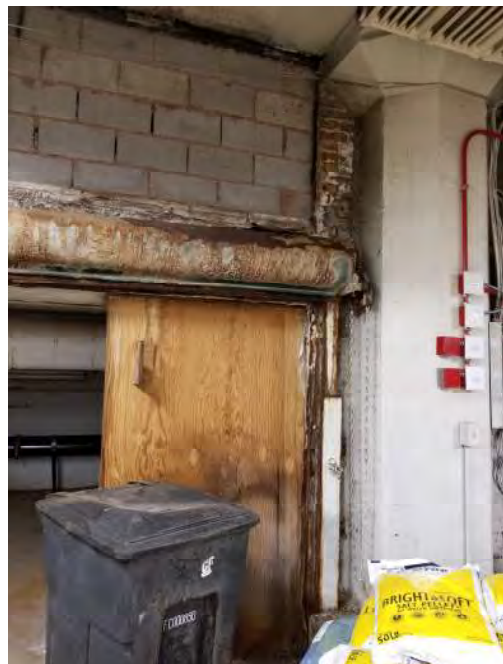
Deteriorated Masonry at Tunnel Entrance

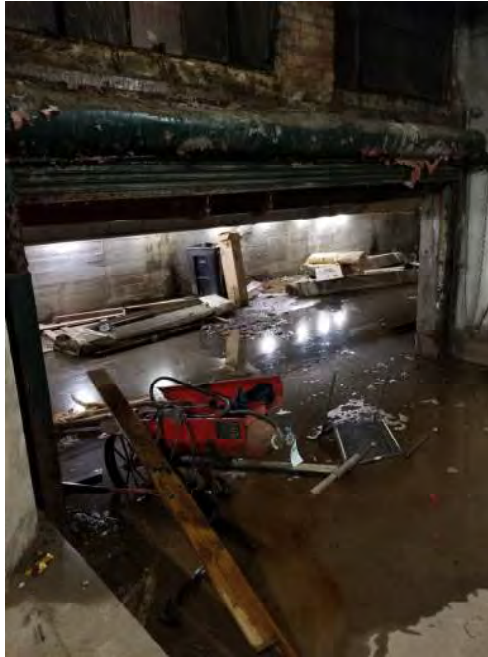
In the tunnel beneath 1819 W. Pershing, there was visible leaking at the west entrance to the tunnel and along the exterior basement walls. There was also approximately 3-4" of standing water at the entrance to the tunnel. At the east entrance of the tunnel, there were many locations of spalled concrete and exposed, rusted rebar. The damaged sections of the concrete slab were extensive and will need to be replaced. The rebar was visible, and by measuring, we estimated it to be #4 bars spaced at 2" on center. There were areas of rusted rebar spanning from exterior building wall to exterior tunnels wall, that occurred approximately every 10'. In some locations, the rebar was falling out of the slab and no longer in contact with the concrete.

Standing Water at West Tunnel Entrance

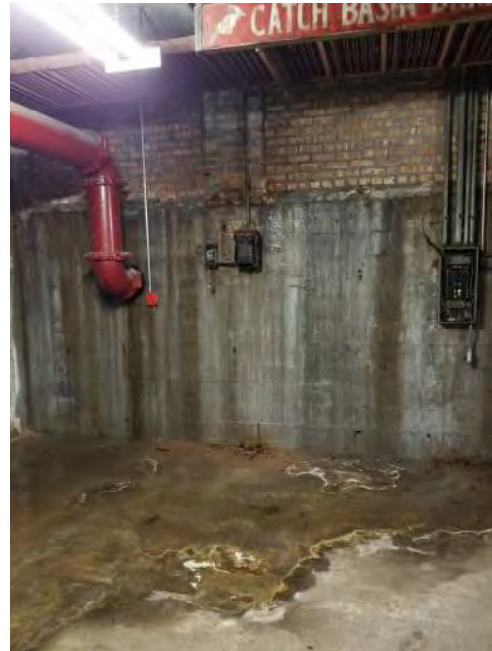
Water Leaks on Interior Face of Wall

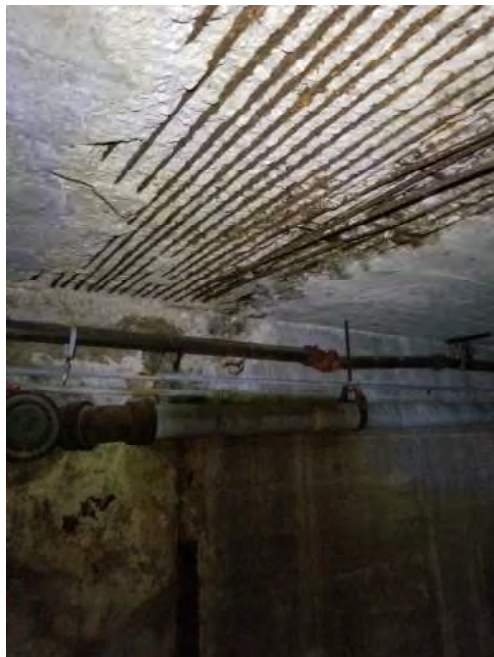
Exposed Rebar in Tunnel Roof Slab

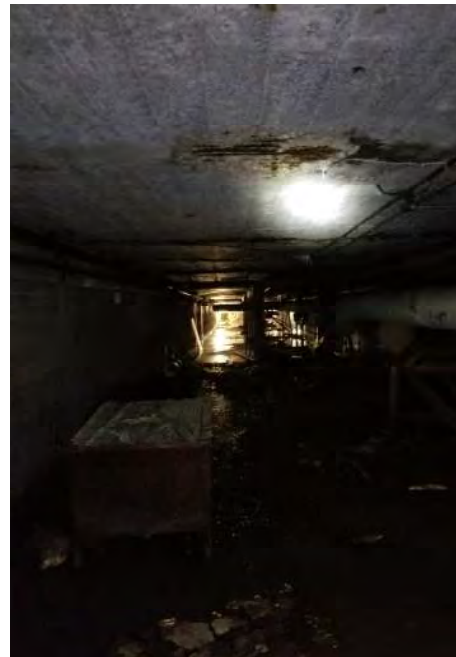
Strips of Rusted Rebar at 10' on center

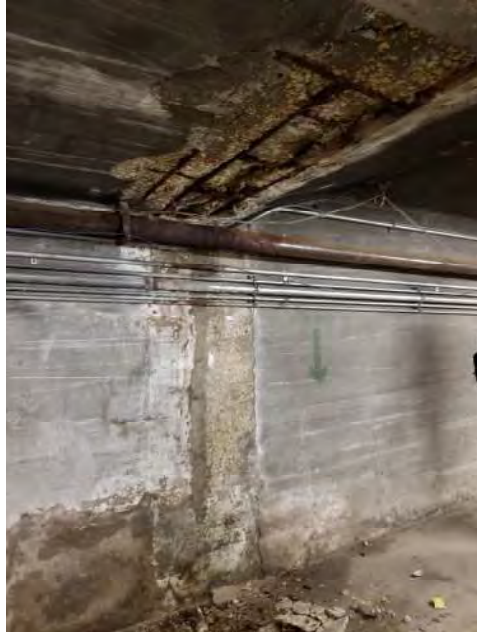
At the link between the 1819 and 1769 W. Pershing buildings, we observed an area of water damage and deteriorated structure. The concrete on the underside of the slab and the concrete on the face of the column that supports the link building above had spalled off, and pieces of concrete were on the floor slab of the link tunnel. The rebar in the underside of slab and in the face of the column was exposed and extensively rusted.

Deterioration in Underside of Link Slab

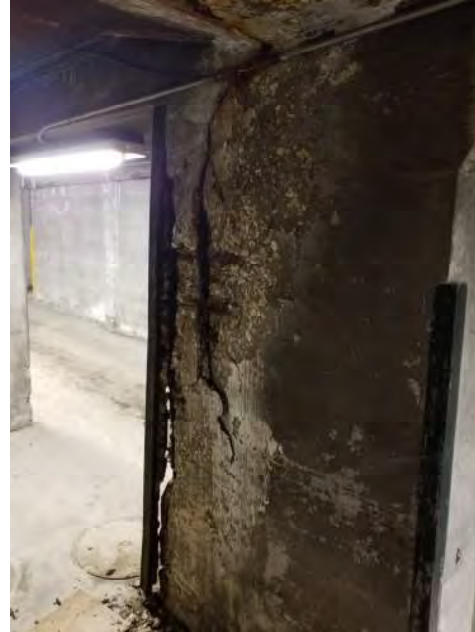
Deterioration of Link Column

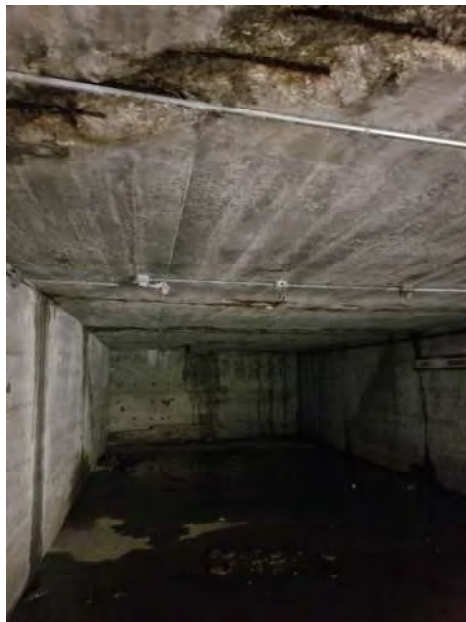
In the tunnel of the 1769 W. Pershing building, we observed the same areas of rusted rebar in the slab occurring at approximately 10' on center that we observed in the 1819 W. Pershing building. There were visible leaks within the tunnel and many areas of deteriorated slab reinforcement. There was also cracking, spalled concrete, and rusted rebar in the interior face of the basement wall.

Tunnel, Looking East

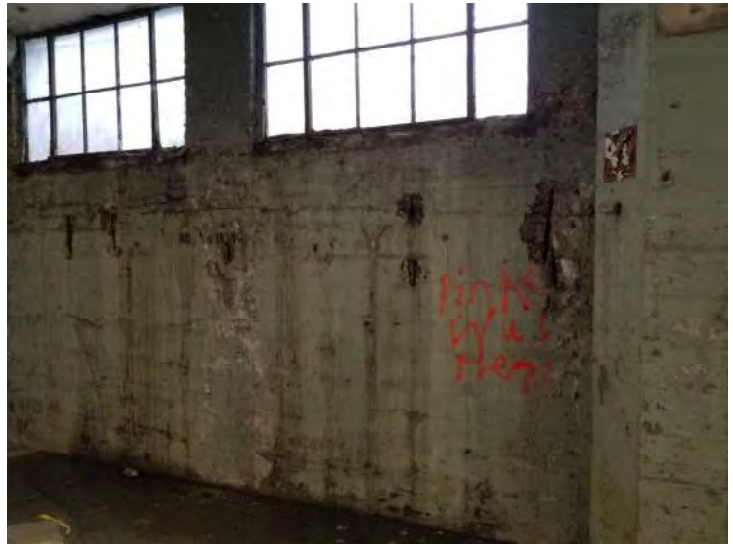
Exposed Rebar in Basement Wall
