PERSHING ROAD BUILDING
1769 W Pershing Ave, Chicago, IL 60609
Facility Evaluation Report 07/09/2021

HARDING MODE JOINT VENTURE

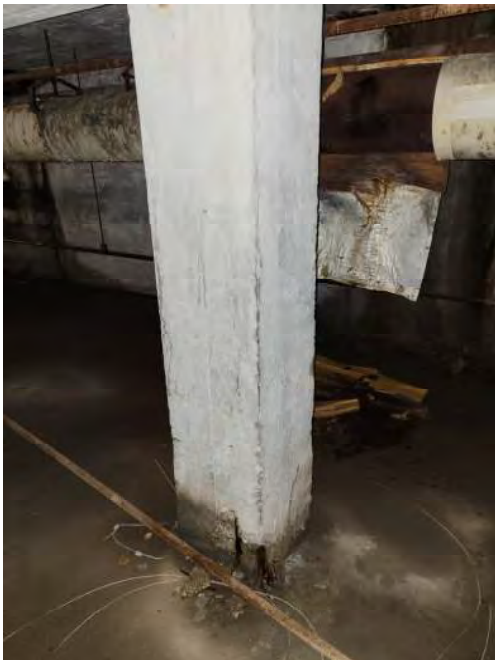
There was portion of the tunnel slab that had been supported by a dropped concrete beam and reinforced concrete posts on each end. The bottom of each of the existing concrete posts has excessive spalling and corroded rebar.

Concrete Post in Tunnel with Exposed Rebar

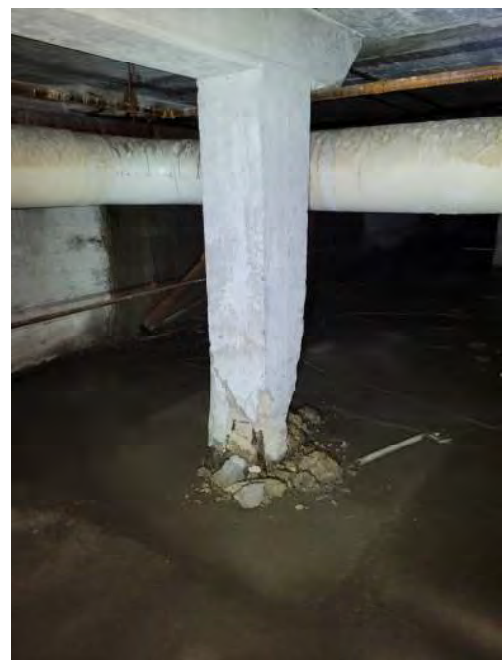
Concrete Post in Tunnel with Spalling at Base
