## STRUCTURAL ASSESSMENT REPORT

Date: **June 28, 2021**  
Date of visit: **June 25 & June 28, 2021**

Project: **ERP Pershing Structural Assessment**  
**1769, 1819, & 1869 W. Pershing**  
**Chicago, Illinois**

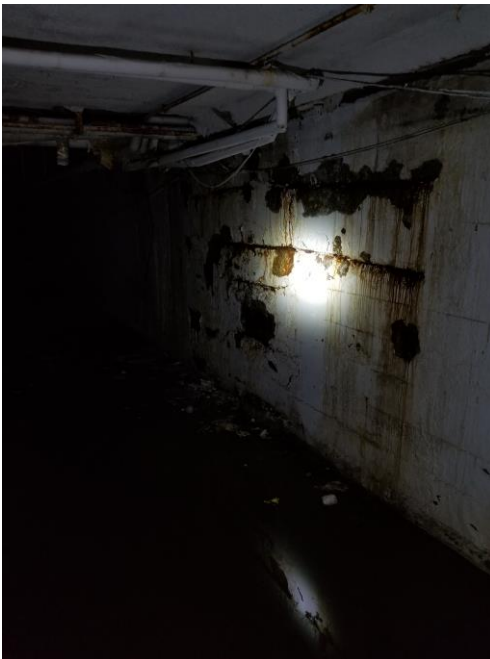
In the basement of 1869 W. Pershing, at the tunnel area beneath the loading docks, we observed spalled concrete and exposed, rusted rebar from water damage that was occurring at the joint in the building basement wall and the pavement slab above the tunnel. There was damage in the concrete wall under the exterior face of the building above, and there were some areas of the tunnel slab that were deteriorated and may need replacement.

***Deteriorated Rebar in West Building Tunnel***

Due to the severe deterioration of the tunnel slabs and the column beneath the link building, we recommend that any loading on the slab, such as from vehicle traffic, be removed from the slab immediately. Temporary shoring and bracing may be installed underneath the slab to provide support until permanent repairs can be made. Shoring should be placed immediately under the link building column and slab, and vehicle traffic through the area should be rerouted until the shoring is installed. Along the tunnels, shoring should be placed immediately under traffic areas and all areas used for loading dock purposes. The areas used for parking should be barricaded from traffic and parking; shoring can be installed under these areas, if desired. See the attached key plan for shoring requirements. The temporary shoring should be designed by the shoring contractor's licensed Illinois Structural Engineer.

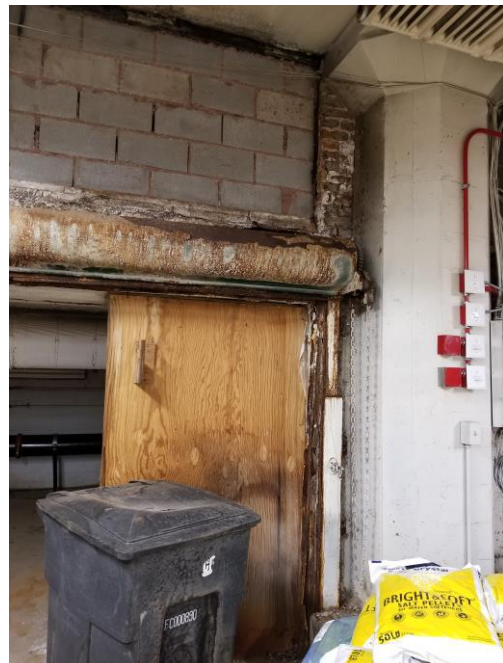
***Deteriorated Masonry at Tunnel Entrance***

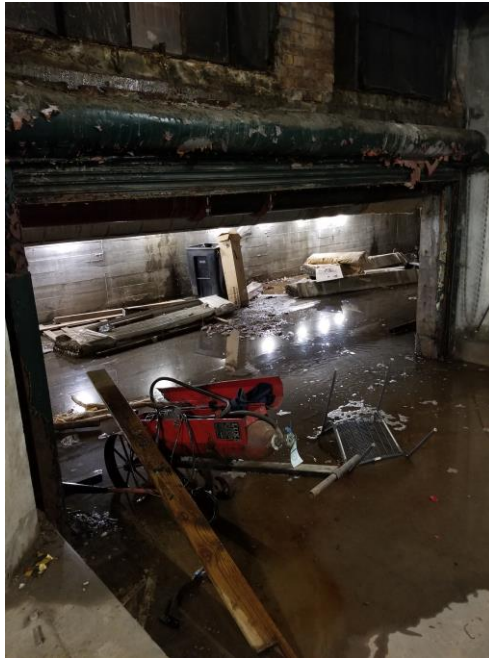
In the tunnel beneath 1819 W. Pershing, there was visible leaking at the west entrance to the tunnel and along the exterior basement walls. There was also approximately 3-4" of standing water at the entrance to the tunnel. At the east entrance of the tunnel, there were many locations of spalled concrete and exposed, rusted rebar. The damaged sections of the concrete slab were extensive and will need to be replaced. The rebar was visible, and by measuring, we estimated it to be #4 bars spaced at 2" on center. There were areas of rusted rebar spanning from exterior building wall to exterior tunnels wall, that occurred approximately every 10'. In some locations, the rebar was falling out of the slab and no longer in contact with the concrete.

***Standing Water at West Tunnel Entrance***

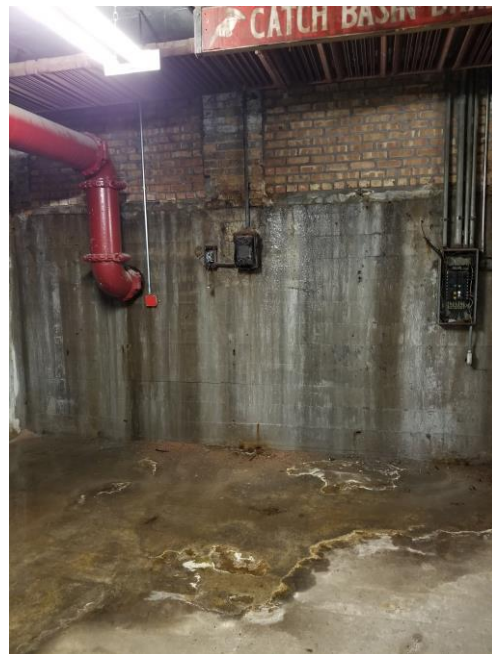
***Water Leaks on Interior Face of Wall***

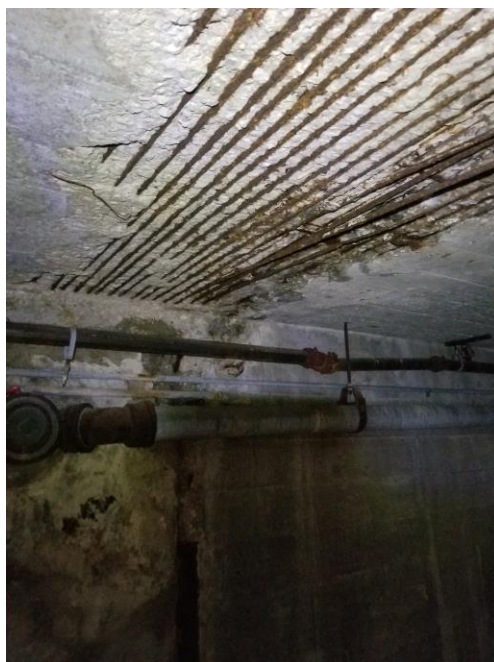
***Exposed Rebar in Tunnel Roof Slab***

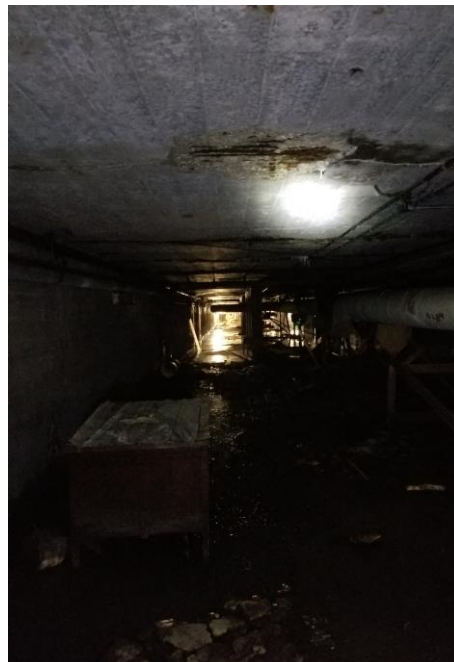
***Strips of Rusted Rebar at 10' on center***

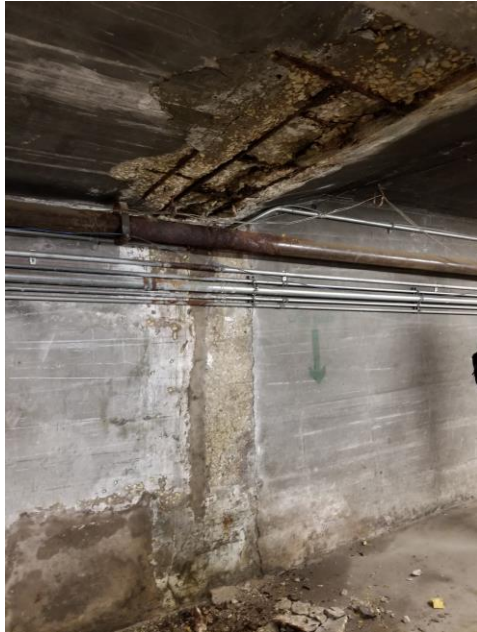
At the link between the 1819 and 1769 W. Pershing buildings, we observed an area of water damage and deteriorated structure. The concrete on the underside of the slab and the concrete on the face of the column that supports the link building above had spalled off, and pieces of concrete were on the floor slab of the link tunnel. The rebar in the underside of slab and in the face of the column was exposed and extensively rusted.

***Deterioration in Underside of Link Slab***

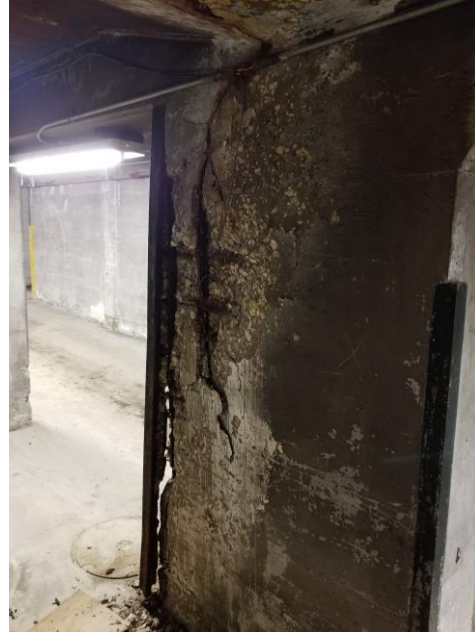
***Deterioration of Link Column***

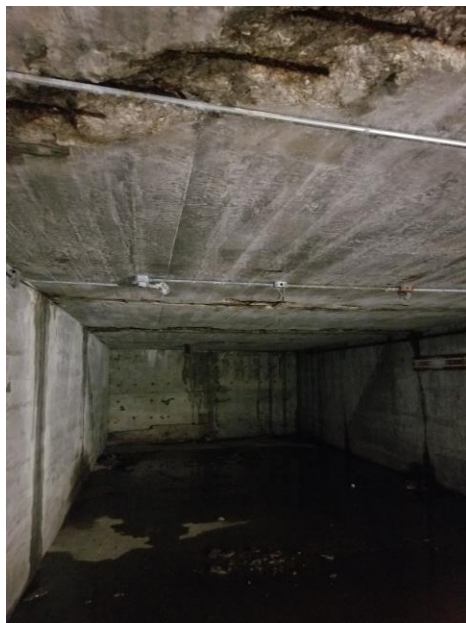
***Tunnel, Looking East***

In the tunnel of the 1769 W. Pershing building, we observed the same areas of rusted rebar in the slab occurring at approximately 10' on center that we observed in the 1819 W. Pershing building. There were visible leaks within the tunnel and many areas of deteriorated slab reinforcement. There was also cracking, spalled concrete, and rusted rebar in the interior face of the basement wall.

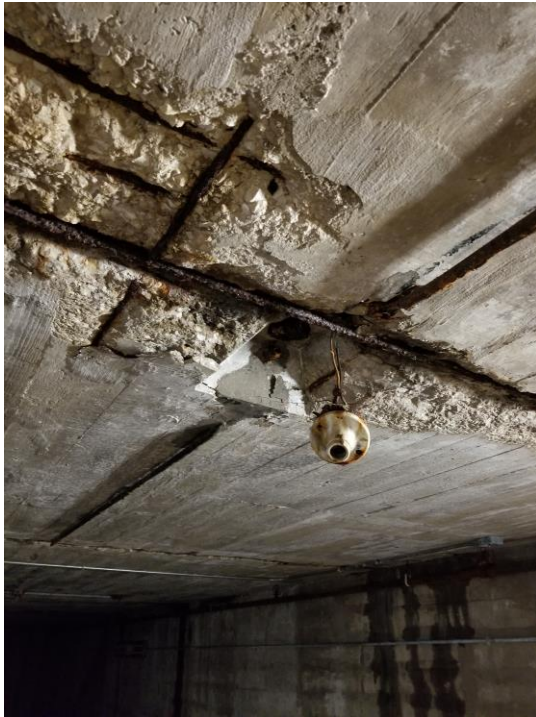
***Exposed Rebar in Tunnel Slab***

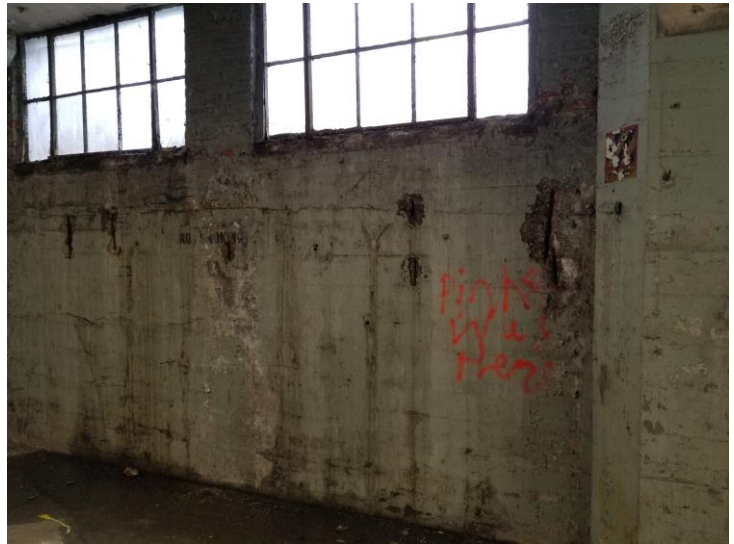
***Exposed Rebar in Basement Wall***

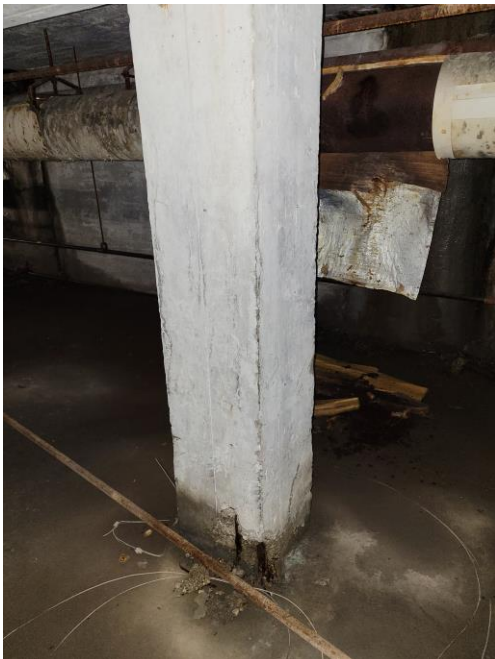
There was portion of the tunnel slab that had been supported by a dropped concrete beam and reinforced concrete posts on each end. The bottom of each of the existing concrete posts has excessive spalling and corroded rebar.

***Concrete Post in Tunnel with Exposed Rebar***

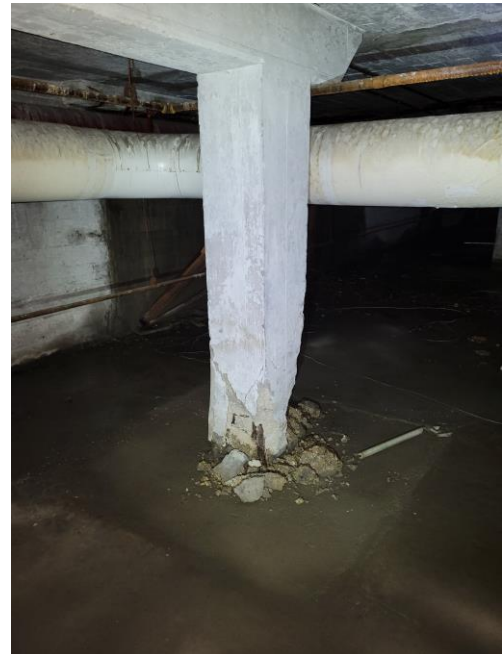
***Concrete Post in Tunnel with Spalling at Base***
