PERSHING ROAD BUILDING
1869 W Pershing Ave, Chicago, IL 60609
Facility Evaluation Report 07/30/2021

HARDING MODE JOINT VENTURE

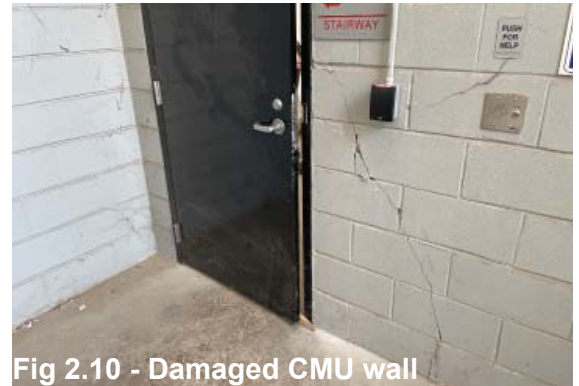
Fig 2.10 - Damaged CMU wall

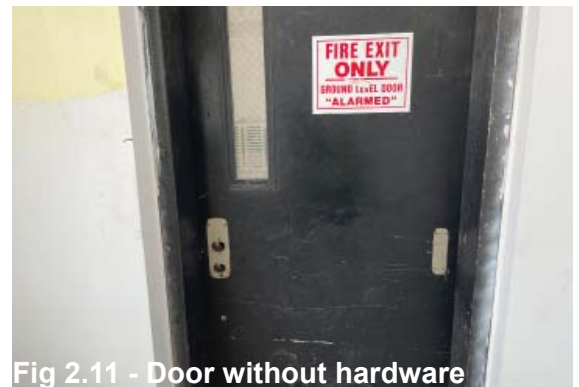
Fig 2.11 - Door without hardware

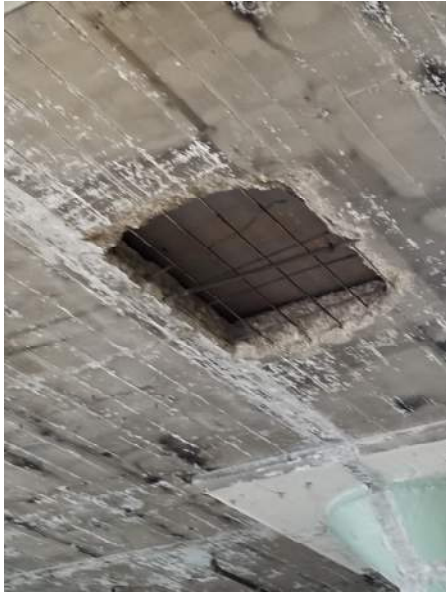
The building structure was generally in good condition. On Level 6, we observed a hole in the roof concrete slab, where the concrete had been removed, but the rebar was still intact and visible. We also observed a concrete beam above the Elevator B-6 opening that appeared to have been cut. Some of the bottom bar reinforcement and stirrups in the cut beam were visible. Generally, on Level 6, we observed several locations of concrete spalling and exposed, rusted rebar. Typically, when reinforcing is exposed to water and rusts it expands. The forces that result from the rusting cracks and eventually spalls the concrete cover. The majority of the locations of rusted rebar and spalled concrete were around skylights. It appeared that there had been leaks in the past, which caused the rebar to rust and concrete to spall. At the time of our visit, we did not observe any leaks, possibly the roof and skylights had been repaired and the water damage rusting and spalling occurred some time ago.

Cut Slab Near Column M.2

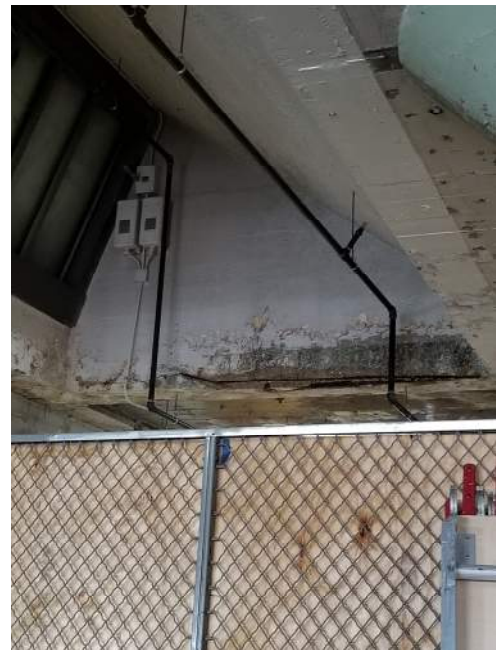
Exposed Rebar around Skylight

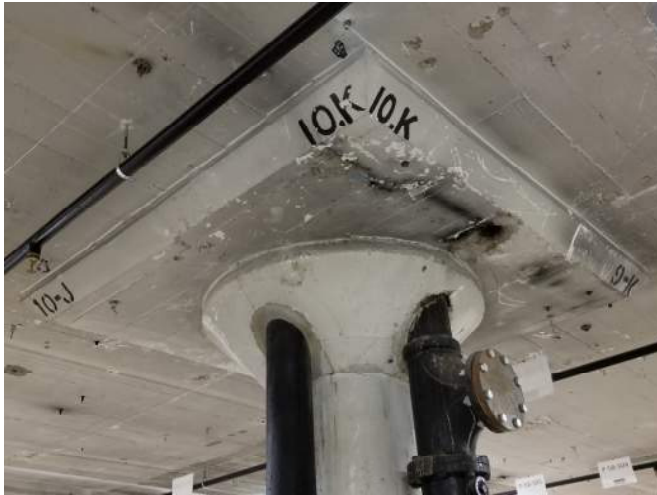
Pipes Through Column Capital

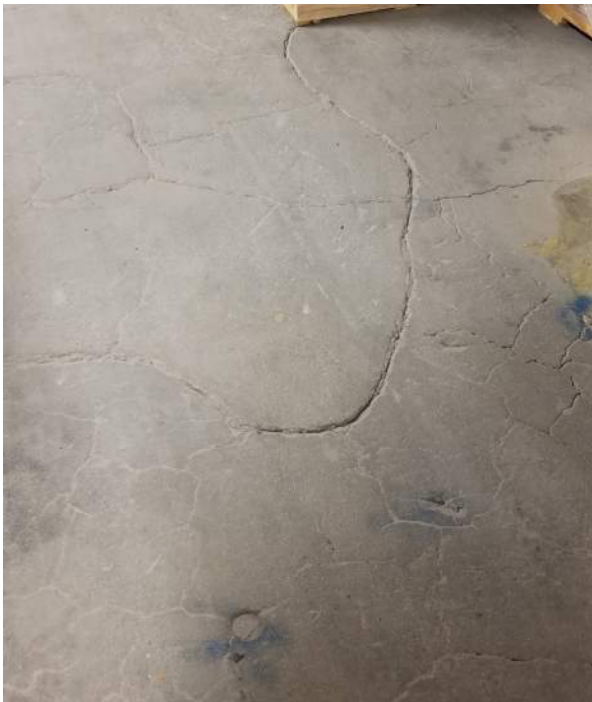
Floor Cracks at Level 5

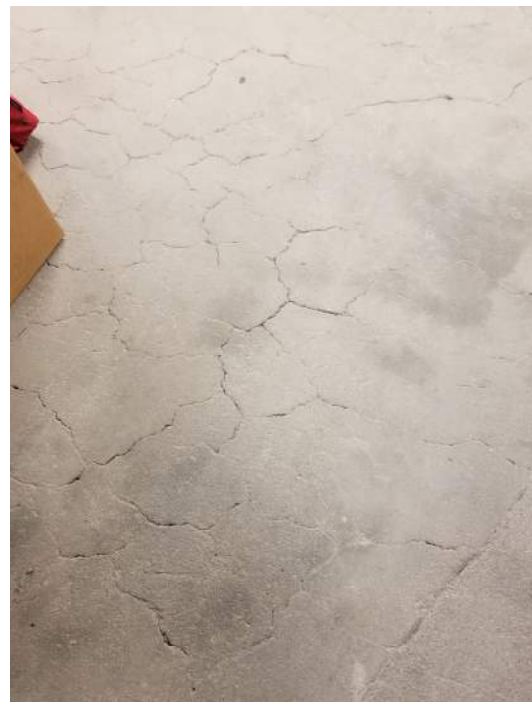
Floor Cracks at Level 5

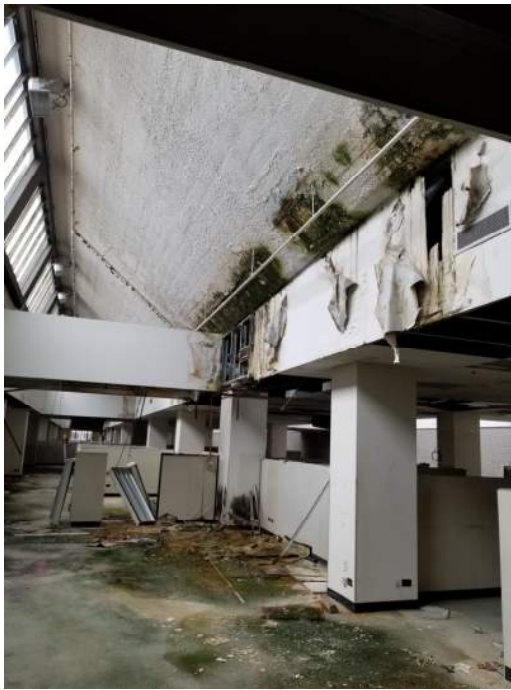
Water Damage at Skylights

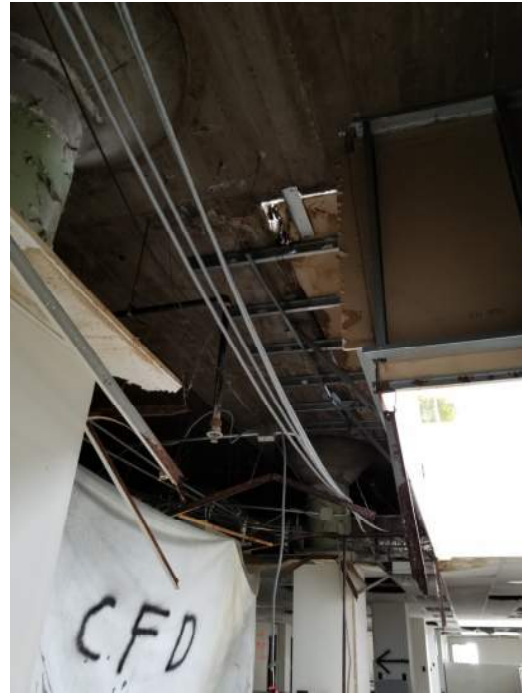
Water Damage at Skylights

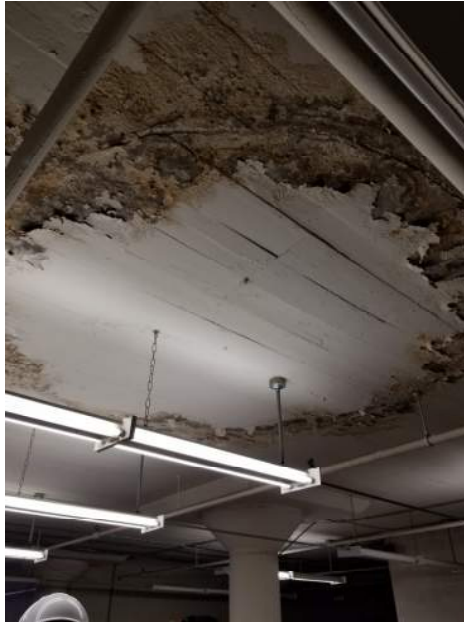
Level 5 Water Damage

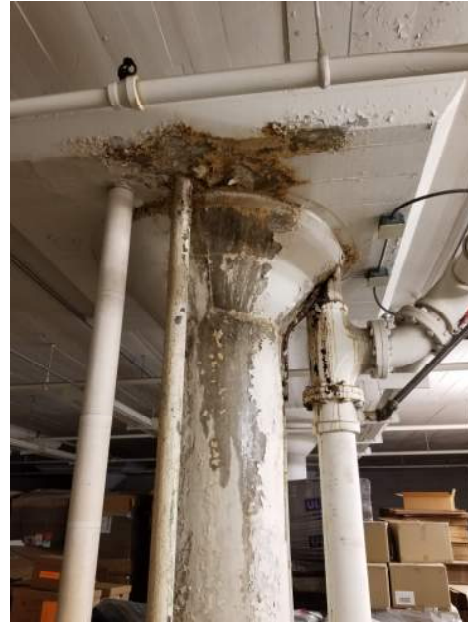
Water Damage at Column

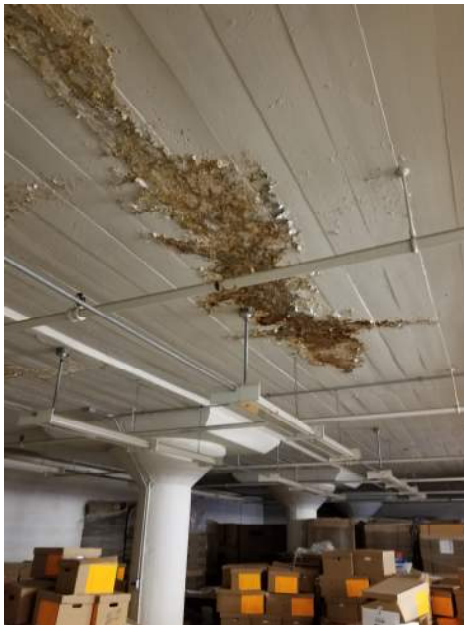
Level 5 Water Damage

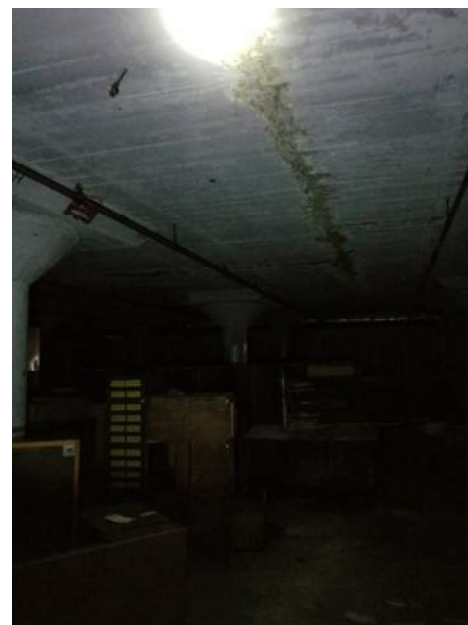
Continuous Crack at Slab Underside

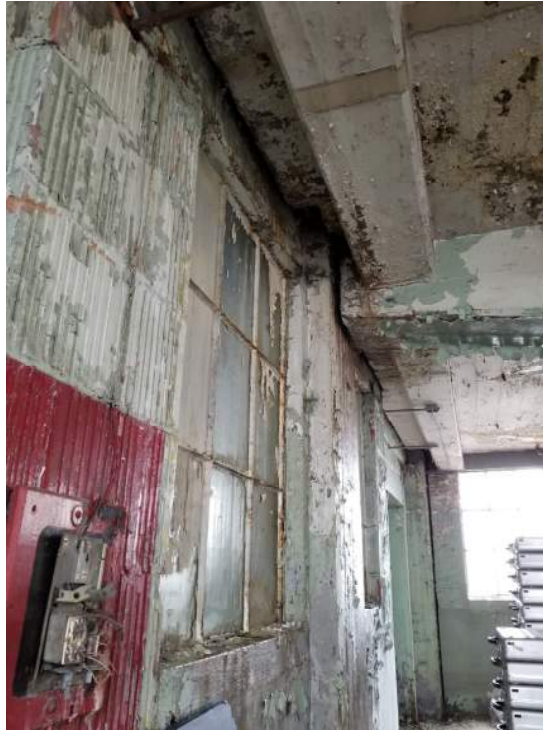
At Level 3, in the interconnecting bridge building, we observed water dripping through the building expansion joints on each side. There was some deterioration of the structure due to water damage.

***Water Damage at Expansion Joint between
Main Building and Interconnecting Bridge***

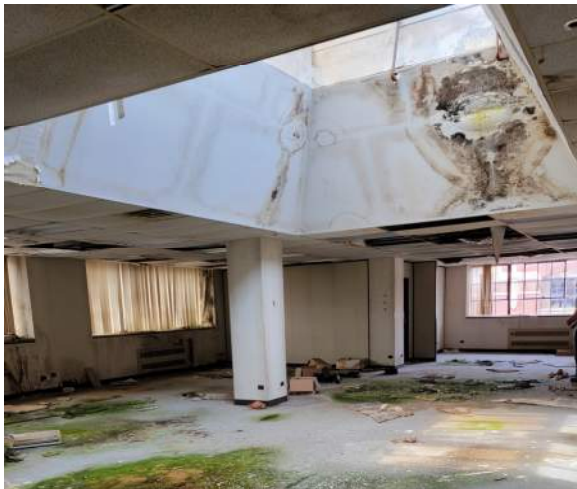
Mold and Corrosion @ Skylight

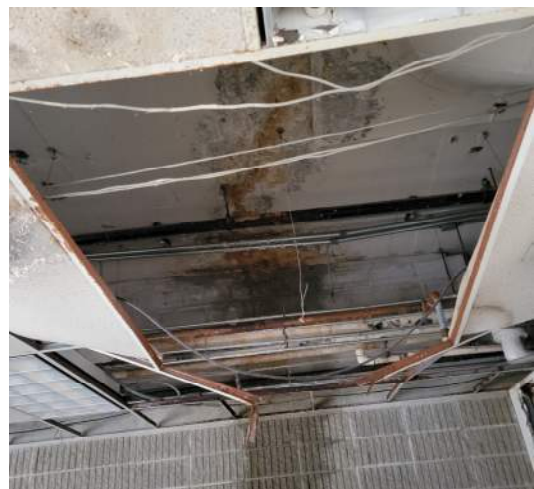
Water Damage and Cracking in Roof Slab

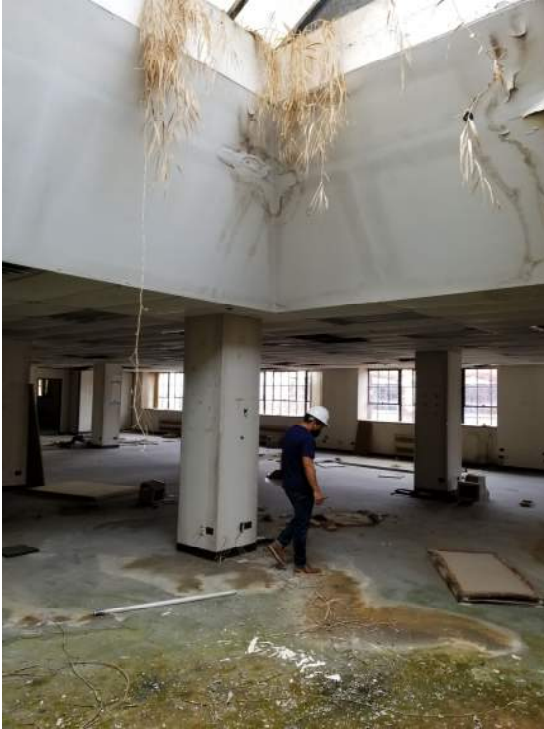
Plant growth at skylight areas

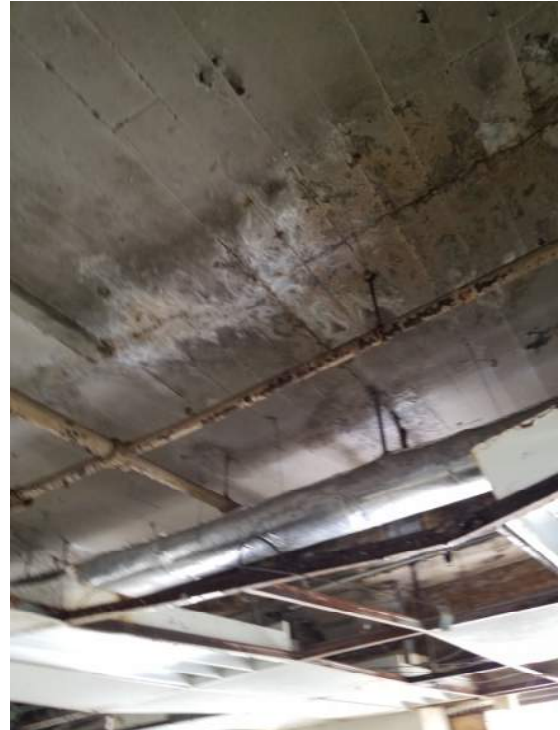
***Corrosion visible on underside of
Roof slab***

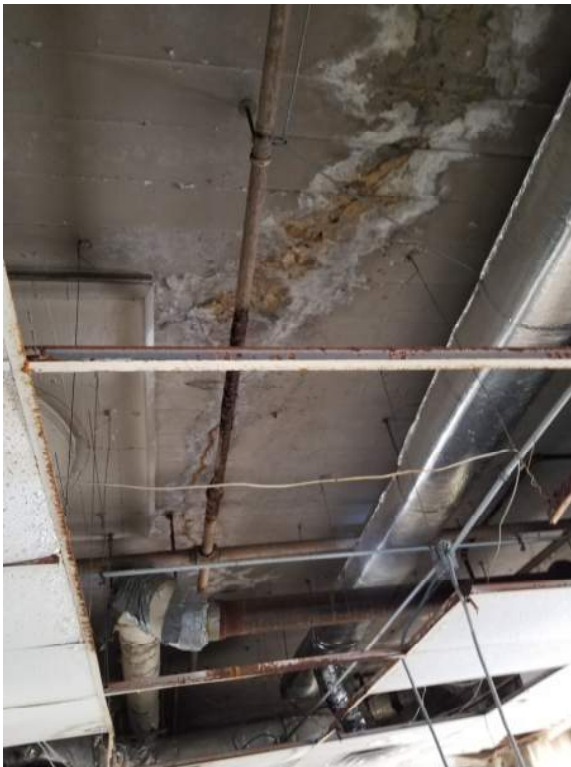
***Corrosion visible on underside of
Roof slab***

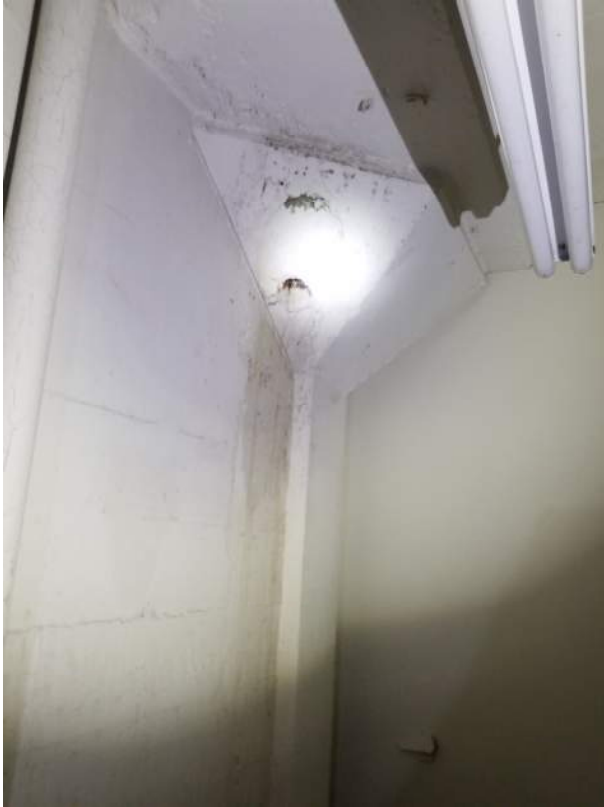
Active leak through column capital

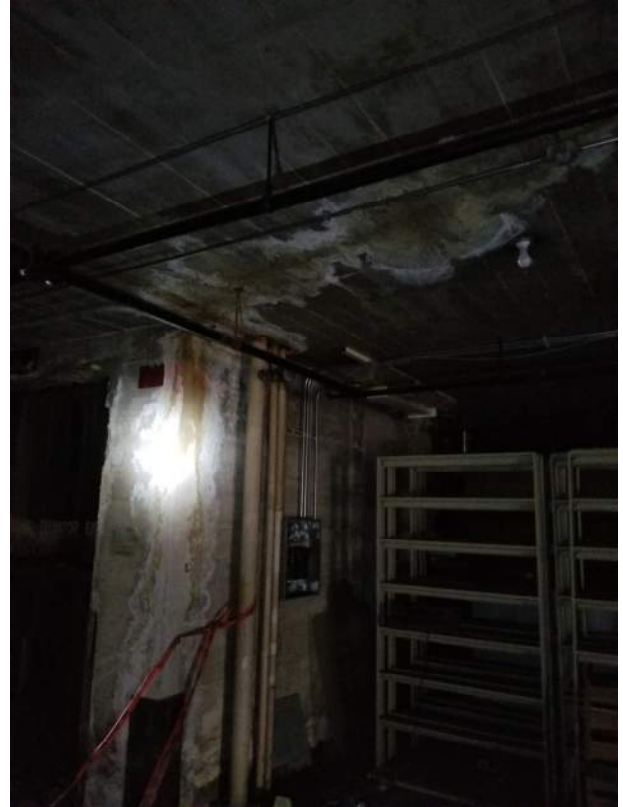
***Corrosion of slab surrounding the
freight elevator shaft***

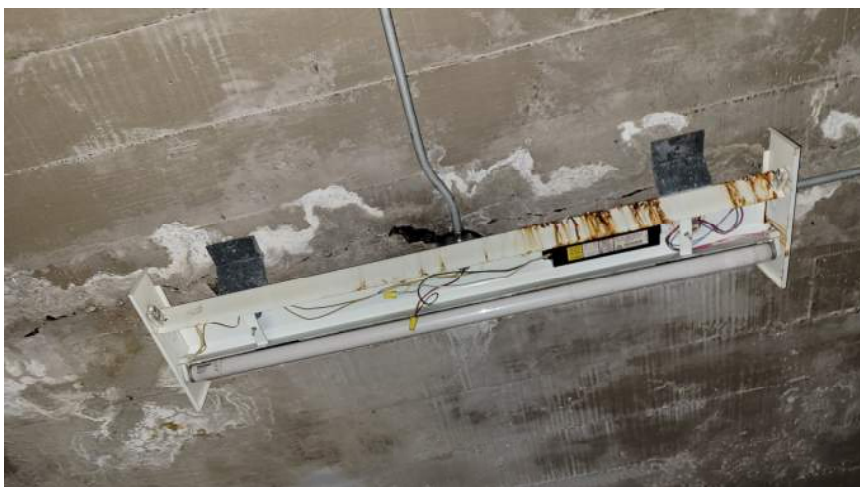
Cracking @ Water Infiltration in Floor Slab

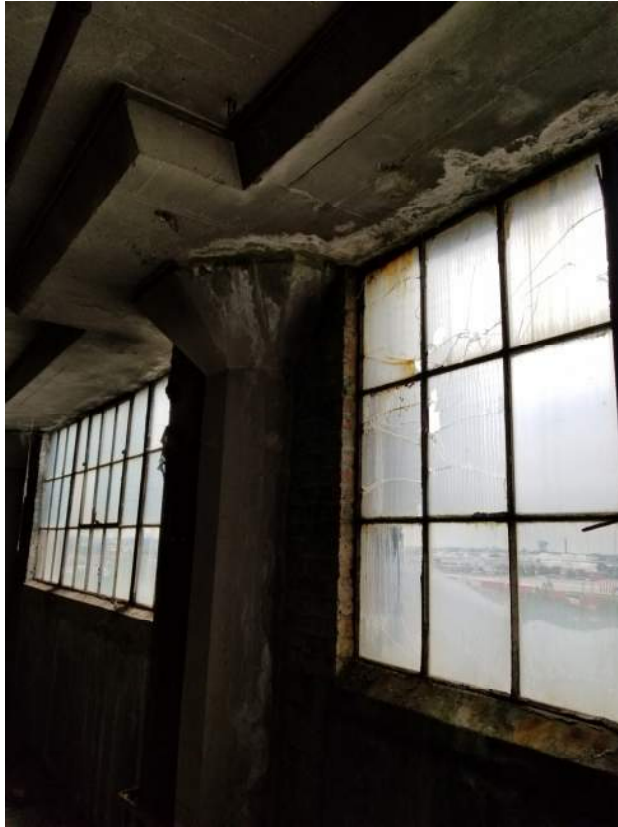
***Deterioration of spandrel beam on
north side of building***

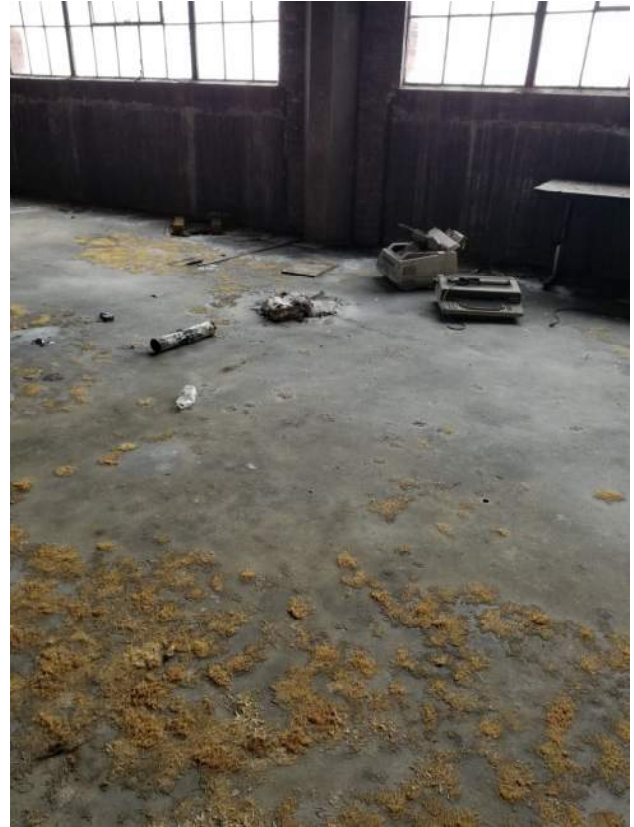
***Life forms growing on surface of
5th floor slab***

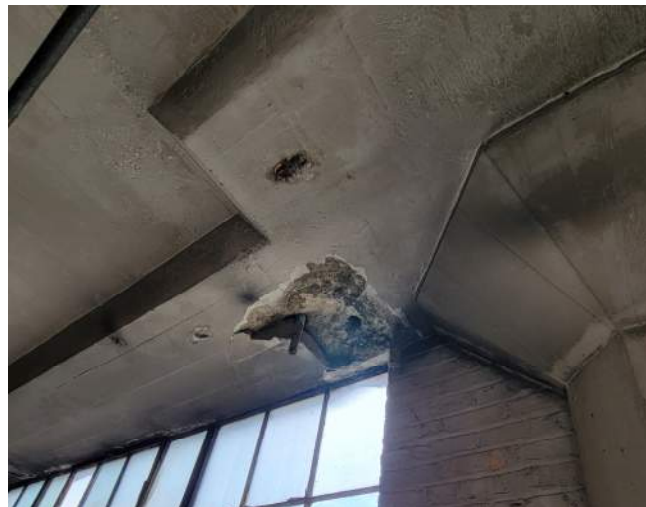
Spalling at North Spandrel Beam

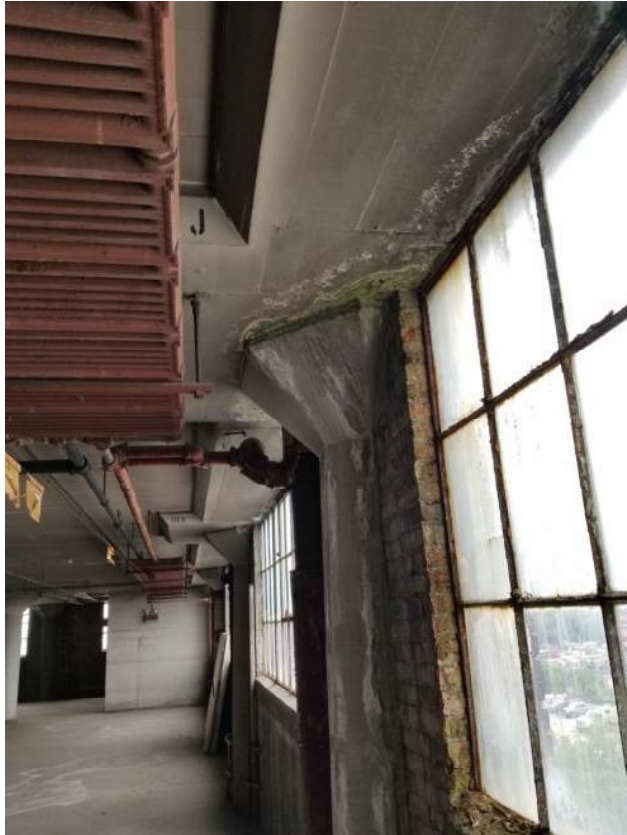
***Deterioration of spandrel beam on
north side of building***

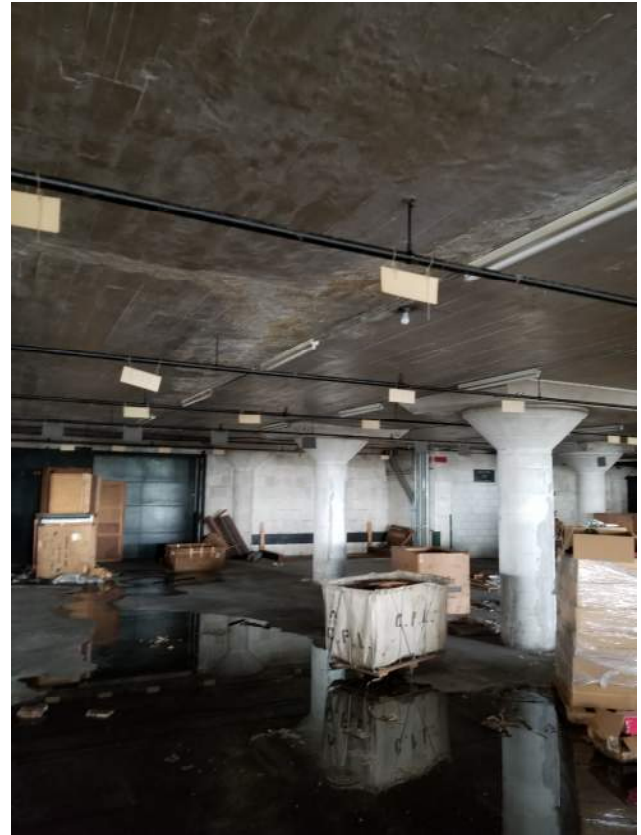
***Crack running through multiple
bays, with corrosion***

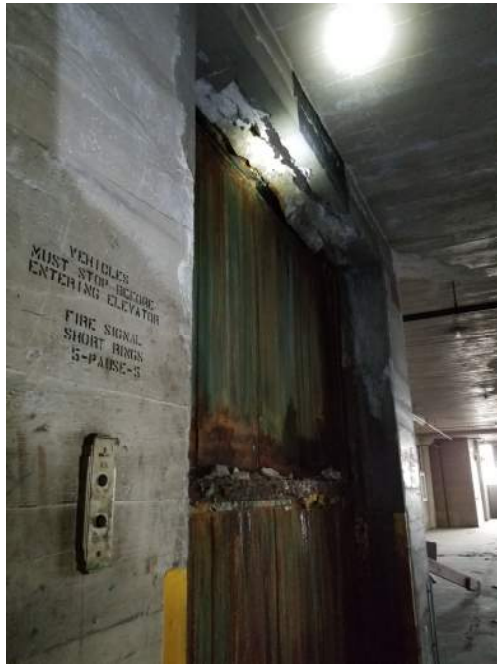
Elevator 13 Concrete Beam Deterioration

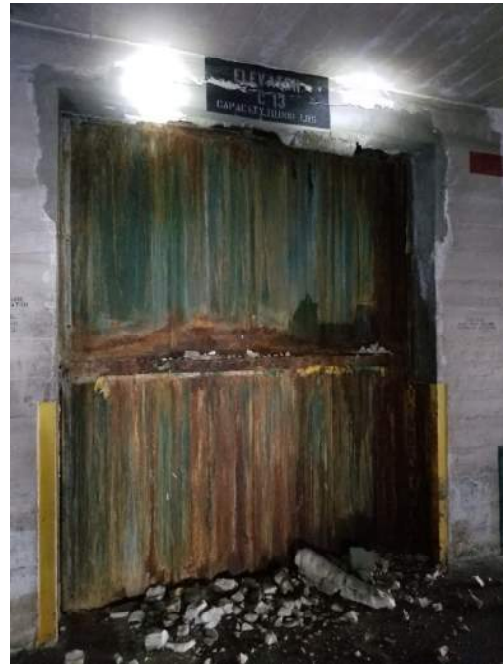
Elevator 13 Spalled Concrete

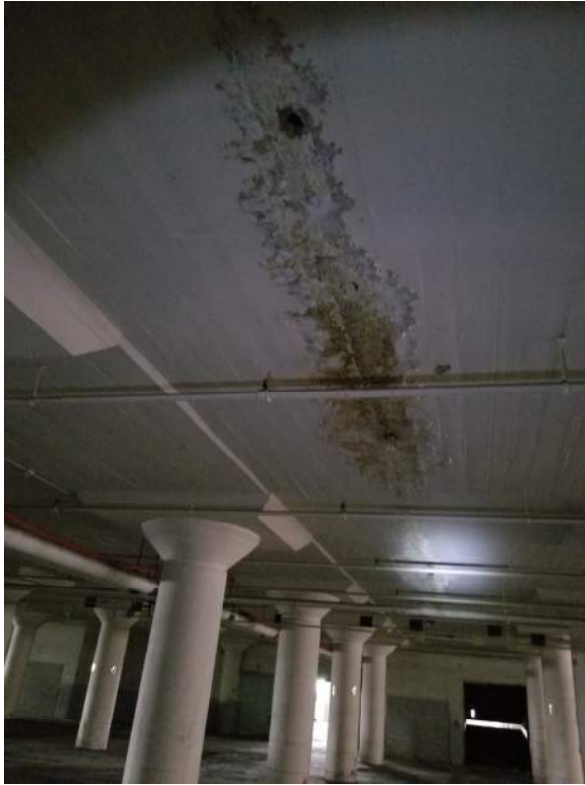
***Corrosion visible on underside of
3rd floor slab***

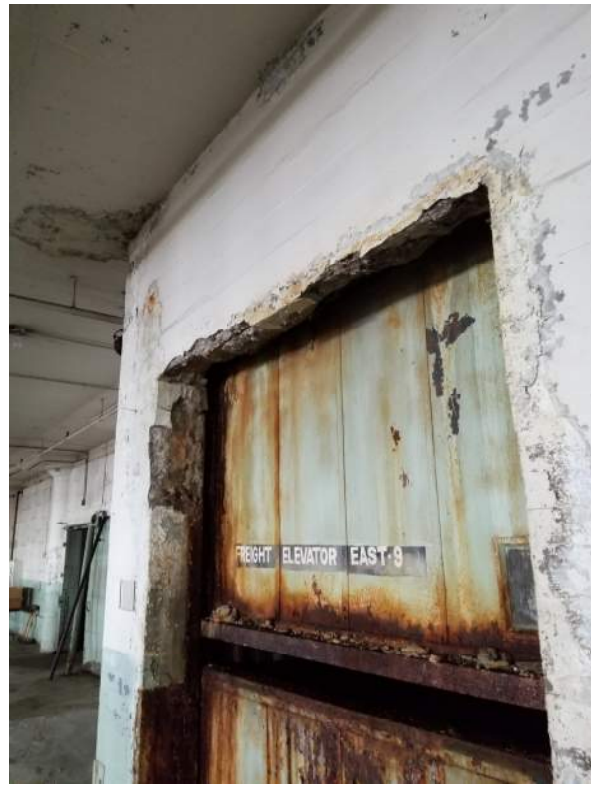
***Deteriorated beam at freight elevator,
and corrosion in adjacent 3rd floor slab***

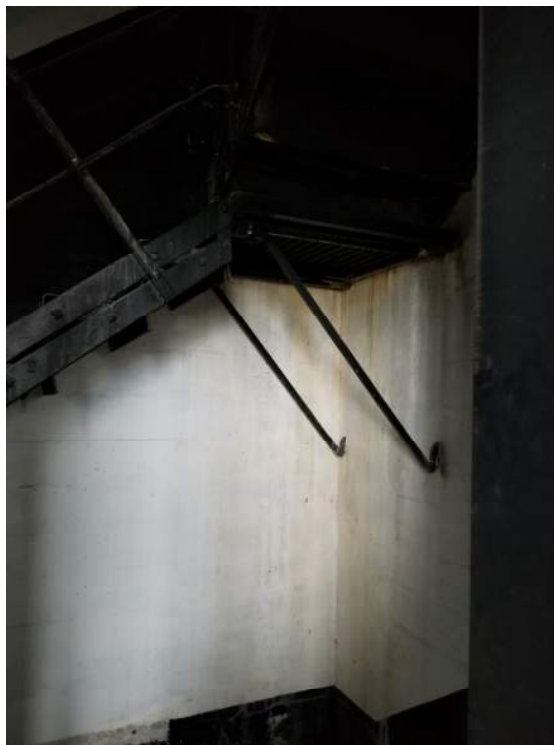
We also observed the condition of a metal stair, possibly cast iron, in the 1769 W. Pershing building. This stair had more visible rust, including on the face of the stair shaft walls.

Rust from Metal Stair Structure

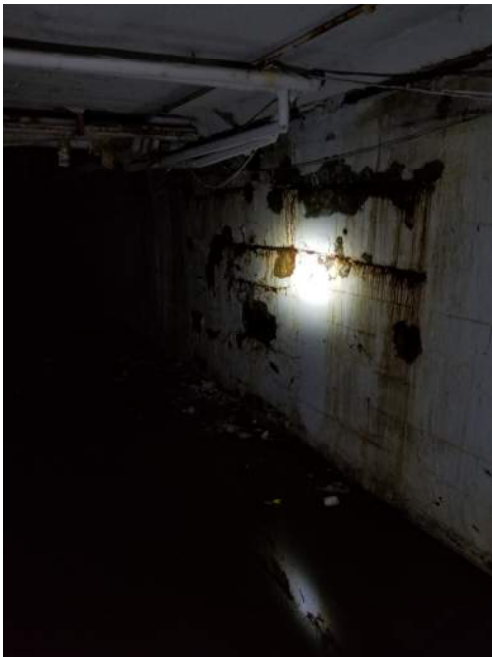
In the basement of 1869 W. Pershing, at the tunnel area beneath the loading docks, we observed spalled concrete and exposed, rusted rebar from water damage that was occurring at the joint in the building basement wall and the pavement slab above the tunnel. There was damage in the concrete wall under the exterior face of the building above, and there were some areas of the tunnel slab that were deteriorated and may need replacement.

Deteriorated Rebar in West Building Tunnel

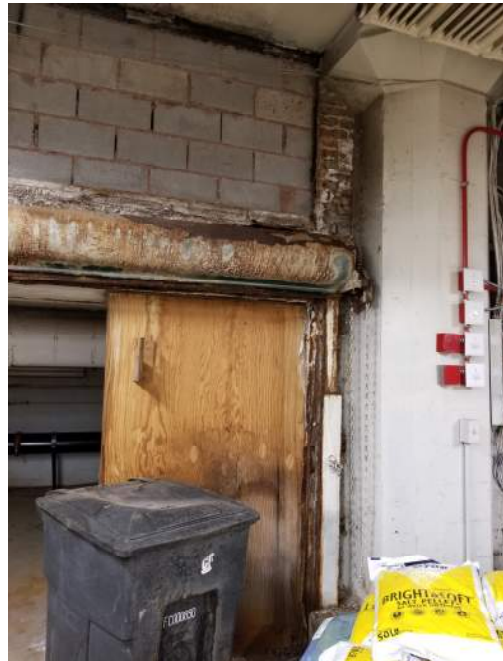
Deteriorated Masonry at Tunnel Entrance

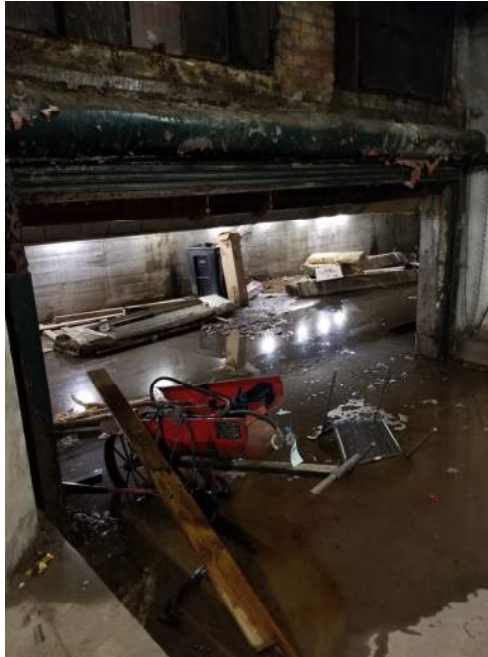
Standing Water at West Tunnel Entrance

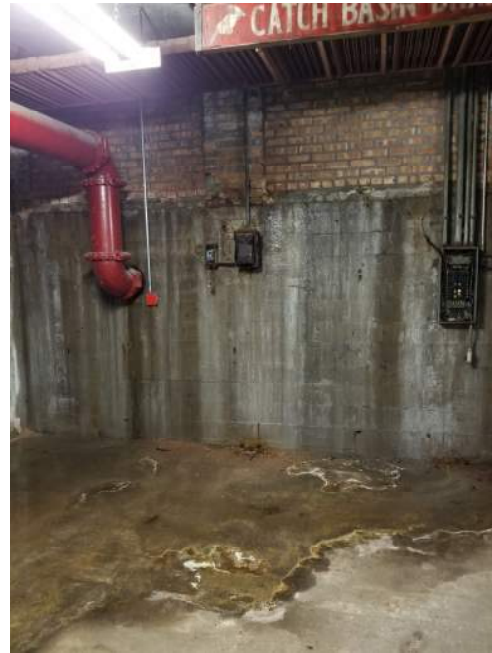
Water Leaks on Interior Face of Wall

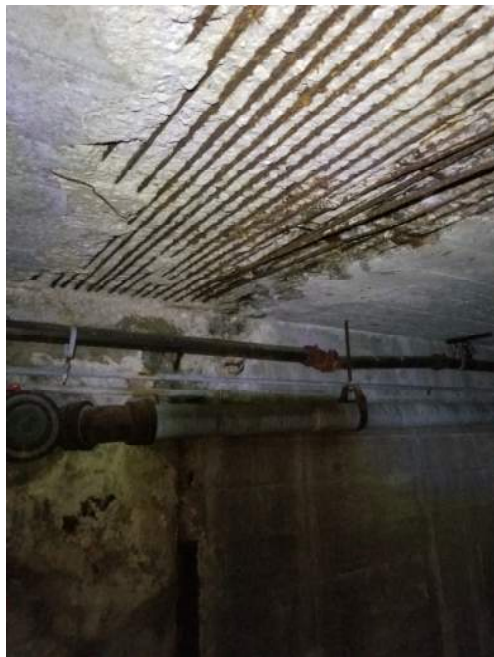
Exposed Rebar in Tunnel Roof Slab

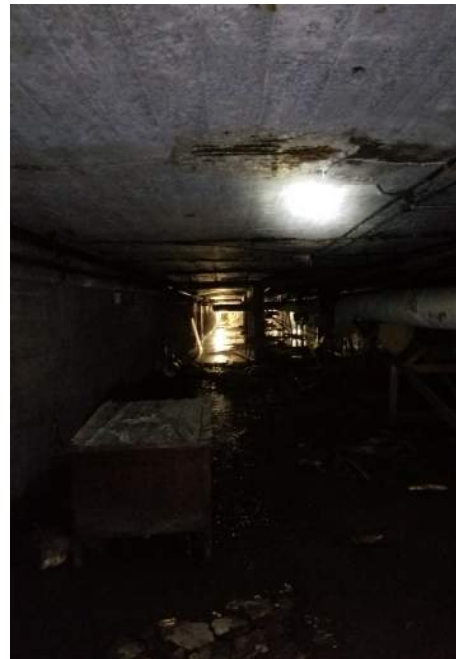
Strips of Rusted Rebar at 10' on center

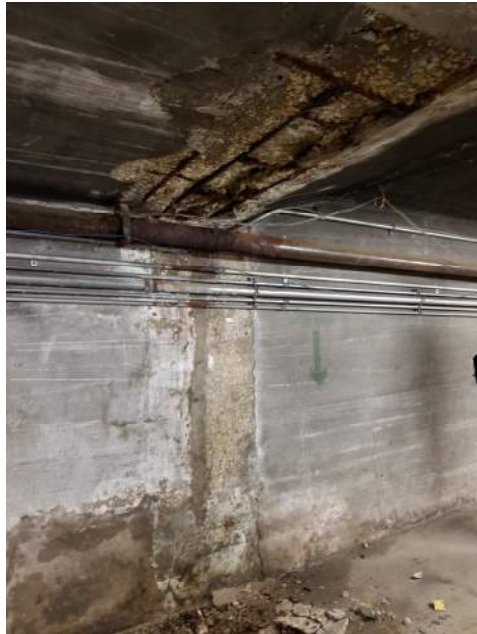
At the link between the 1819 and 1769 W. Pershing buildings, we observed an area of water damage and deteriorated structure. The concrete on the underside of the slab and the concrete on the face of the column that supports the link building above had spalled off, and pieces of concrete were on the floor slab of the link tunnel. The rebar in the underside of slab and in the face of the column was exposed and extensively rusted.

Deterioration in Underside of Link Slab

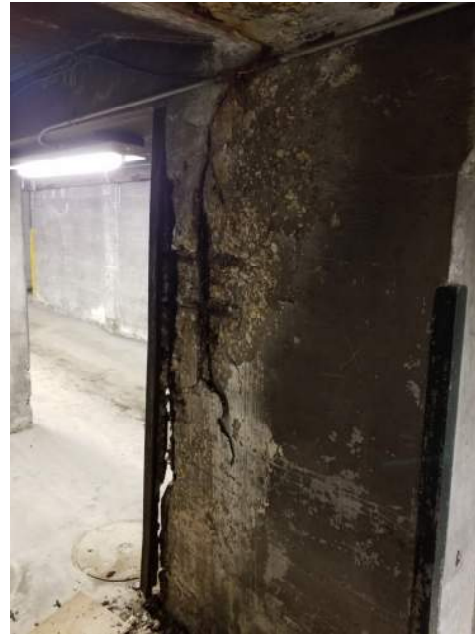
Deterioration of Link Column

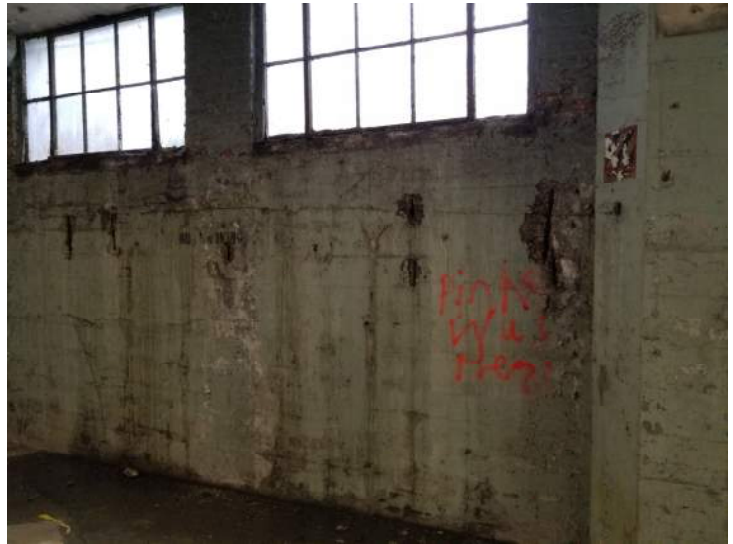
Exposed Rebar in Basement Wall

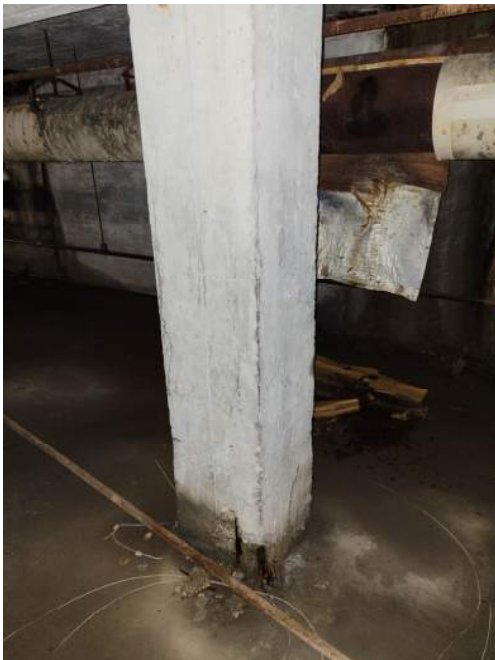
There was portion of the tunnel slab that had been supported by a dropped concrete beam and reinforced concrete posts on each end. The bottom of each of the existing concrete posts has excessive spalling and corroded rebar.

Concrete Post in Tunnel with Exposed Rebar

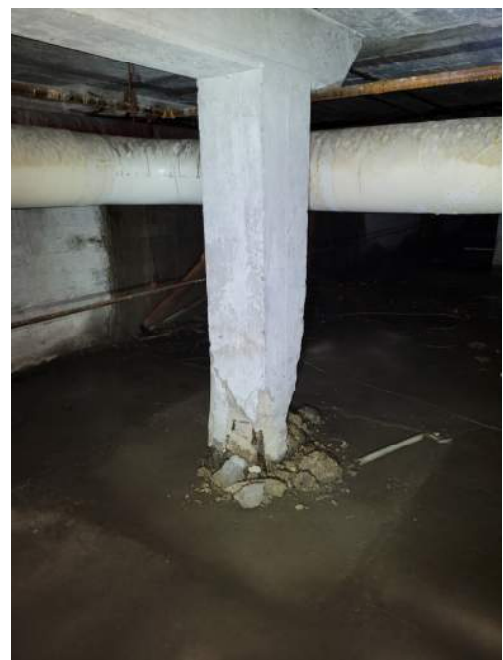
Concrete Post in Tunnel with Spalling at Base
