2021-F326-REN CIP- Lakeview Health Center Renovations

Project Address: 2849-61 N. Clark St., Chicago Illinois

Investigation – HVAC, ELECTRICAL, PLUMBING, FIRE PROTECTION & FIRE ALARM AND TELECOMMUNICATION

### OBSERVATIONS AND CONCLUSIONS

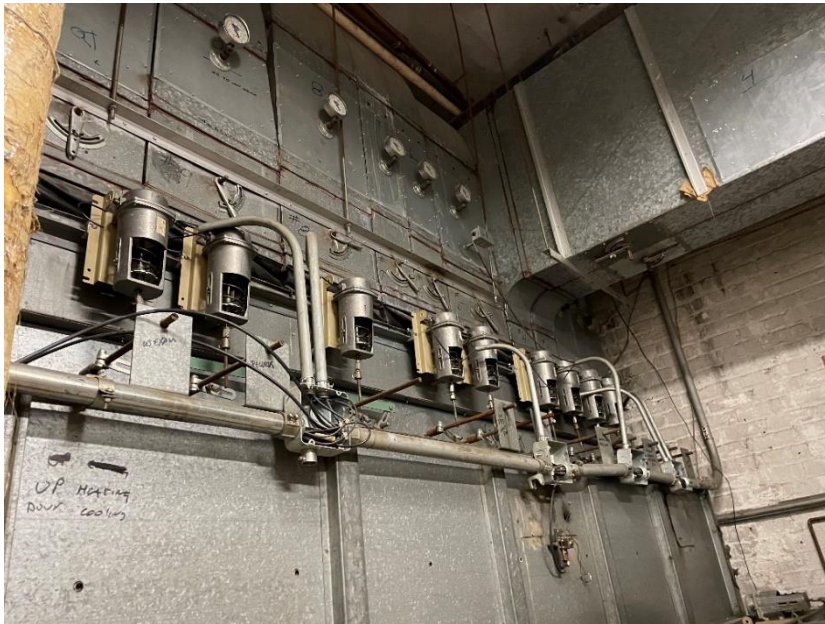
The air handling unit (AHU-1) located within the basement of mechanical room in the building are over its service life. This unit is Pneumatically controlled. AHU contains DX cooling coils served by the CU-1 and Steam coils. The unit has a return fan. Supply fans for these air handling units are not VFD driven. The Supply fan motor of this AHU has been replaced twice in 5 years' time.

Existing AHU-1 Plenum with Damper Pneumatic actuator

The entire pneumatic control system should be replaced with a DDC and will have a new building automation system (BAS) including digital electronic actuators, thermostats, control panels, user interface, and operating system.

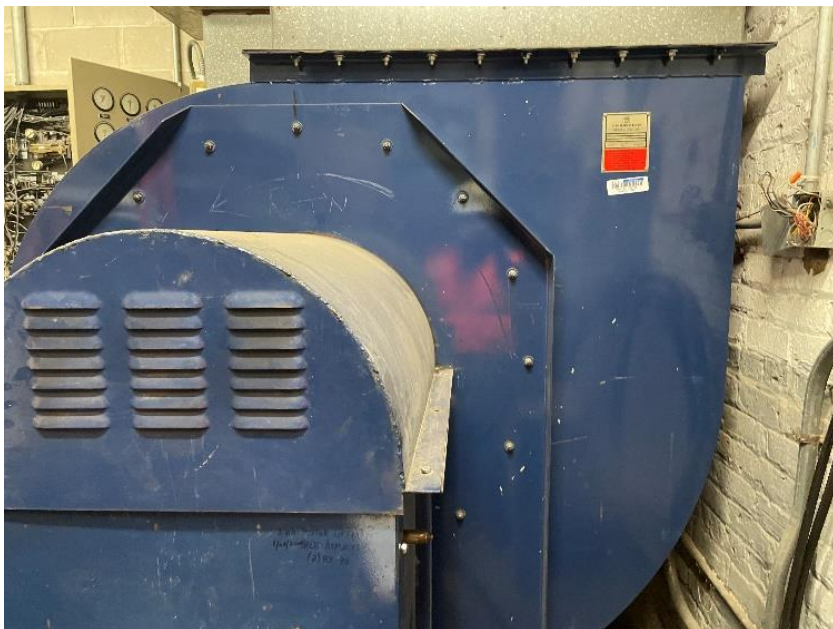
Existing Return fan - 1

| HVAC Equipment | Quantity | Location | Age | Life Expectancy | Equipment Condition | Notes |
|---|---|---|--|---|---|---|
| Return fan 1 -10HP@13500cfm | 1 | Basement Floor - Mechanical room | Original (1977 to 83)<br>Over 40 yrs old | | Operational | Past service life recommended to replace |

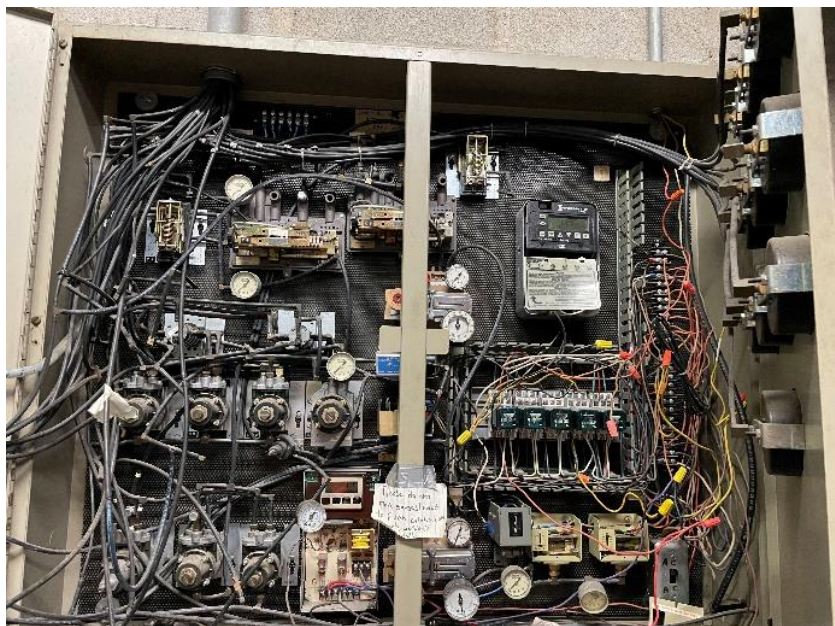
### Pneumatic Control Panel AHU-1

The heating, ventilation, and air-conditioning (HVAC) systems use a pneumatic control system to operate the valve actuators. Interviewed persons on-site stated the existing pneumatic actuators are unreliable and some are not working, they open the damper manually and would like them to be replaced with electric actuators. Thermostats are working but obsolete and must be replaced and connected to the new BAS.

| HVAC Equipment | Quantity | Location | Age | Life Expectancy | Equipment Condition | Notes |
|---|---|---|--|---|---|---|
| HVAC Control panels | 1 | Basement Floor - Mechanical room | Original (1977 to 83)<br>Over 40 yrs old | NA | REPLACE | Pneumatic controls mus t be replace with DDC controllers |

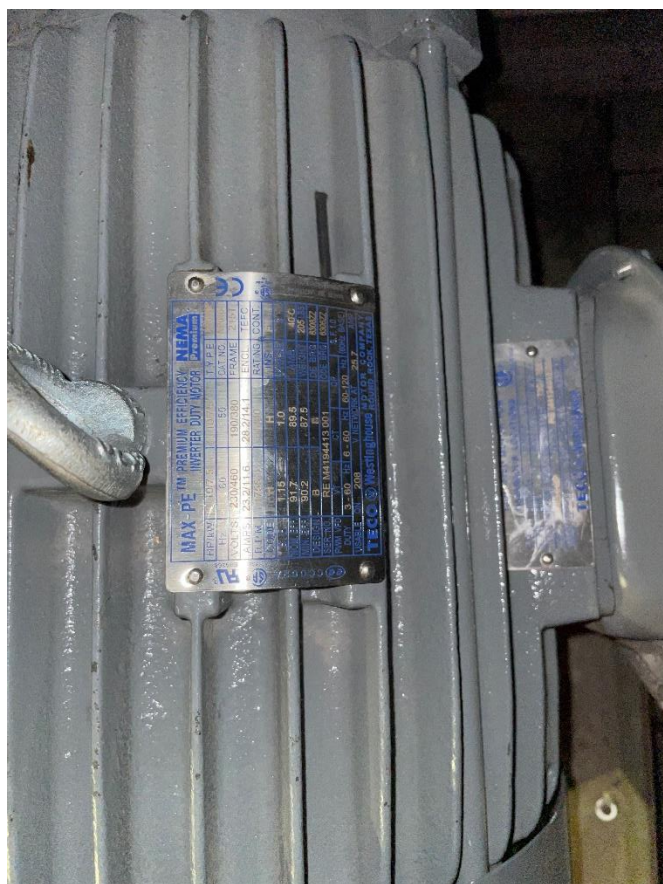
### Existing AHU-2 Fan Motor

| HVAC Equipment | Quantity | Location | Age | Life Expectancy | Equipment Condition | Notes |
|---|---|---|--|---|---|---|
| AHU-2 -10HP @ 12690cfm | 1 | 2nd Floor - Mechanical room | Original (1977 to 83)<br>Over 40 yrs old | 15 - 20 years | Operational | VFDs on AHUs. Fan Motor recently been replace, recomend to replace. Heating Control valve is replace with Electric motor actuator.causes unbalnce to the heating system |

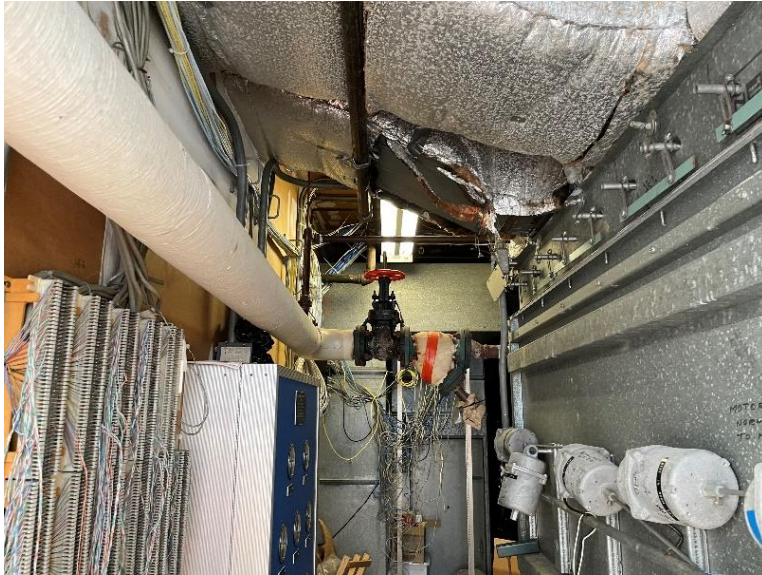
Existing AHU-2 Plenum Dampers Manually controlled Actuator are Disconnected

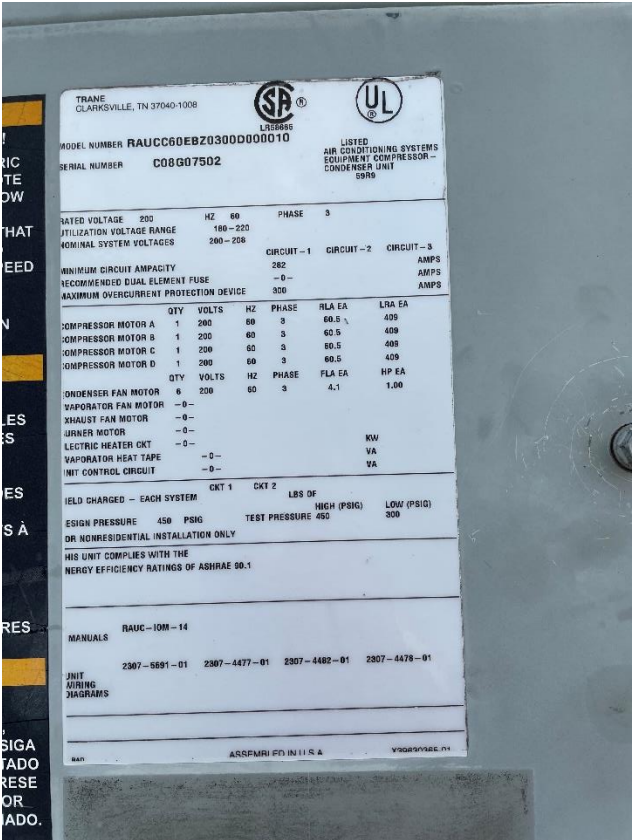
Existing Condensing unit CU-1

| HVAC Equipment | Quantity | Location | Age | Life Expectancy | Equipment Condition | Notes |
|---|---|---|--|---|---|---|
| Condensing Unit (CU-1)- 60T | 1 | Roof | Original (1977 to 83)<br>Over 40 yrs old | 25- 35 years | Operational | Past service life recommended to replace. Having Breakdowns, tripping contactors replace. |

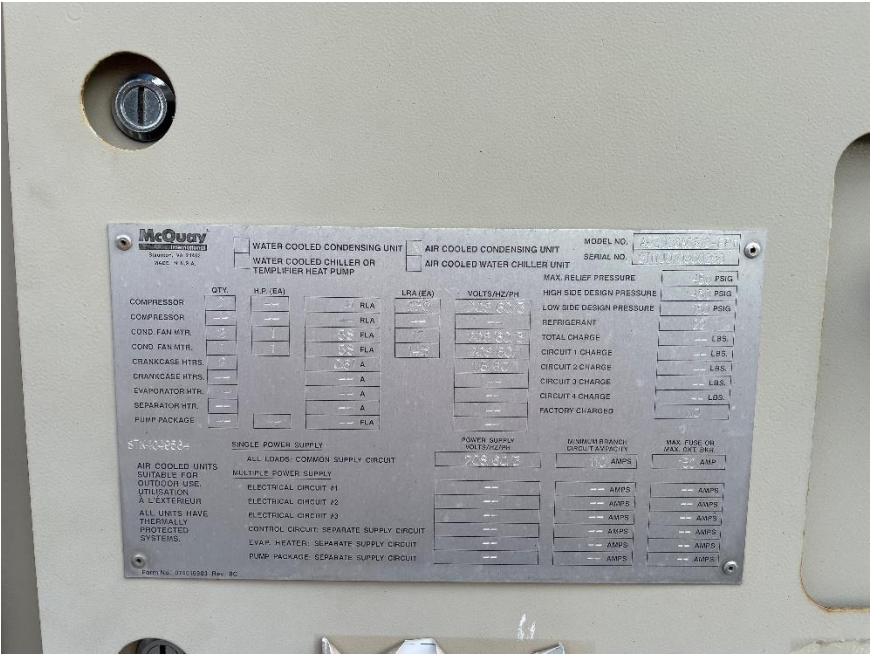
Existing Condensing unit CU-2

| HVAC Equipment | Quantity | Location | Age | Life Expectancy | Equipment Condition | Notes |
|---|---|---|--|---|---|---|
| Condensing Unit (CU-2) -30T | 1 | Roof | Original (1977 to 83)<br>Over 40 yrs old | 25- 35 years | Operational | Past service life recommended to replace |

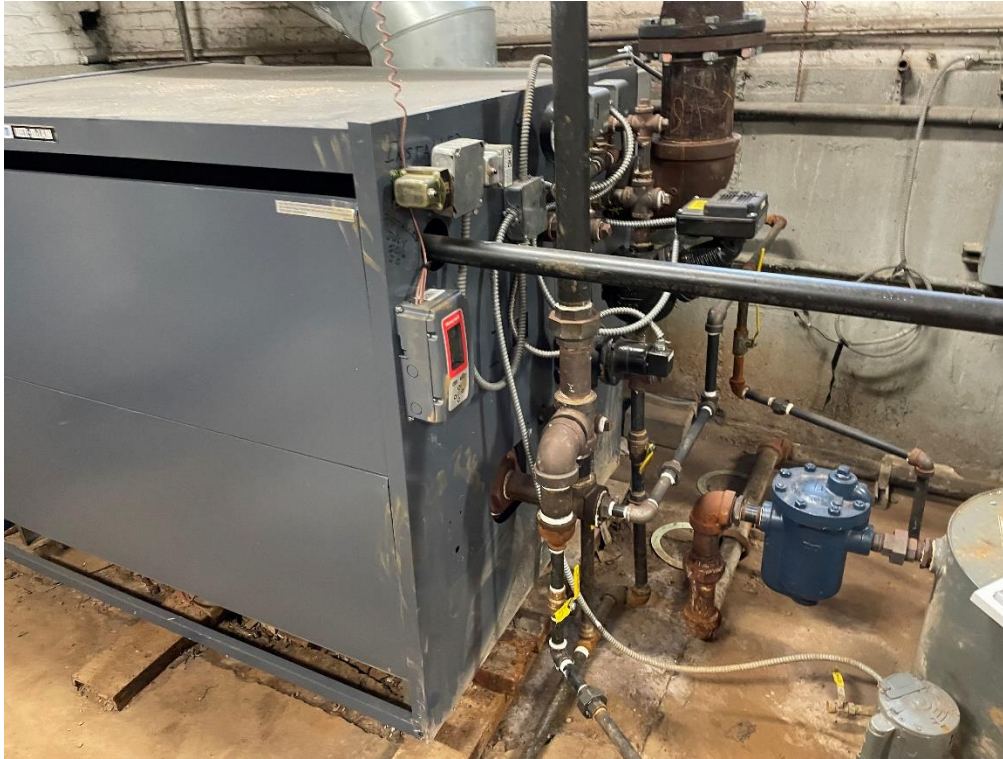
Existing Boiler Recently Installed

| HVAC Equipment | Quantity | Location | Age | Life Expectancy | Equipment Condition | Notes |
|---|---|---|--|---|---|---|
| Boiler (Steam) | 1 | Basement Floor - Mechanical room | New | 30 - 40 years | Operational | Need's controls upgrade to interface to a new BAS |

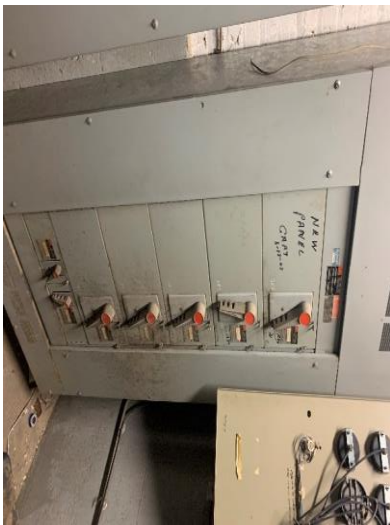
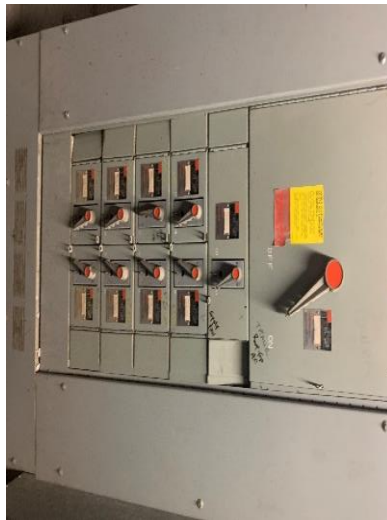
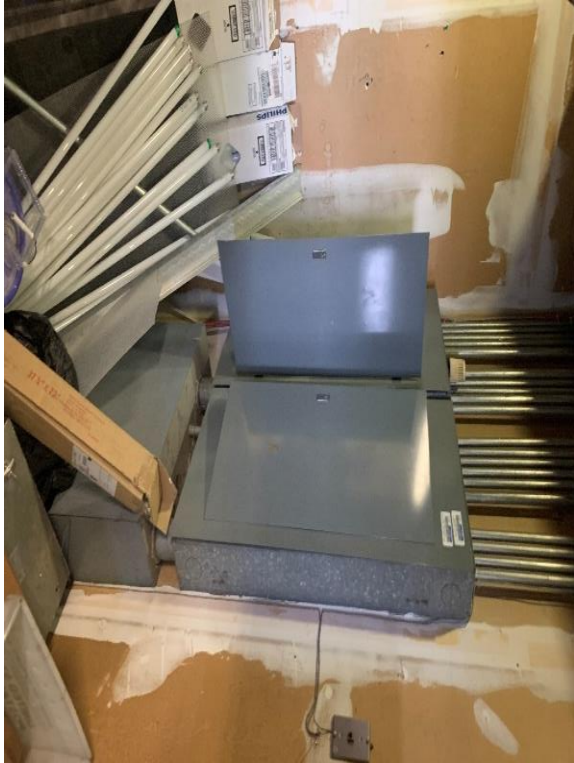
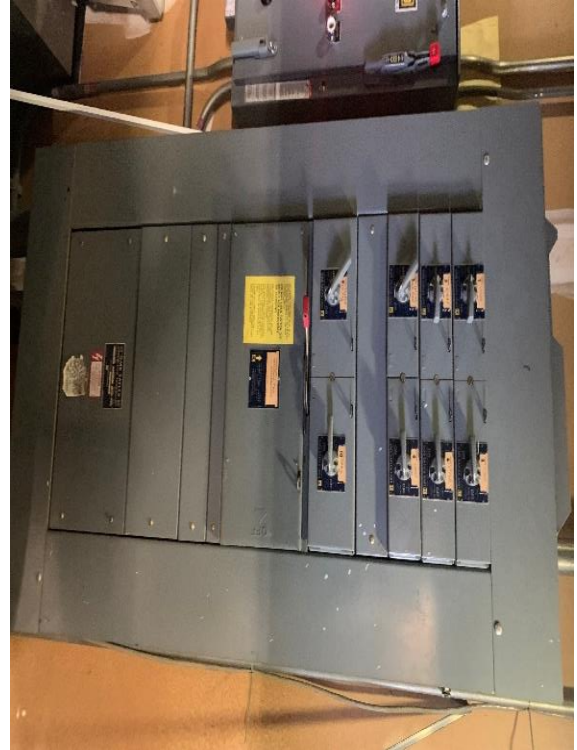
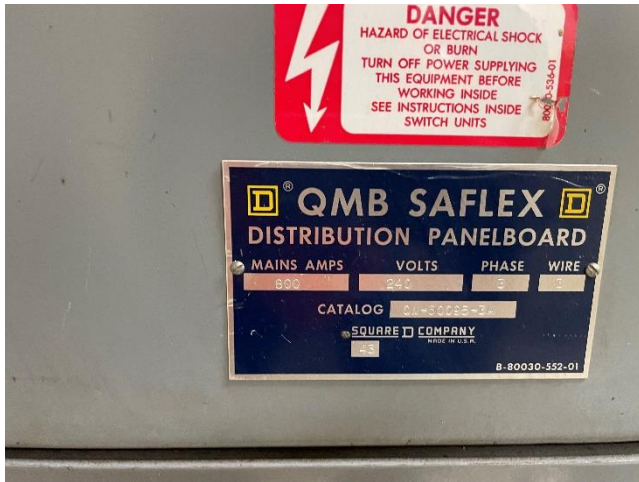
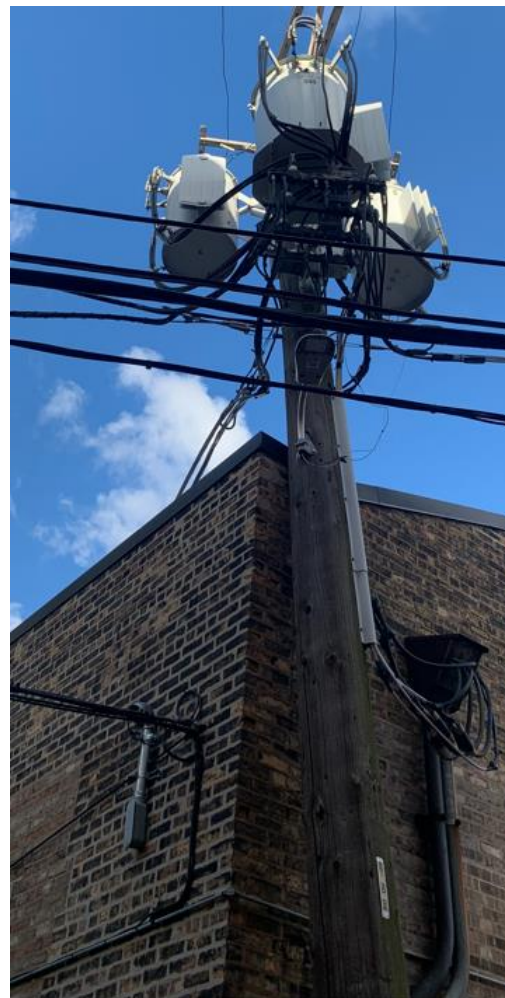
Incoming Service enters the building thru the electrical utility room east of the building distribution panels are old serve by a main 800Ampere and 600Ampere

A power panels and light panels are located in various rooms serving HVAC, compressors, lightings, receptacle, emergency lighting, telecommunications and various medical equipment in the building.

1. Due to the uncertainty surrounding the power distribution panels, it is recommended that a power distribution study be performed in order to gauge the usability of the existing system, and to determine which breakers should be replaced, if any. In addition, it is also recommended that a maintenance test be performed in accordance with National Electrical Testing Association standards by means of MTS guidelines.

2. Adding a new elevator will result to upgrade the service entrance panel and the meters should also be replaced.
3. A new power and controls wiring will be provided for the HVAC equipment that will be replace.

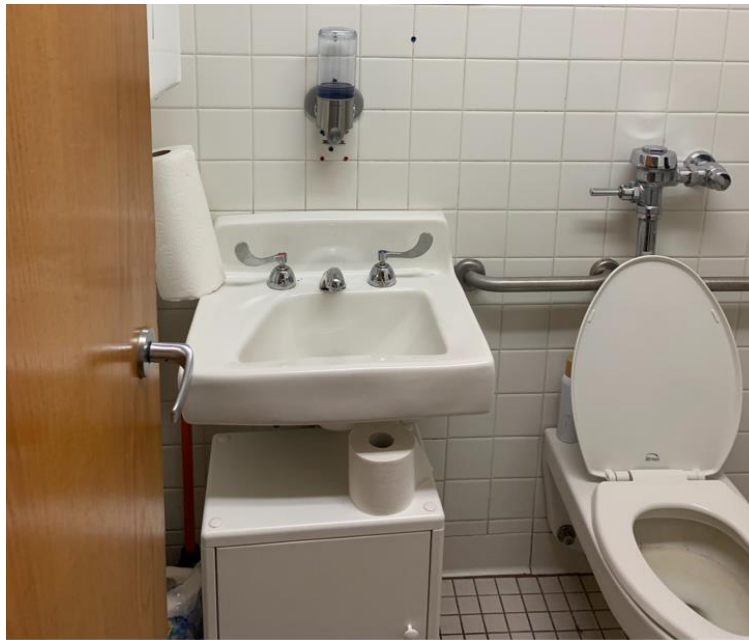
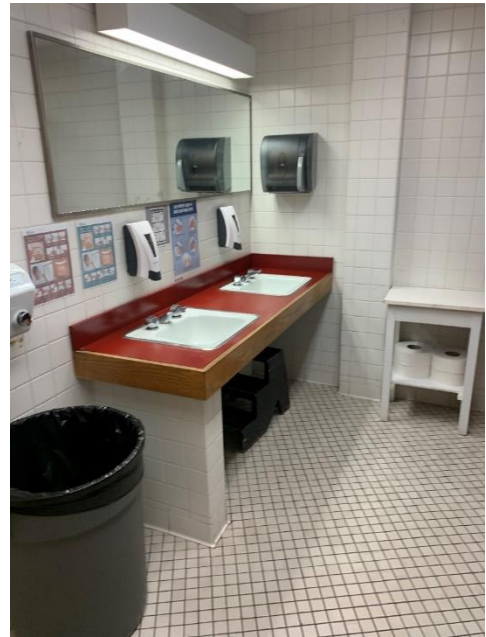
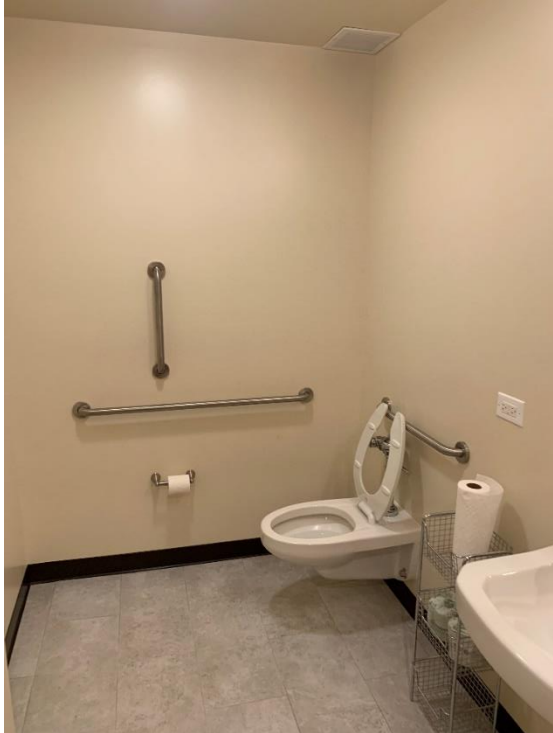
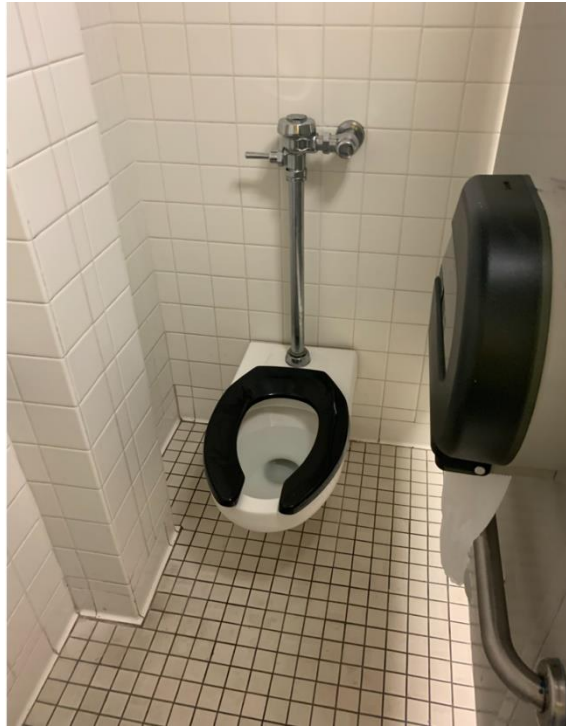
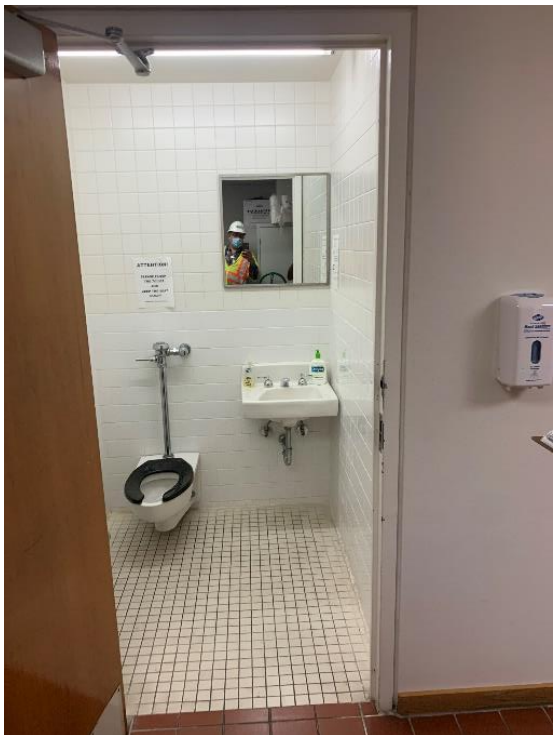
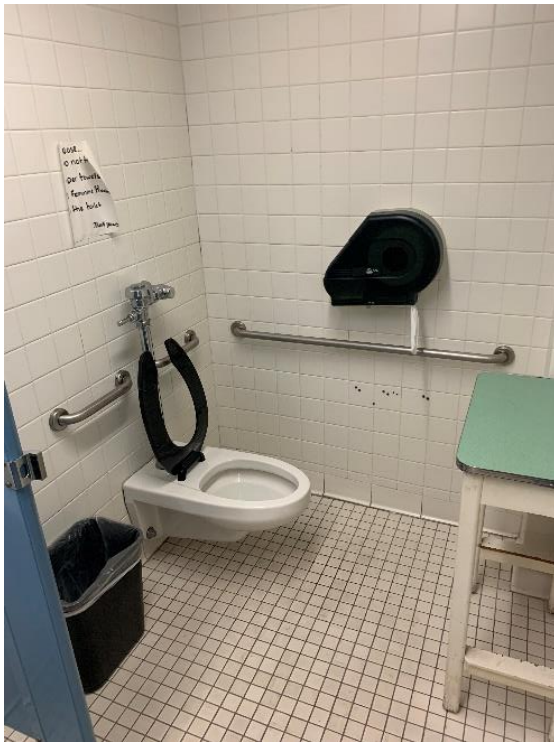
## **PHOTOS (1<sup>st</sup> floor Toilets)**

1<sup>st</sup> Floor Toilet rooms will be renovated to improve accessibility. Plumbing fixtures will be upgraded for this work. This will include the water closet, urinals, lavatory and floor drain. Pipe leaks will be address on this project. There are 8 total toilet rooms on the 1<sup>st</sup> floor.

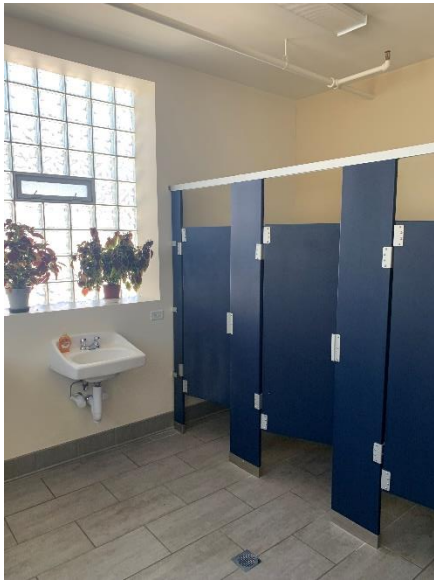
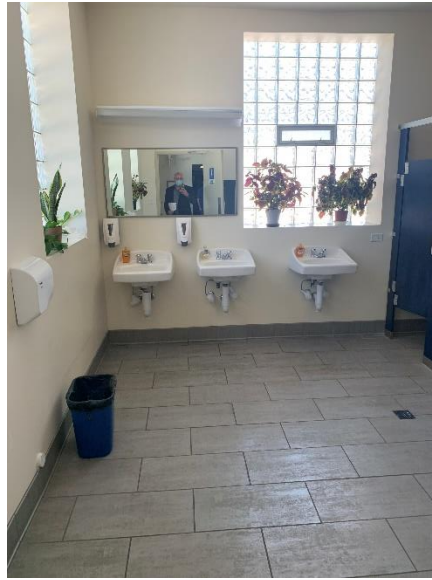
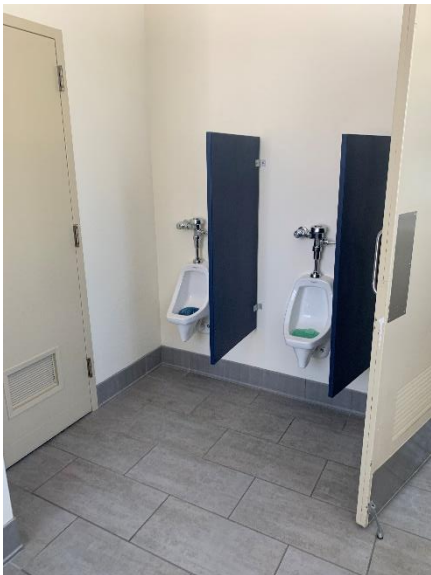
PHOTOS (2<sup>nd</sup> floor Toilets)

2<sup>nd</sup> Floor toilets No work required since its recently renovated 2 years ago unless renovated due for ADA compliance new plumbing fixtures will be replace.

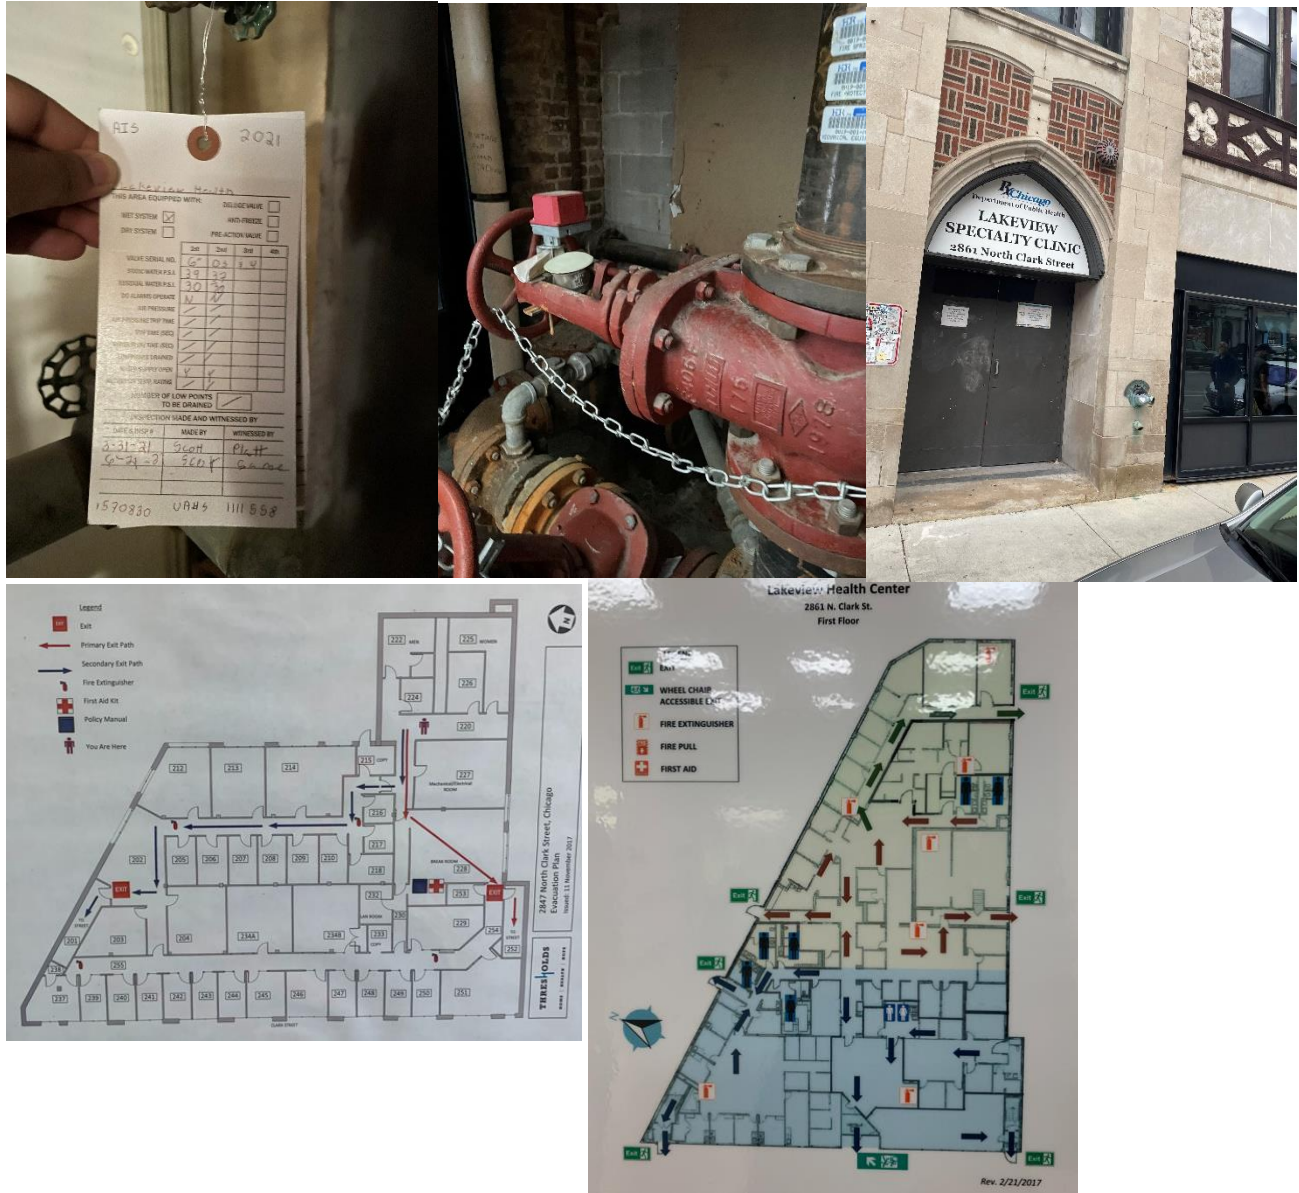
The building both floors is protected by sprinkler systems using city pressure with local audible interior alarm bell. There is no fire alarm or detection present on this building.

If required by code a full fire alarms systems must be provided. A fire panel, tamper switch panel will be install this will send output to new BAS system for monitoring.
