### Management Report

The HOH Group, Inc.  
Lakeview Health Center  
2849 North Clark Street, Chicago, IL

**Section:** Main Roof  
**Size:** 10178  
**Overall Grade:** D

**Inspection Date:** 10/20/2021  
**Inspector:** David Marcinkowski

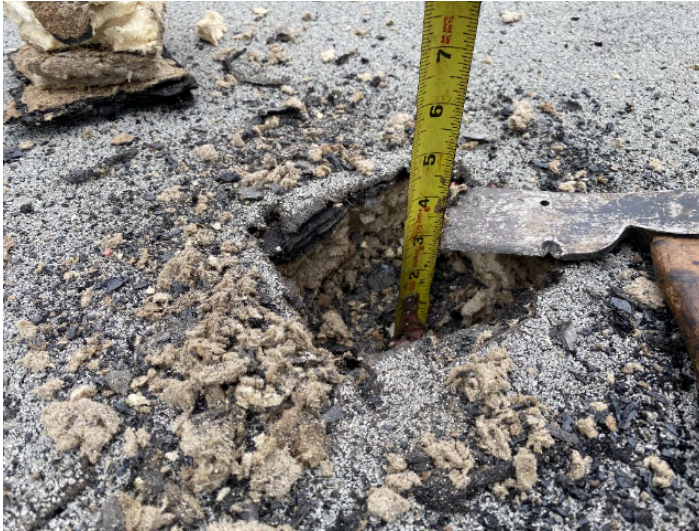
Test Cut 1  
Wood Deck  
Red Rosin  
Base Sheet  
2-Ply Asphalt Felt Vapor Retarder  
Polyiso Insulation  
Perlite Coverboard  
Granulated Modified Bitumen Roof System  
Total 3" Thickness

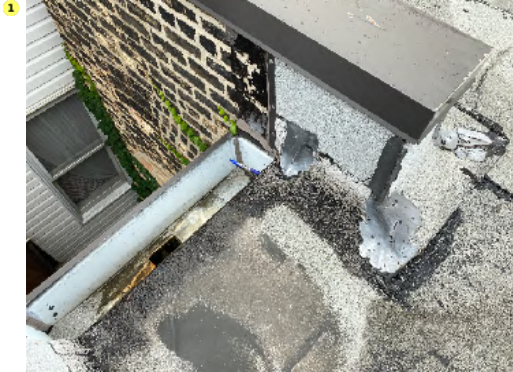
### Modified Bitumen - Flashing- The flashing lap open (Emergency)

An open flashing lap will result in a roof leak and possible insulation damage.

We will clean and seal the open lap to ensure water tightness.

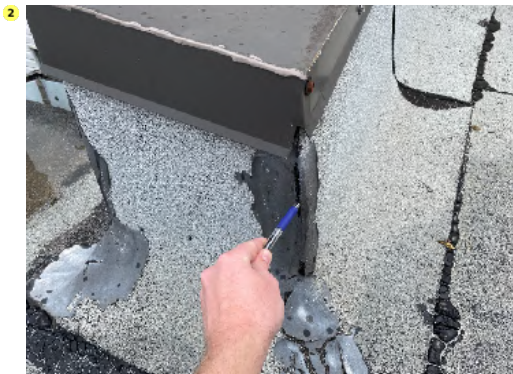
### Modified Bitumen - Flashing- Open flashing corner (Emergency)

The membrane flashing corner is open.

The corner will be repaired to make the flashing watertight.

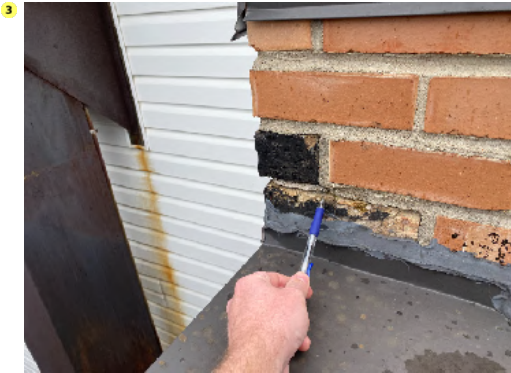
### General - Masonry- Masonry defective (Emergency)

The masonry on the parapet walls are deteriorated and need to be repaired.

The masonry should be repaired.

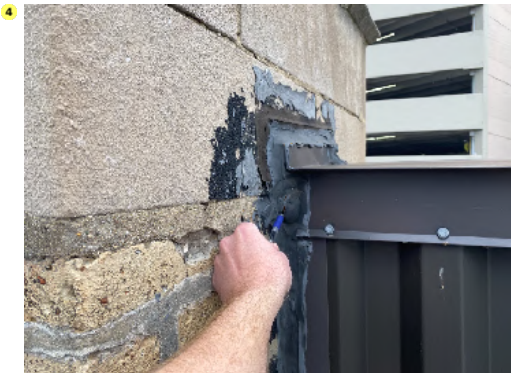
### Sheet Metal - Caulk- Caulking failure (Emergency)

The caulking has failed.

New caulking will be installed .

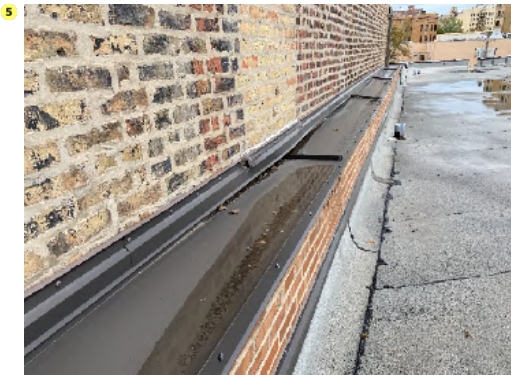
### Sheet Metal - Expansion Joint Open (Emergency)

Sheet metal cap was not properly designed as an expansion joint and is deformed.

Install a new sheet metal expansion joint cap.

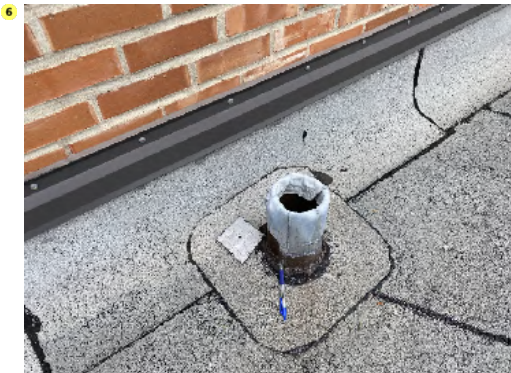
### Modified Bitumen - Penetration- Plumbing vent lead flashing base (Emergency)

The base of the lead flashing is open.

The base of the lead flashing will be sealed with roof cement.

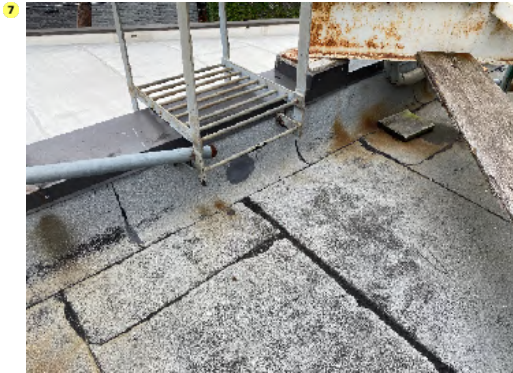
### Modified Bitumen - Walk pads missing (Emergency)

Walkpad are needed to protect the roof membrane.

We will install new walkpads.

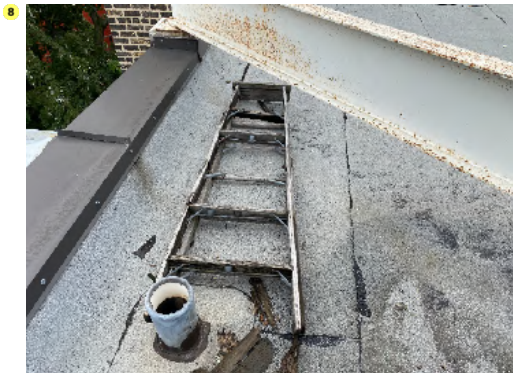
### Modified Bitumen - Loose Debris (Emergency)

Loose debris has a high probability of blowing around on the roof and causing damage to the waterproofing membrane.

Remove loose debris from roof area.

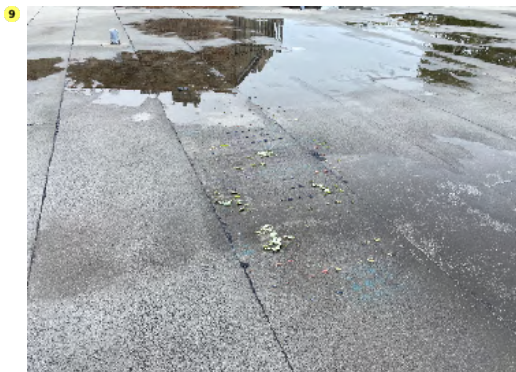
### Modified Bitumen - Membrane- Puncture or Tear in Membrane (Emergency)

A puncture or tear has been discovered in the roof membrane.

The area surrounding the deficiency will be cleaned. A proper repair will be performed using compatible materials for the roof membrane type.

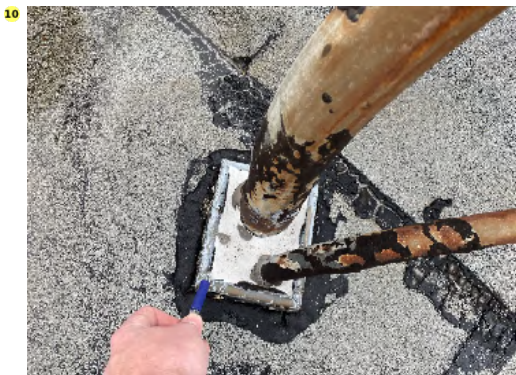
### Modified Bitumen - Penetration- Pitch Pan (Emergency)

The pitch pan around the pipe penetration needs to be refilled.

The pitch pan will be refilled to prevent water leakage.

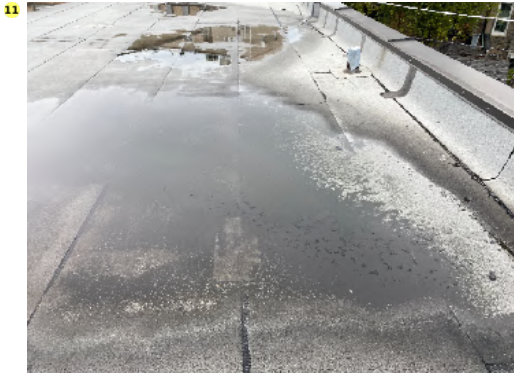
### Modified Bitumen - Membrane- Ponding (Emergency)

Ponding of water on the roof.

Ponding will lead to the premature failure of the roof membrane.

The existing roof is reaching the end of its serviceable life. The lack of tapered insulation has lead to ponding and the premature deterioration of the roof membrane. Numerous leaks have been reported inside. Flashings are beginning to open, even those that have previously been repaired. Satellite imagery was unable to verify when the last roof was installed. A-1 recommends a complete tear-off and replacement.

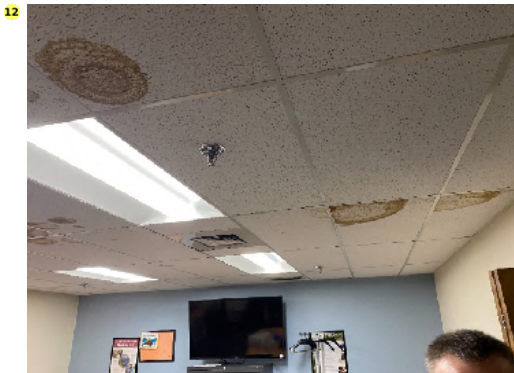
### General - Leaking Area (Emergency)

The roof is leaking in this area.

The roof will be inspected in this area and deficiencies repaired as needed.

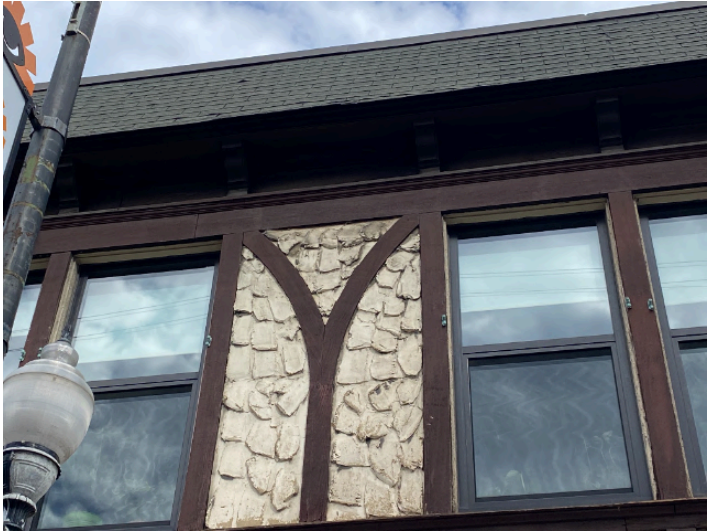
No Test Cut Performed  
Wood Deck (suspected)

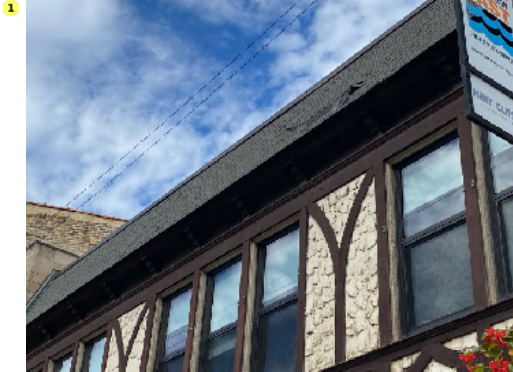
### Shingles - Shingles are damaged (Emergency)

Shingles showing signs of visible damage

Shingles will be removed and replaced with new,

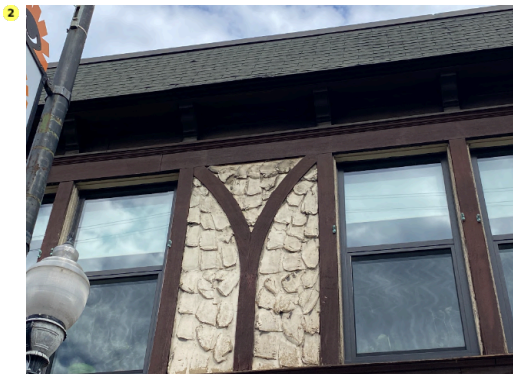
### Shingles - Shingles are worn (Emergency)

Shingles are showing signs of weathering and age.

Shingles will be removed and replaced with new.
