**EXHIBIT C**  
**10.22.2021**

HOH Project # 5422:

2021-F326-REN CIP- Lakeview Health Center Renovations

Project Address: 2849-61 N. Clark St., Chicago Illinois

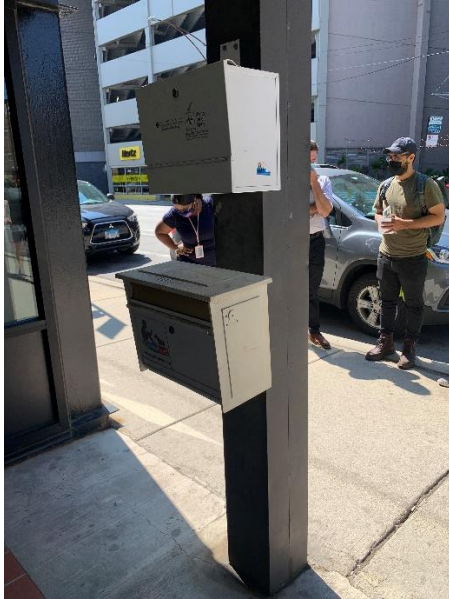
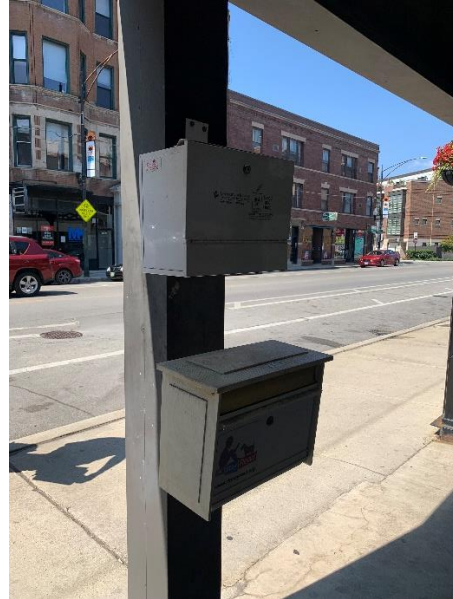
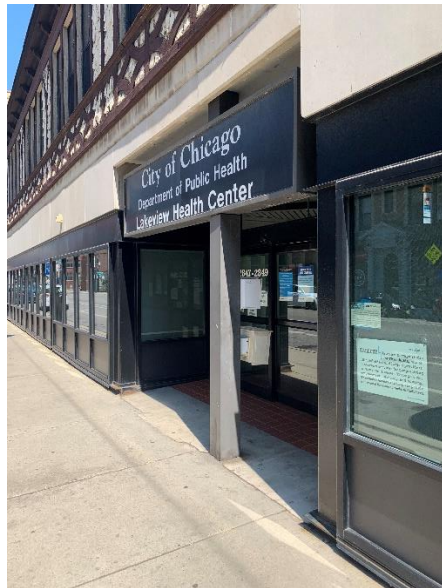
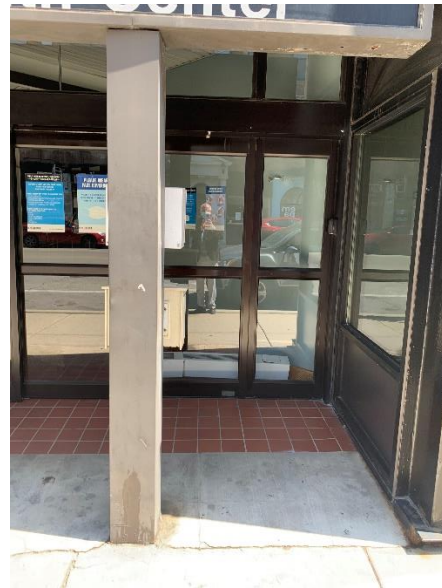
1. Sample boxes at the entry present a protruding object hazard and should be relocated.

Pic 1, 2, 3 & 4: Sample boxes to be removed and reinstalled to side panel.

**Recommendation:** Final location to be coordinated. Immediate removal is recommended to avoid potential injury since they are in the path of travel in and out of the facility.

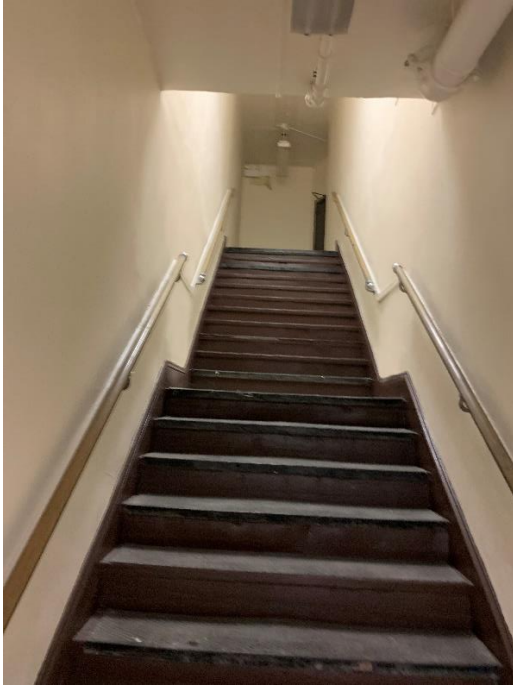
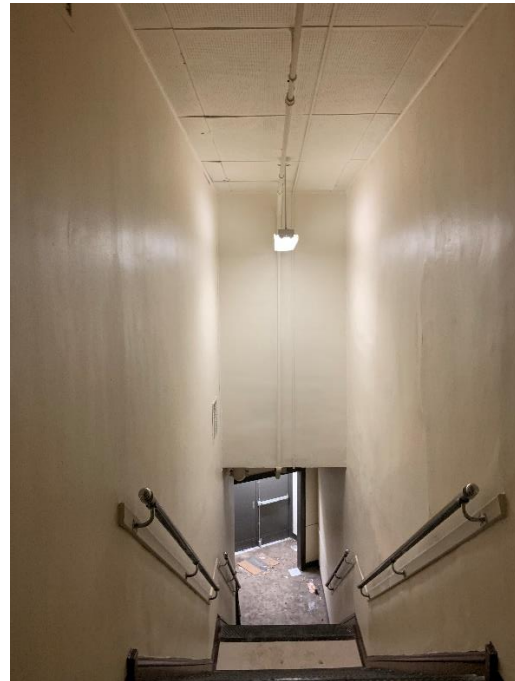
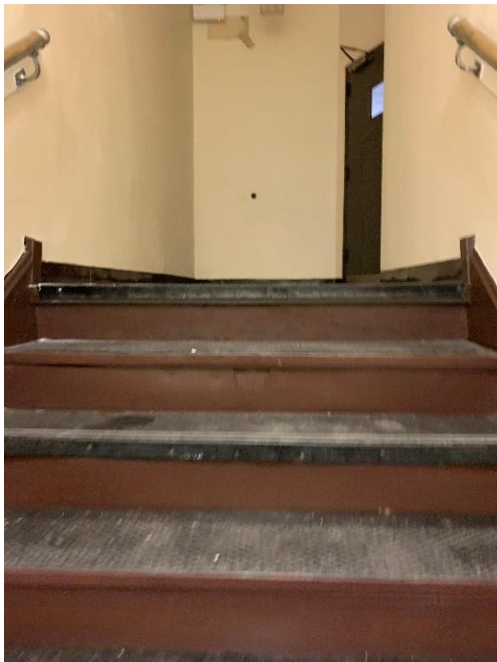
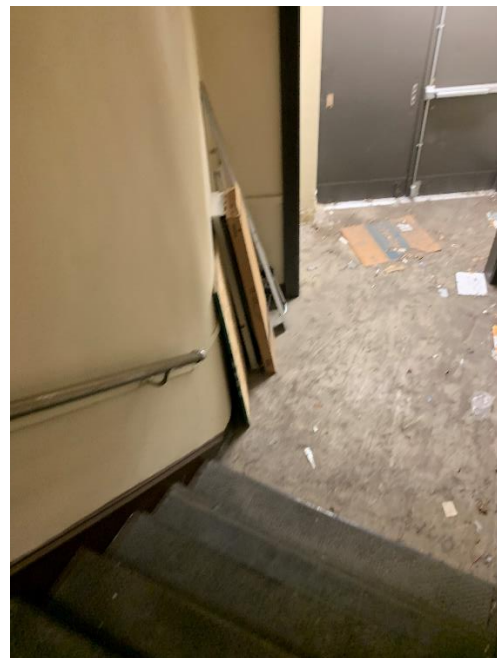
Pics 5, 6, 7 & 8:

Handrails at both staircases are non-compliant with ADA requirements.

Recommendation: Removal of existing non-compliant handrail and installation of new ADA compliant handrails is recommended. Finishes shall be removed and replaced since they are damaged, very old and worn out.

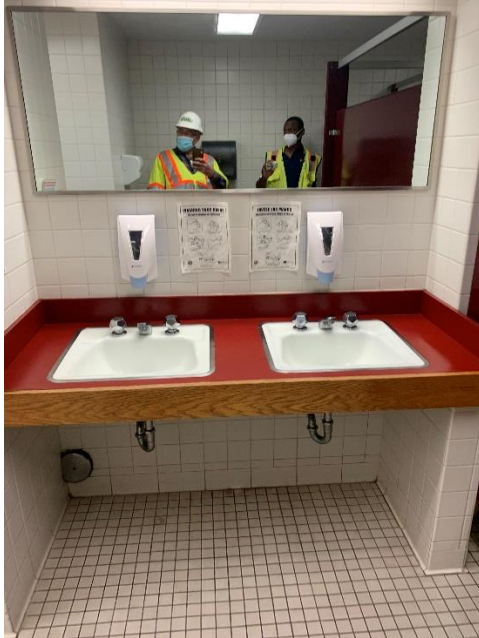
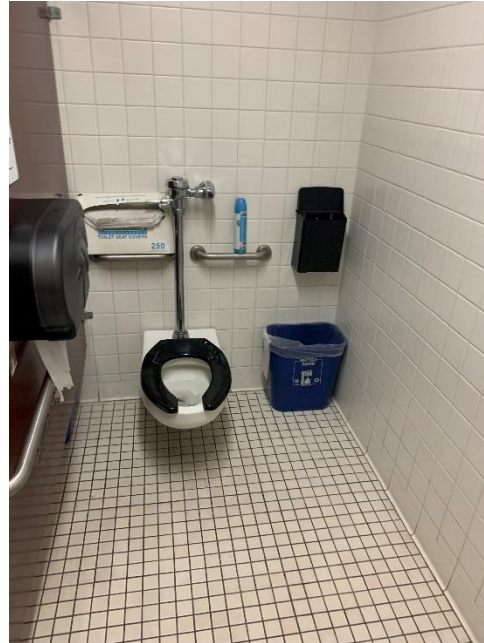
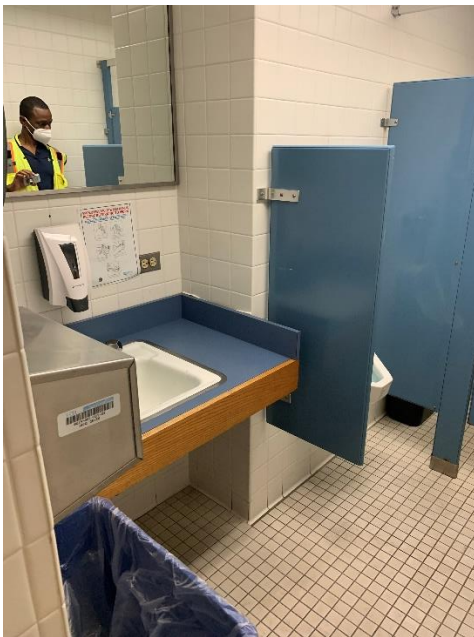
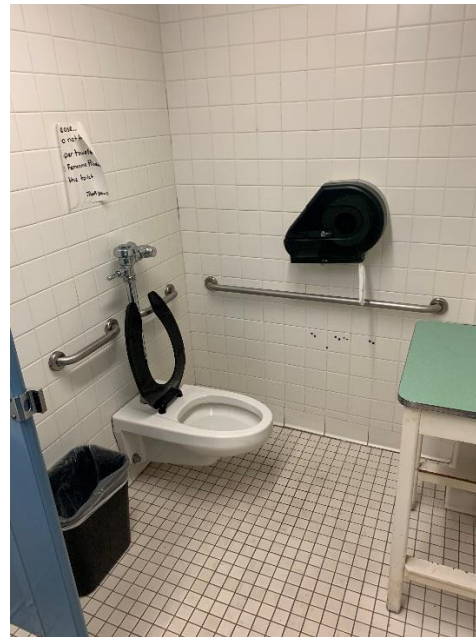
Pics 9, 10, 11 & 12: First floor restrooms' plumbing fixtures to be removed and replaced per ADA requirements.

Recommendation: New first floor restrooms' layout and new plumbing fixtures and accessories to comply with ADA requirements. New finishes shall be installed after removal of existing restroom plumbing fixtures and existing finishes. 2 Men, 2 Women, 1 Staff and 2 single ADA restrooms were observed.

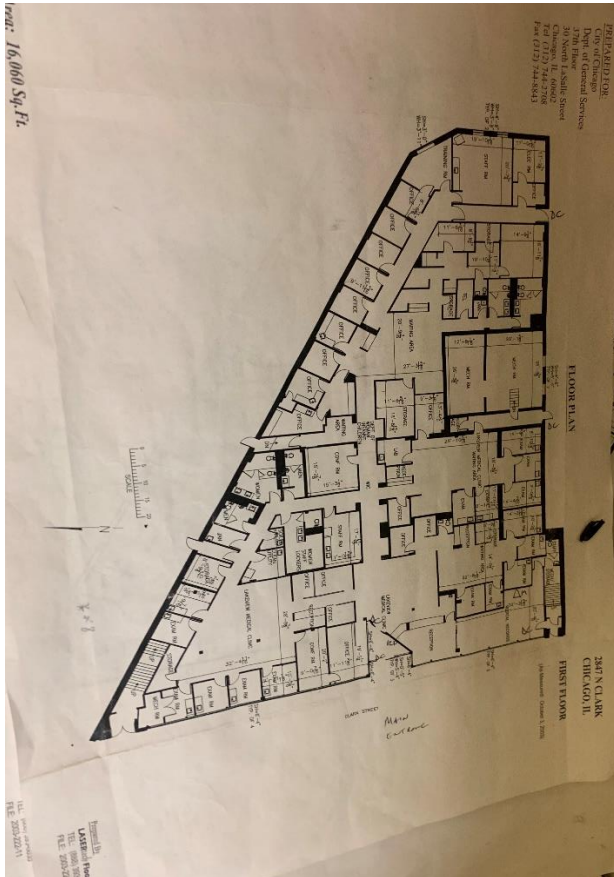
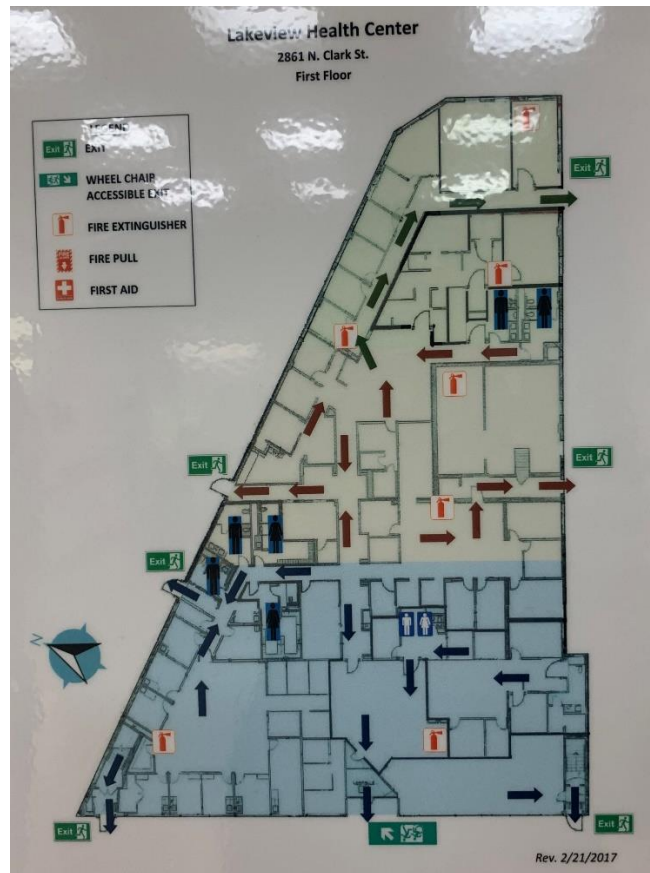
Pics 13 & 14: ADA compliant room signage is not provided for all rooms and spaces with CDPH first floor occupied areas.

Recommendation: Provide ADA compliant room signage in all first-floor rooms and spaces. Total 16,060SF.

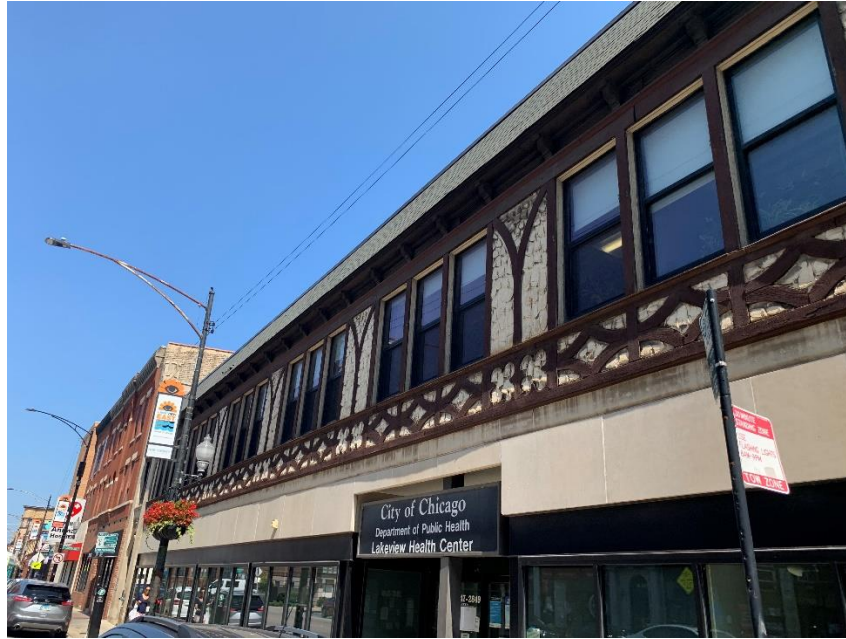
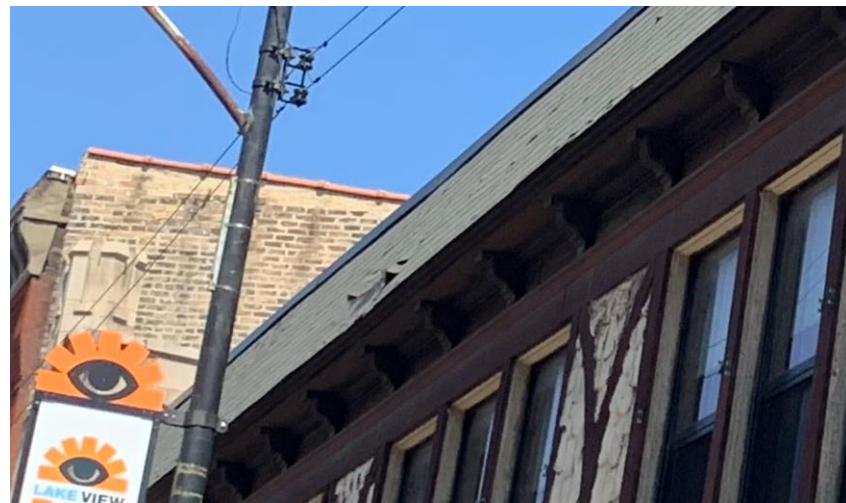
1. The asphalt shingles on the mansard roof were observed to be loose and in danger of falling off. Replace asphalt shingles and underlayment.

Pics 15 & 16: The shingles on the mansard roof shall be removed and replaced.

Recommendation: The shingles along Clark Street elevation must be removed and replaced in kind.

Remove and Replace asphalt shingles and underlayment including all accessories related to Clark St elevation.

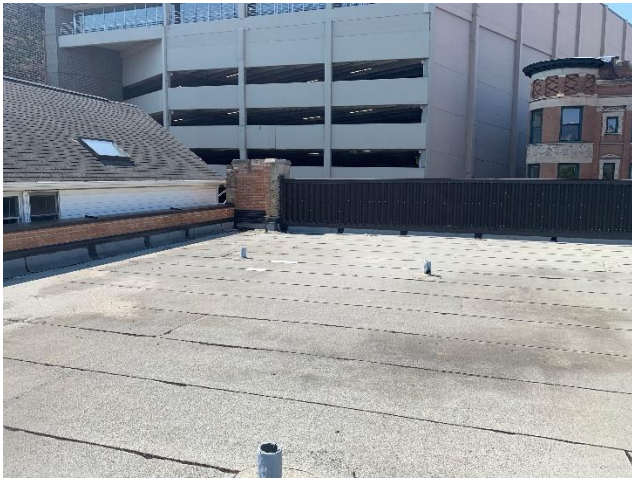
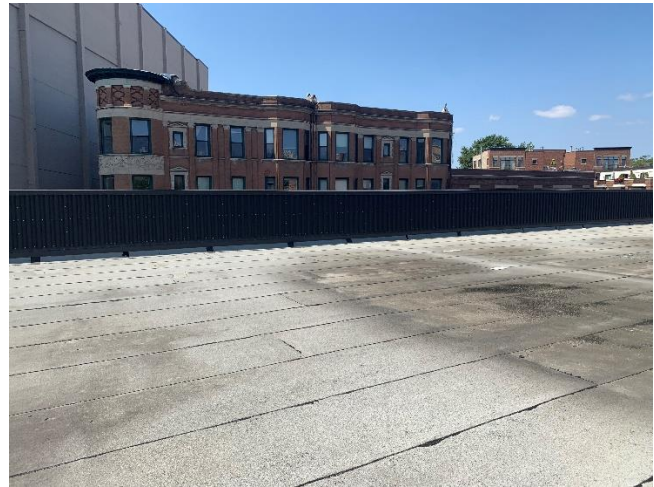
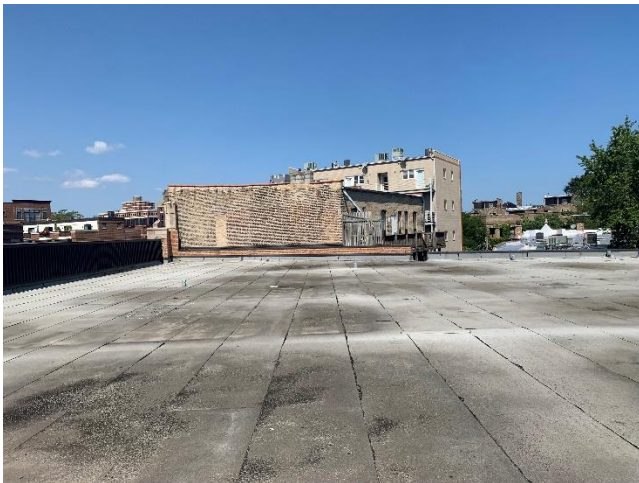
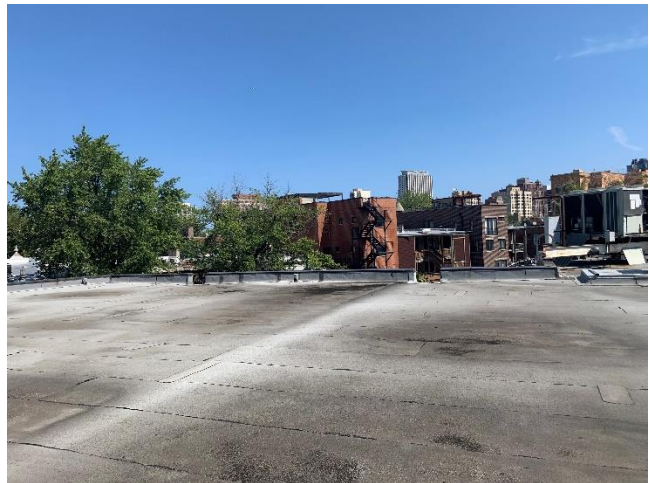
2. The upper roof was reported to have been leaking from snow melt in the spring and is not properly pitched to drain. The modified bit roof is showing evidence of ponding. Remove existing membrane, investigate condition of roof components, and provide new tapered insulation and roof membrane.

Pics 17, 18, 19 & 20: Ponding in roofing system confirms its deterioration and need for removal and replacement.

Recommendation: Remove existing roofing system and replace with new system. Provide proper slopes and roof drainage. Roof leak damage to be repaired in exterior envelope: parapet walls, upper floor lintels and miscellaneous roof system accessories. Repair of interior damage caused by roof leaks shall be executed: remove and replace some acoustical ceiling tiles, gypsum board walls and ceilings and patch, prepare and paint accordingly. Once the AOR and roofing consultant visit the site and perform core samples and provide lab results to verify and confirm visual observations the assessment is to remove existing roofing system and replace with new system to be determined by owner. TPO is the recommended system to be used.

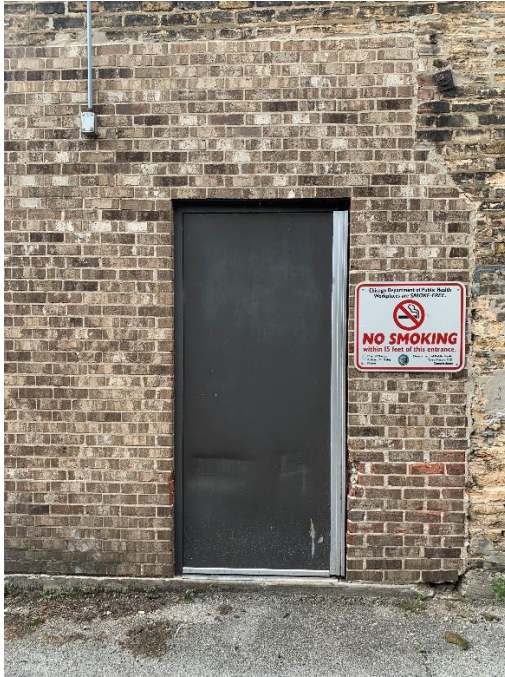
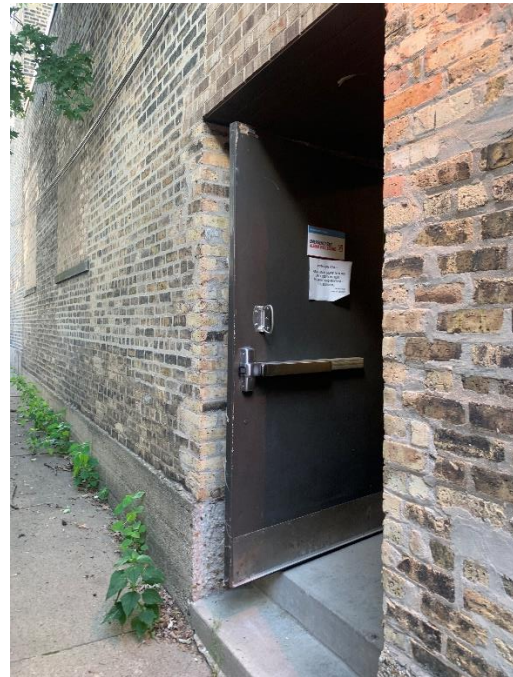
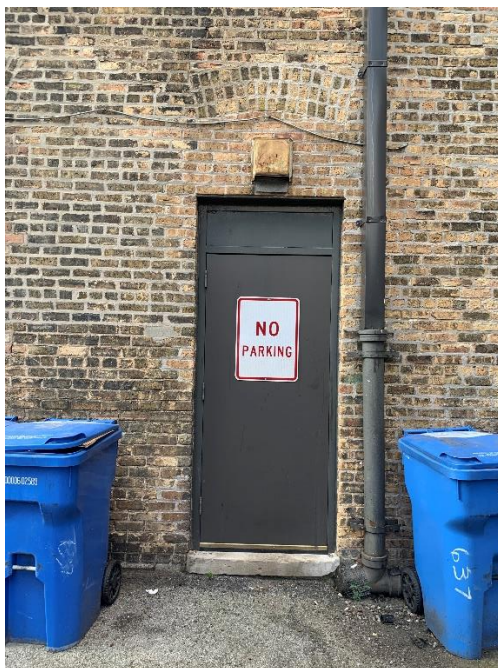
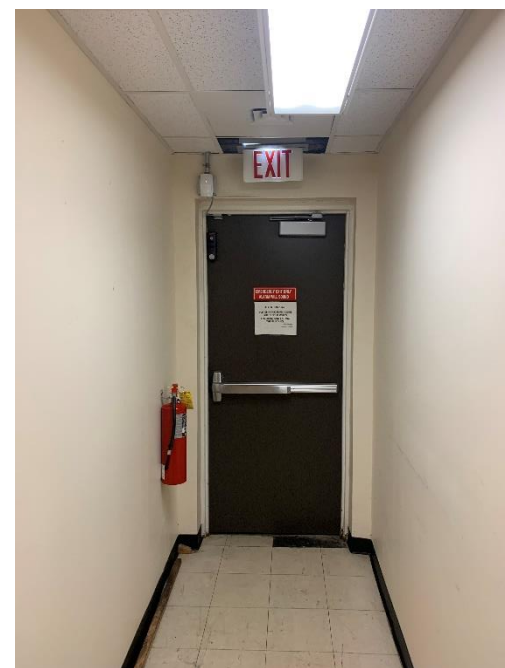
Pics 21, 22, 23 & 24: Interior panic hardware needs to be assessed by door and security consultant to deem if appropriate or in need of replacement. A total of 3 doors facing Clark St, 2 doors facing the alley and 2 at the setback facing the neighbor at the south side of building.

Recommendation: All exit doors were photographed but they need to be tested for proper functioning. AOR and door security consultant to test every one of the exit doors with their exit panic hardware for compliance.

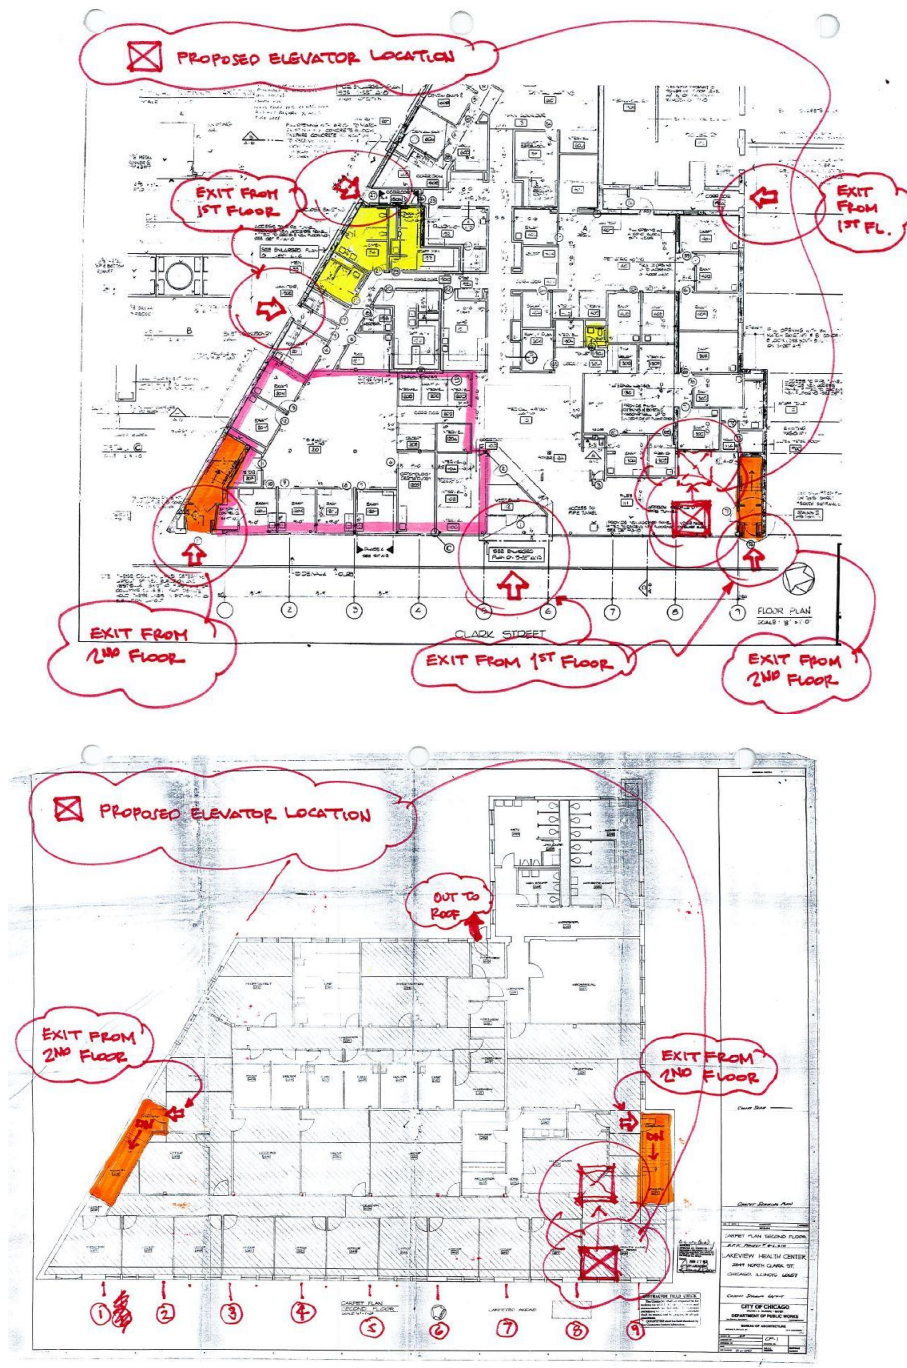
Pics 25 & 26: show the locations for exit doors for first and second floors.

Pics 25 & 26: Show suggested location for elevator close to south staircase. This location seems to be most appropriate because it will need the least amount of disturbance to the facility's two levels.

An elevator consultant with KONE elevators has been contacted to give a proposal based on the sketches 25 and 26. When we receive the information will share it with the team. The hydraulic elevator requested is a 2500 lb for 2 stories ADA compliant.

Recommendation: if budget allows the elevator shall be installed to make 2<sup>nd</sup> floor ADA accessible.

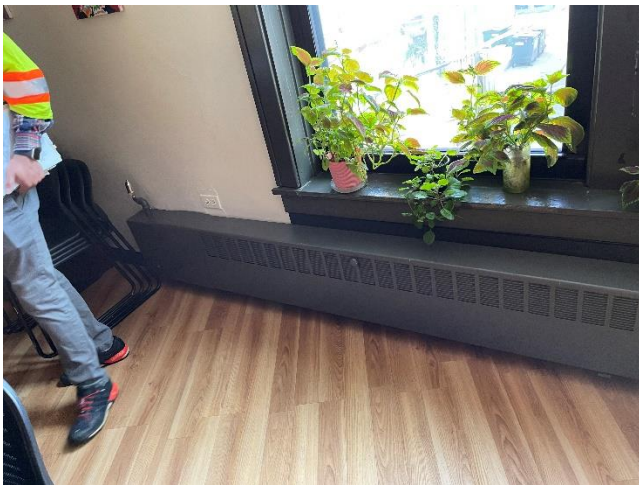
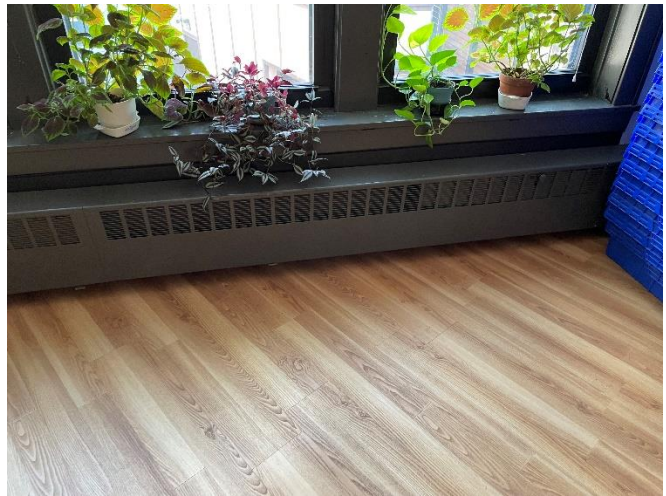
2. The second-floor wood windowsills appear to be deteriorating. Consider replacing sills and capping with aluminum trim to match new windows.

Pics 27 & 28: Show the wood windowsills that may have been painted after the window replacement but need to be replaced or capped with aluminum to match the windows.

Recommendation: Remove and replace existing damaged wood sill with new wood sill and paint to match existing.

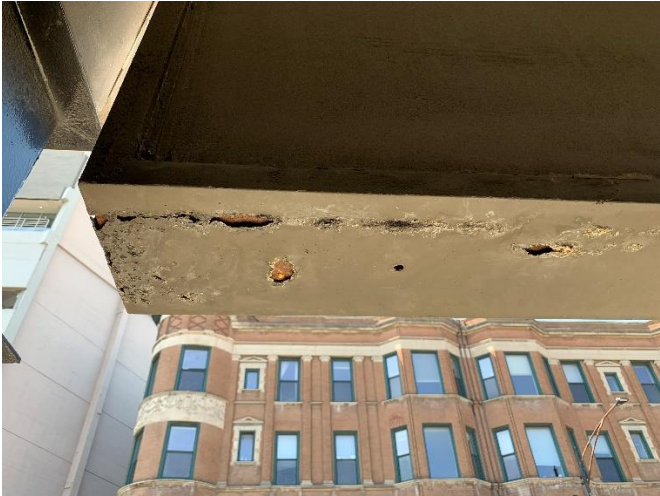
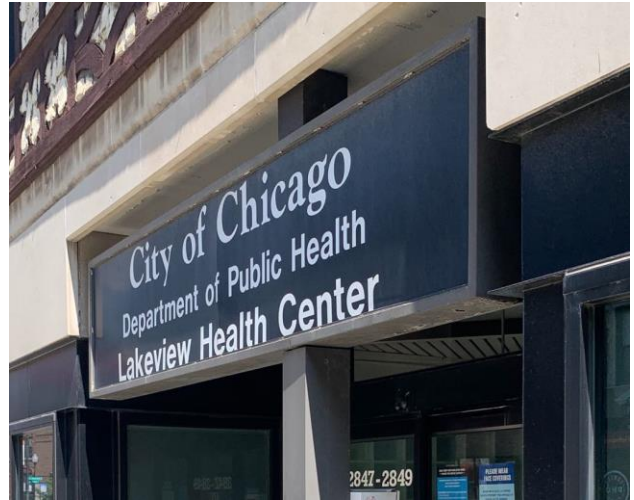
3. A new facility sign should be considered – corrosion was observed at the existing sign enclosure.

Pic 29 & 30: Sign enclosure shows corrosion.

Recommendation: Provide aluminum sheet to match gauge and color over existing enclosure if budget is tight. Another sign could be considered if budget allows it.

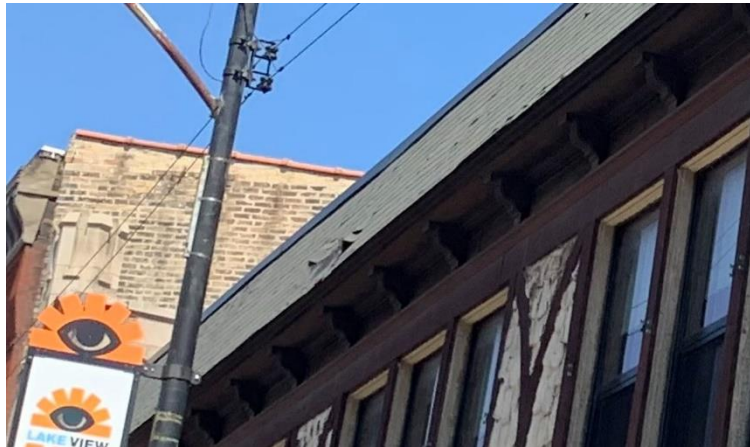
Pic 31: Shingle roof shows damage and deterioration and needs to be removed and replaced.

Recommendation: AOR agrees with AIS recommendation to use metal standing seam roofing system in lieu of asphalt shingles to improve life expectancy of roofing system as well as better aesthetics.

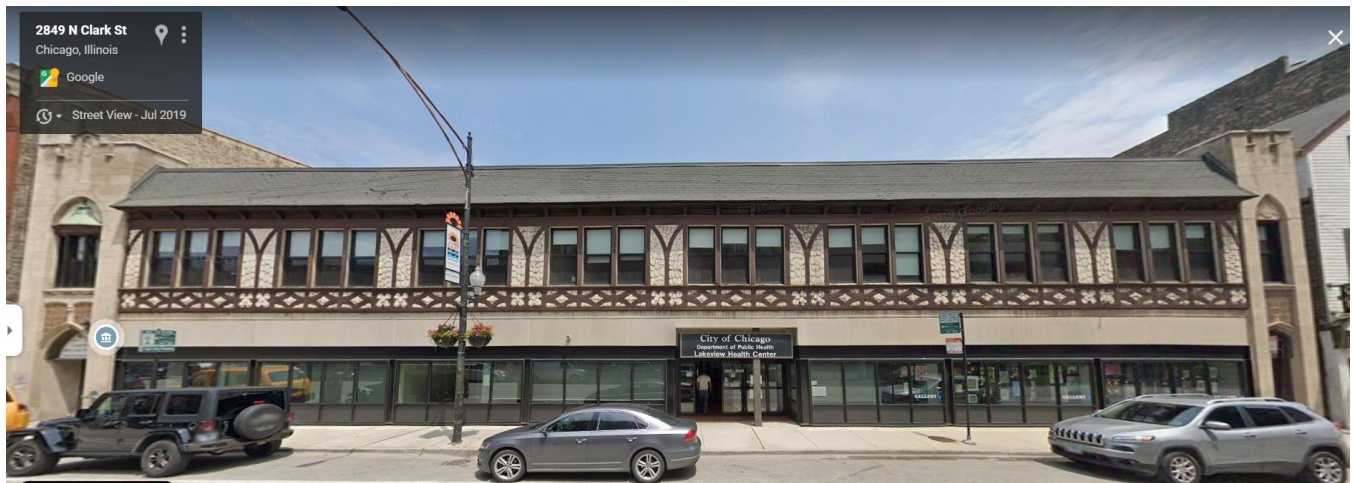
Pic 32: Shingle roof shows damage and deterioration and needs to be removed and replaced.
