Public Building Commission  
**North Park Village – Chapel Building F**  
**Chicago, IL**  
Preliminary Property Condition Assessment  
October 21, 2021

This Property Assessment of the North Park Village Chapel Building F was prepared by KOO LLC at the request of the Public Building Commission of Chicago for the purpose of informing decisions on the potential renovation or restoration of the building. The Chapel building is located at 5801 N. Pulaski Road F. Completed in the 1930's, and originally part of the Municipal Tuberculosis Sanatorium (M.T.S.), the building is a Chapel and is currently closed.

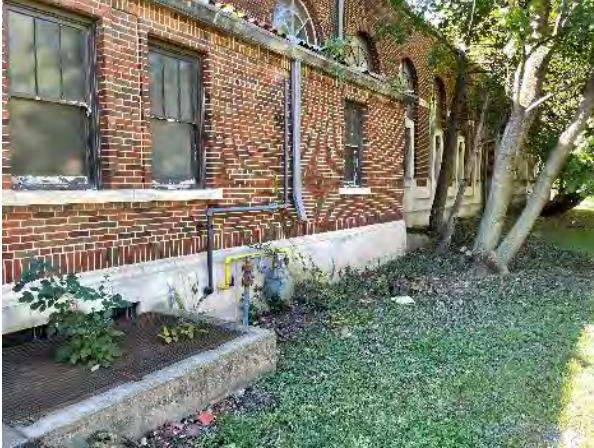
3.1.1.1 Although overall review of site and storm drainage was not part of the scope of this report. There are a number of locations where downspouts are damaged, not draining properly, or not extending far enough to grade. This can cause stormwater to backflow onto the building.

Work Item	Description of Recommended Work	Opinion of Probable Costs to be provided by PBC	
		Traditional Construction	
		Critical	Non-Critical
3.1.1 Storm Water Drainage			
Critical		\$0.00	
	Selective regrading at building corners to address drainage issues		
Non-Critical			\$0.00

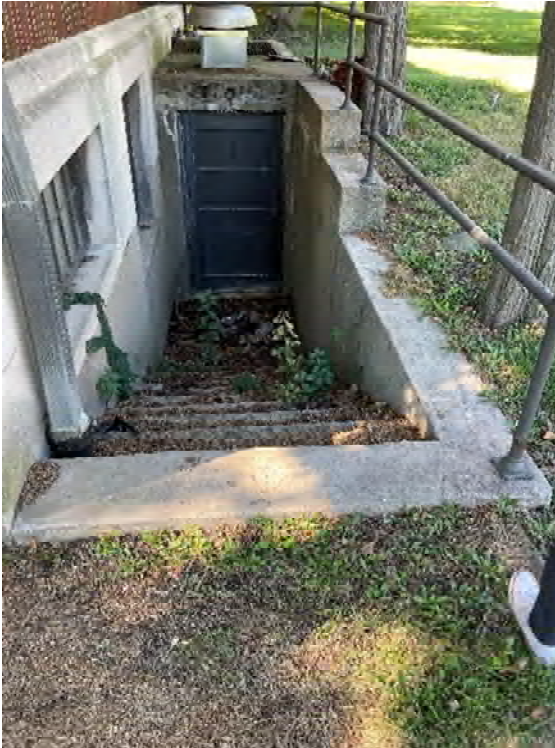
3.1.5.1 Landscape debris is present at stairs from the basement to grade.

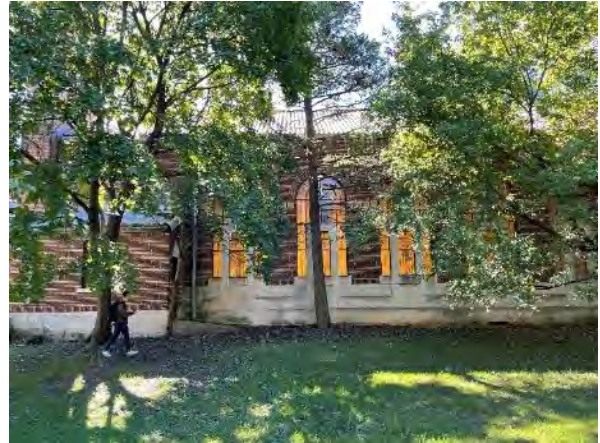
3.1.5.2 – There are multiple mature trees adjacent to the façade. This causes landscape debris build up on the existing building.

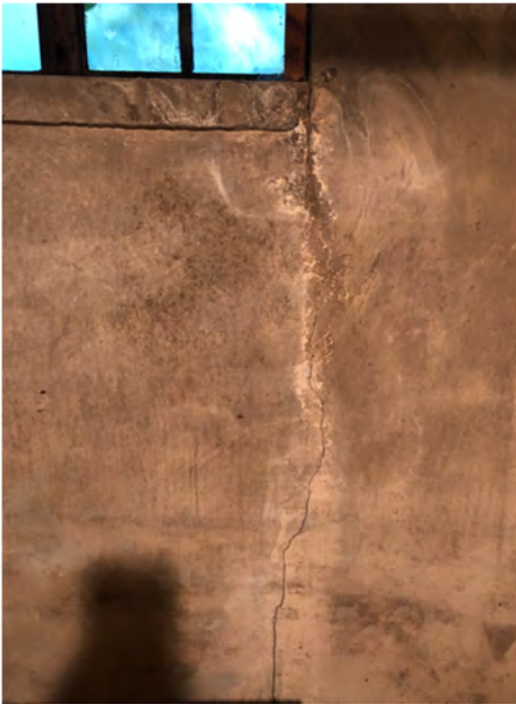
3.2.1.1 Concrete basement wall exhibits signs of minor cracking.

3.2.1 Foundation and Building Structure			
Critical		\$0.00	
	At Basement Provide 200 LF of epoxy injection at concrete foundation wall cracking		
	At Basement Provide 200 LF of epoxy injection at concrete slab cracking		
	Concrete beams with exposed reinforcement bars and spalled concrete should be repaired. Repair will consist of abrasive blast cleaning to remove rust, and possibly addition of new reinforcement. Concrete patch repair mix will be used to replace lost section. Assume 25% repair of concrete beams in the Basement		
	Structural framing at roof should be inspected (or replaced), which will require seletive demo. KOO recommends that PBC, with assistance of KOO procure a contractor to perform Destructive Testing in order to expose structural elements concealed from view, prior to the completion of the Construction Document phase.		
Non-Critical			\$0.00

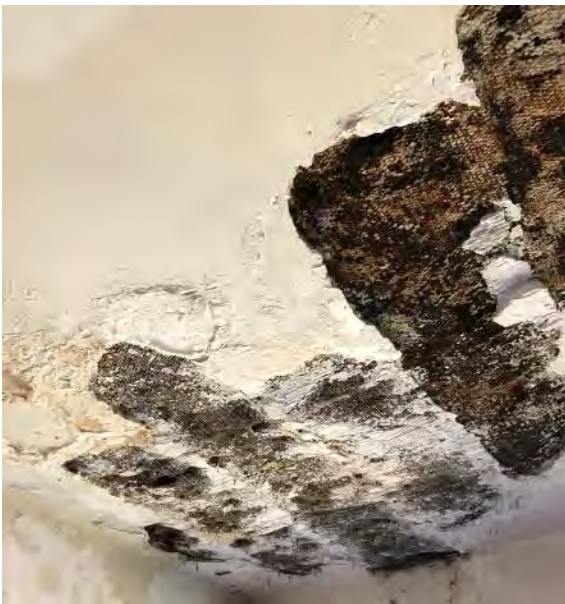
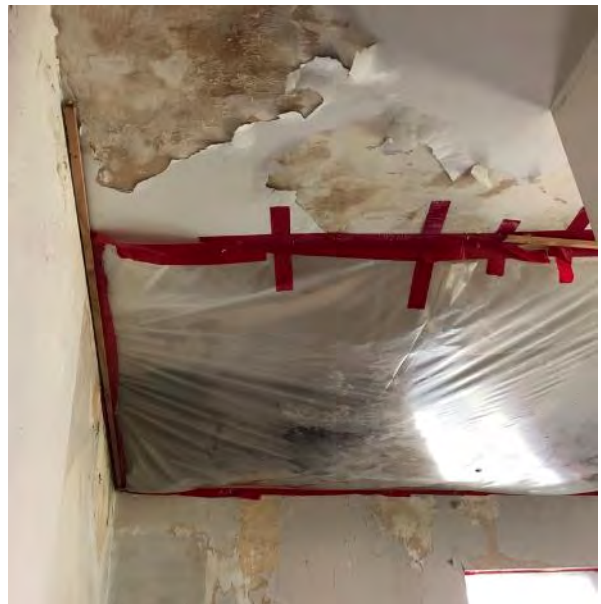
3.2.1.3. Ceilings show signs of significant water damage. This is an indication that water damage to the roof structure is expected. It is expected that the roof be composed of timber. Structural framing system should be inspected (or replaced) to ensure no structural deficiencies, which will require selective demo.

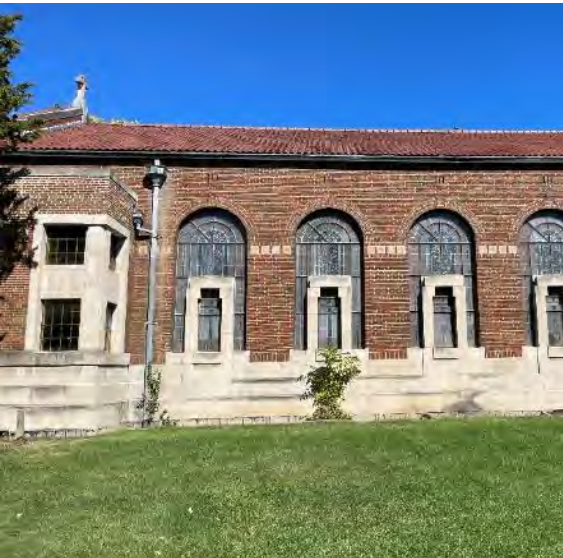
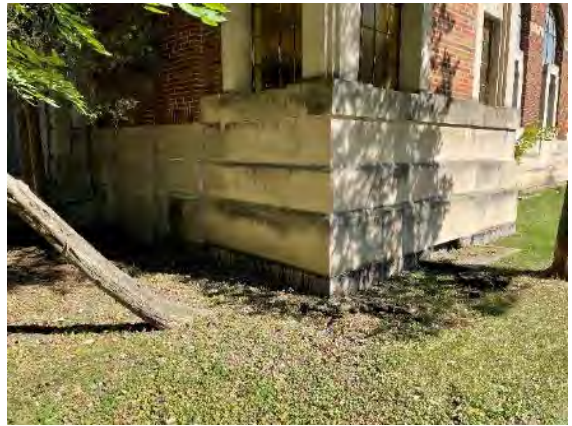
3.2.2.3 Exterior brick wall is in a good condition.

3.2.2.4 Dirt and debris built up at the exterior base of the building.

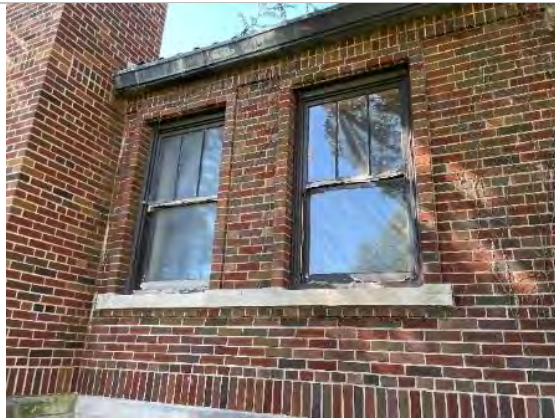
3.2.2.5 Exterior windows are not in good condition.

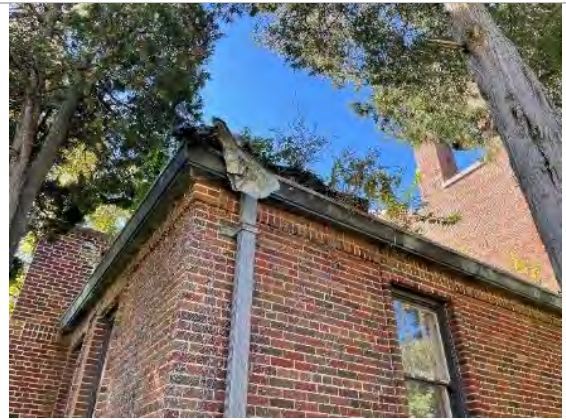
3.2.2.6 Plants and dirt built up on the gutter of the building.

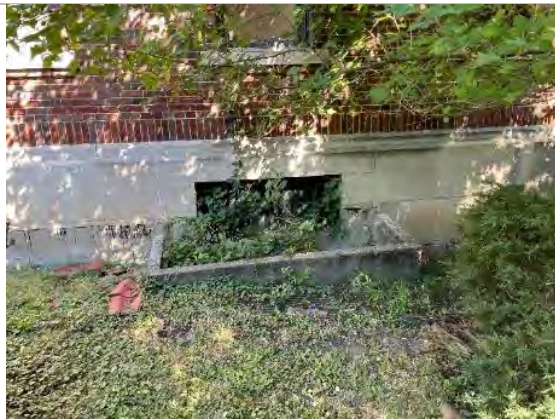
3.2.2.7 Light well is covered with dirt and plants.

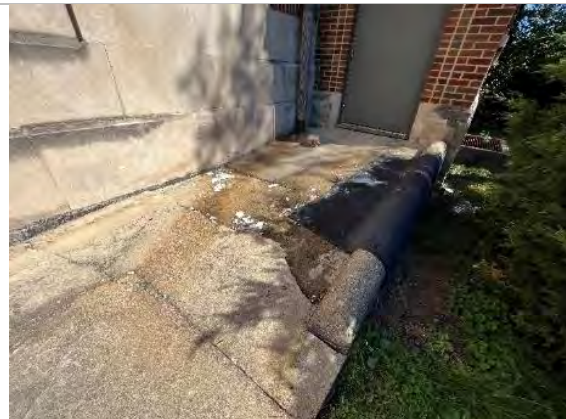
3.2.2.8 Concrete paths into exit doors are damaged.

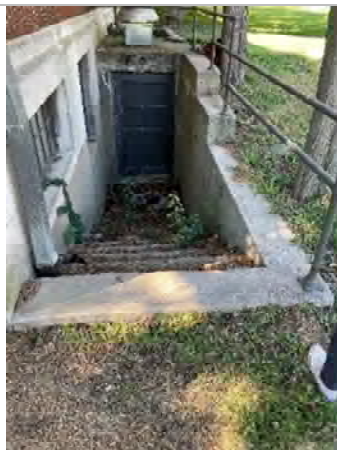
3.2.2.9 Dirt and debris built up along the wall, steps and door of basement exit door.

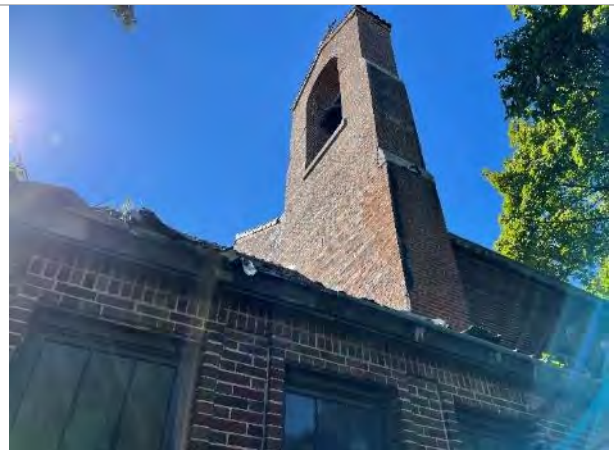
3.2.2.10 Cracking on bell tower allows water to leak through brick.

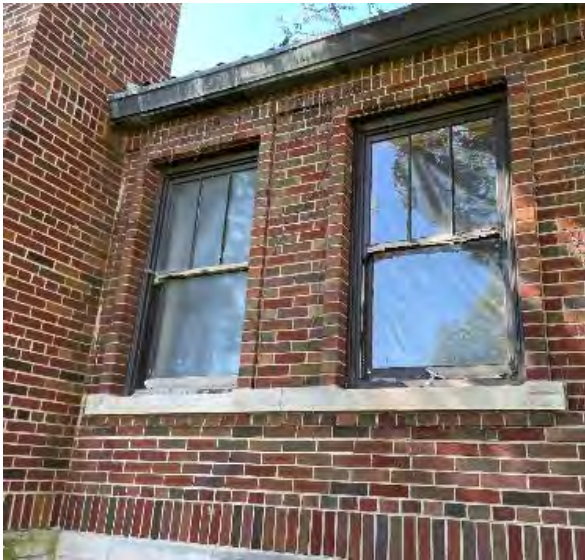
3.2.3.1 Existing Double Hung windows in poor condition

3.2.3. Fenestration System			
Critical		\$0.00	
	At the back of house spaces, provide new thermally broken, insulated double hung windows. Assume 20 windows.		
	At the Narthex and Nave, repair the broken stained glass. Assume 115 SF		
	At the Narthex stairwell to second floor, provide new thermally broken, insulated casement windows with frosted glazing panels. Assume 6 windows		
Non-Critical			\$0.00

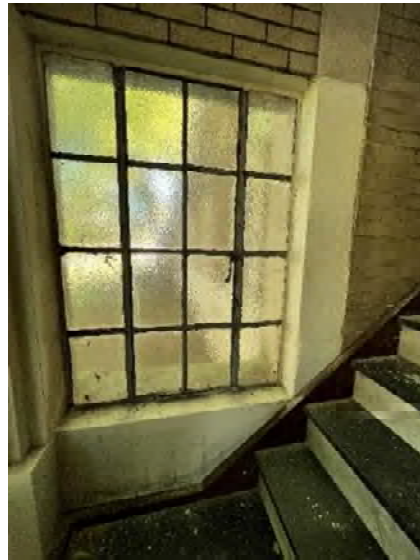
3.2.3.2 Existing divided light casement windows in poor condition

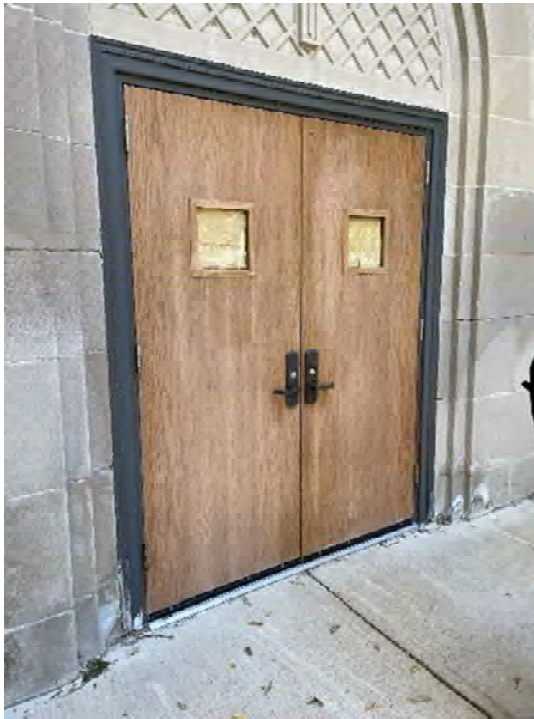
3.2.4.1 Main Entry Door, Hardware in fair condition but glazing is damaged.

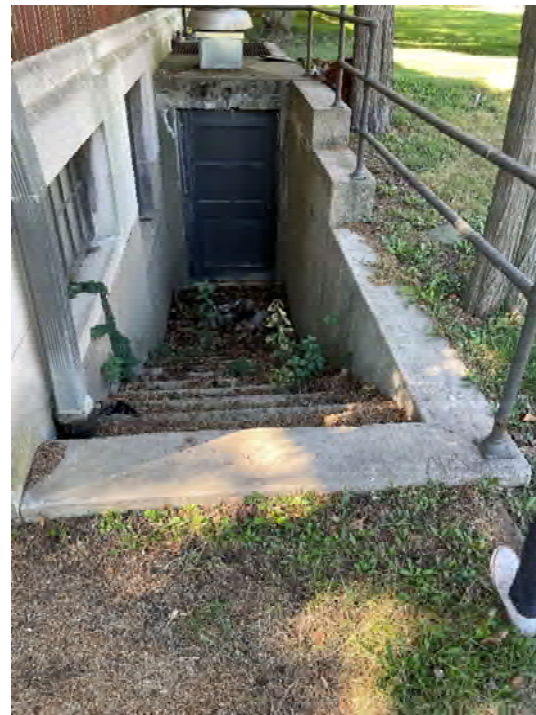
3.2.4.2 Basement doors are in poor condition and past their usable life

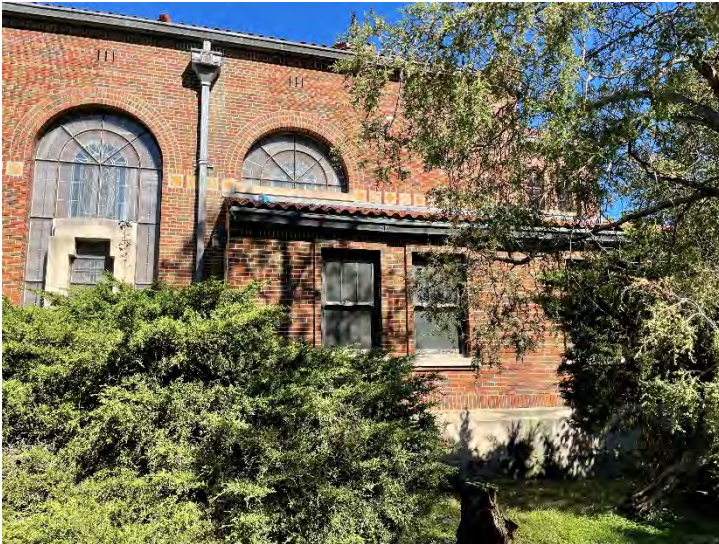
3.2.7.1 Given the interior finishes, it should assume roofs are in poor condition when viewed from the ground.

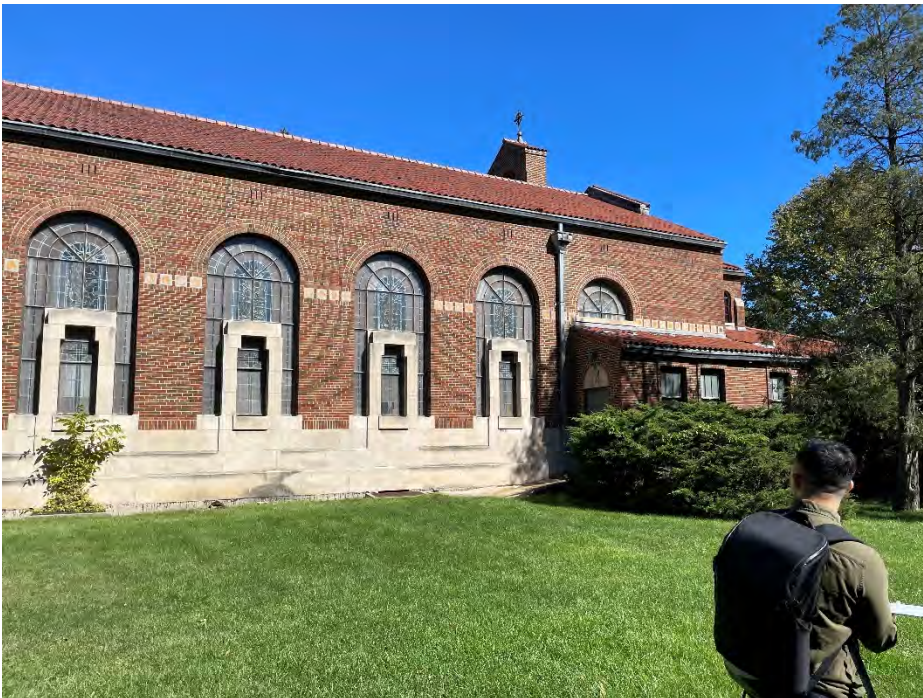
3.2.7.2 Given the interior finishes, it should assume roofs are in poor condition when viewed from the ground.

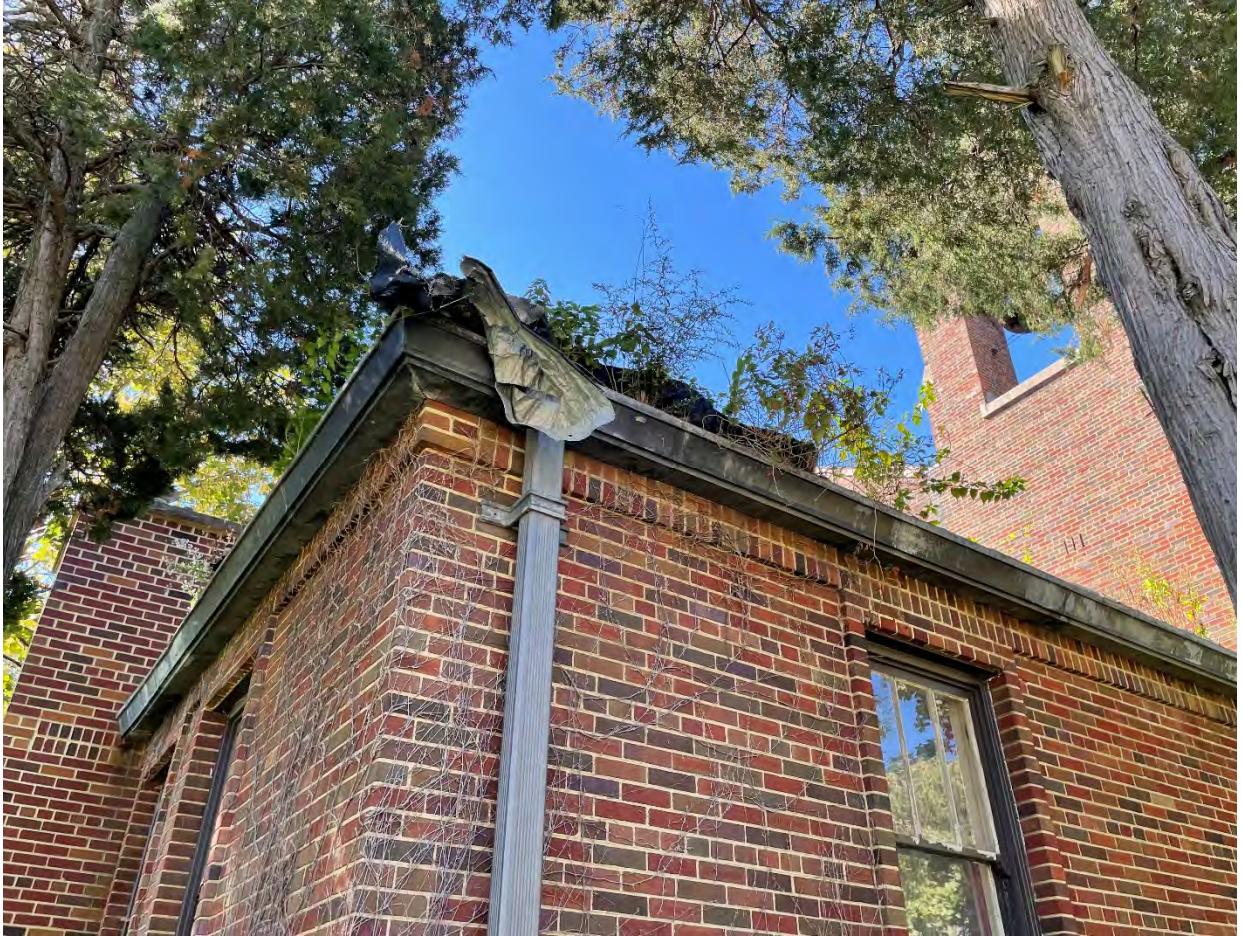
3.2.7.3 Overgrowth and damaged sheet metal on north west corner of the building

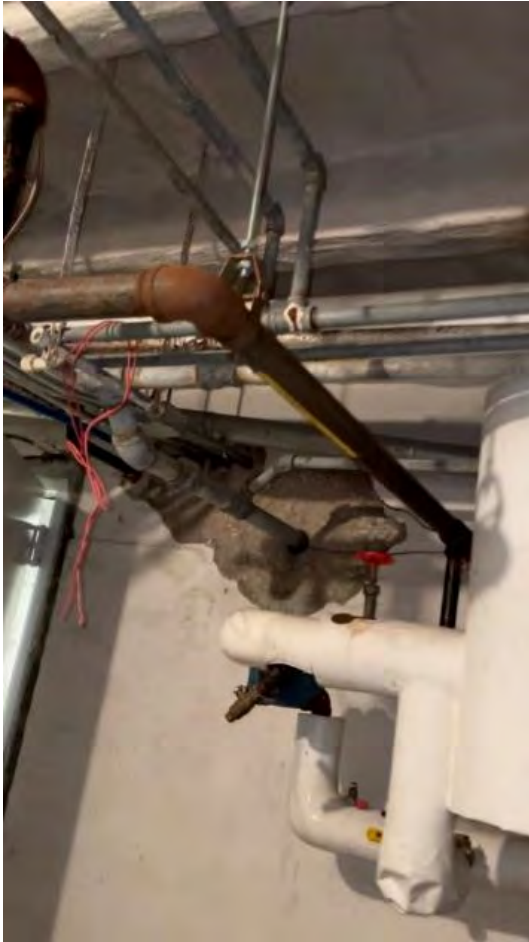
3.3.1.1. Galvanized domestic water piping is present throughout the basement. Piping is uninsulated.

3.3.1 Plumbing			
Critical		\$0.00	
	Replace plumbing fixtures throughout the building		
Non-Critical			\$0.00
	Replace galvanized domestic water piping throughout

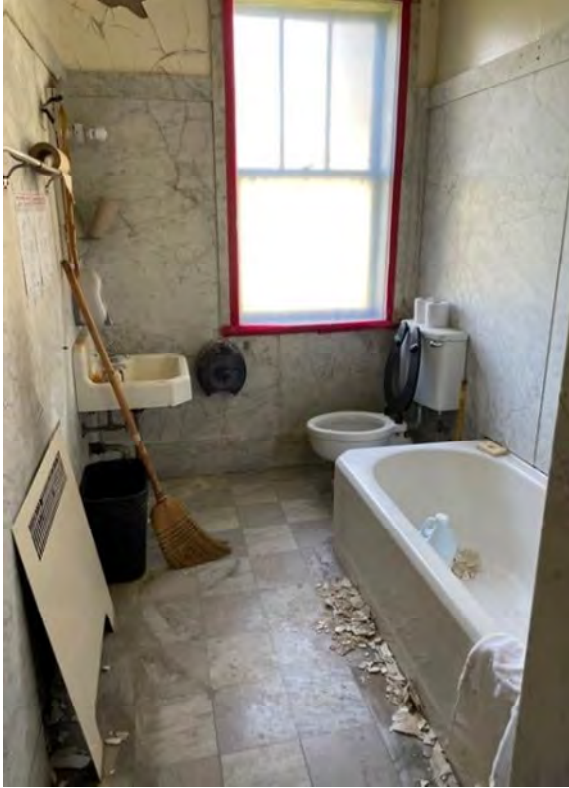
3.3.1.2. An existing bathroom on the first floor. All fixtures warrant replacement.

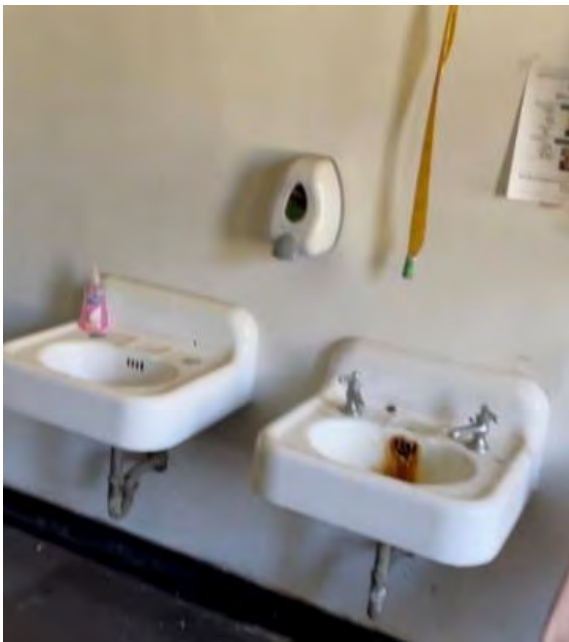
3.3.1.3 Existing lavatories in a first-floor bathroom. All fixtures warrant replacement.

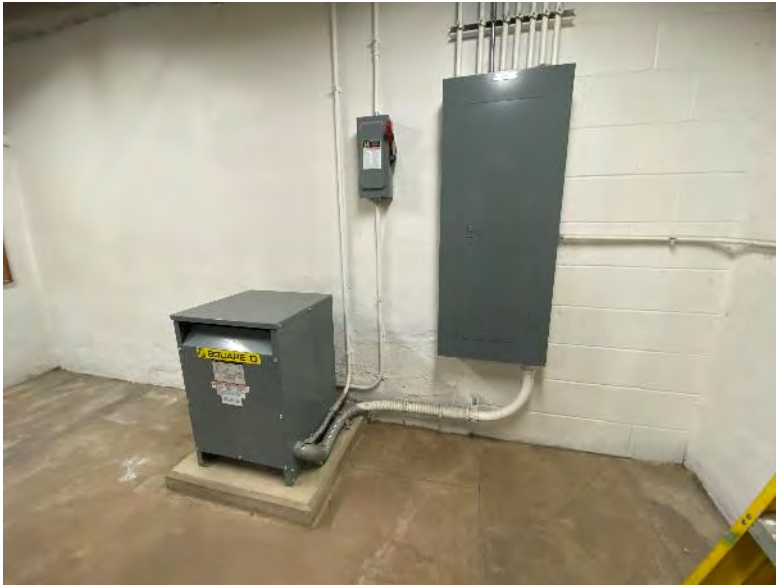
**3.3.4.2.1** As mentioned in the executive summary The second panelboard without a tag is located on the main level. The 225A 208 volt, 3-phase, 4-wire panelboard is fed from a 45kVA transformer located in a previously allocated electrical room on the lower level. This panel provides power to the lighting and all general system and receptacles on the main level of the chapel. It is recommended a panel director is completed and fixed to the interior of the panel in accordance with Chicago Electrical Code 408.4.

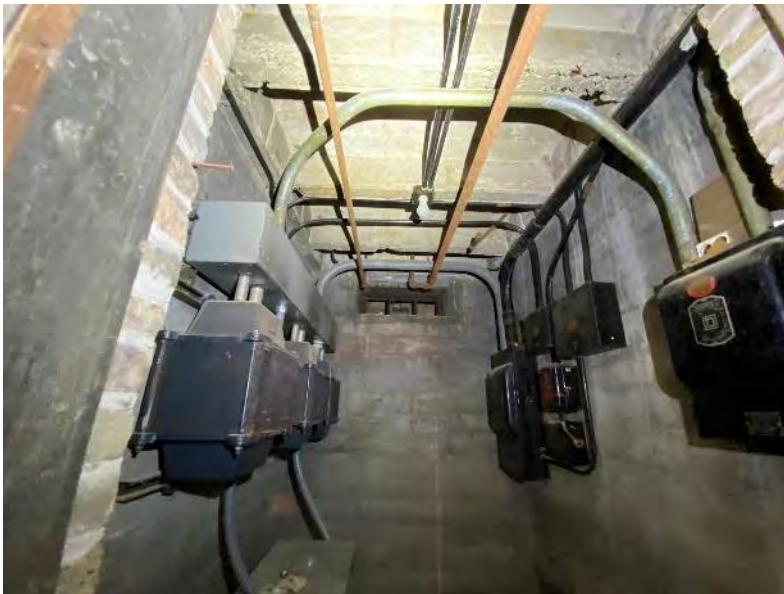
3.3.4.4.2.3 Electrical Room with insufficient clearances and out of date/non-function equipment.

The electrical room located on the lower level is crowded and contains obsolete equipment which has been abandoned in place. It is recommended that abandoned equipment be removed to ensure proper working clearances are met for the working equipment within the space.

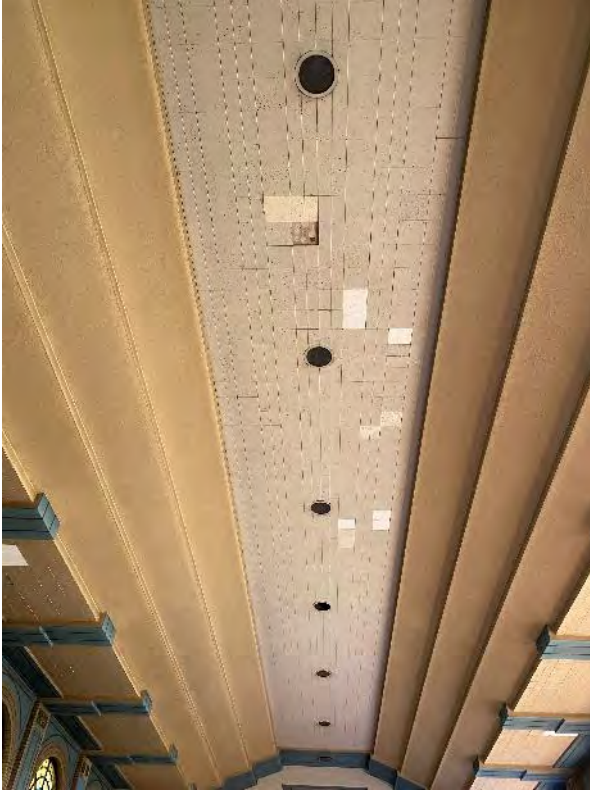
3.3.4.3.1 View of the ceiling with no emergency light fixtures, emergency service, or emergency battery units were observed.

No emergency light fixtures, emergency service, or emergency battery units were observed in the building. New emergency battery units, fixtures with integral batteries, or a central Chicago approved auxiliary source of power (such as generator or UPS) is required for the building to meet all current requirements of the Chicago Electrical Code Article 700.

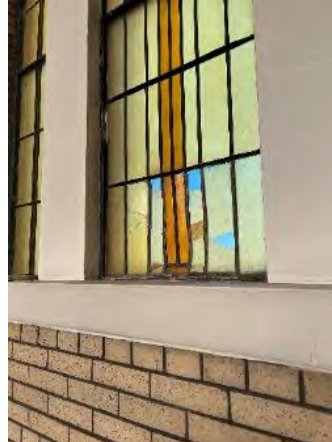
3.4.1.1.2 Stained glass is broken and not in good condition.

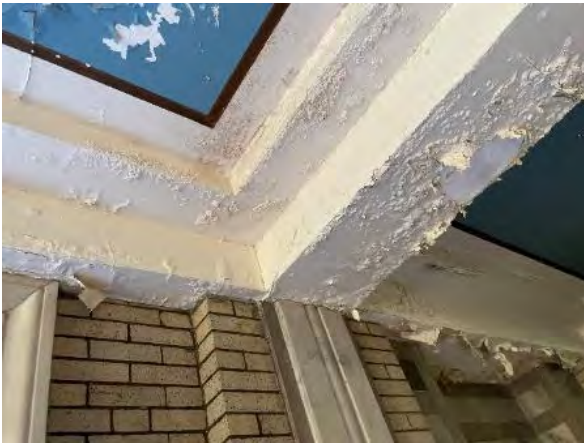
3.4.1.1.3 Plaster ceiling in the vestibule is not in good condition.

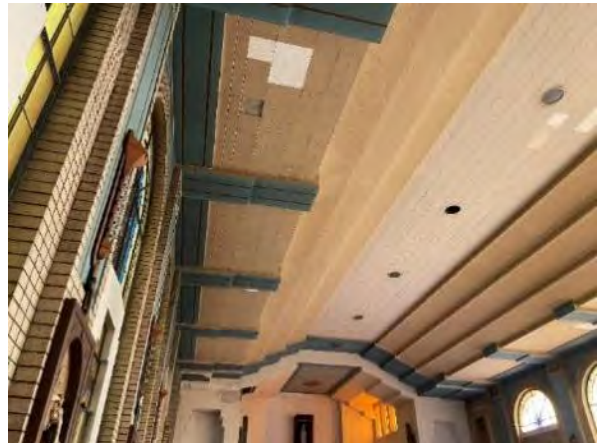
3.4.1.1.4 Ceiling tiles are missing in main hall ceiling.

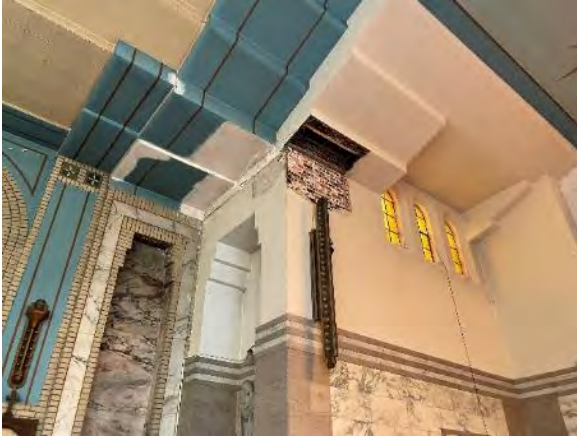
3.4.1.1.5 Ceiling is missing.

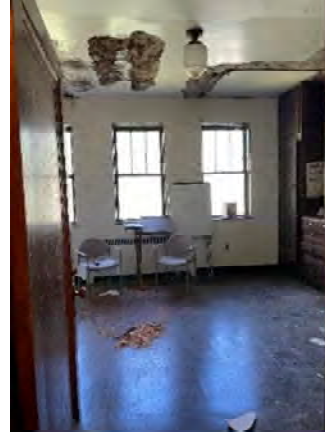
3.4.1.1.6 Ceiling in the outfit room is damaged by moisture.

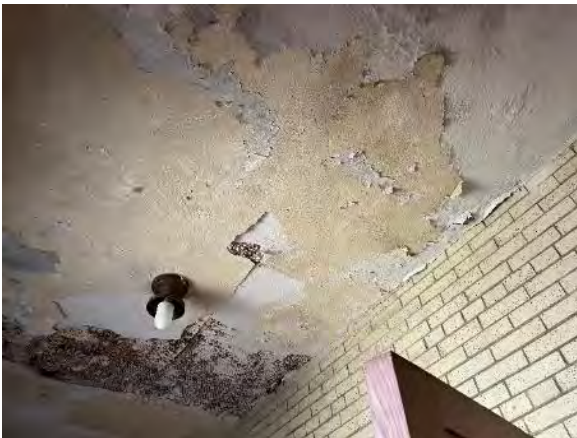
3.4.1.1.7 Ceiling in exit hall is damaged by moisture.

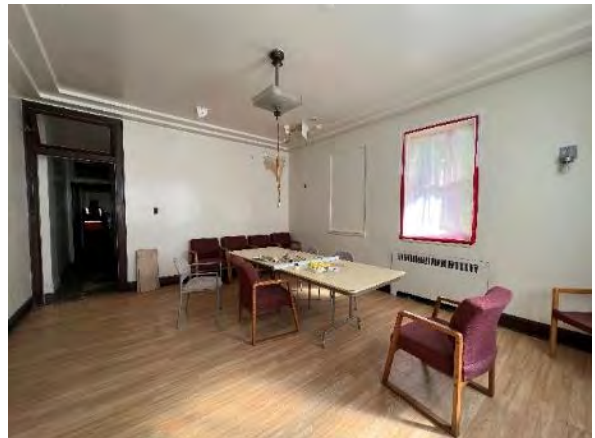
3.4.1.1.8 Office floor is in good condition. Ceiling shows damaged by moisture in the corner.

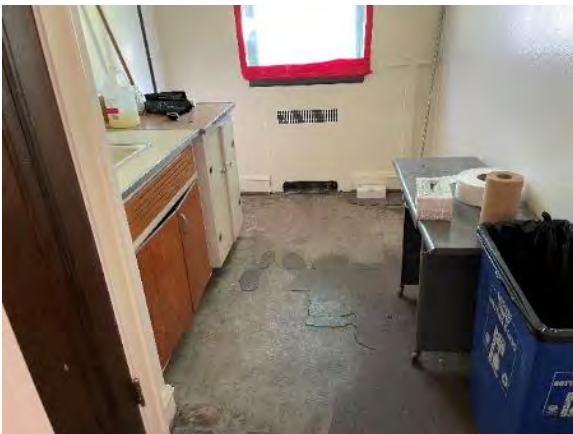
3.4.1.1.9 Floor tiles are missing in the pantry.

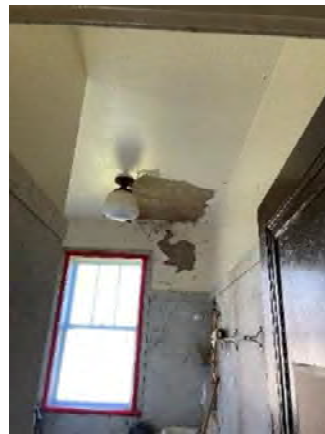
3.4.1.1.10 Ceiling is damaged by moisture in the bathroom.

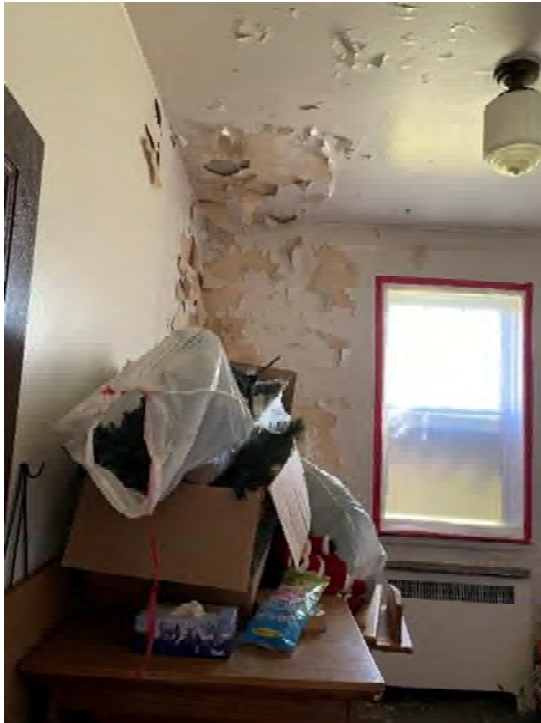
3.4.1.1.11 Ceiling and dry wall in bedroom shows damaged by moisture.

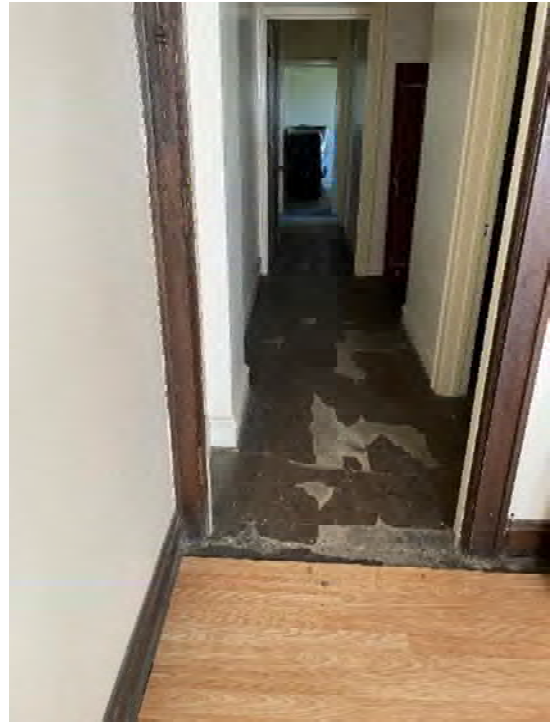
3.4.1.1.12 Floor tiles are missing in the hall way from office to bedrooms.

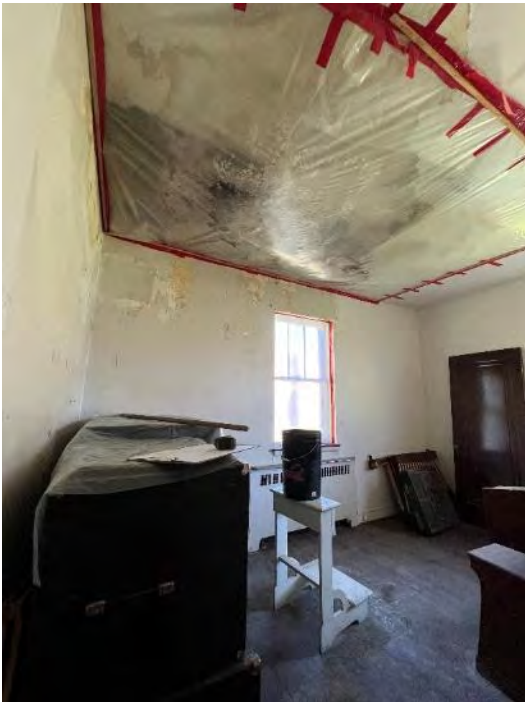
3.4.1.1.13 Room is damaged by water leaking through roof.

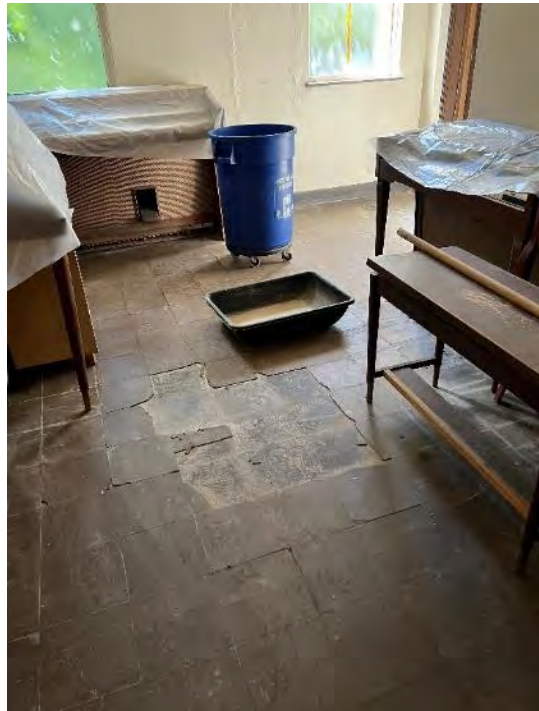
3.4.1.1.14 Floor tiles are missing.

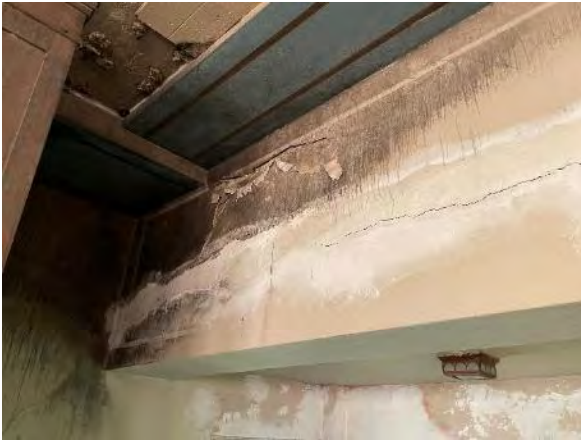
3.4.1.1.15 Concrete beam is damaged by moisture, potential mold growth.

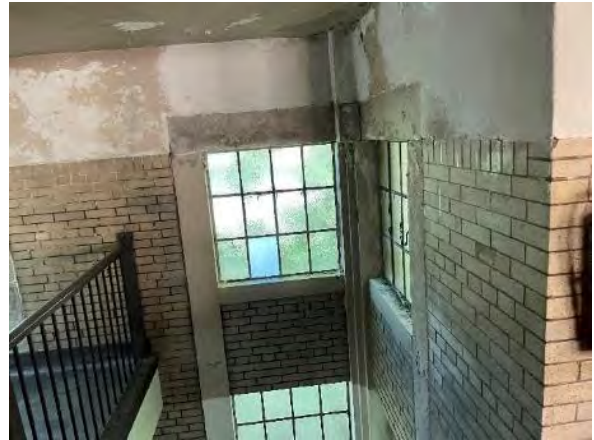
3.4.1.1.16 Window sills are damaged by moisture, and show some cracking.

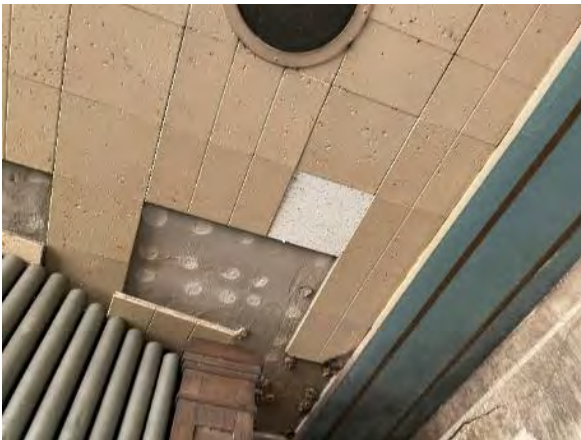
3.4.1.1.17 Ceiling tiles are missing in the choir area.

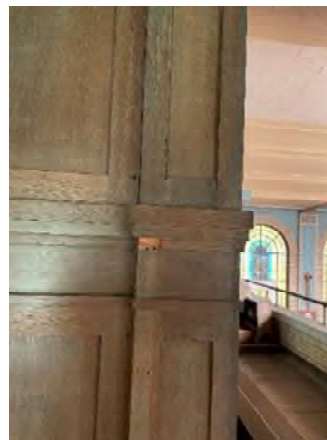
3.4.1.1.18 Some piece of trim on millworks is missing.

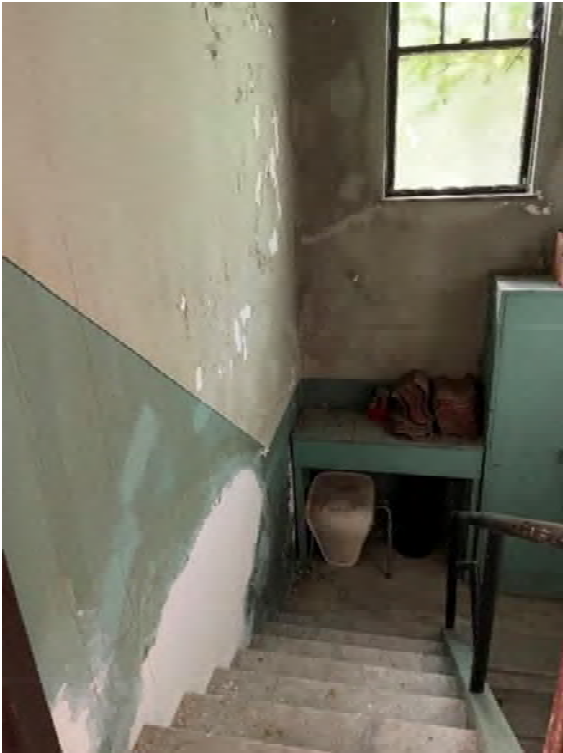
3.4.1.2.1 Stairs down to basement are in good condition; however, it is not ADA compliant

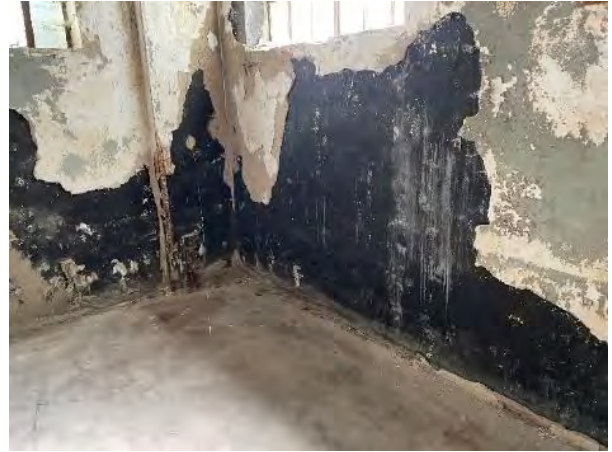
3.4.1.2.2 Basement wall is damaged

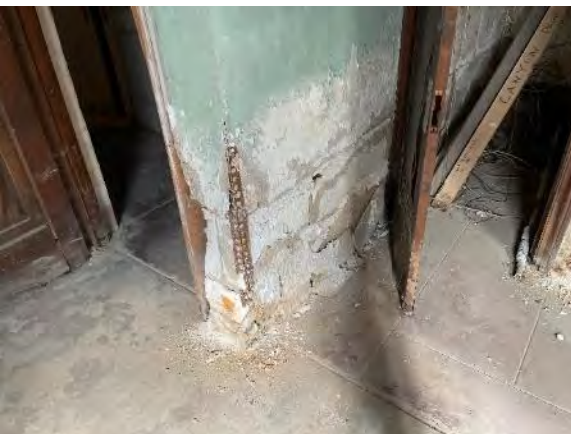
3.4.1.2.3 Basement wall is damaged by moisture

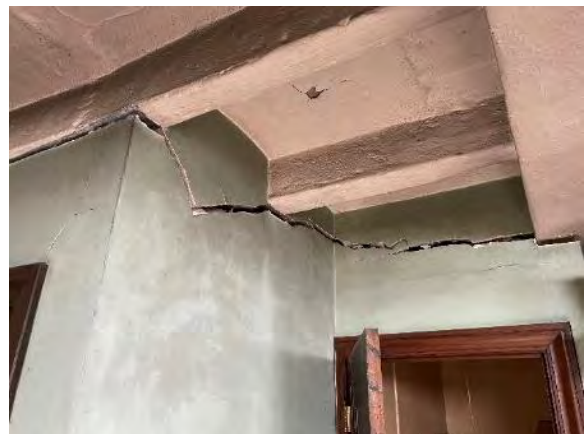
3.4.1.2.4 Wall is cracking.

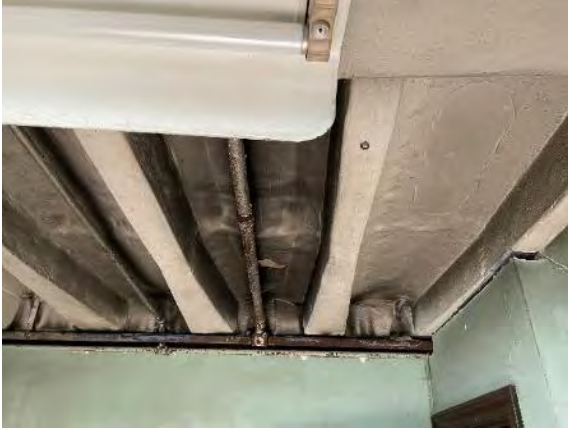
3.4.1.2.5 Basement ceiling and fire proofing is damaged

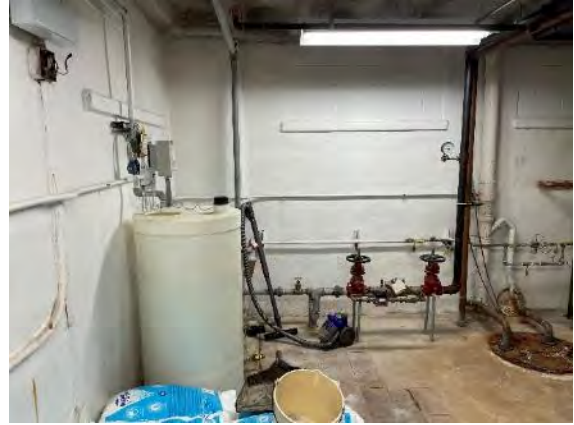
3.4.1.2.6 Basement floor is in good condition. There are couple spots of damage by moisture.

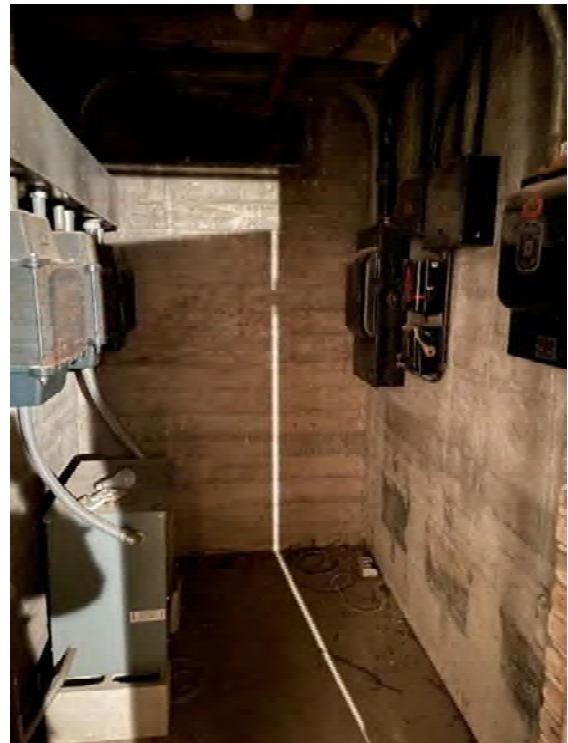
3.4.1.2.8 Dirt and debris built up in basement. Wall showed damaged from moisture.

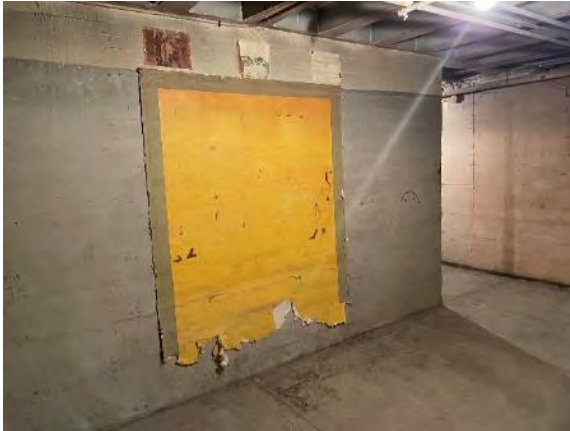
3.4.1.2.9 Dirt and debris built up in basement corridor. Some wall is damaged from moisture.

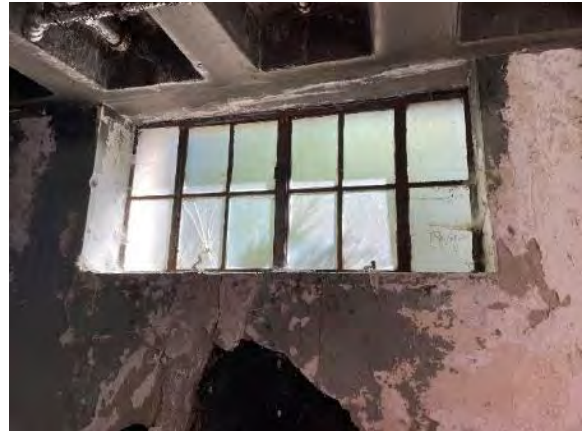
3.4.1.2.10 Windows in the basement are in poor condition.
