Public Building Commission
North Park Village – Gymnasium Building B
Chicago, IL

Preliminary Property Condition Assessment
October 21, 2021

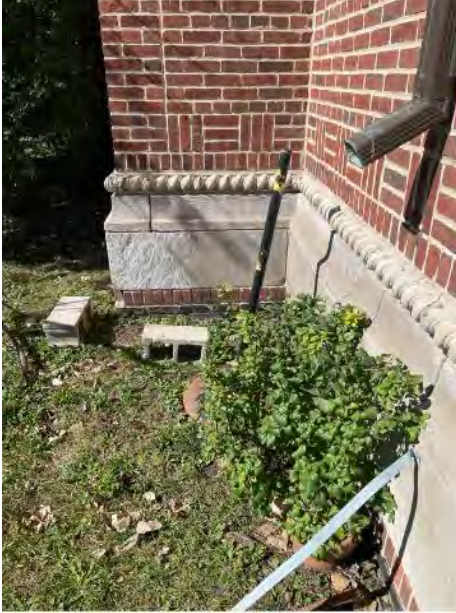
3.1.1. Although overall review of site and storm drainage was not part of the scope of this report. There are several locations where downspouts are damaged or not draining properly, causing stormwater to back flow onto the masonry façade.

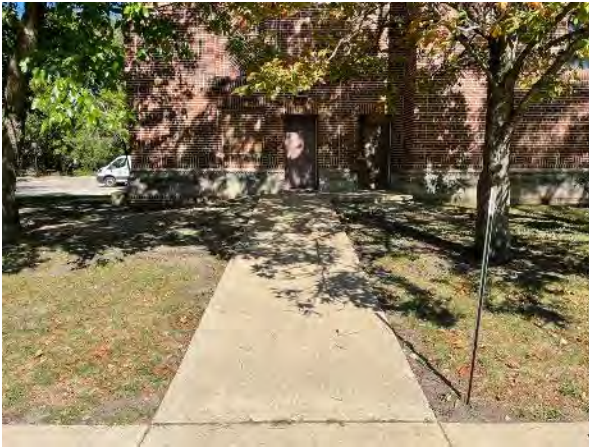
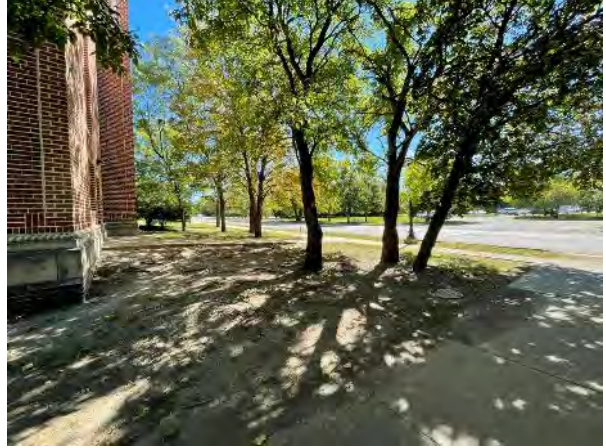
3.1.2.1 Southwestern frontage landscape area has settled and eroded.

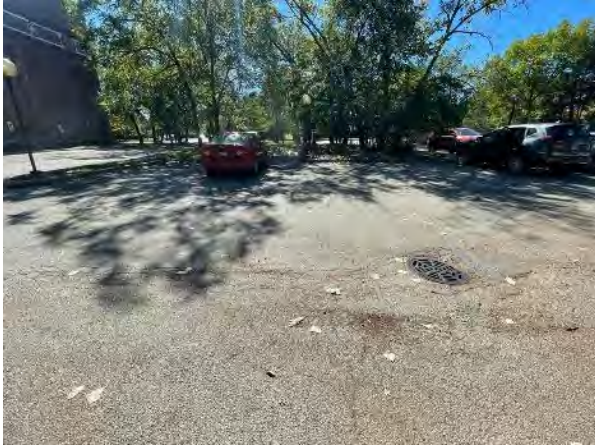
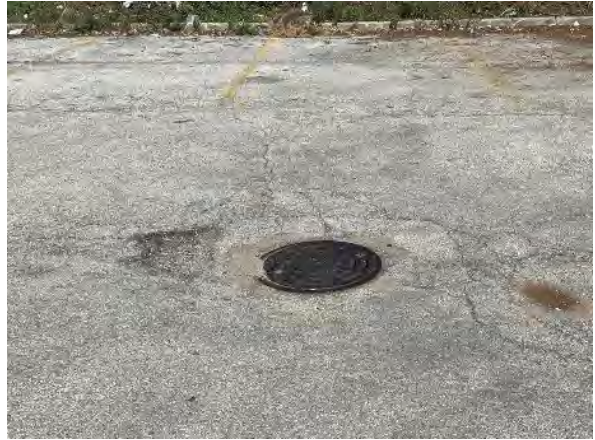
3.1.3.4 Catch basis have settled in parking areas

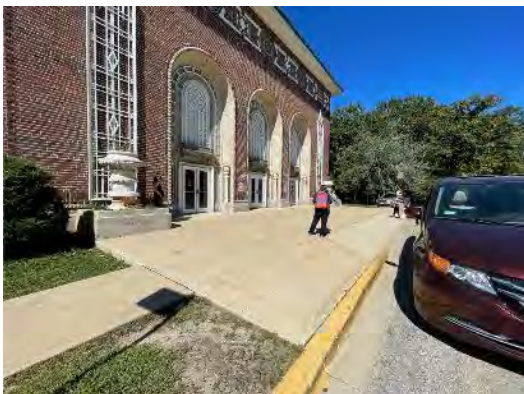
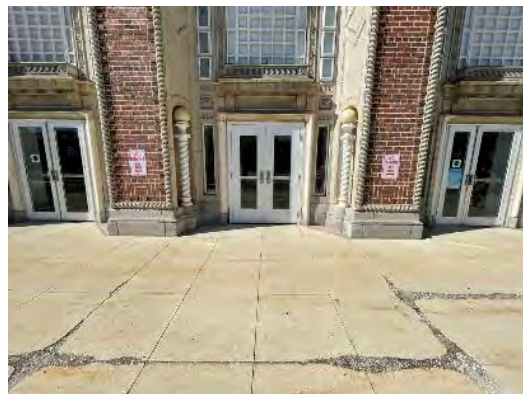
3.1.4.2 Eastern, concrete entrance plaza is deteriorated. Associated curb ramp is non-conforming in the vehicular drop-off area

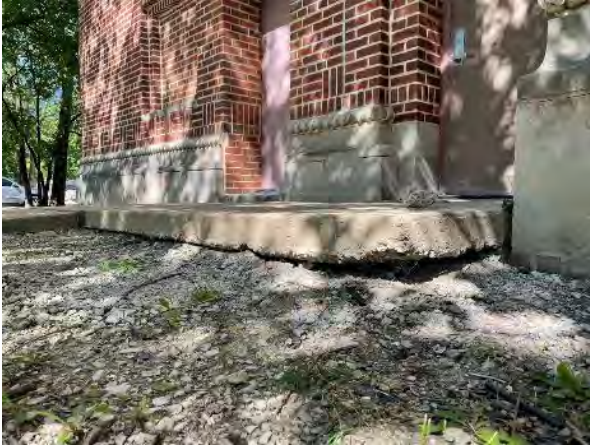
3.1.4.3 Settlement of earth and washout are compromising the sidewalk at the southern entrance.

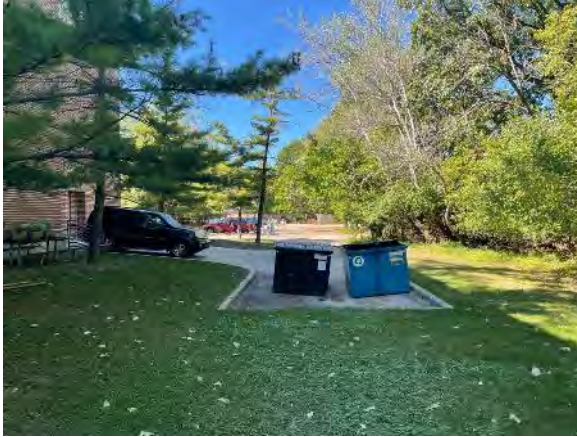
3.1.5.1 Trash Enclosure missing from Trash Area

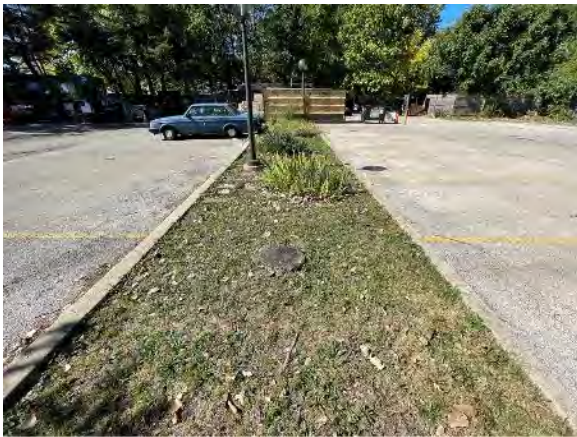
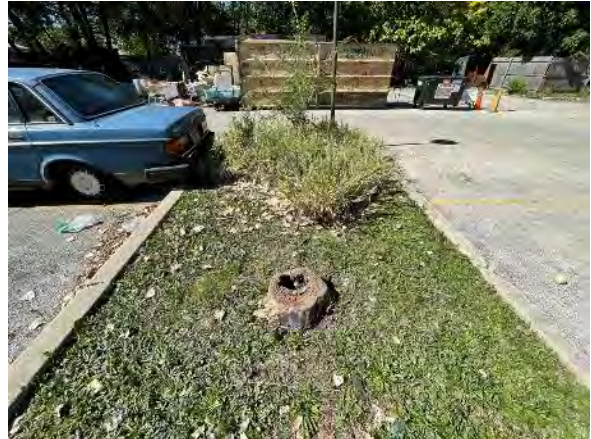
3.1.5.2 Two trees are missing from center parking lot island

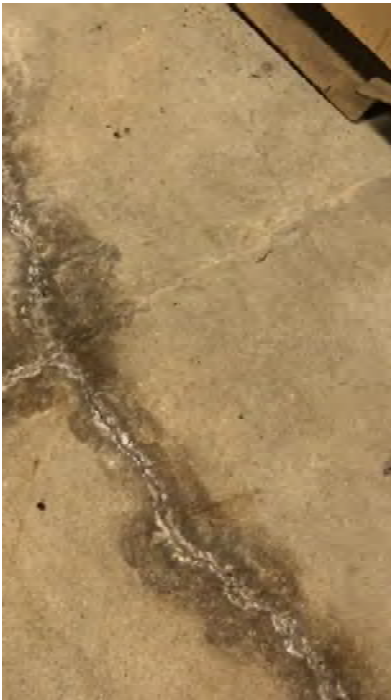
3.2.1.1 Observed interior slab-on-grade in basement mechanical room appears sound with some minor cracking.

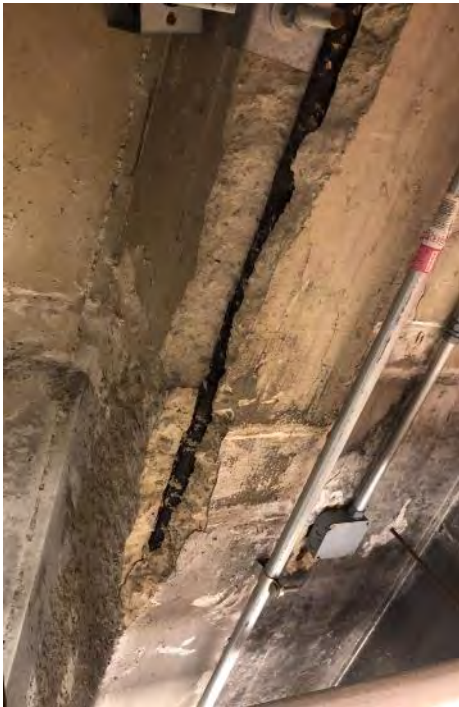
3.2.2.1. Concrete beam with spalling

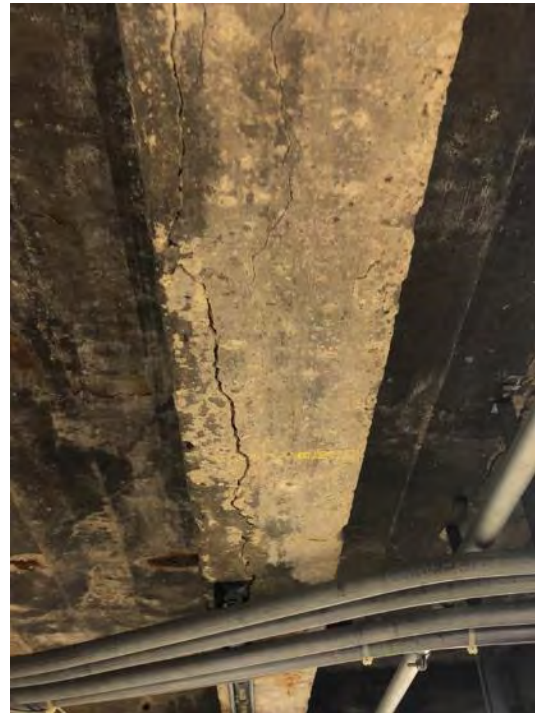
3.2.2.2 Concrete beam with large crack

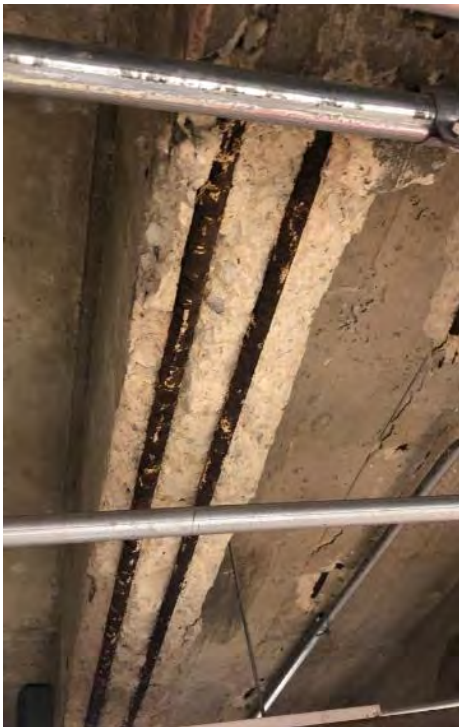
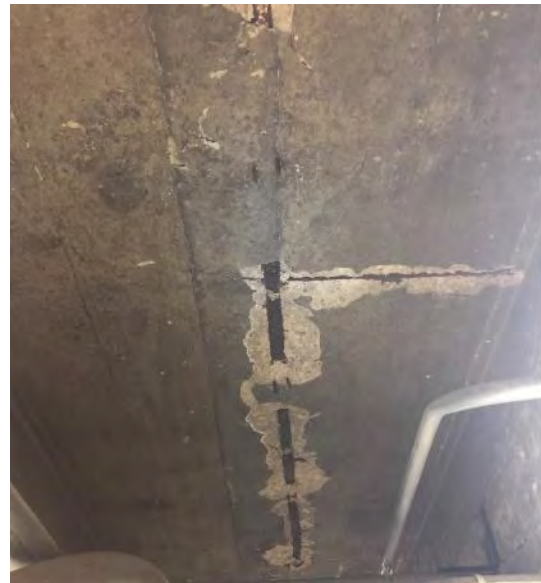
3.2.2.3. Concrete beam with spalling

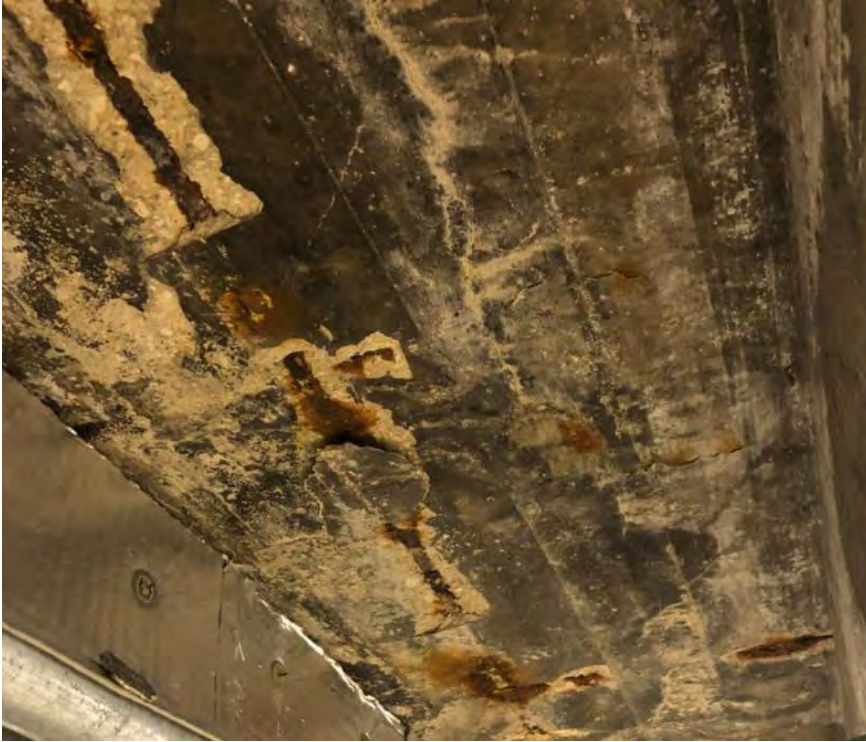
3.2.2.4. Concrete slab with concrete spalling

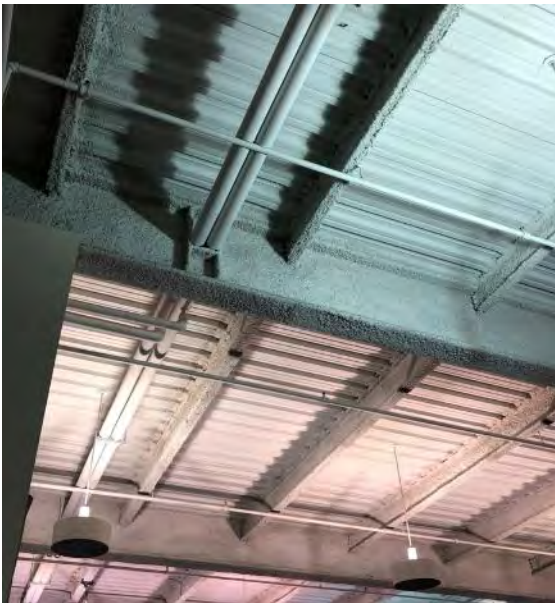
3.2.2.5. Concrete slab with concrete spalling

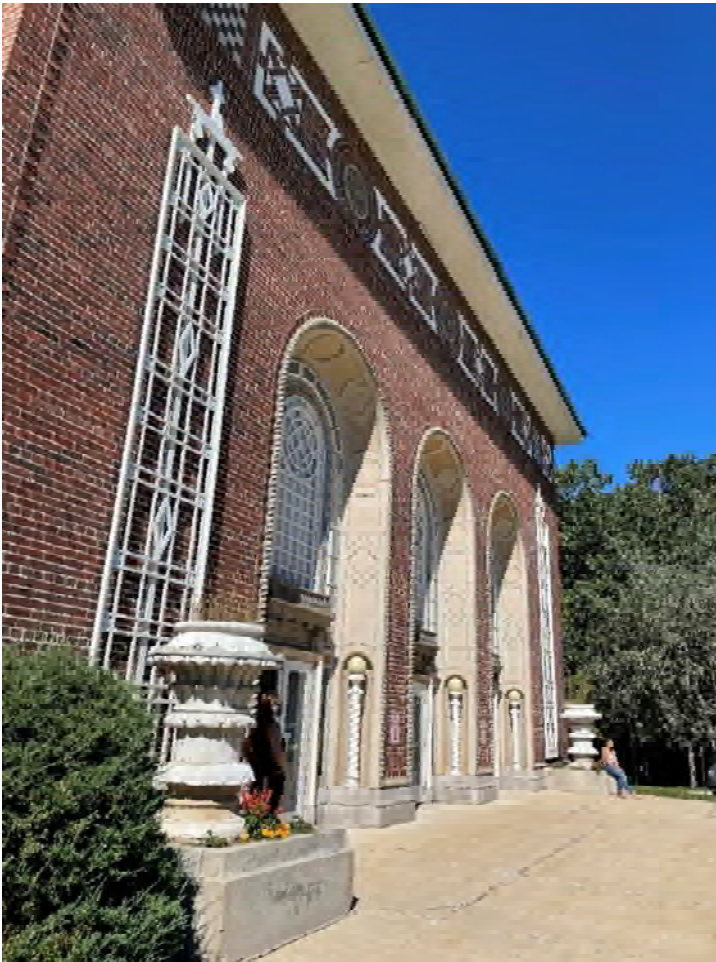
3.2.3.1 Masonry is in state of disrepair and improper tuckpointing has occurred in the past.

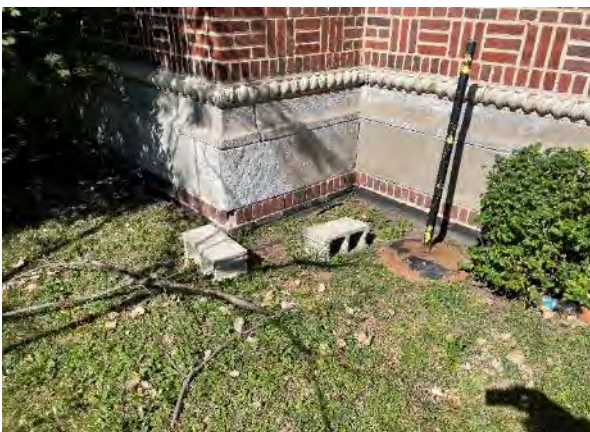
3.2.3.2 Moisture damage to masonry and lime stone décor detail.

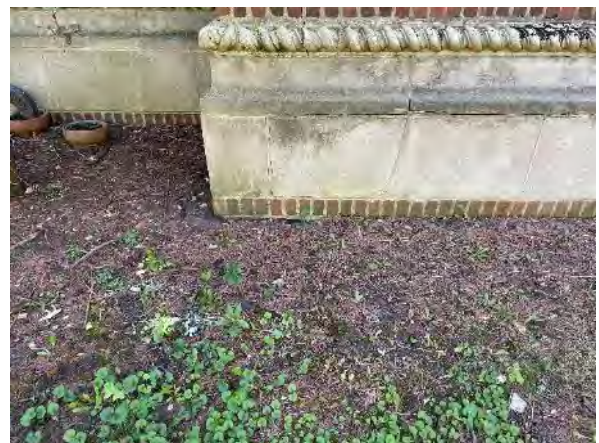
3.2.3.3 Dirt, and Debris build up at perimeter of building.

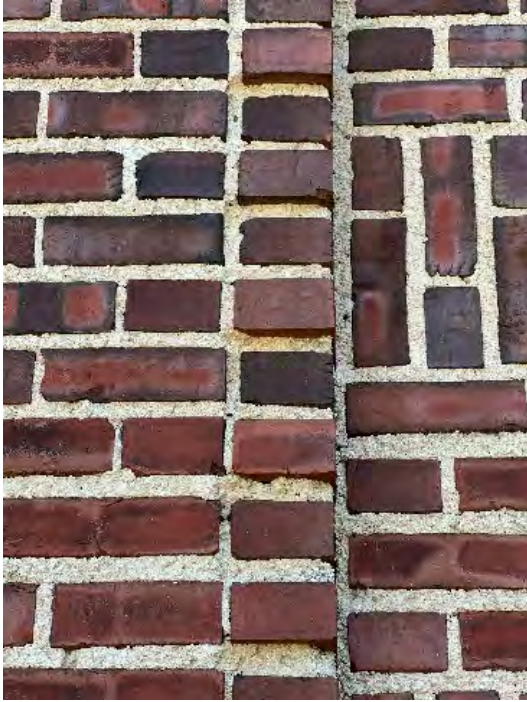
3.2.3.4 Brick shows aging and cracking. Brick's joints are wearing out because of weather condition on site.

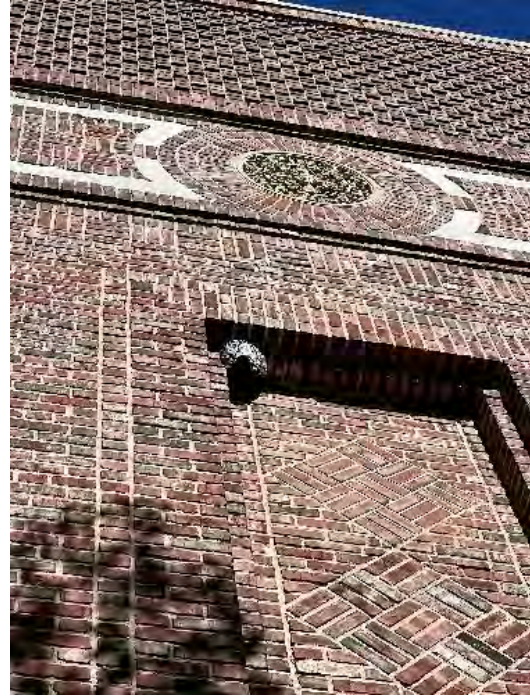
3.2.3.5 Insect nest is building up on brick façade

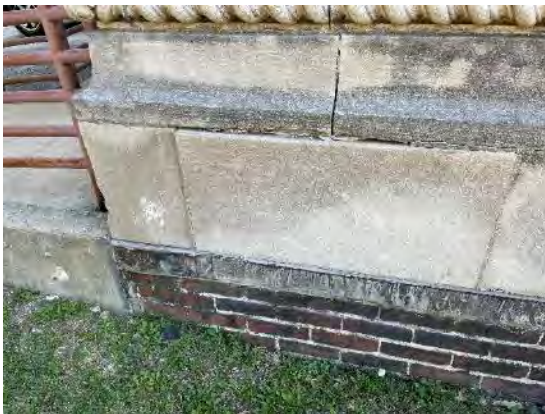
3.2.3.6 Rust/Moisture damage visible at masonry base wall

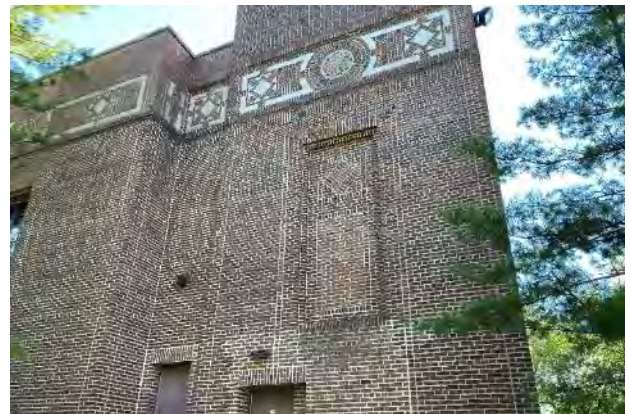
3.2.3.7 Water / Moisture damages masonry's exterior

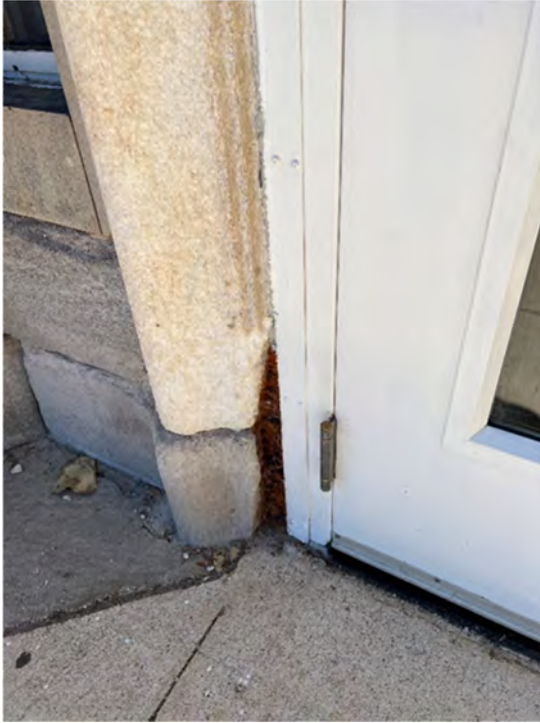
3.2.3.8 Lime stone base got rusted by moisture/
water

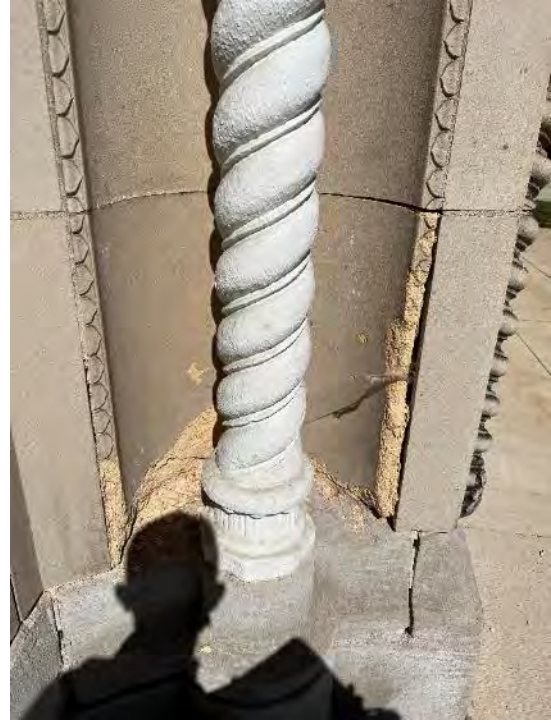
3.2.3.9 Lime stone décor feature got damage by
moisture/ water

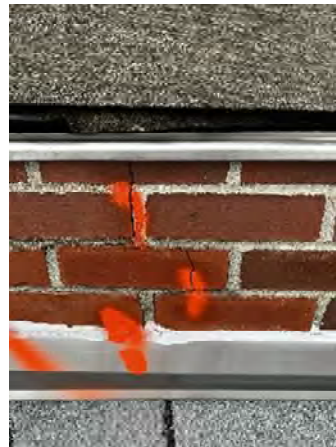
3.2.7.4 Masonry cracking at Masonry Parapet

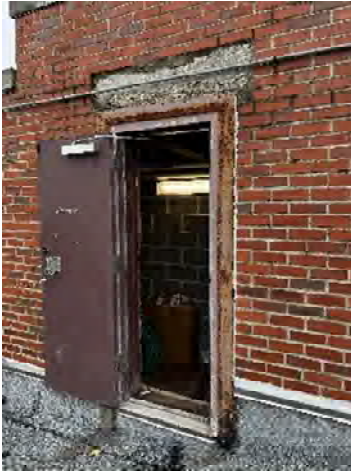
3.2.7.5 Access Door at Roof, door and frame in poor condition

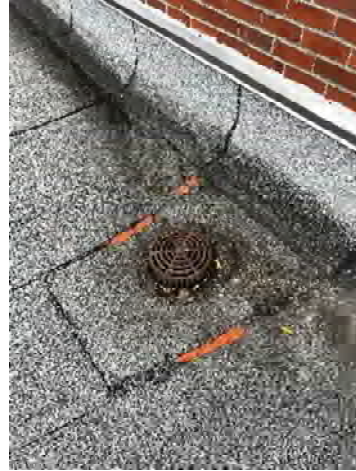
3.2.7.6 Damage to roof membrane at Roof Drain

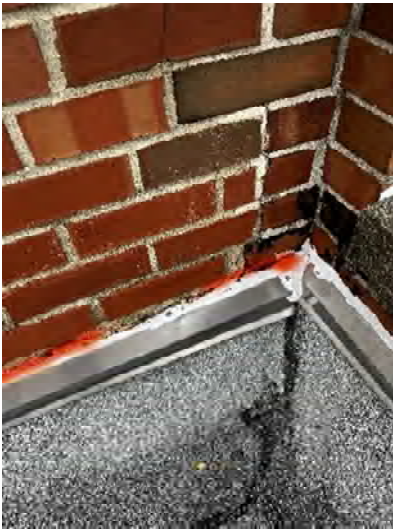
3.2.7.7 Damage to sealant and flashing

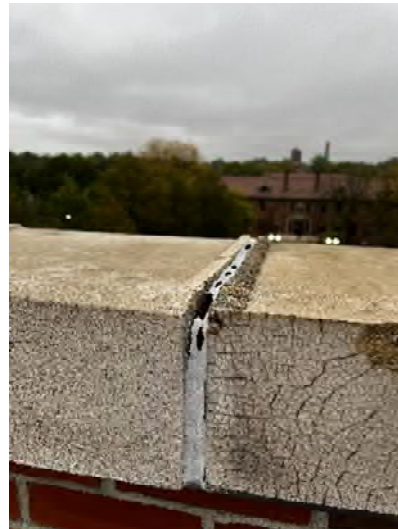
The existing soffit at the roof overhangs is in poor condition, as evidenced by peeling paint, debris build up and organic material growth. This appears due to improperly installed or damaged roofing and gutters installed at the sloped tile roof above.

3.2.7.8 Sealant at Limestone coping

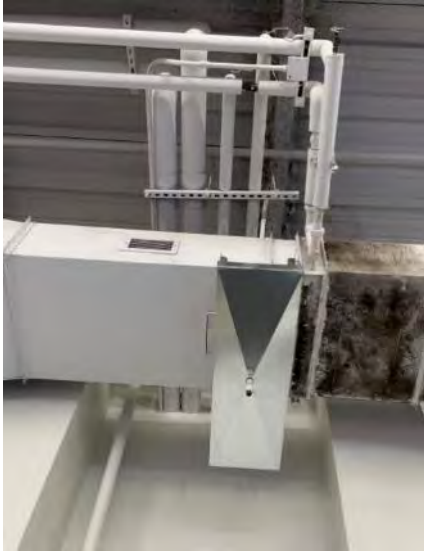
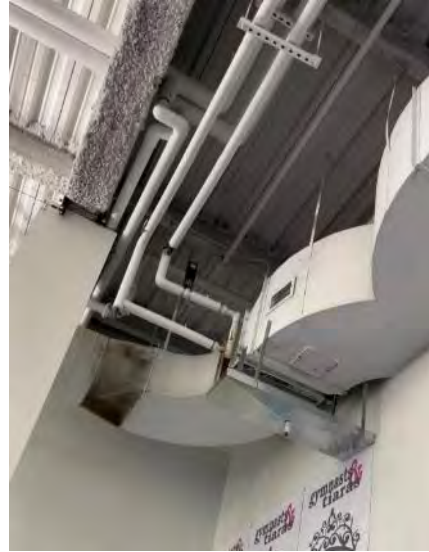
Duct mounted hydronic heating coils were observed on the two air handler systems. There are two heating coils per system, each serving a dedicated façade. Drip pans are located below each heating coil and mold was observed downstream of each heating coil on exposed ductwork/grilles. Reheat coils should be inspected for mold with mold remediated and coils thoroughly cleaned.

3.3.2.4 Existing duct reheater coils with pans and duct mold.

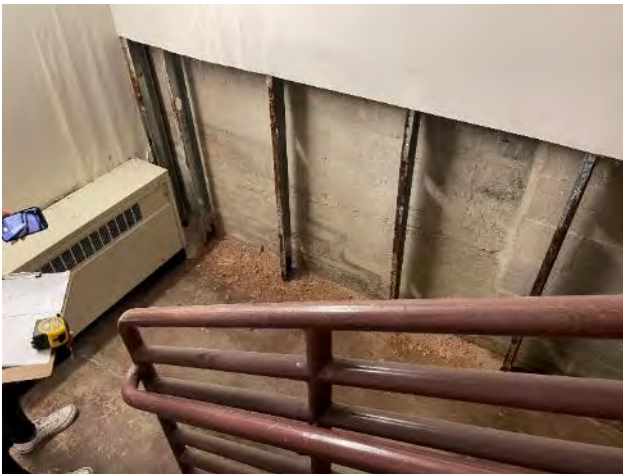
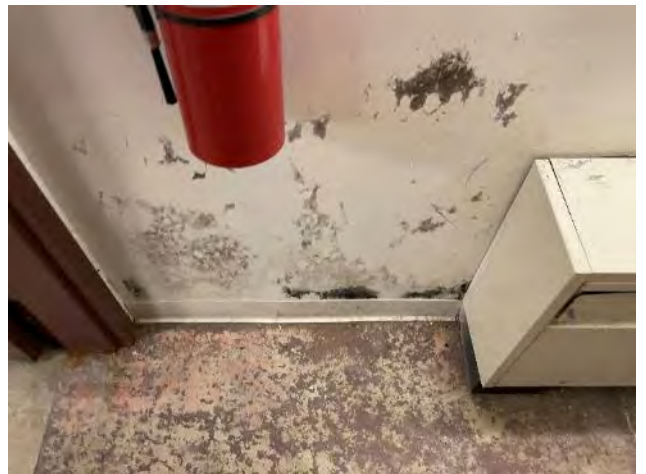
3.4.1.1.1 Dry wall is missing from water damage in the basement. Basement is damp from water penetration.

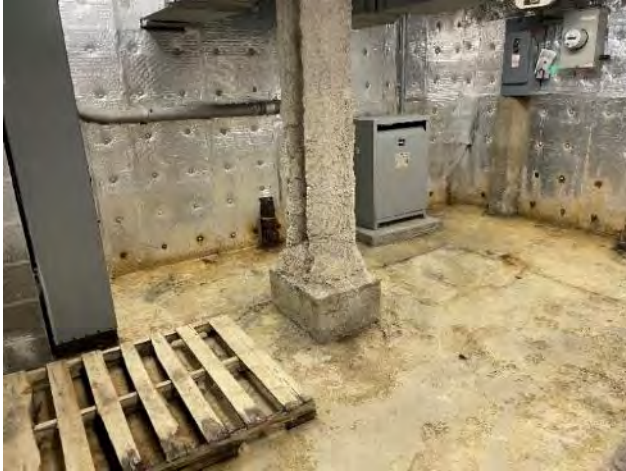
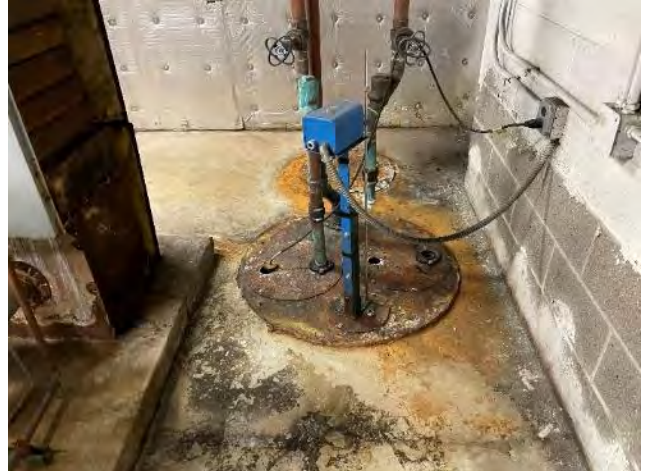
3.4.1.1.2 Floor is damaged by water. Rain water came in through foundation wall and trap in the mechanical room

3.4.1.1.3 Water / Moisture damage mechanical equipment stands.

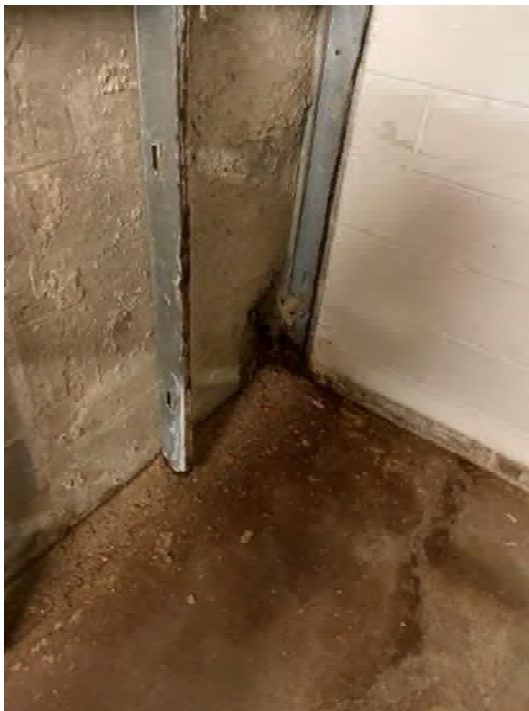
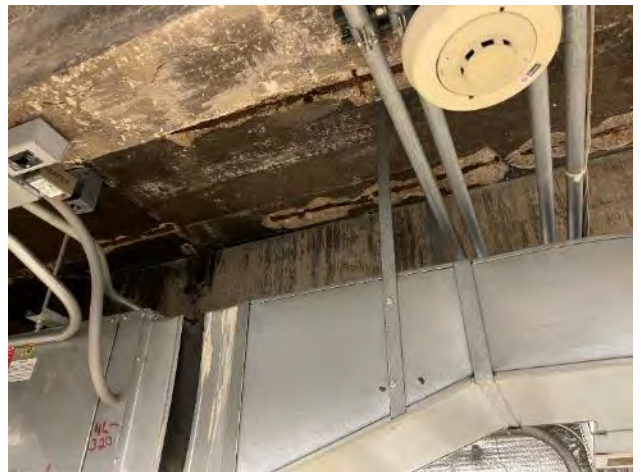
3.4.1.1.4 Foundation wall is damaged by water Leaking through from outside

3.4.1.1.5 Concrete Structure damages and looks damp. Wall shows sign of water leaking.

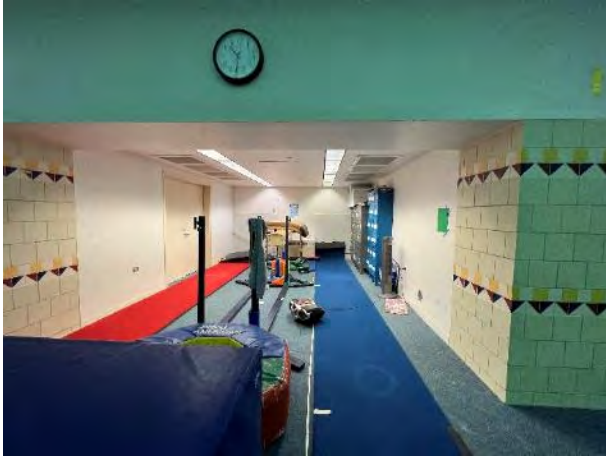
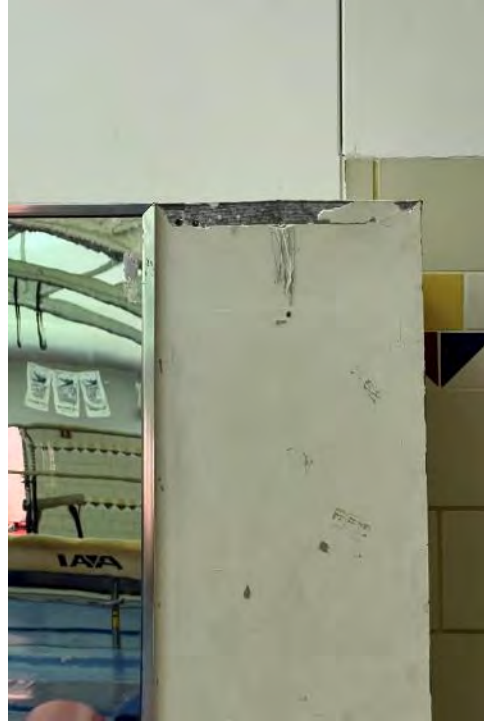
3.4.1.1.10 In the second floor, hall way/ vestibule and locker space now become a storage and extend are for gymnasium equipment.

3.4.1.1.11 Practicing mirror on second floor show damage around the perimeter on dry wall.

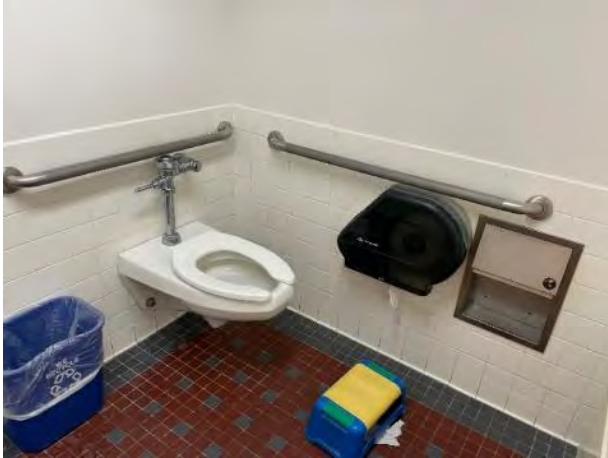
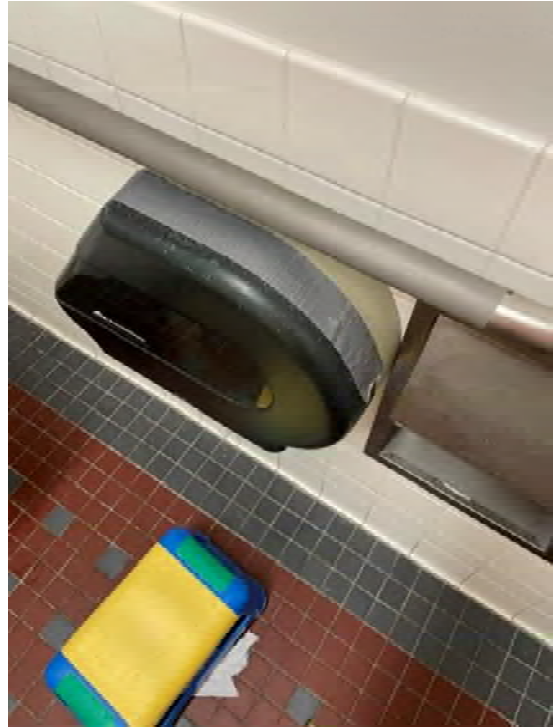
3.4.1.2.3 Toilet and grab bars are in good condition, and need to adjust to meet new ADA code from the city.

3.4.1.2.4 Unisex Restroom is not intended for Children's use

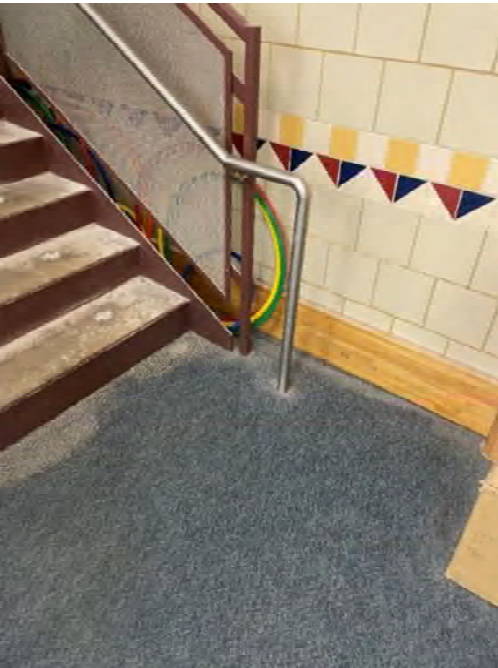
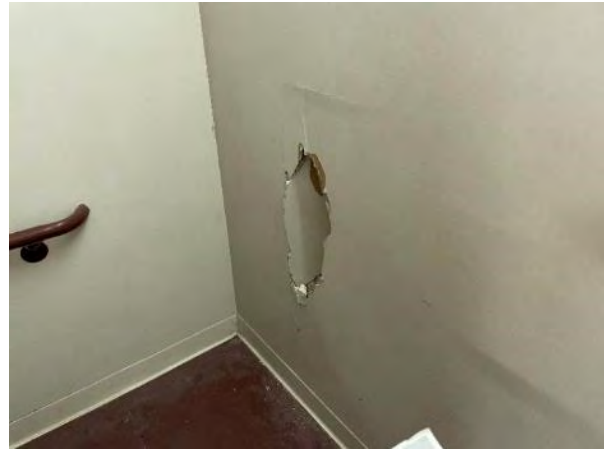
3.4.1.3.3 Hand rail is in a good condition

3.4.1.3.4 Back of house stairs / exist stairs wall show damage.
