January 9, 2026

**Re: DWM Operations Facility
Project No. 04029
4825 West Lawrence Ave, Chicago, Illinois 60630
Ground Penetrating Radar (GPR) Survey Summary Report**

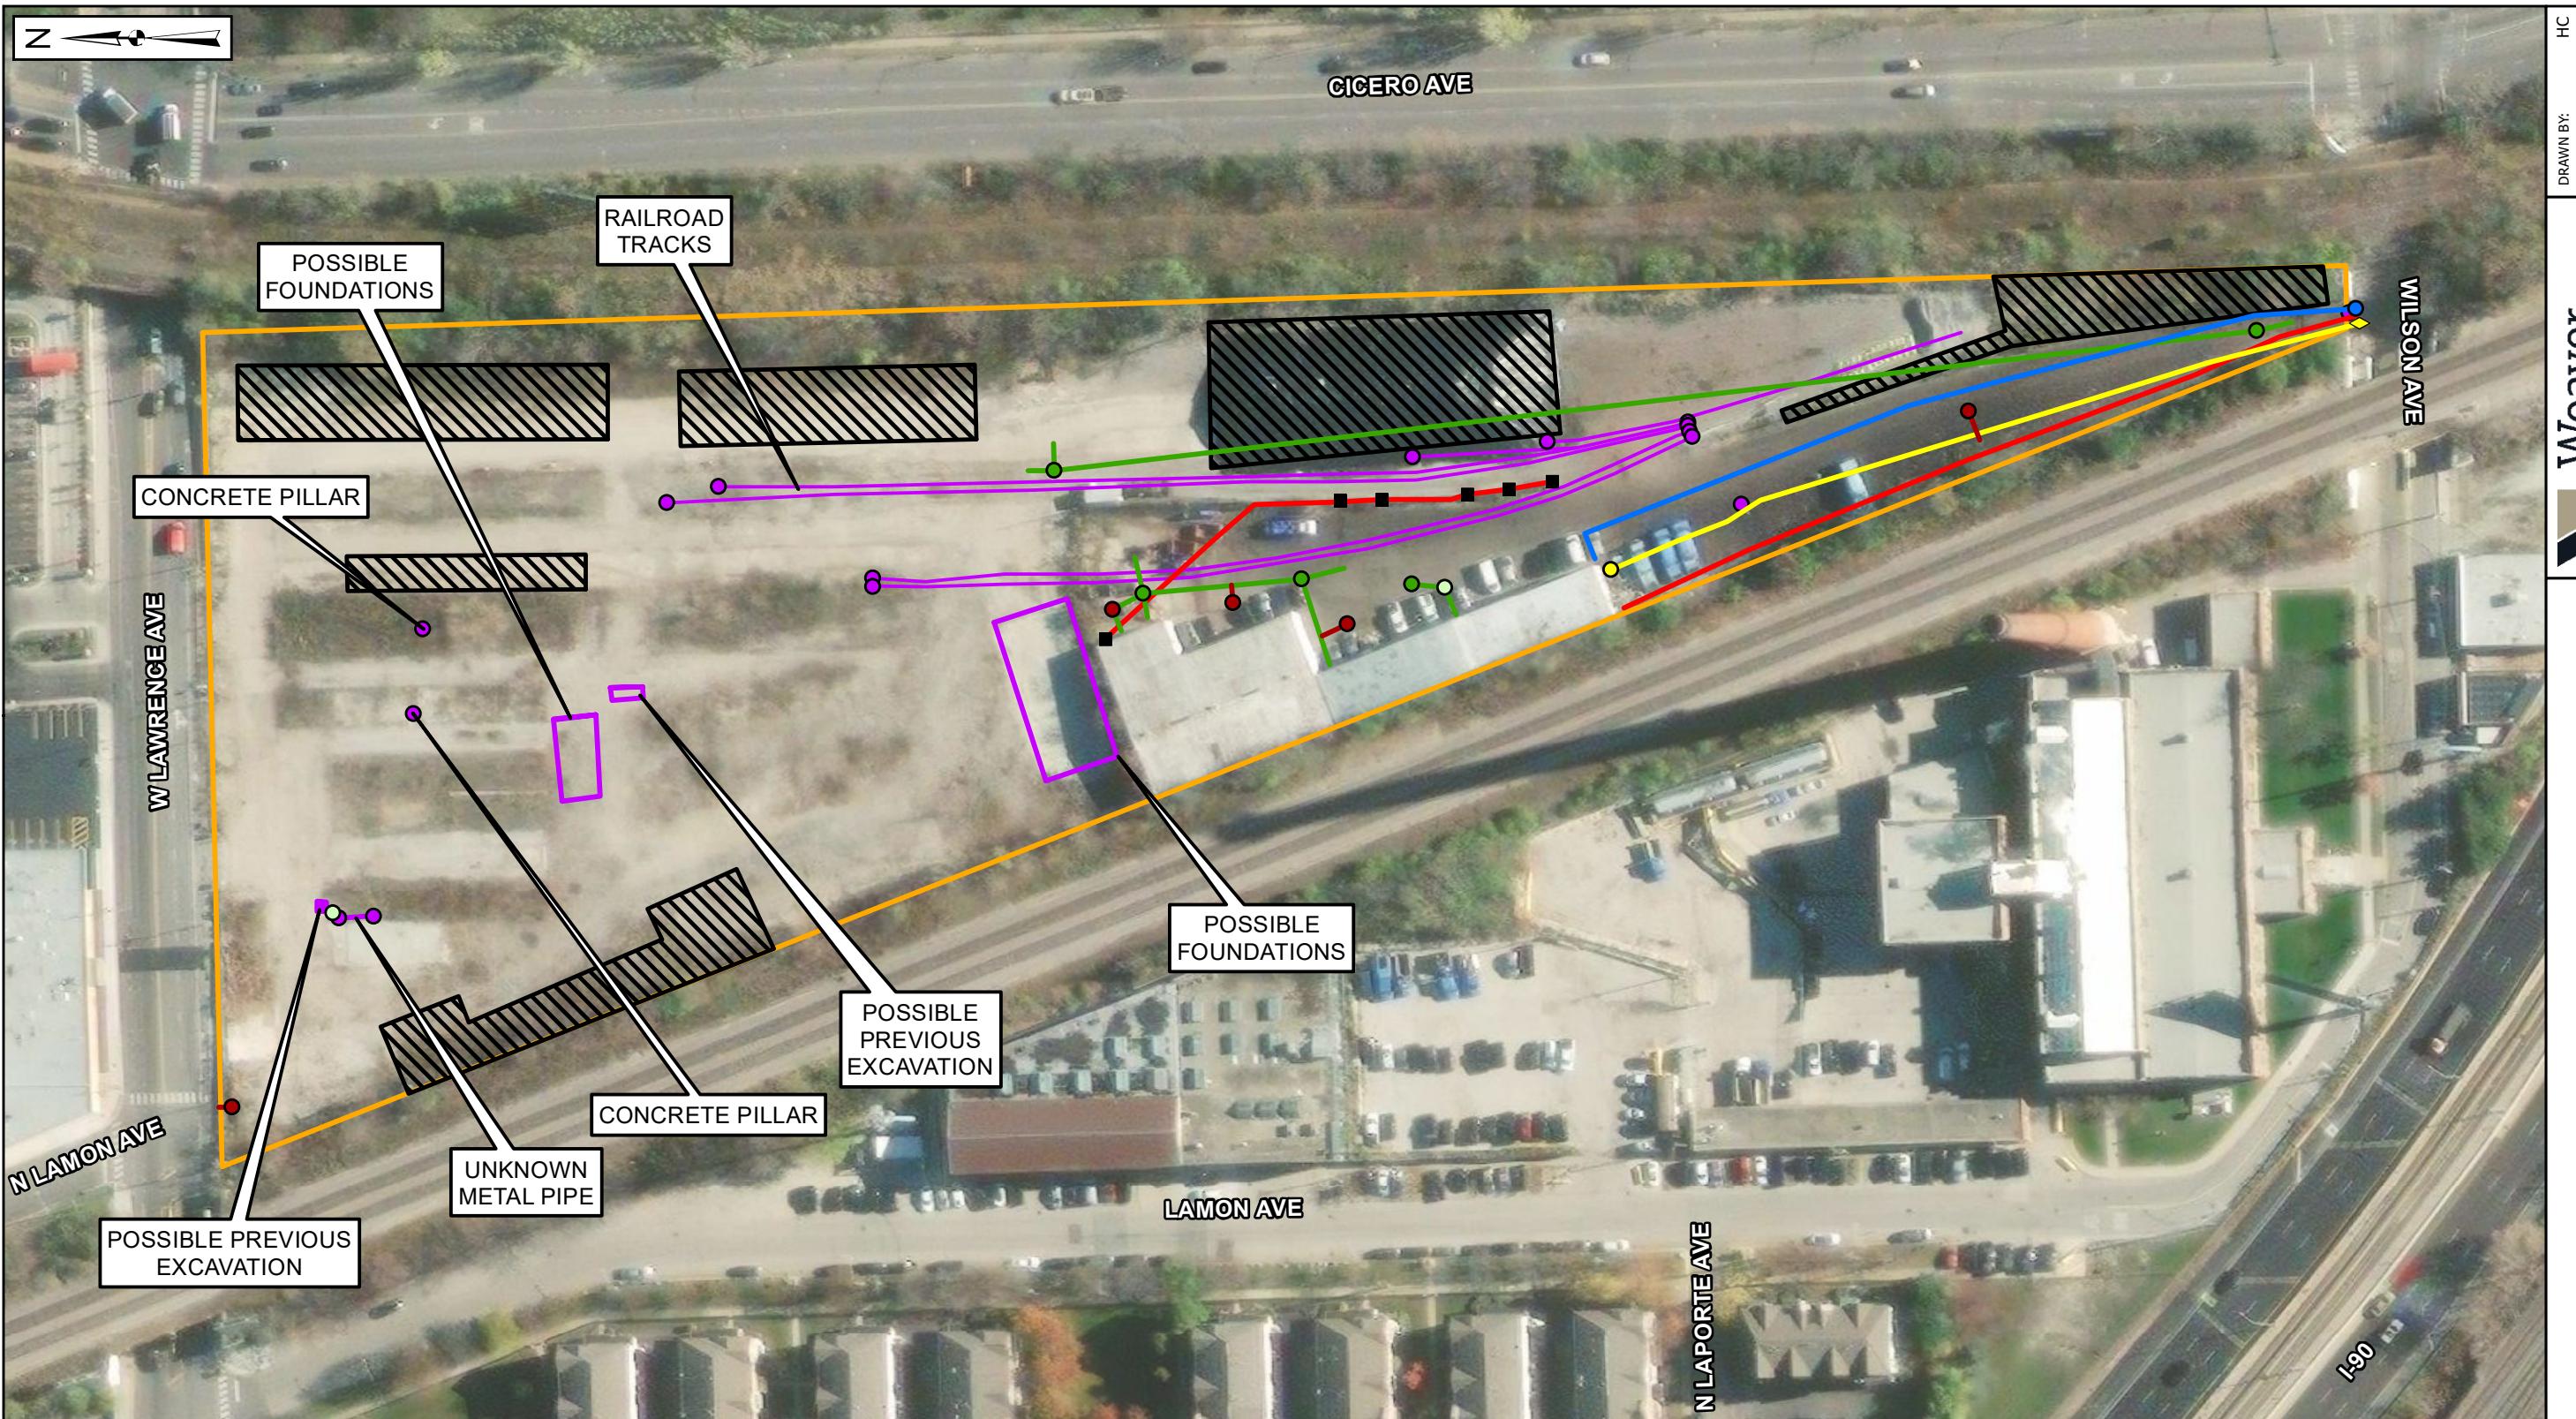
DRAWN BY: HC
REVIEWED BY: JB
DATE: 12/15/2025
FILE: 1012-335-02
CAD: 335_GPRS.mxd
FIGURE 3

A GPR survey was conducted on the entire subject property, as accessible, on November 24-26, 2025 by GPRS. GPRS was accompanied by Ms. Audrey Johnson of WCG. The accessible areas of the subject property were surveyed on a maximum grid spacing of four feet to ensure adequate coverage. The GPRS report indicated the effective depth range of the GPR equipment was approximately two to three feet. During the GPR Survey, the east-central portion and the northeast portion of the subject property could not be surveyed due to the existing salt pile and soil piles. Additionally, areas with standing water were unable to be scanned. The locations of the areas that could not be surveyed are shown on **Figure 3 – GPRS Findings Map**.

GPRS located anomalies that appear to be indicative of buried metal railroad spurs located within similar areas as shown in historical Sanborn fire insurance maps between 1940 and 2004. Based on the GPRS survey, the former on-site railroad spurs appear to have been removed on the northern portion and buried or left in-place on the southern portion of the subject property. Additionally, as shown on **Figure 3**, the GPRS survey identified anomalies that appear to be indicative of buried foundations or other buried building demolition debris on the subject property. At least two of these anomalies appear to correlate with historical structures on the subject property including the “concrete pillar” and “possible foundations” anomalies which appear to be located in the vicinity of the former “MAYFAIR LUMBER CO” building footprint, and the “possible foundation” anomaly located north of the existing building, which may be associated with the building that appeared improved in this area in historical aerial imagery between at least 1962 and 2019.

As previously noted, no anomalies indicative of existing USTs were identified; however, the “possible previous excavation” and “unknown metal pipe” anomalies identified by GPRS in the northwestern portion of the subject property appear to potentially correlate with the location of the historical 1,000-gallon and 500-gallon USTs.
