Asbestos Building Inspection

Public Building Commission of Chicago  
Richard J. Daley Center, Room 200  
50 West Washington Street  
Chicago, Illinois 60602

Department of Water Management  
Operations Facility - DOW 04029  
4825 W. Lawrence Avenue  
Chicago, Illinois 60630

October 14, 2025  
TEM Project 77496

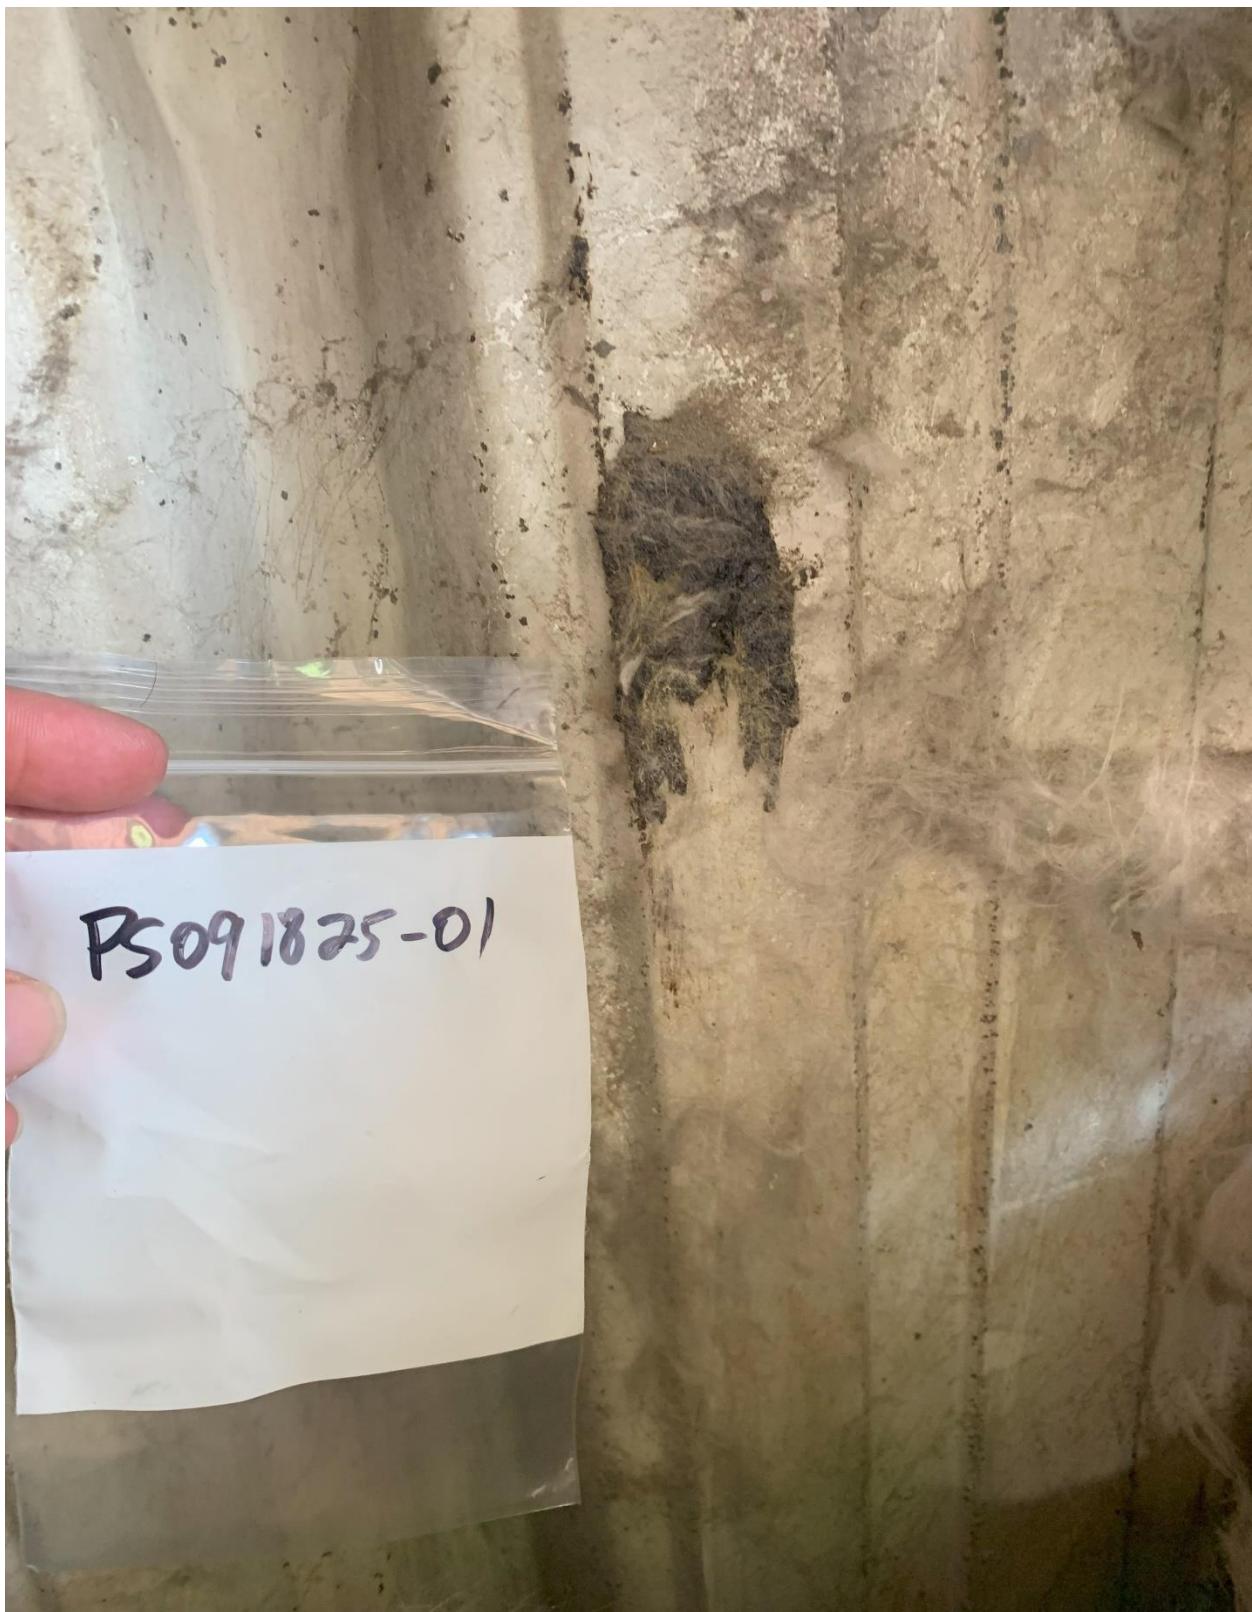
DOW Building - Wall Black Adhesive on Garage Bay Walls – Sample # PS091825-01

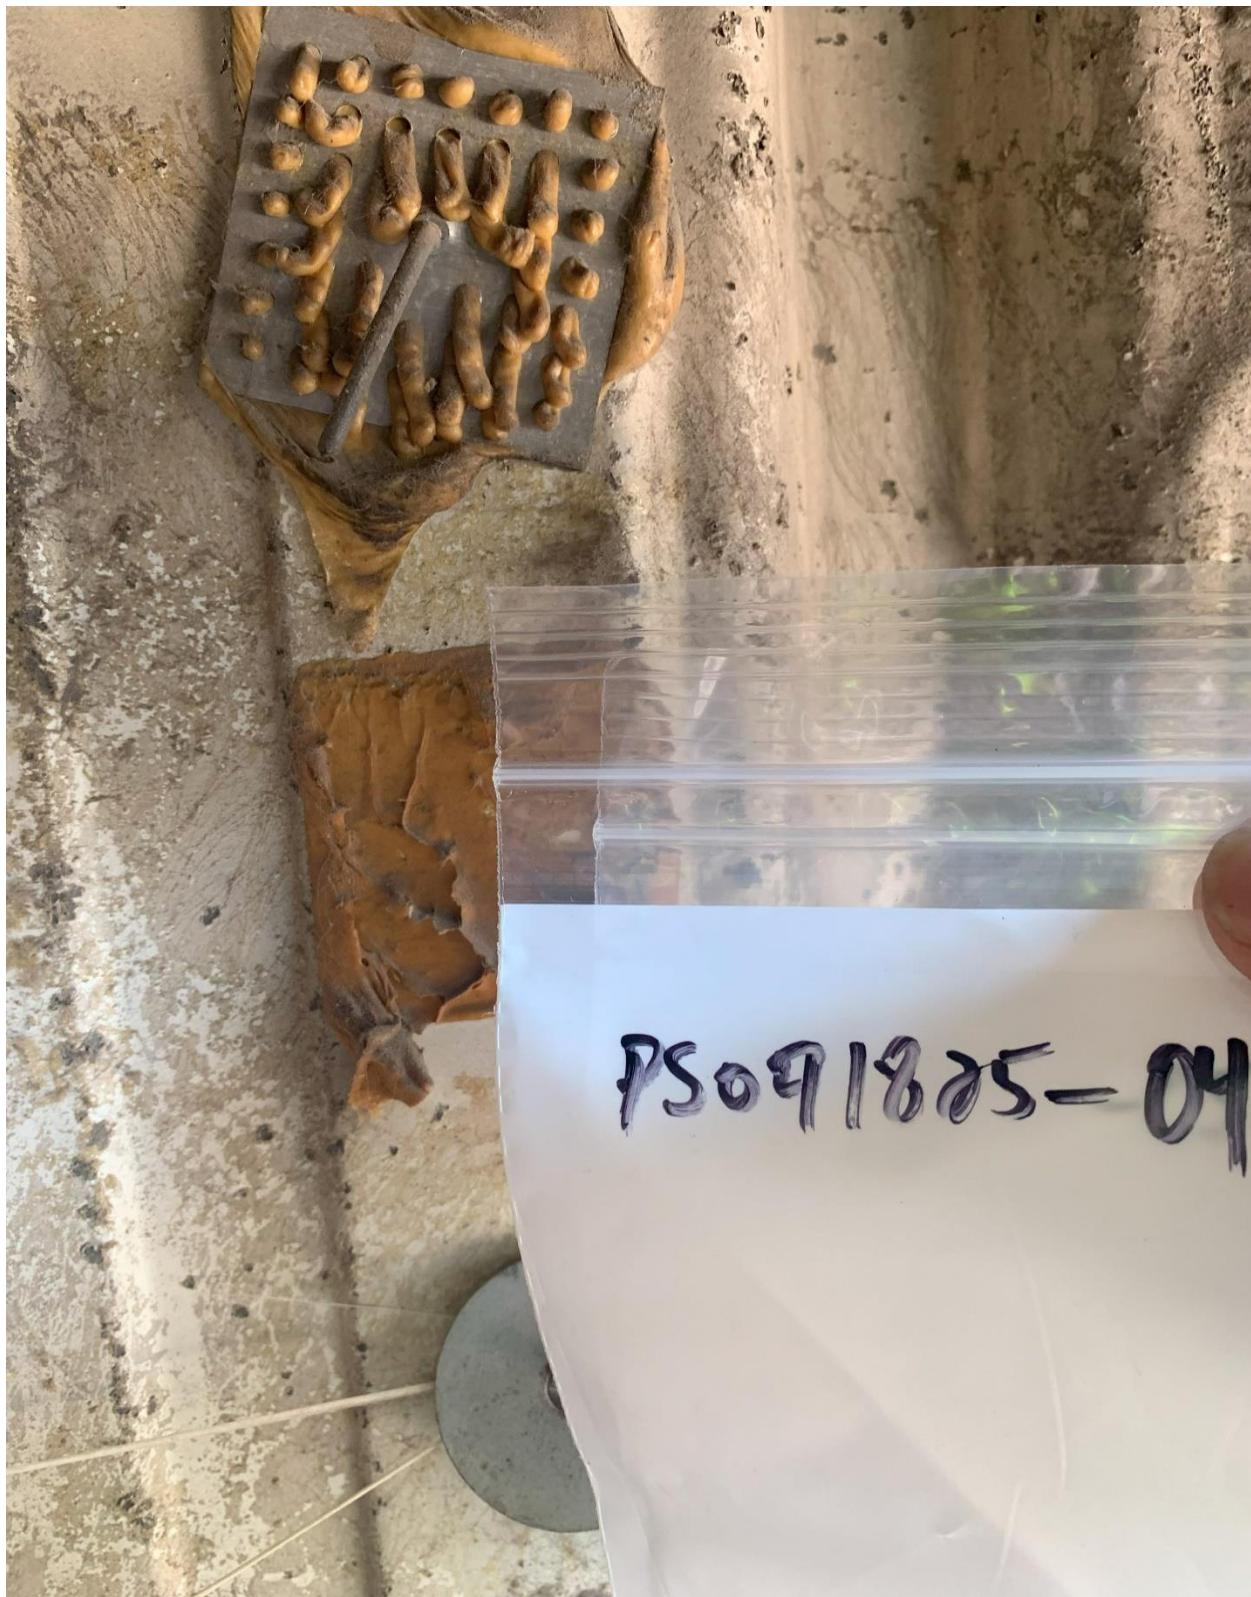
DOW Building - Yellow Adhesive for Wall/Ceiling Insulation – Sample # PS091825-04

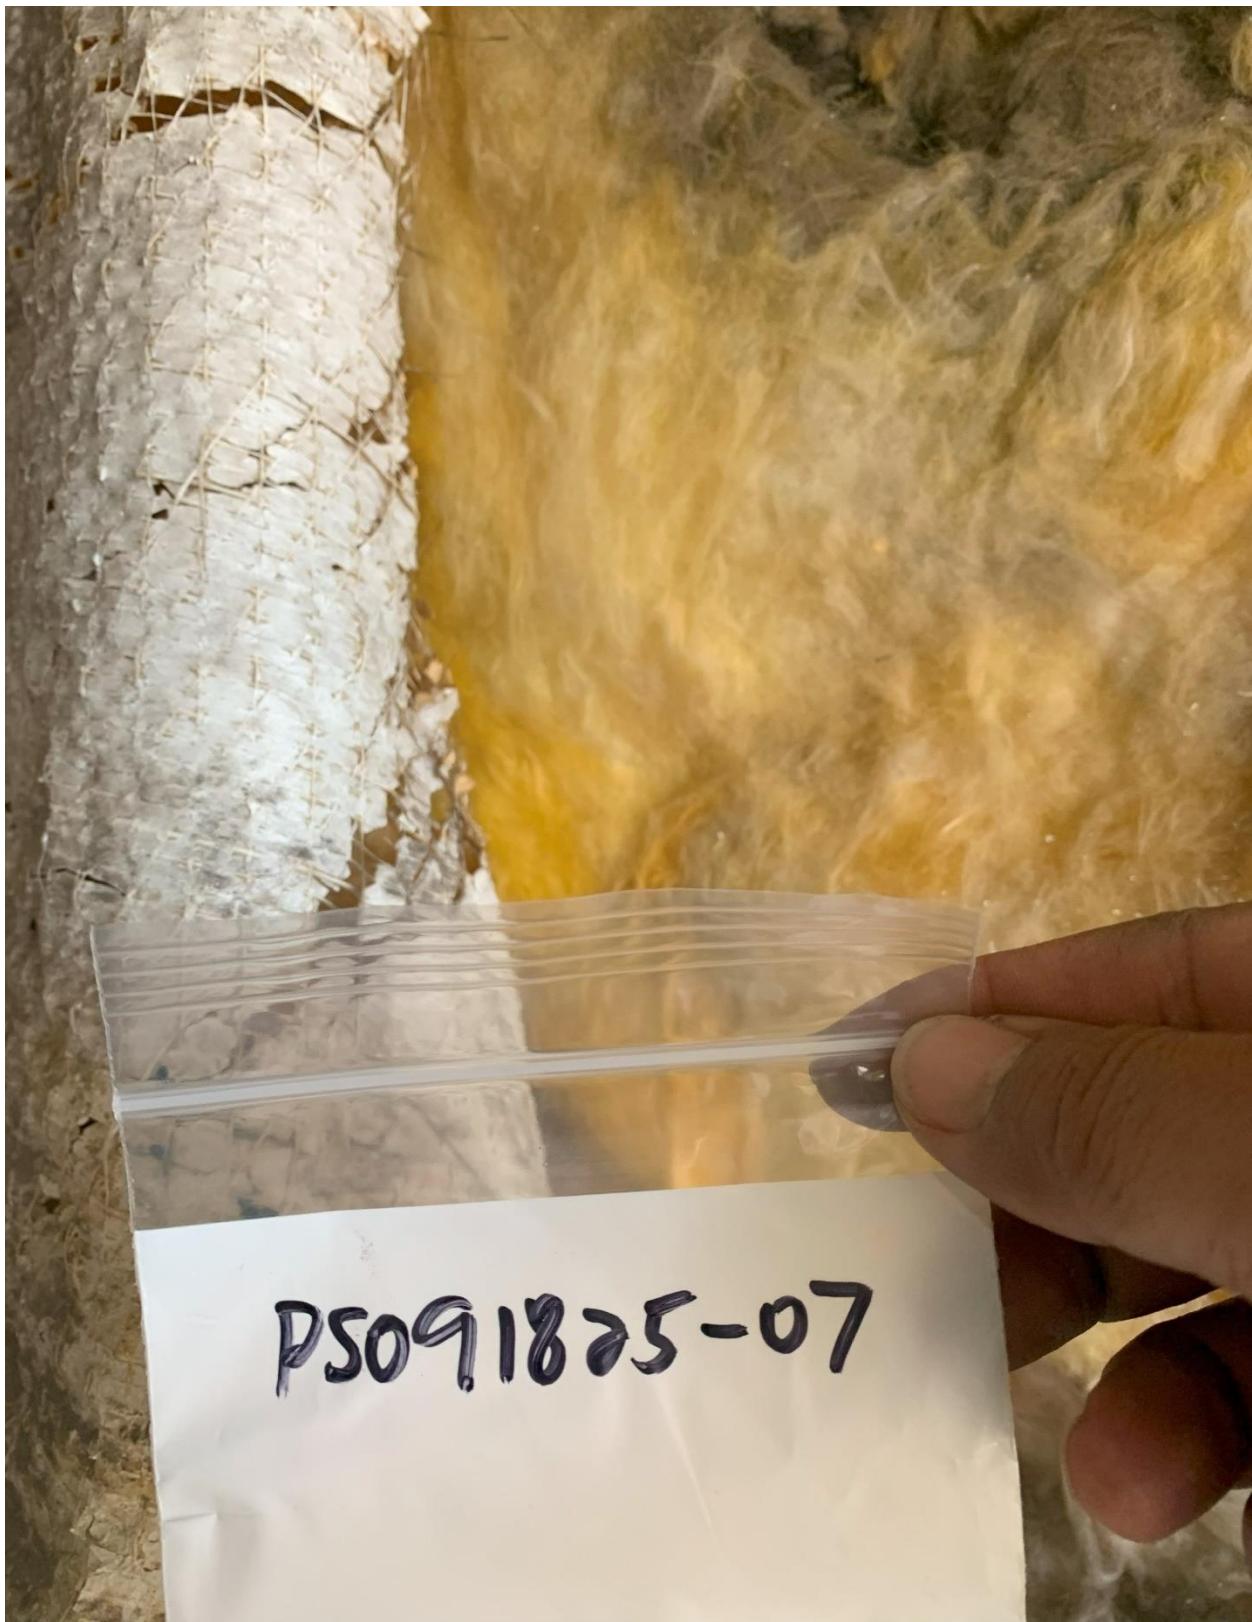
DOW Building - Wall and Ceiling Insulation – Sample # PS091825-07

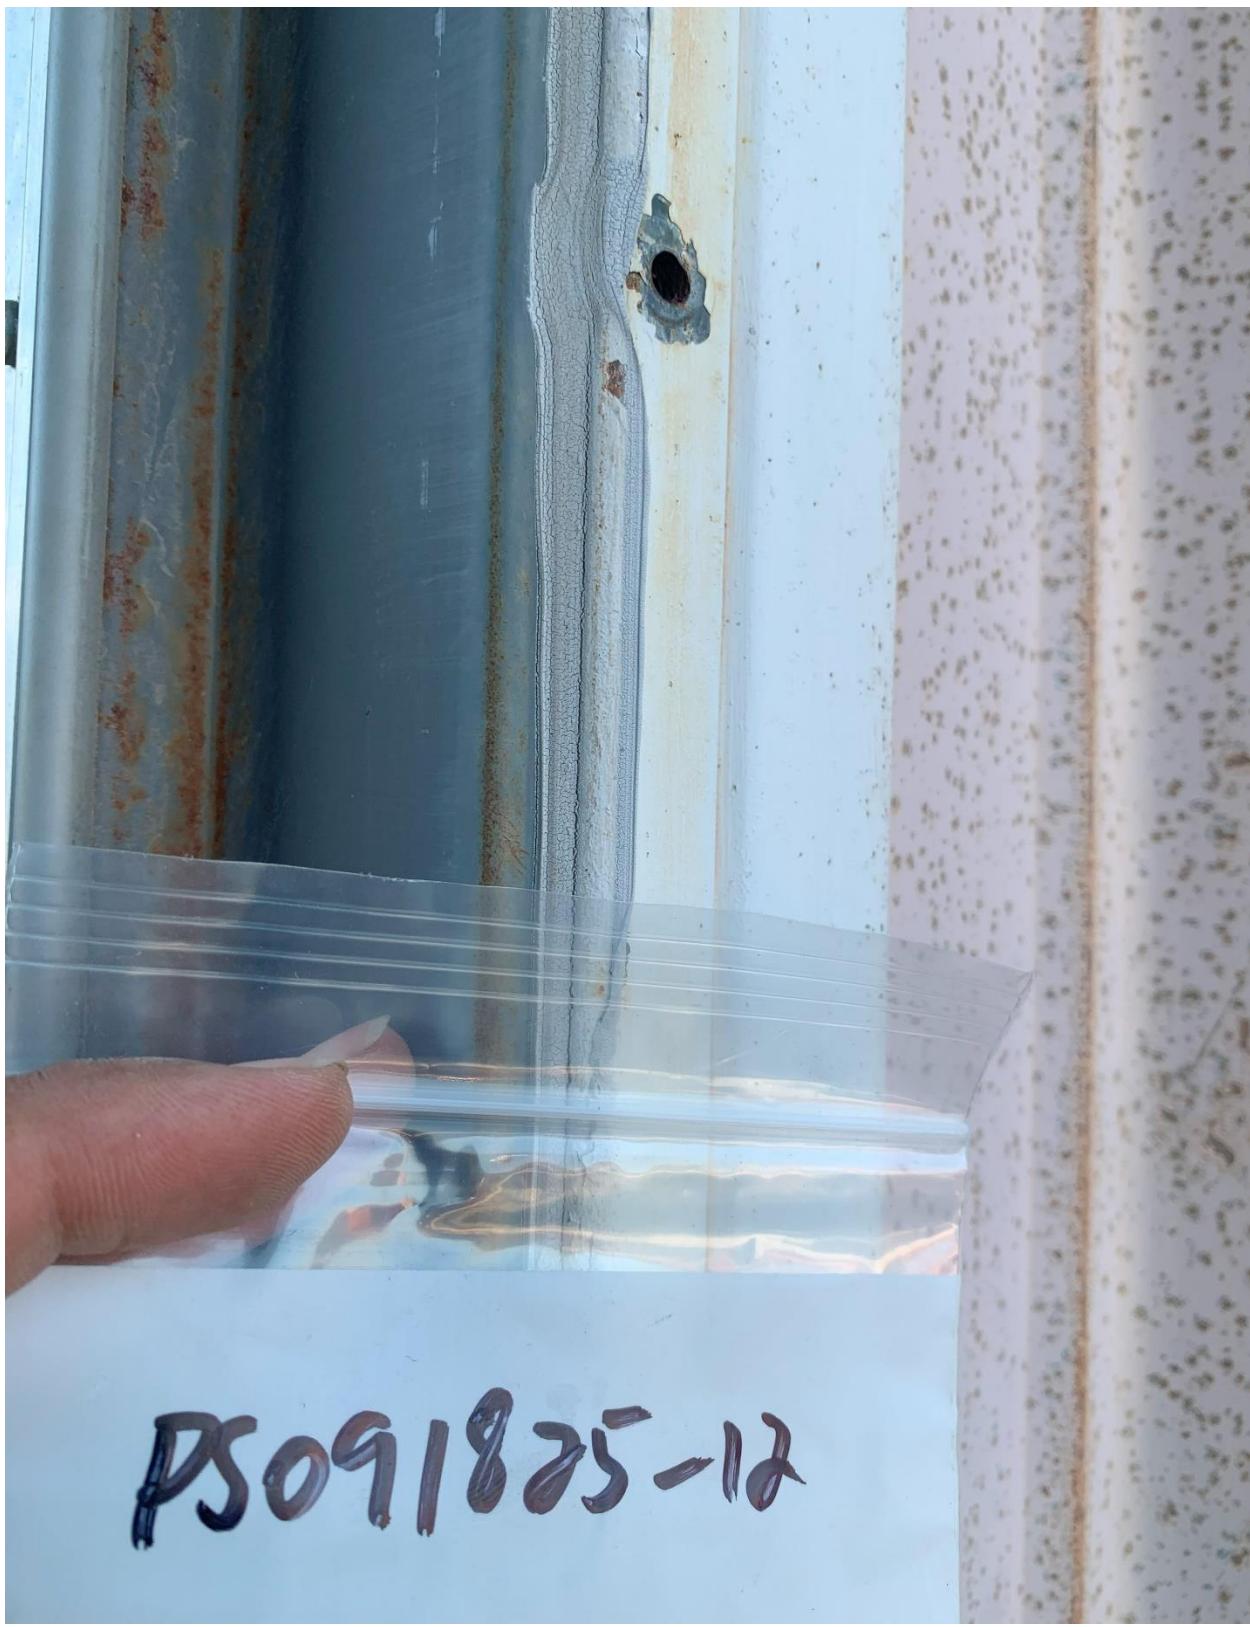
DOW Building - Light Grey Door Caulk – Sample # PS091825-12

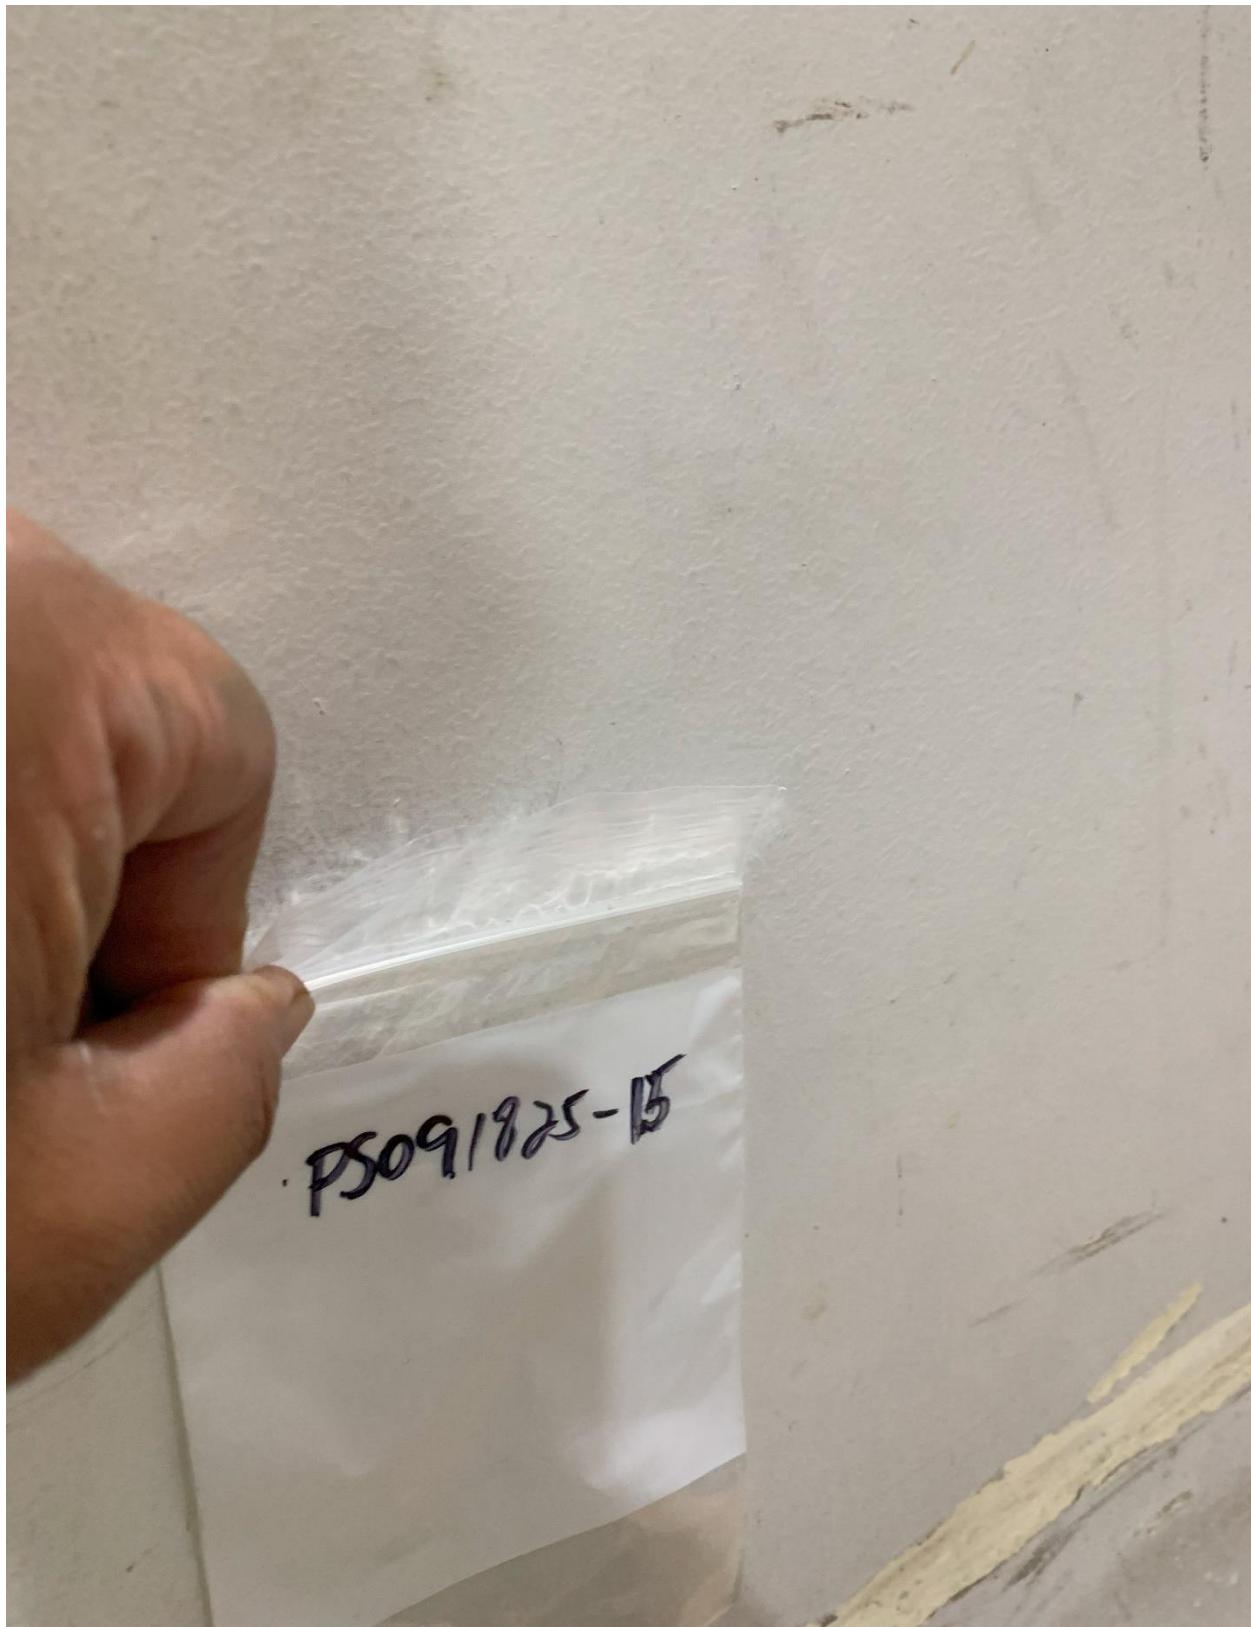
DOW Building – Drywall – Sample # PS091825-15

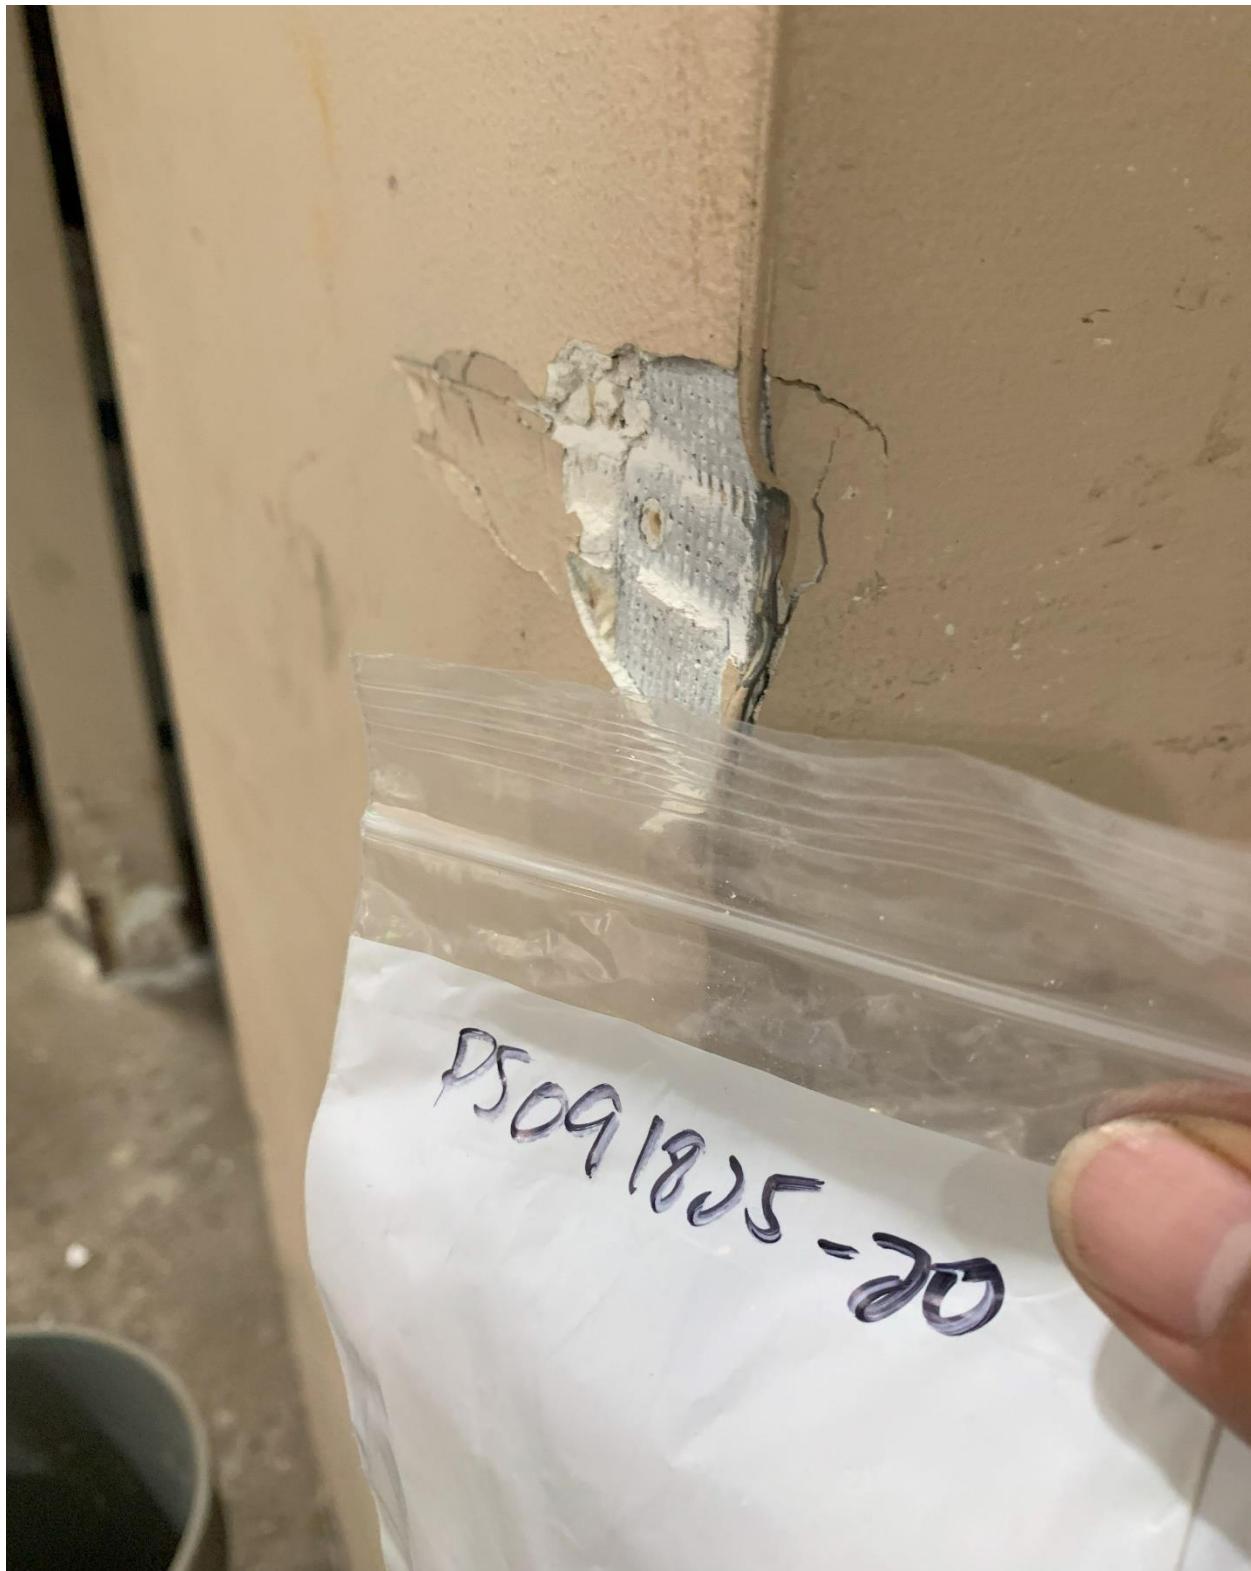
DOW Building - Drywall Joint Compound – Sample # PS091825-20

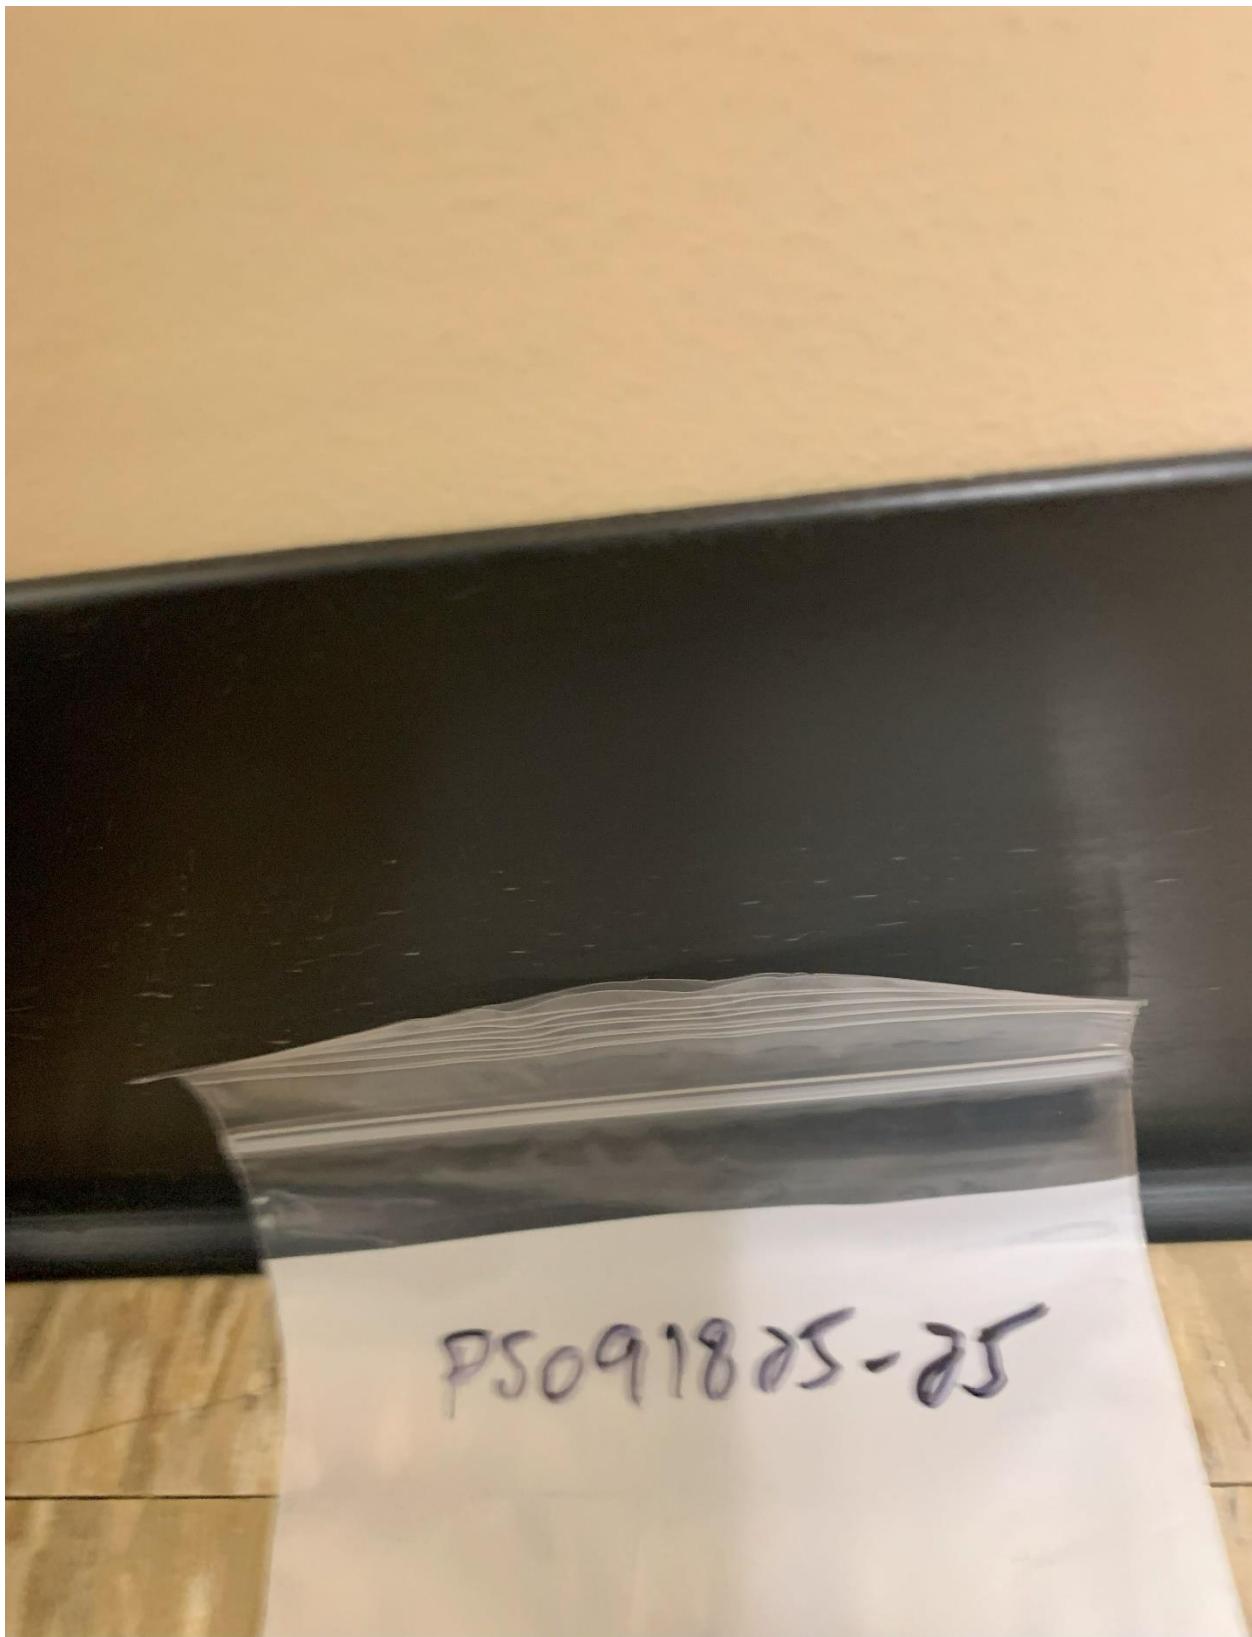
DOW Building - 4" Black Baseboard – Sample # PS091825-25

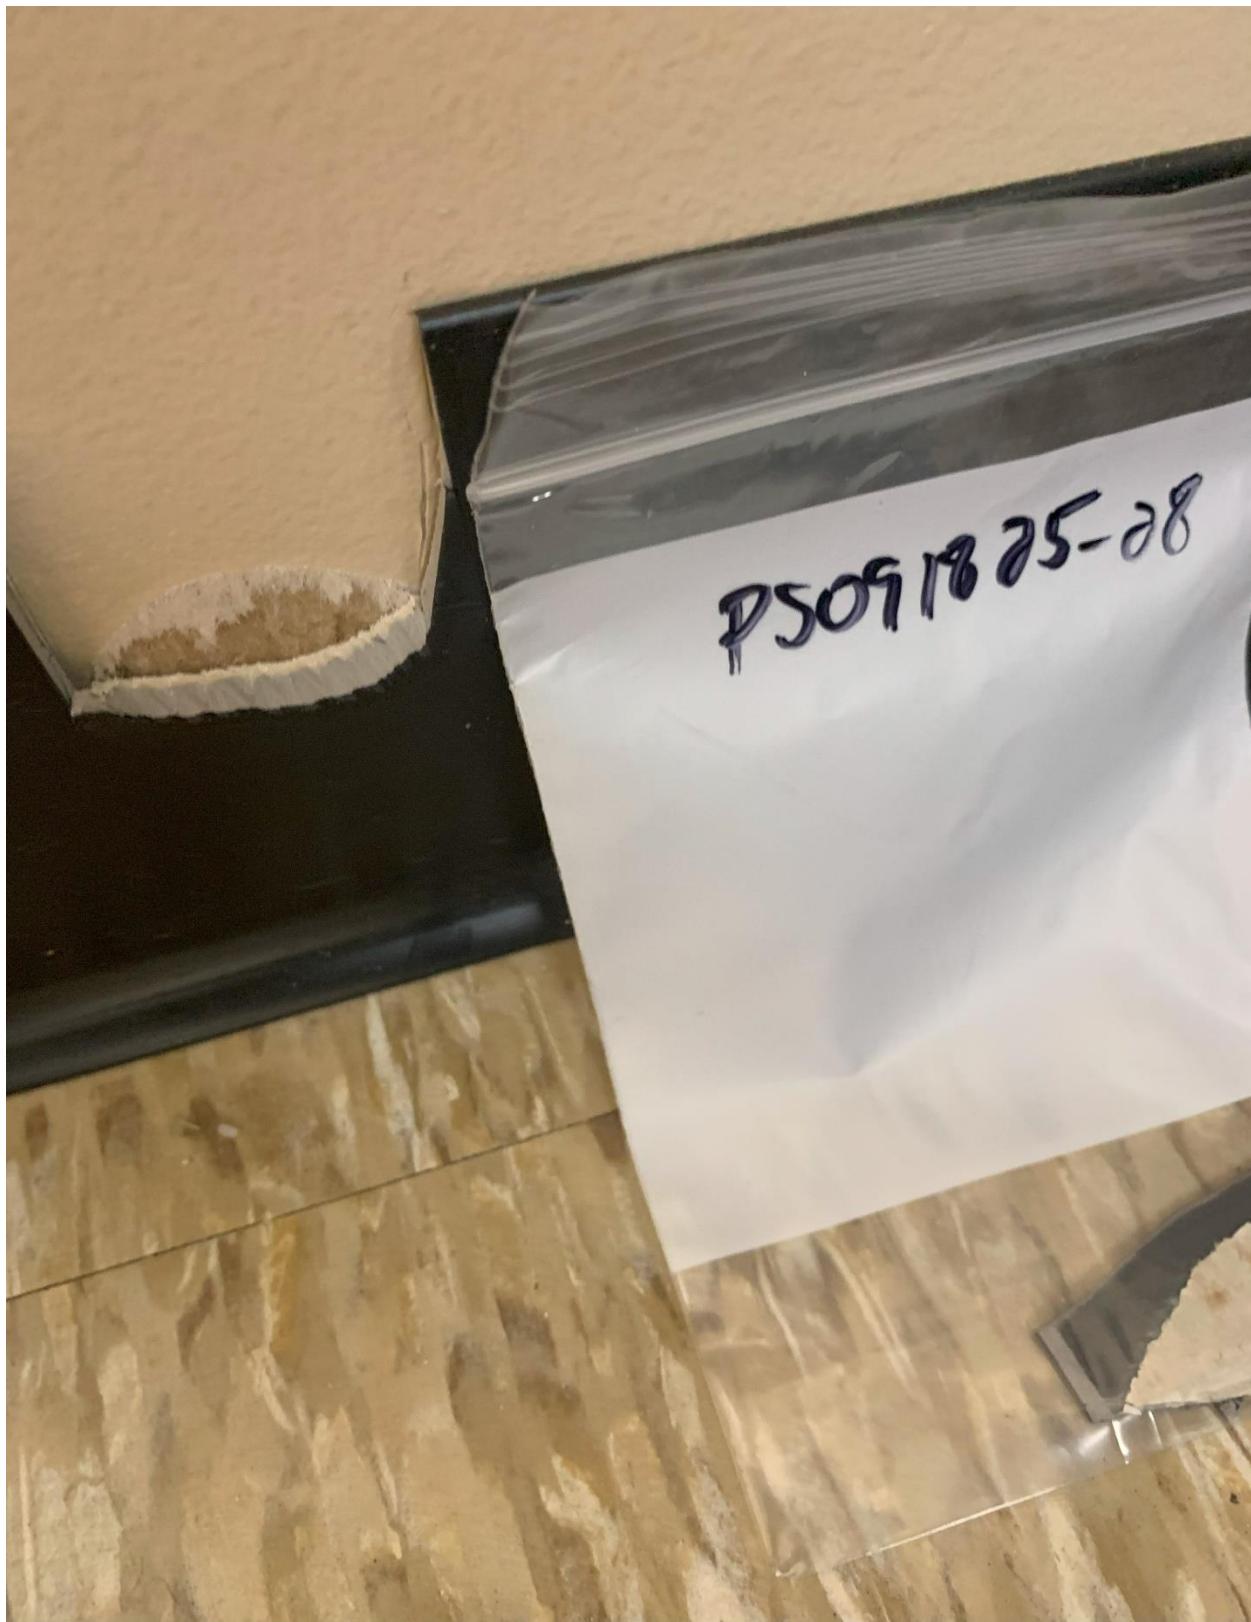
DOW Building - Adhesive for 4" Black Baseboard – Sample # PS091825-28

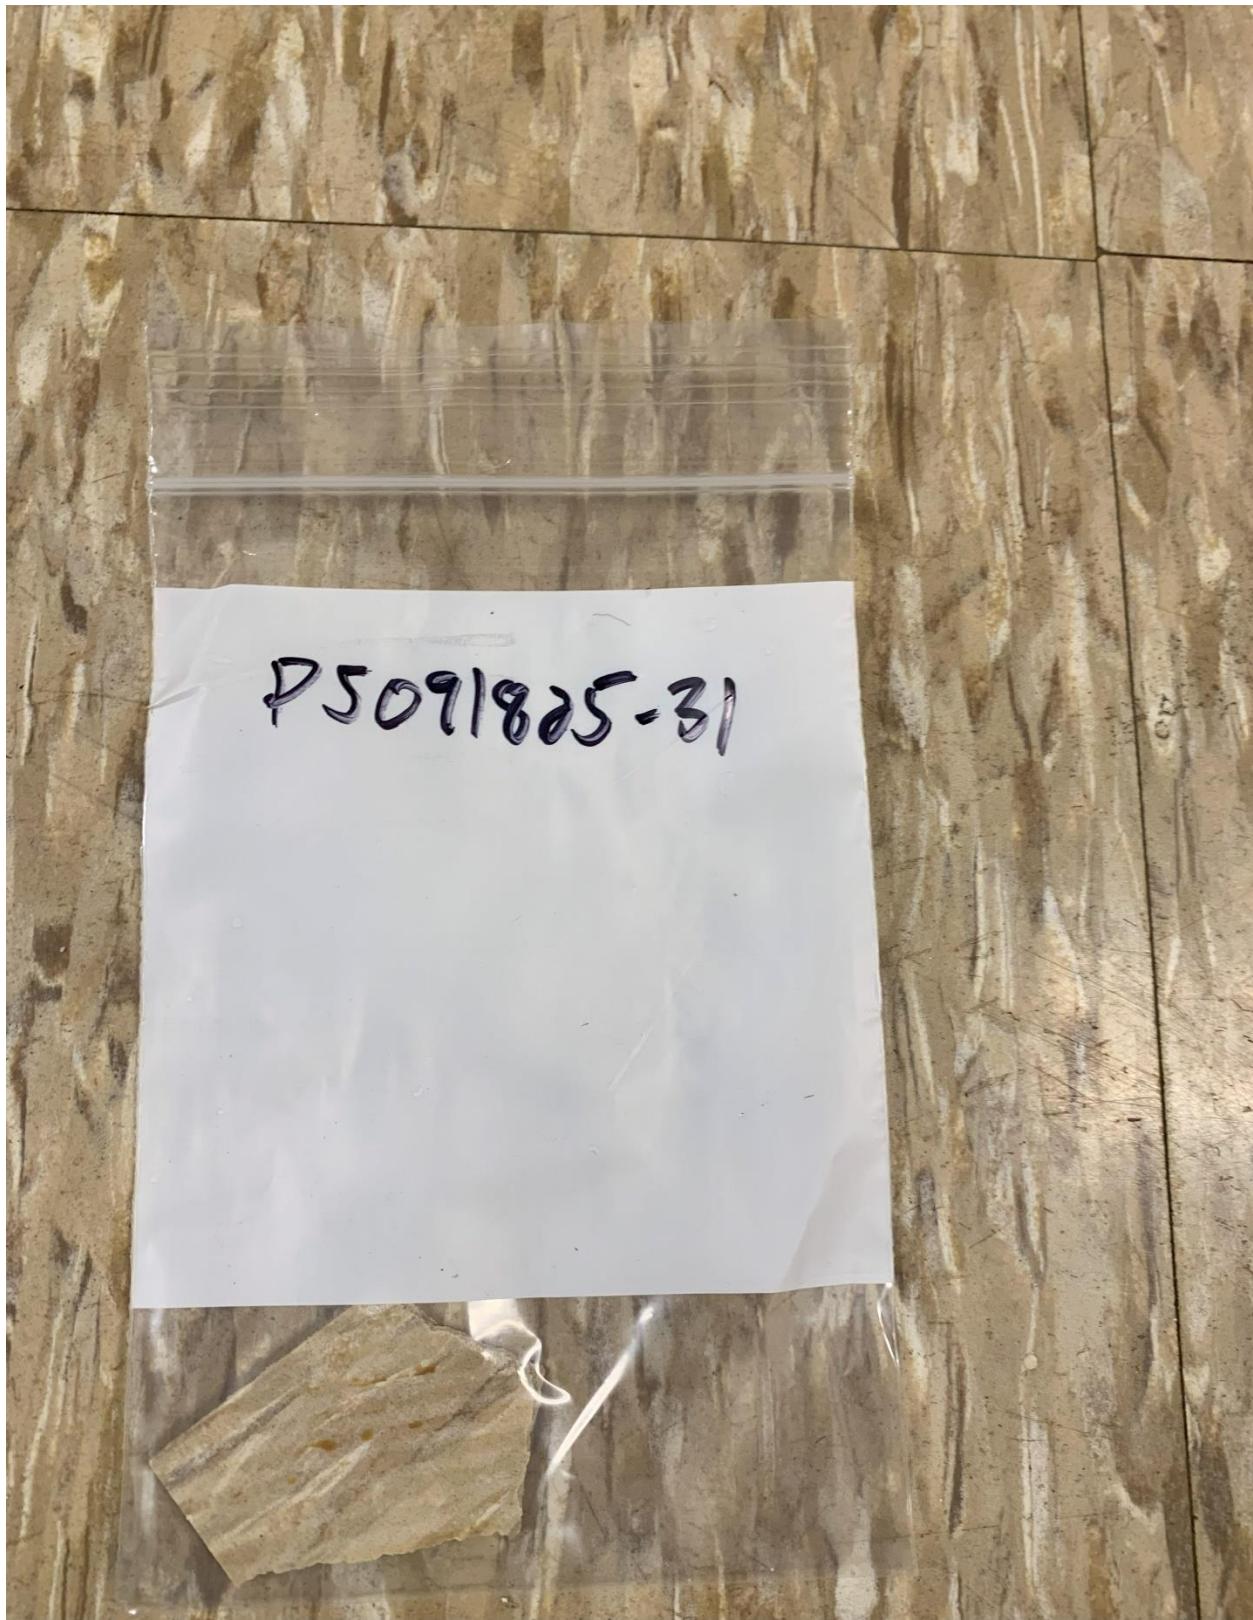
DOW Building - 12"x12" Tan Mix Floor Tile (Top Layer) – Sample # PS091825-31

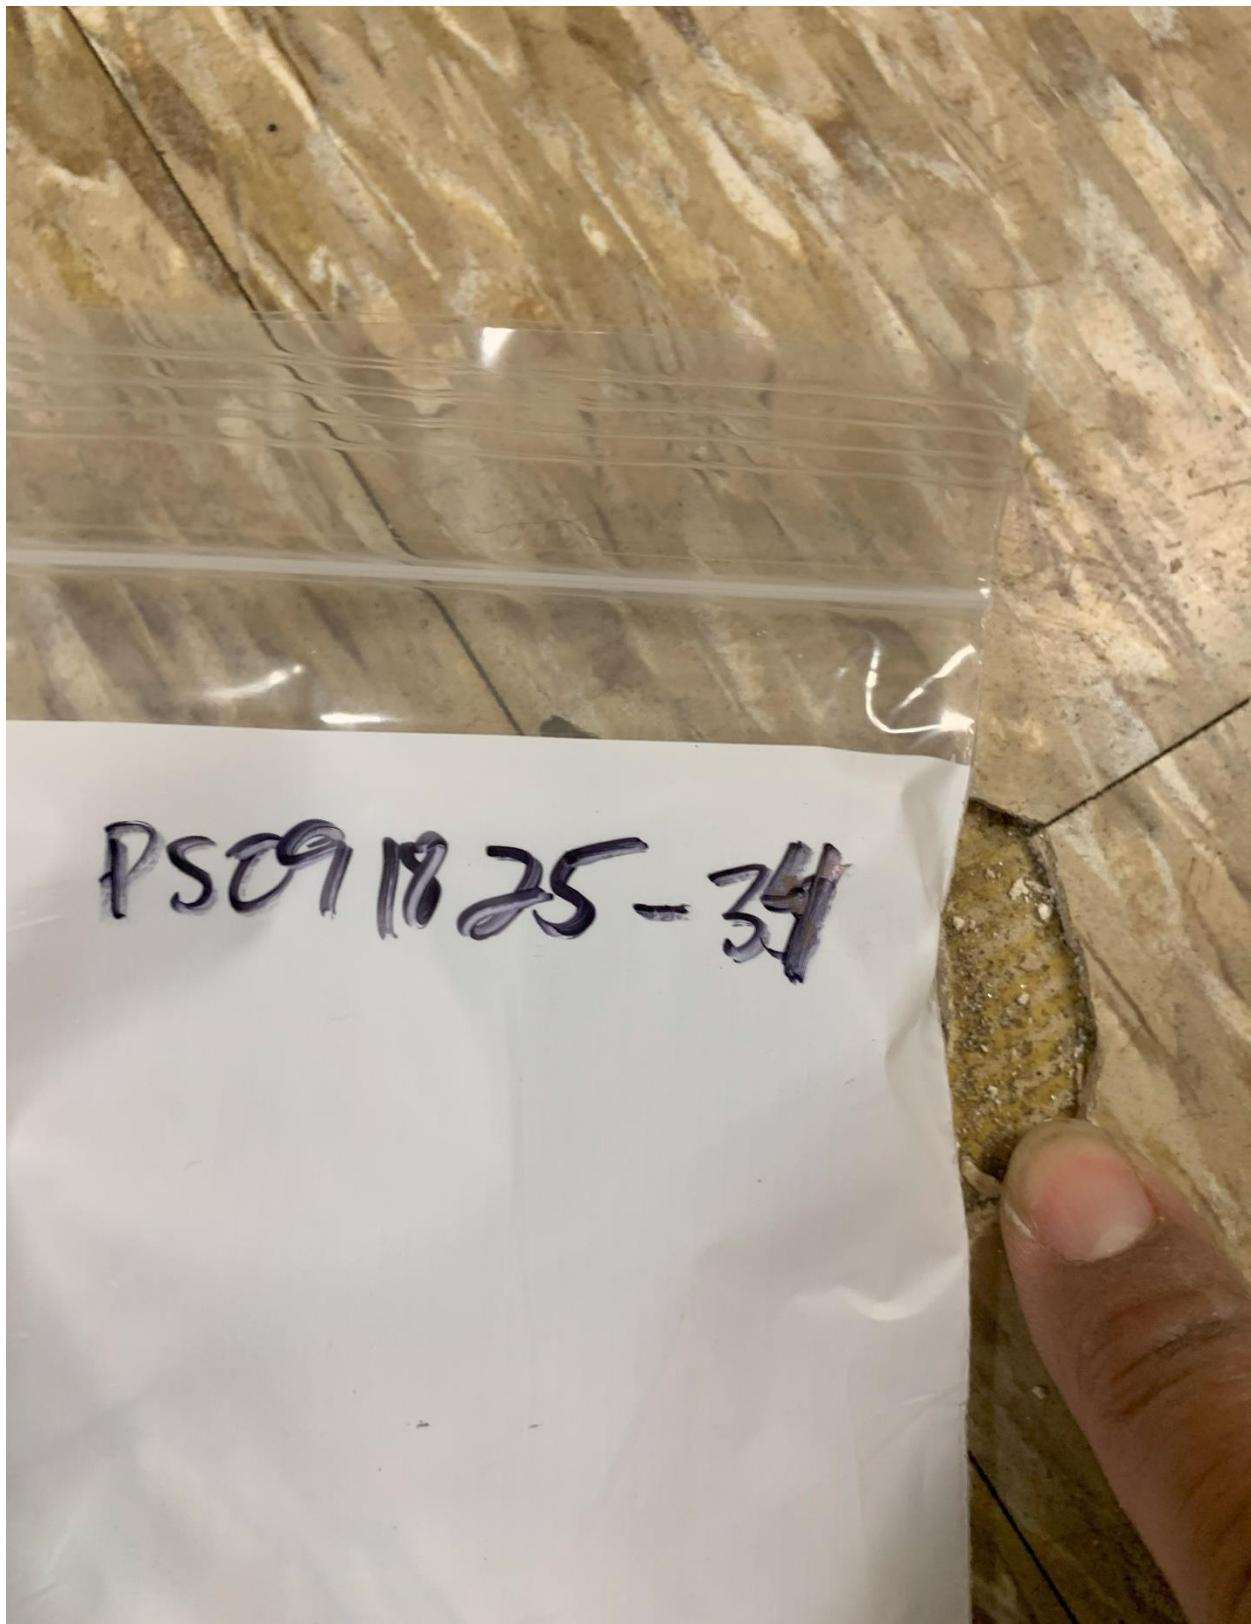
DOW Building - Mastic for 12"x12" Tan Mix Floor Tile -- Sample # PS091825-34

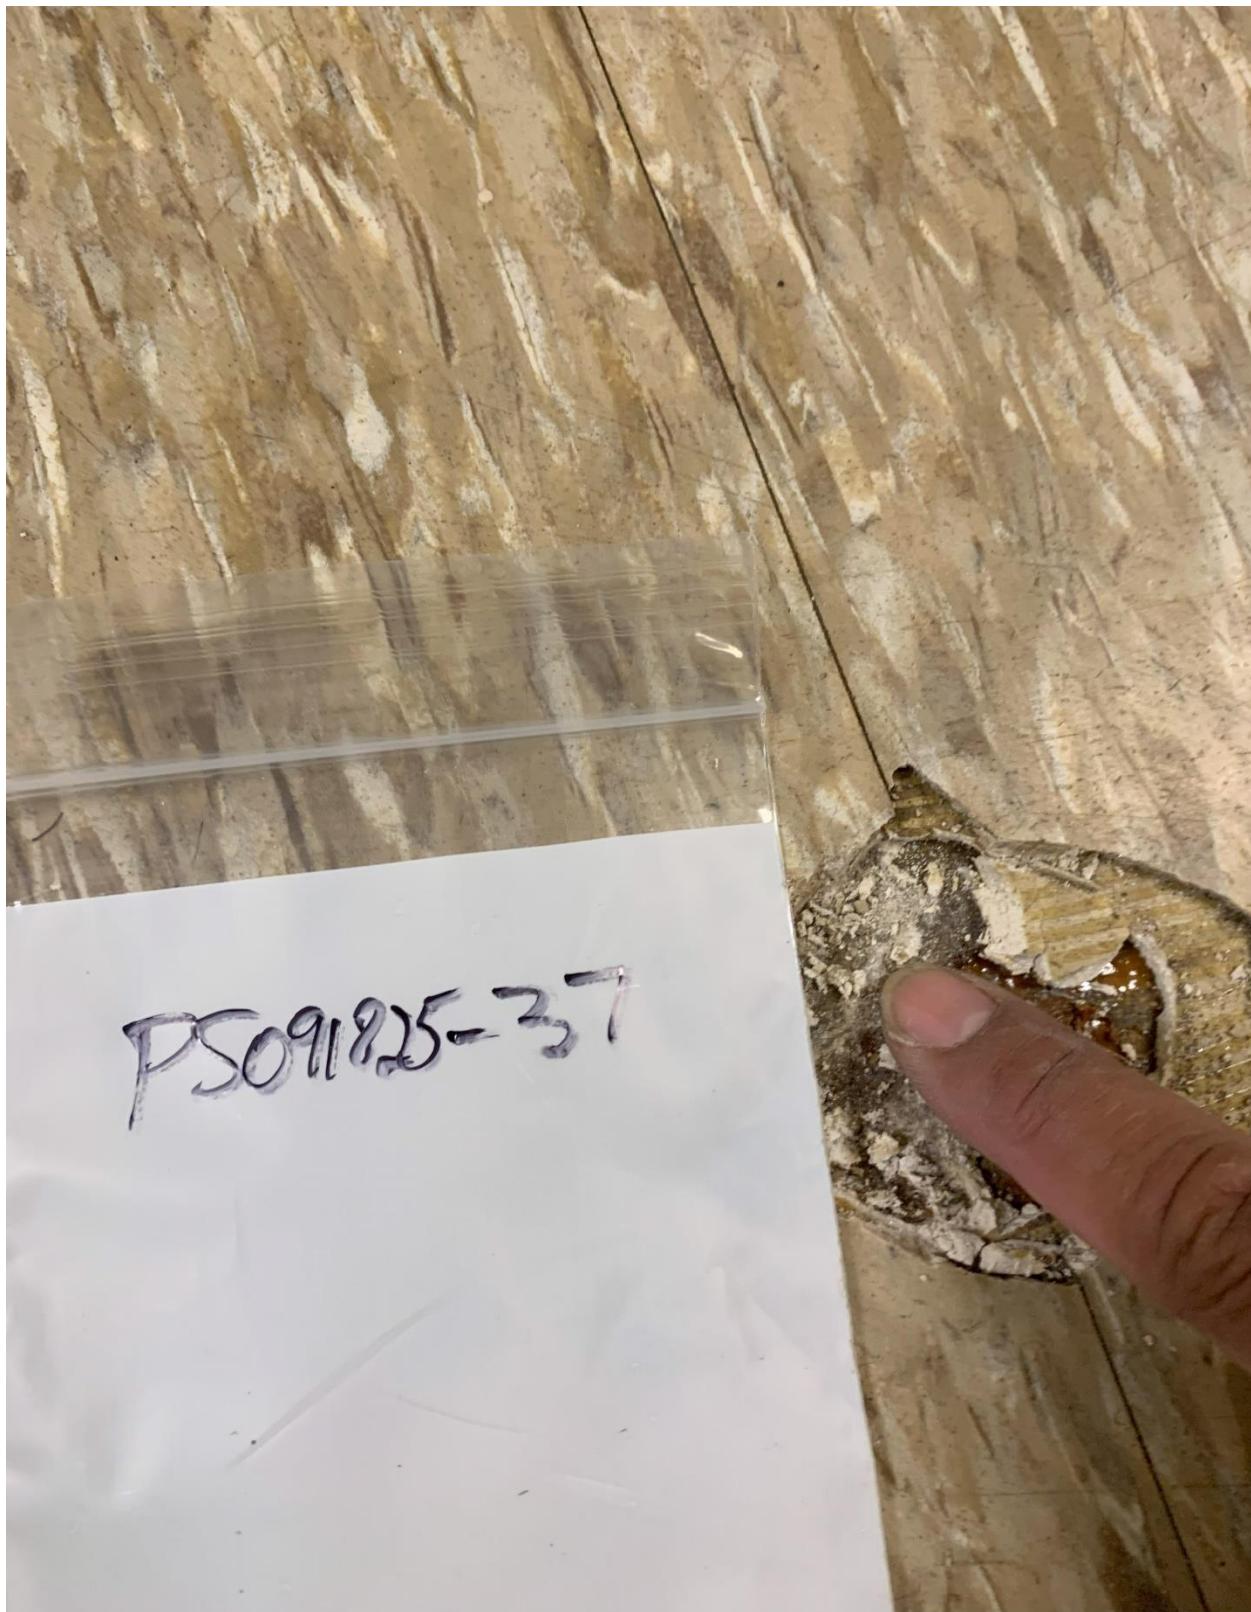
DOW Building - 12"x12" Off-White Floor Tile (2<sup>nd</sup> Layer) – Sample # PS091825-37
