Asbestos Building Inspection

Public Building Commission of Chicago  
Richard J. Daley Center, Room 200  
50 West Washington Street  
Chicago, Illinois 60602

Department of Water Management  
Operations Facility - DOW 04029  
4825 W. Lawrence Avenue  
Chicago, Illinois 60630

October 14, 2025  
TEM Project 77496

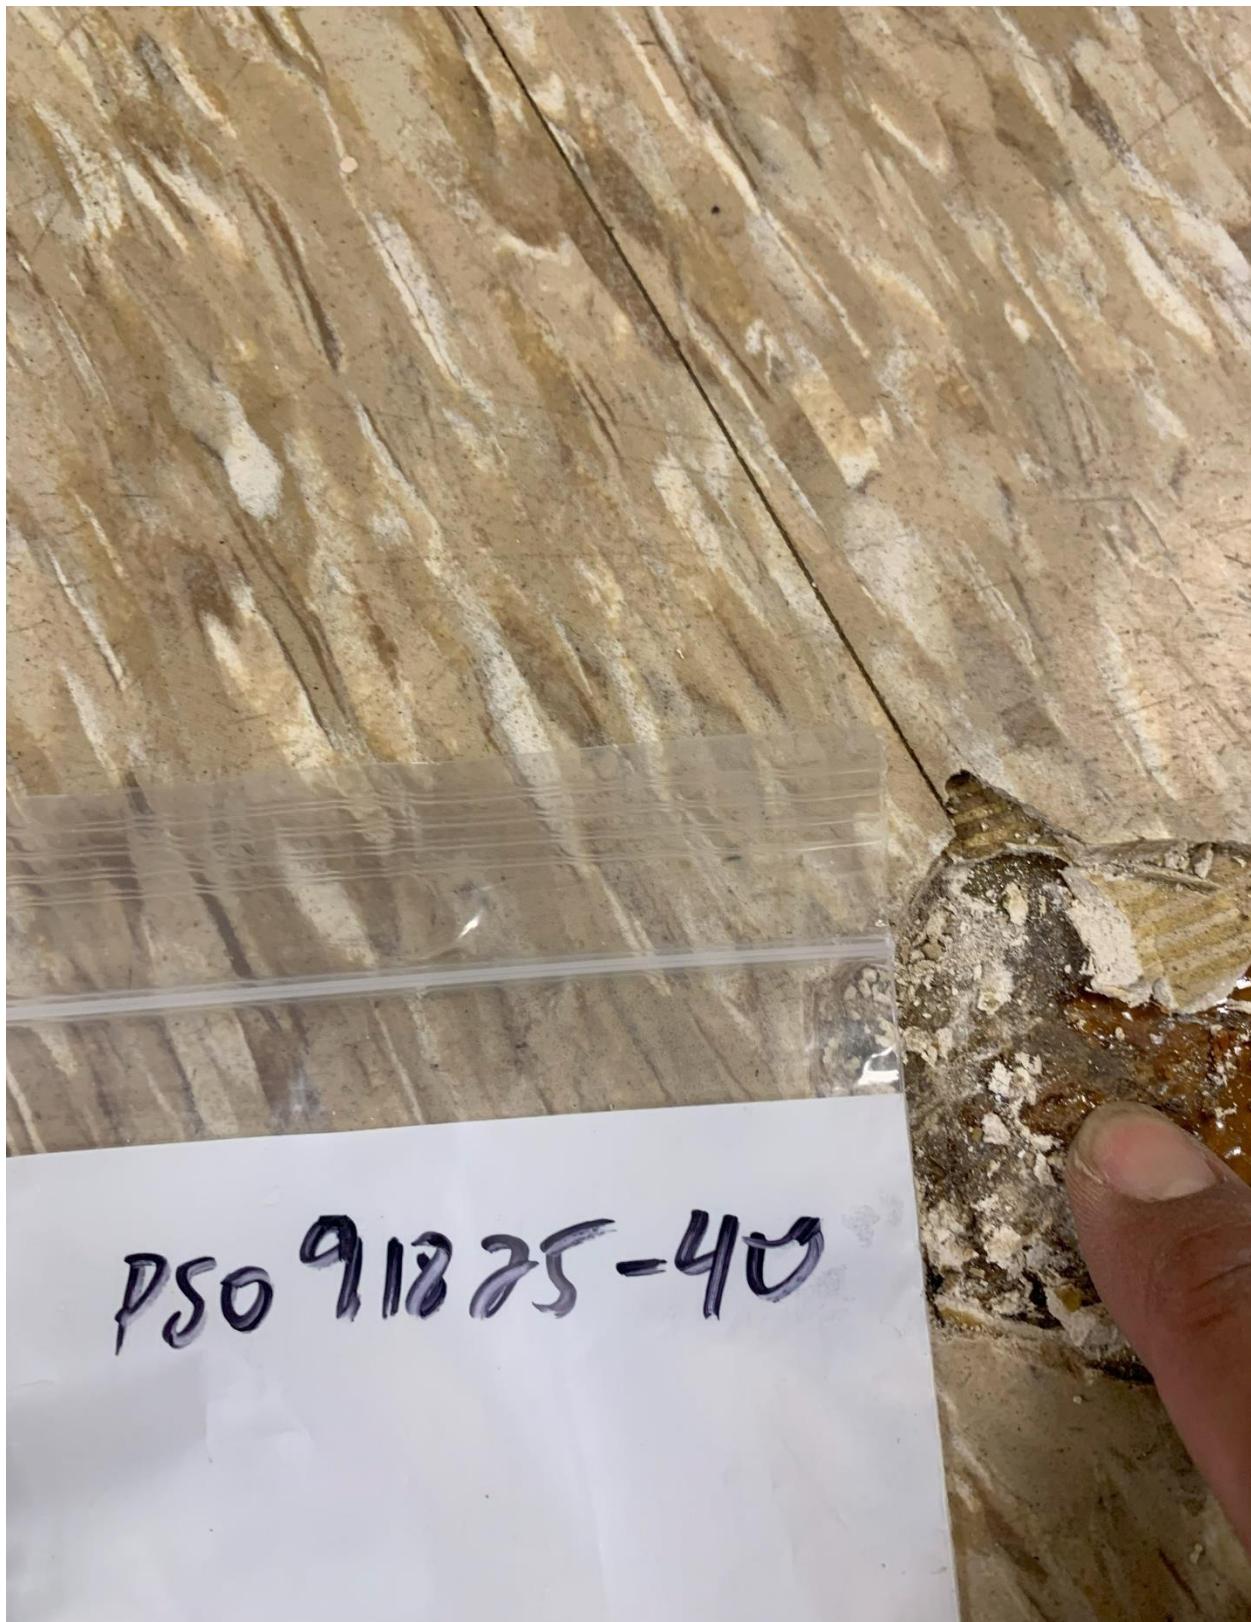
DOW Building - Adhesive for 12"x12" Off-White Floor Tile – Sample # PS091825-40

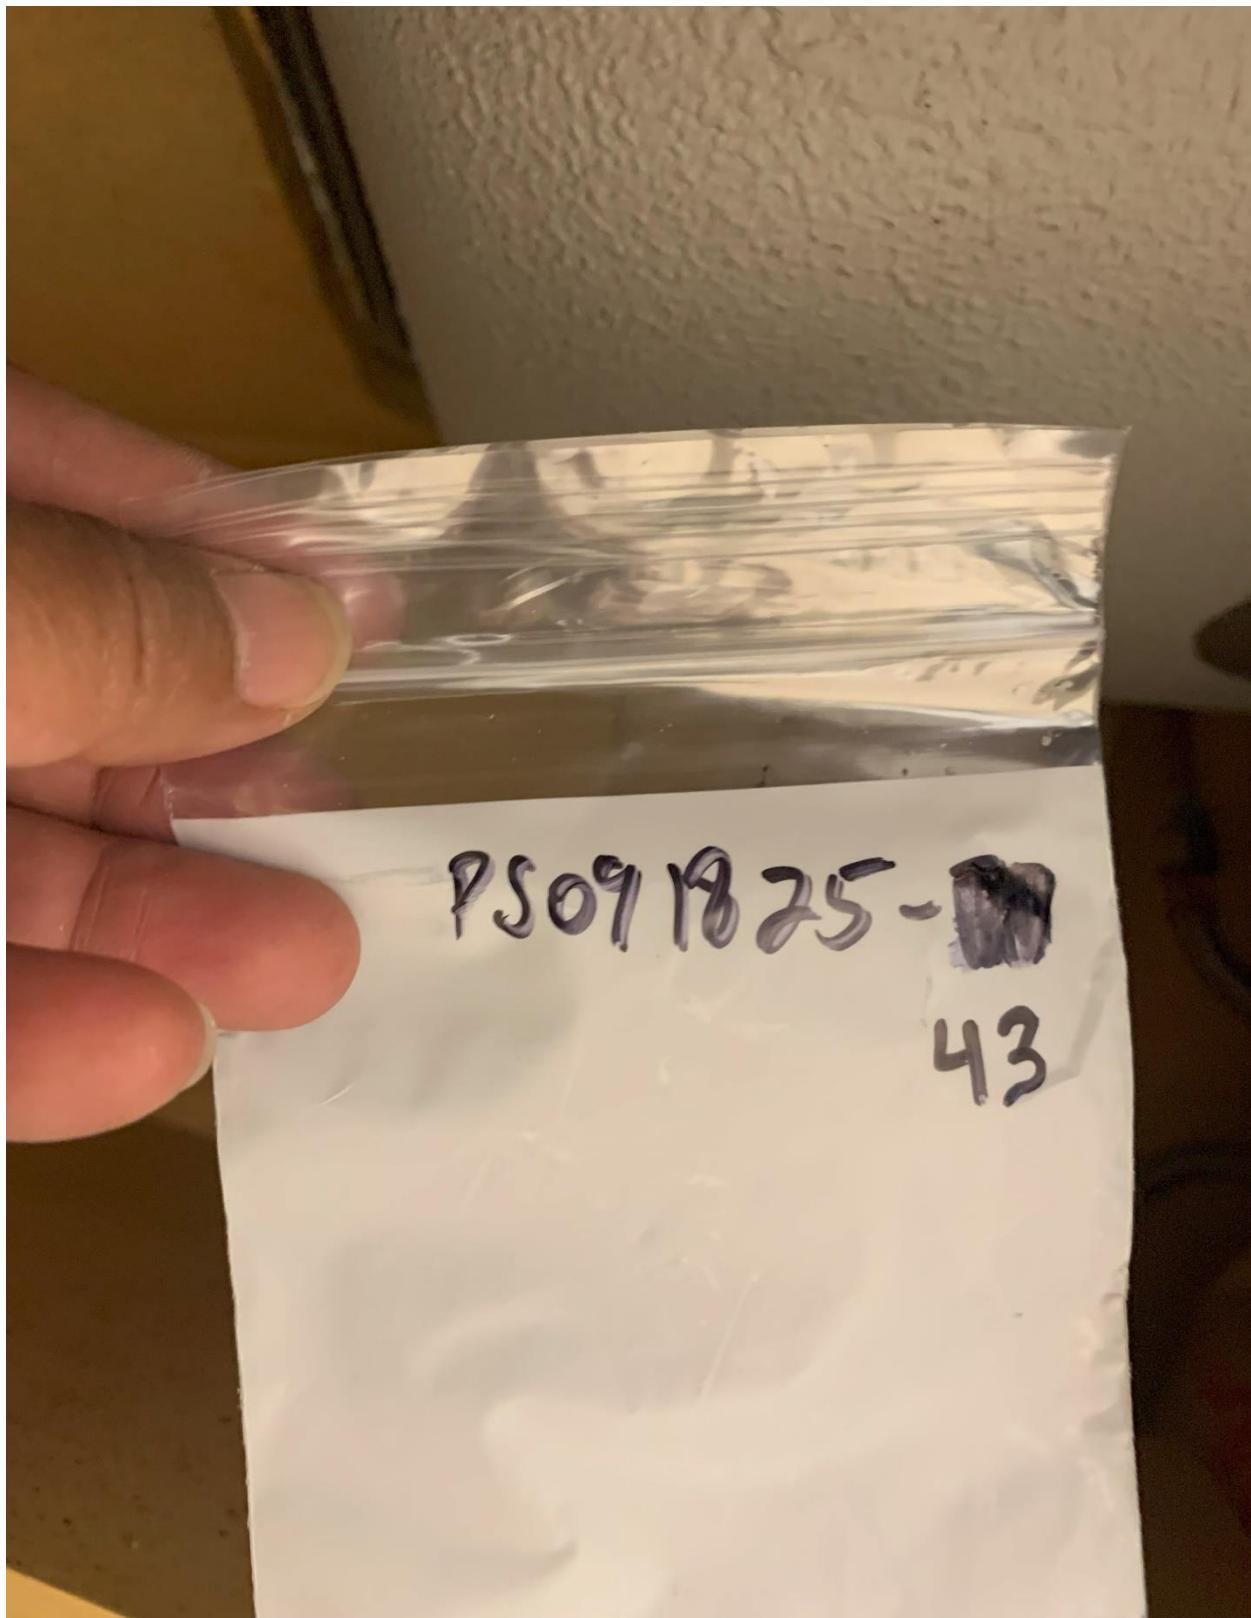
DOW Building - Grey Sink Undercoating – Sample # PS091825-43

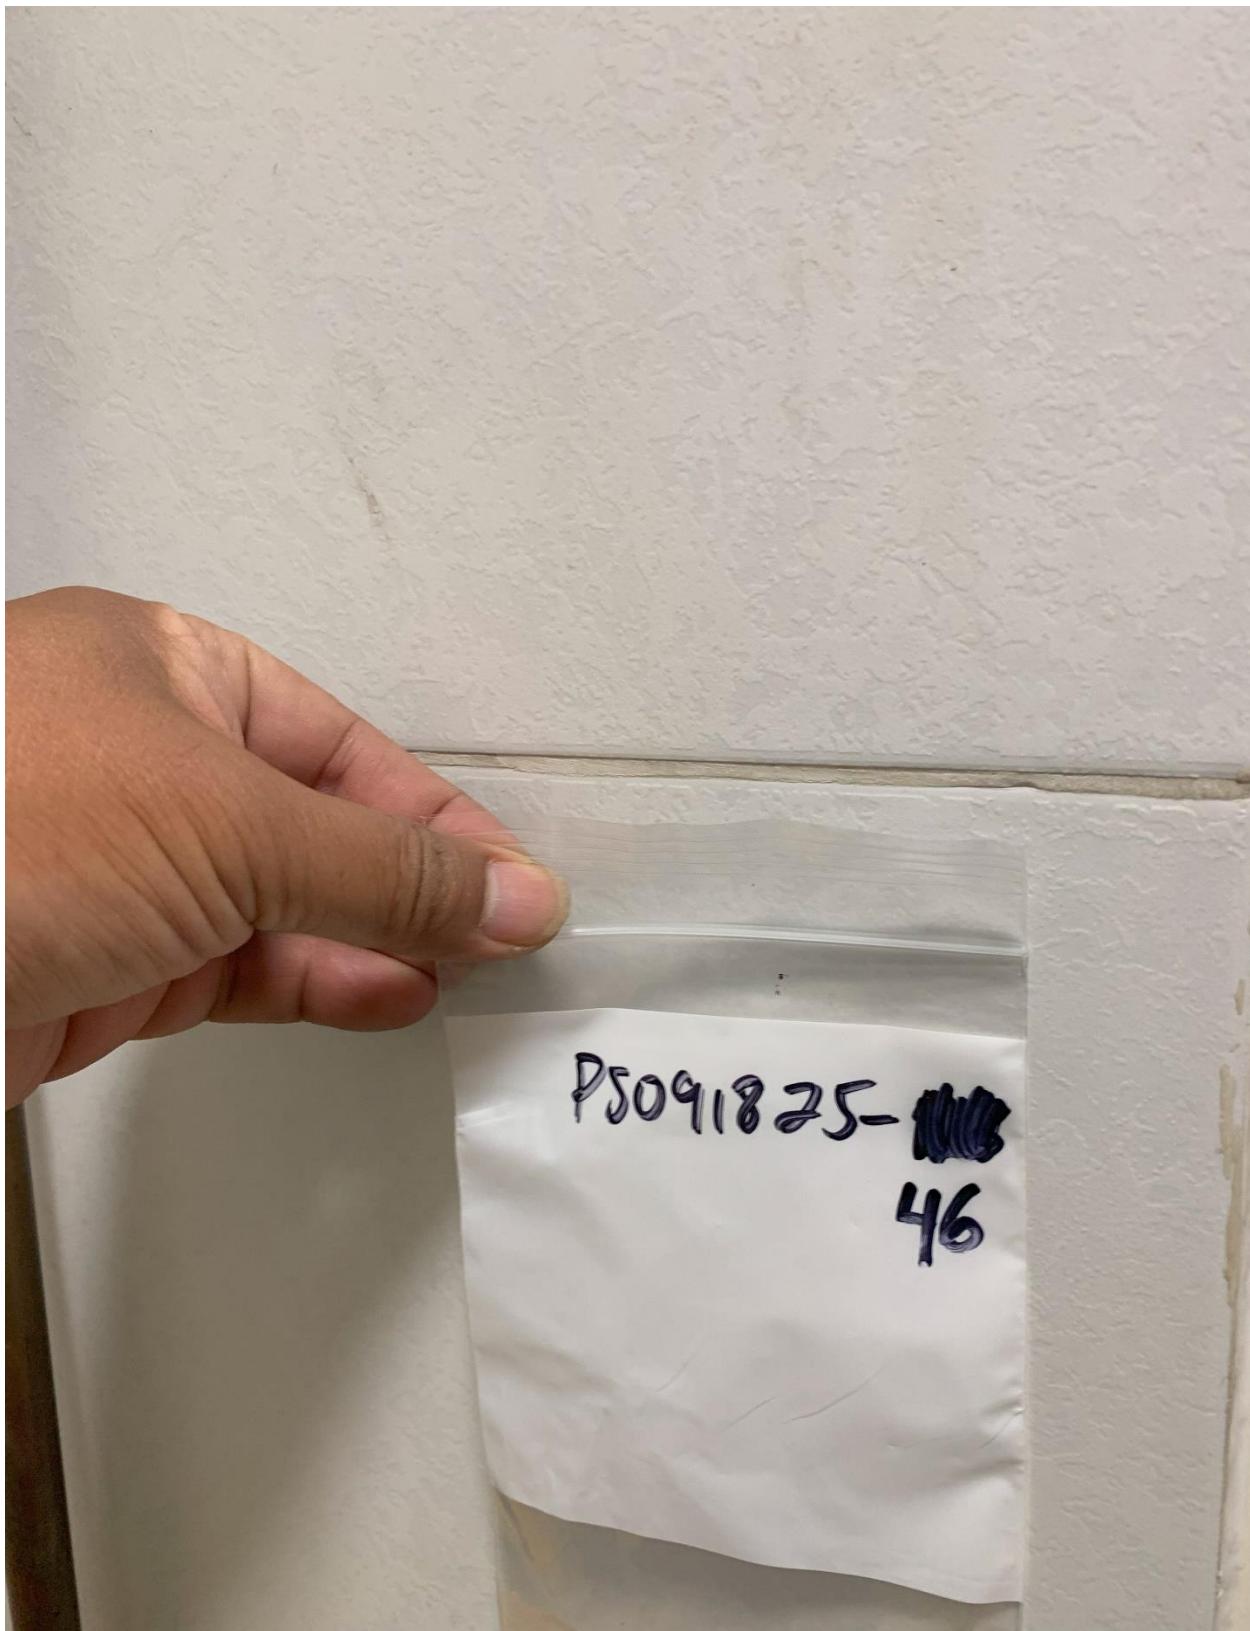
DOW Building - Ceramic Wall Tile – Sample # PS091825-46

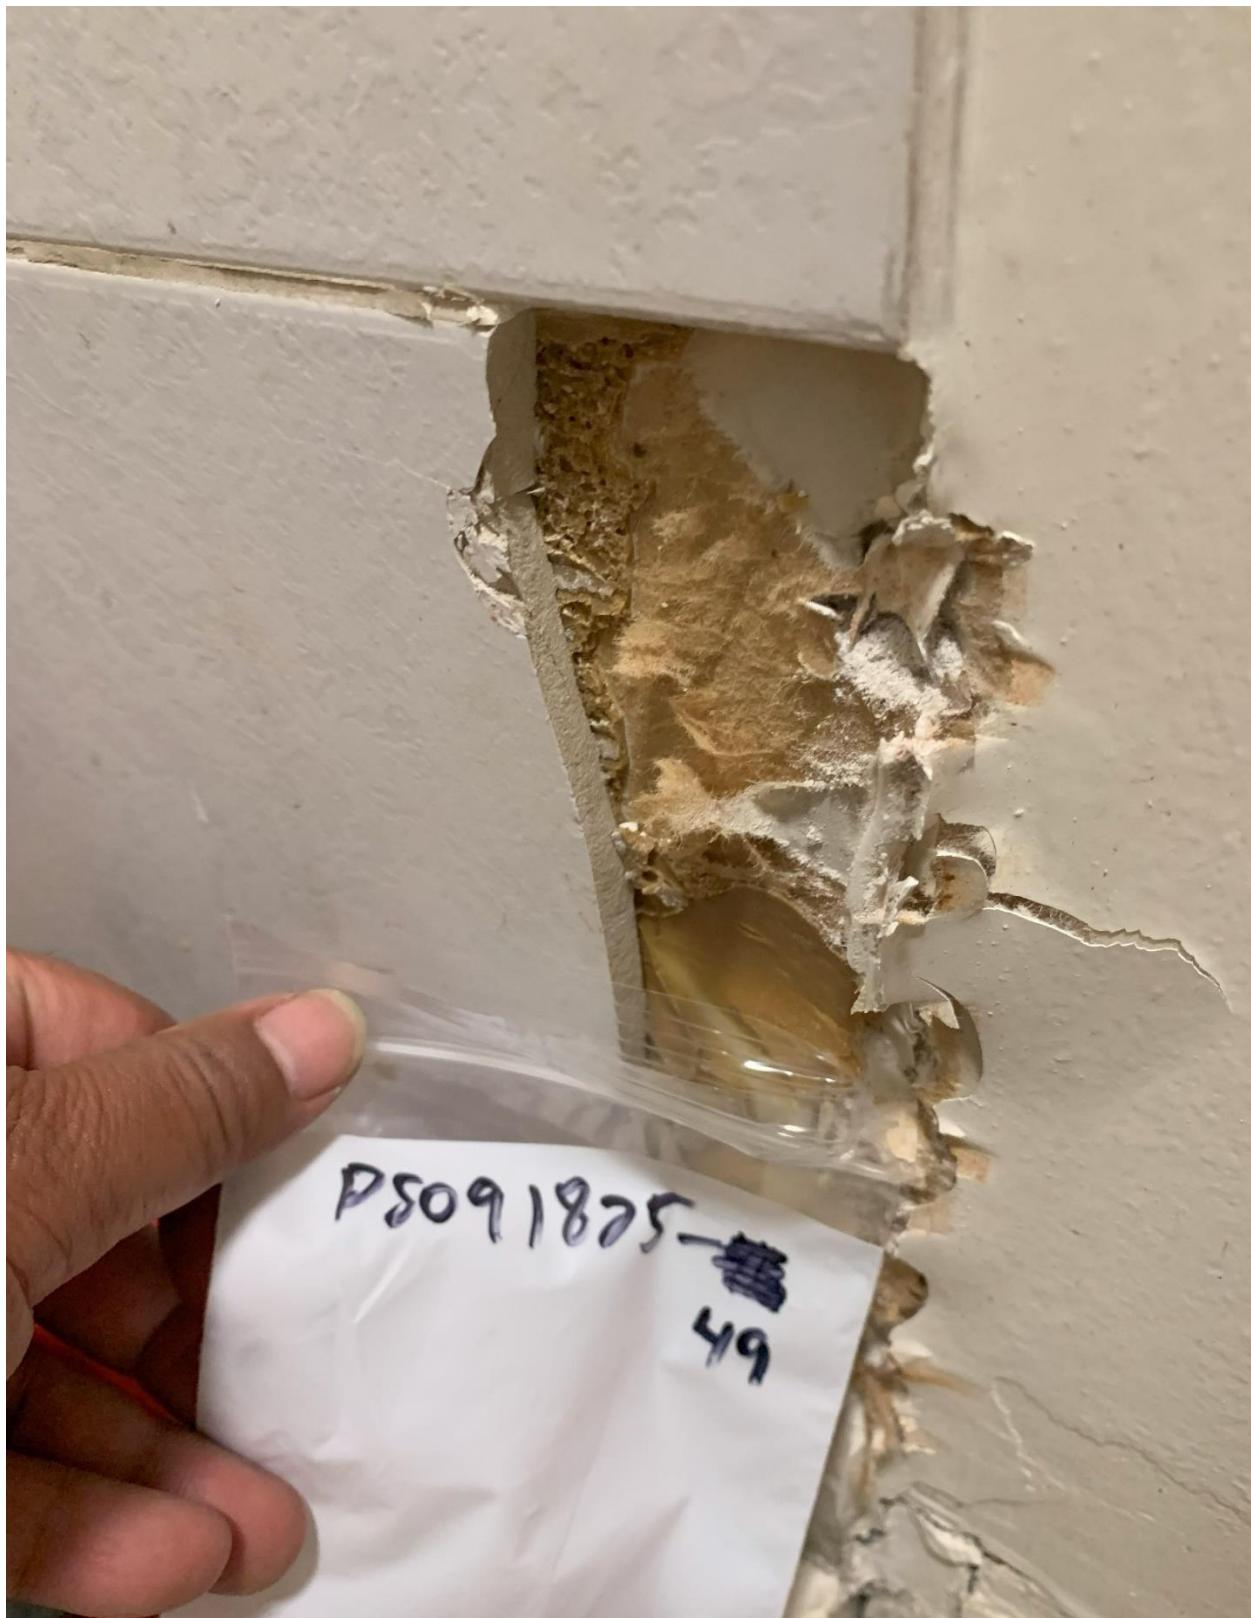
DOW Building - Adhesive for Ceramic Wall Tiles – Sample # PS091825-49

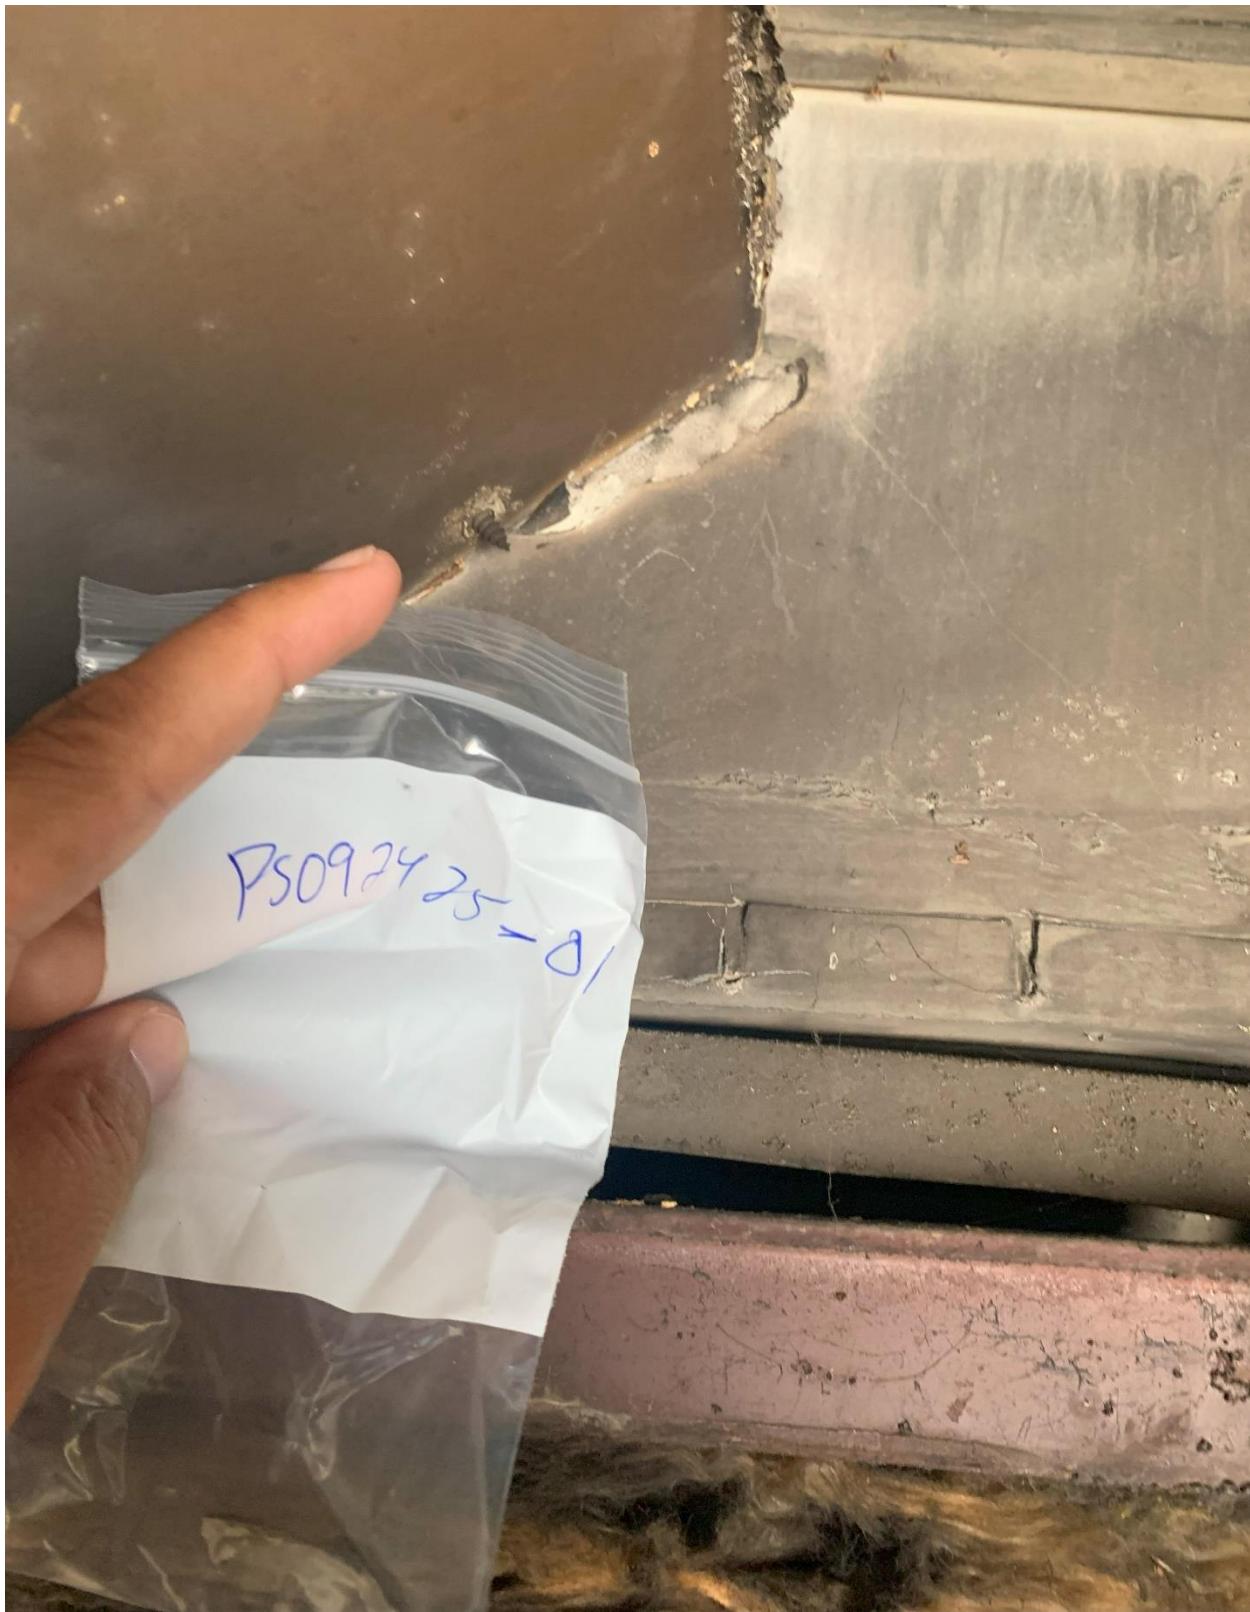
Asbestos containing materials were found to be present during this inspection in the DWM. Asbestos containing roof exhaust caulk were identified on the two (2) ceiling recessed exhausts. The gray caulk is partially exposed to the underside of two (2) exhaust manifolds accessible from the garage bay area with a lift. Licensed asbestos contractors should assist general trade contractors in any ceiling exhaust disturbance or activities associated with roof exhaust. All other suspect materials in the DWM were none detected for asbestos.

DOW Building - Rectangle Roof Exhaust Caulk – Sample # PS092425-DWM01

- Asbestos containing materials in good condition do not pose a risk to occupants unless disturbed. Any renovation, repair, replacement or demolition activities will require asbestos abatement done by a licensed asbestos contractor.
- Incorporate the data from this report into future demolition/renovation documents regarding the presence of ACM.
- If suspect containing materials not listed in the Tables of this report are discovered, contact TEM Environmental, Inc. for additional sampling.
- All future asbestos removal and/or demolition/renovation work involving the disturbance of ACM shall be conducted by IDPH licensed asbestos abatement contractors in accordance with IDPH, OSHA and City of Chicago asbestos regulations and requirements.
- Dispose of ACM generated during removal and/or renovation/demolition with all applicable federal, state, and local regulations.

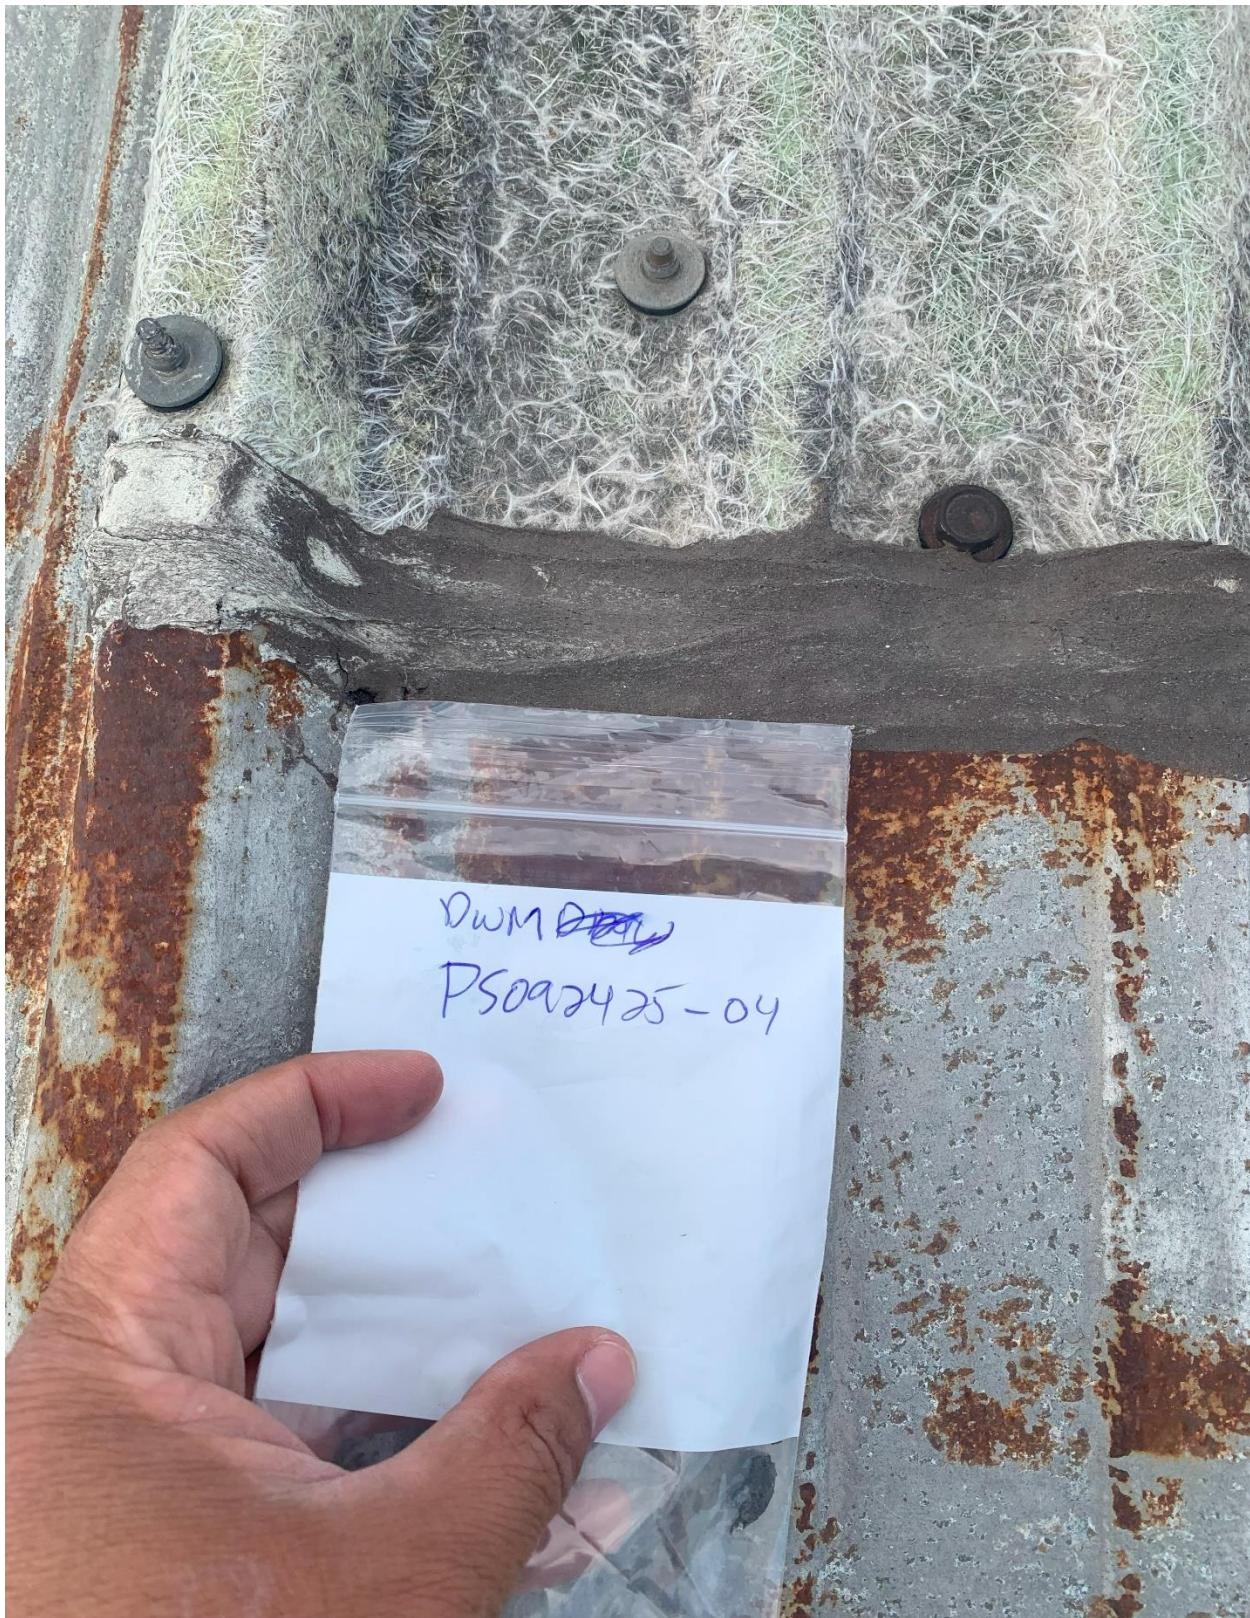
DOW Building - Grey Roof Caulk – Sample # PS092425-DWM04

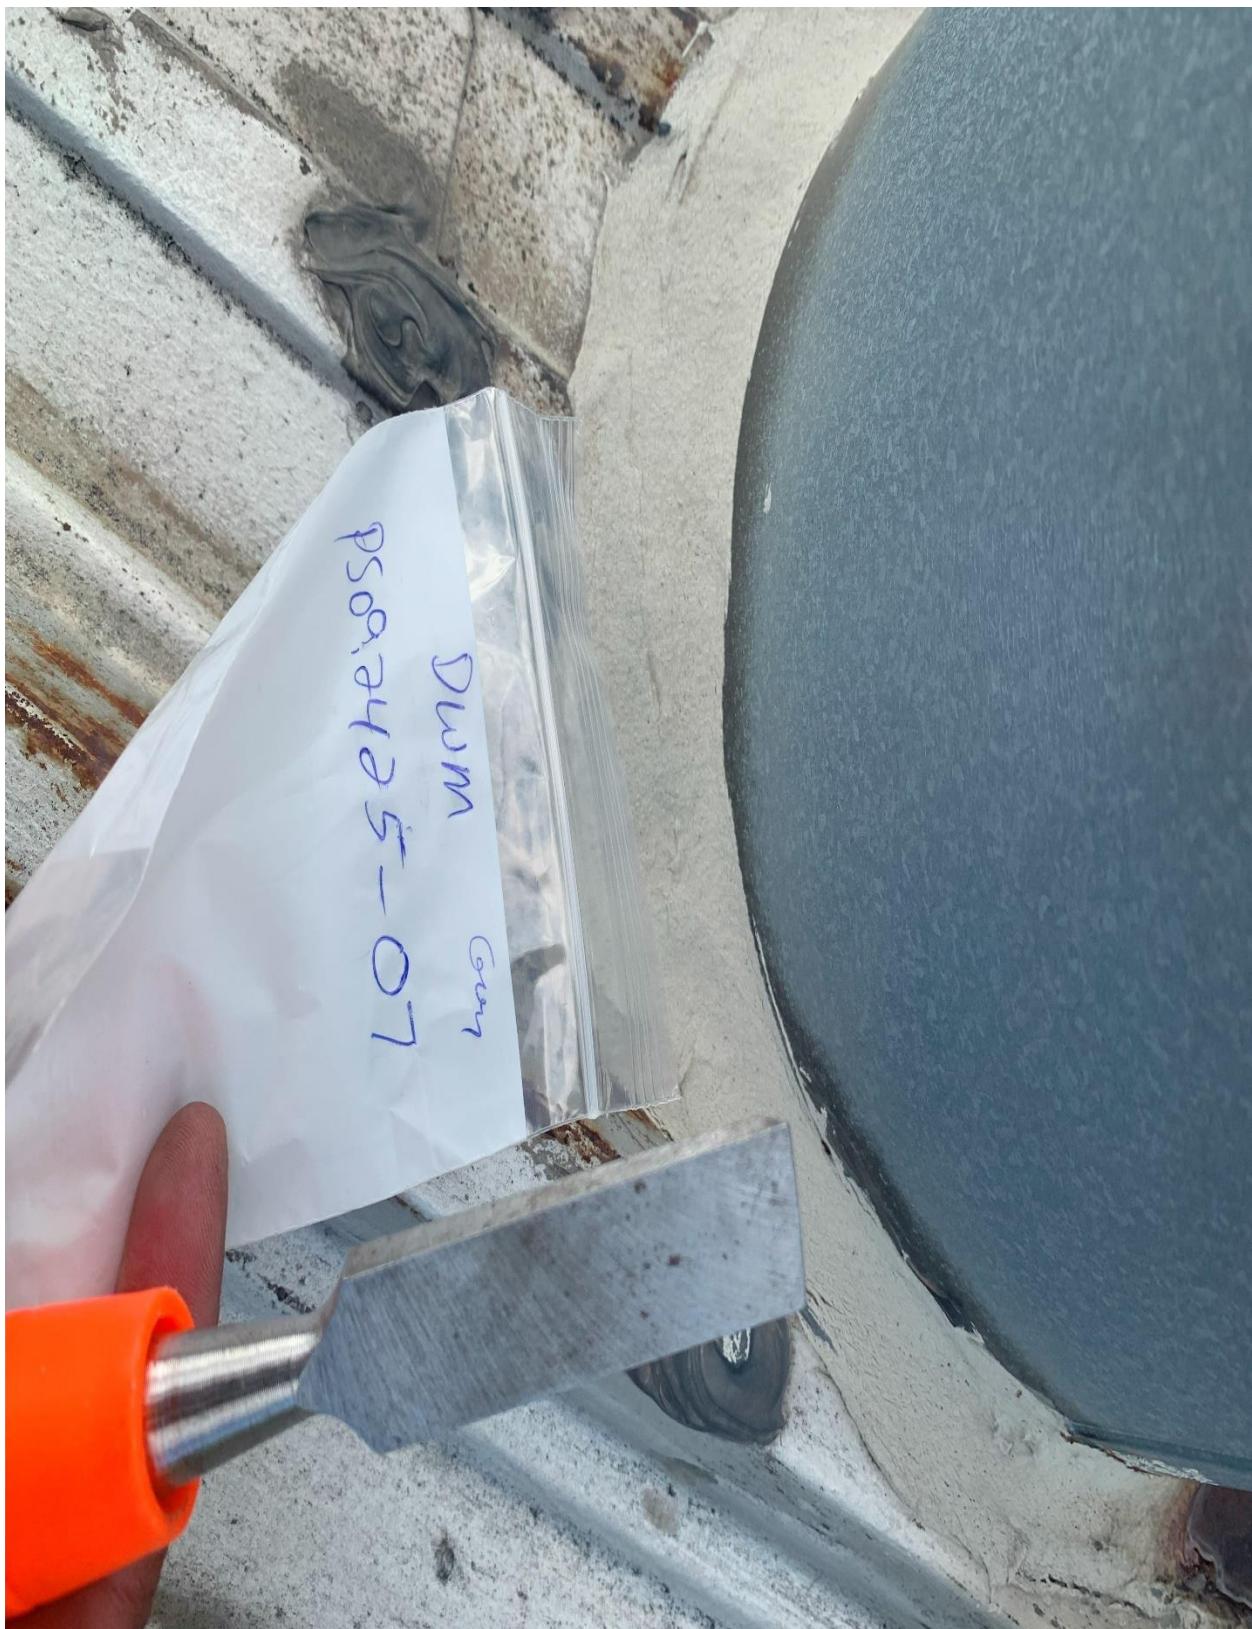
DOW Building - Grey Roof Caulk – Sample # PS092425-DWM07

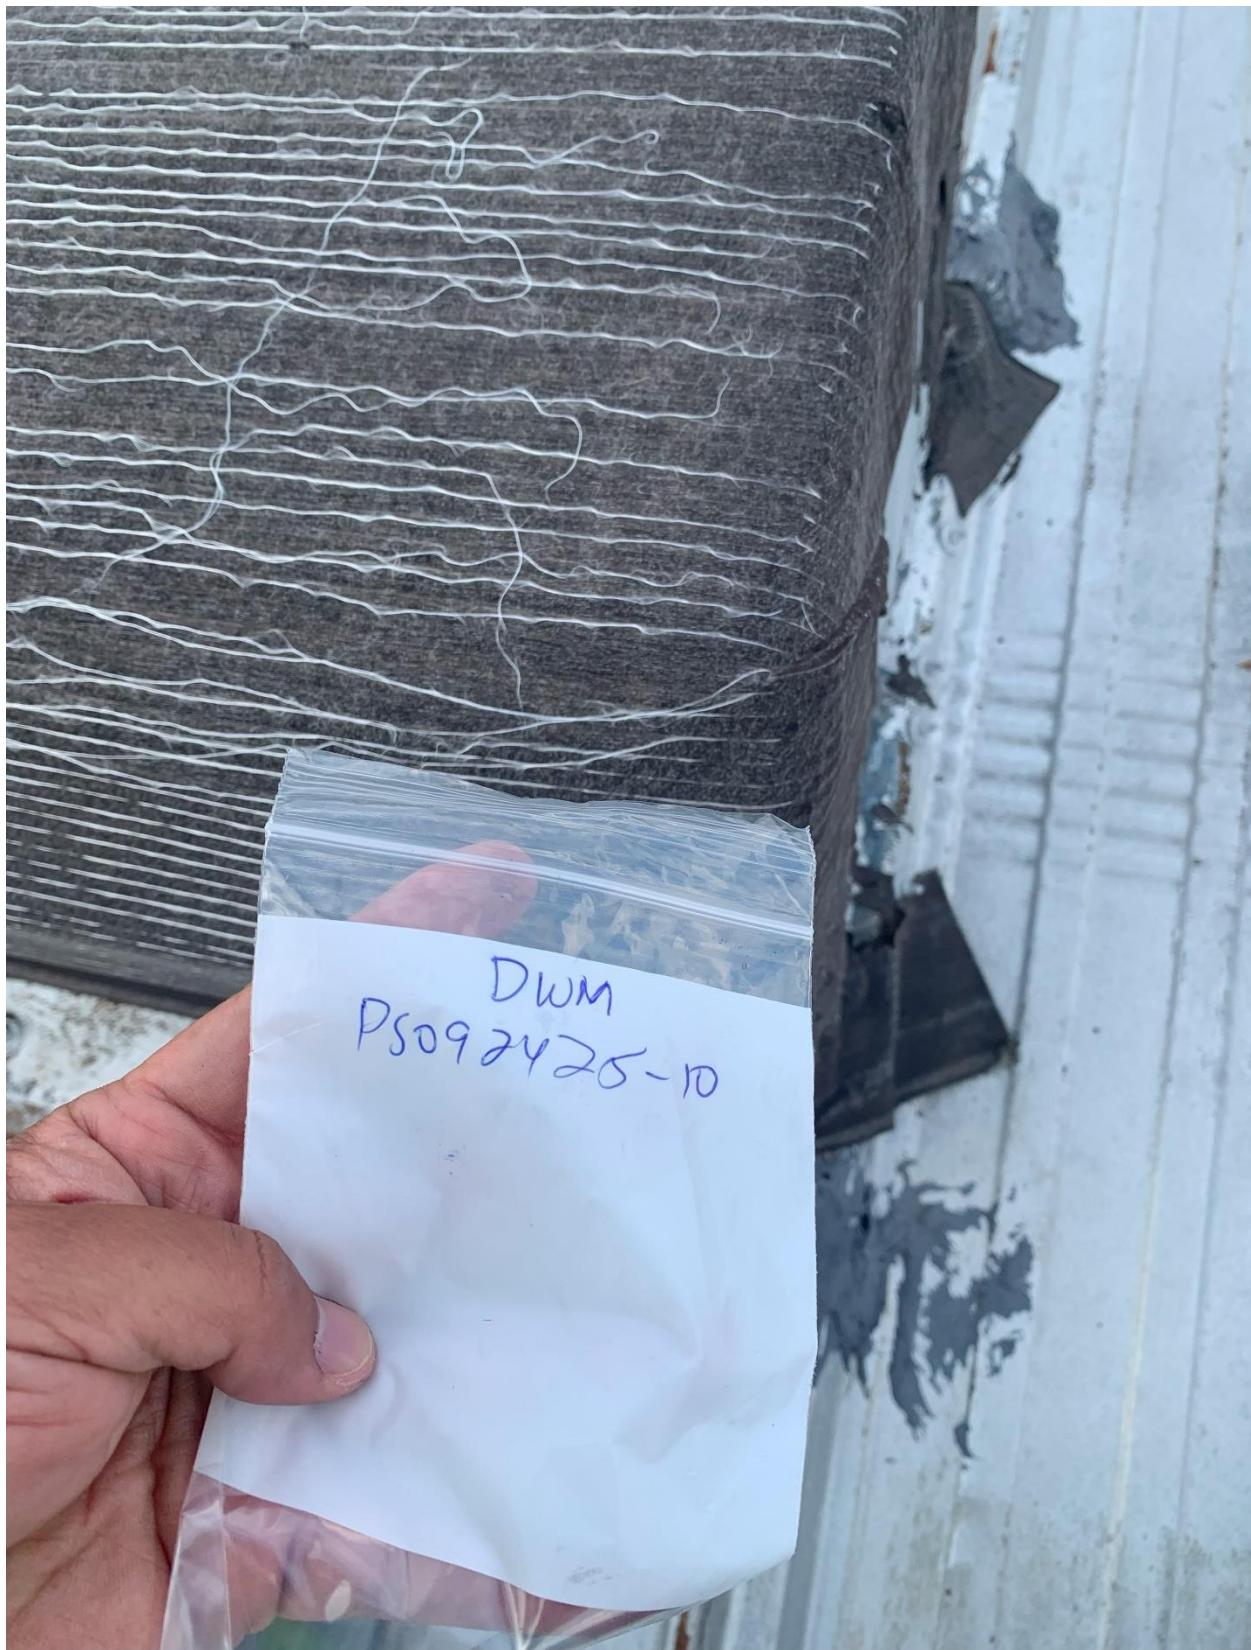
DOW Building – Roof Felt Cover – Sample # PS092425-DWM10

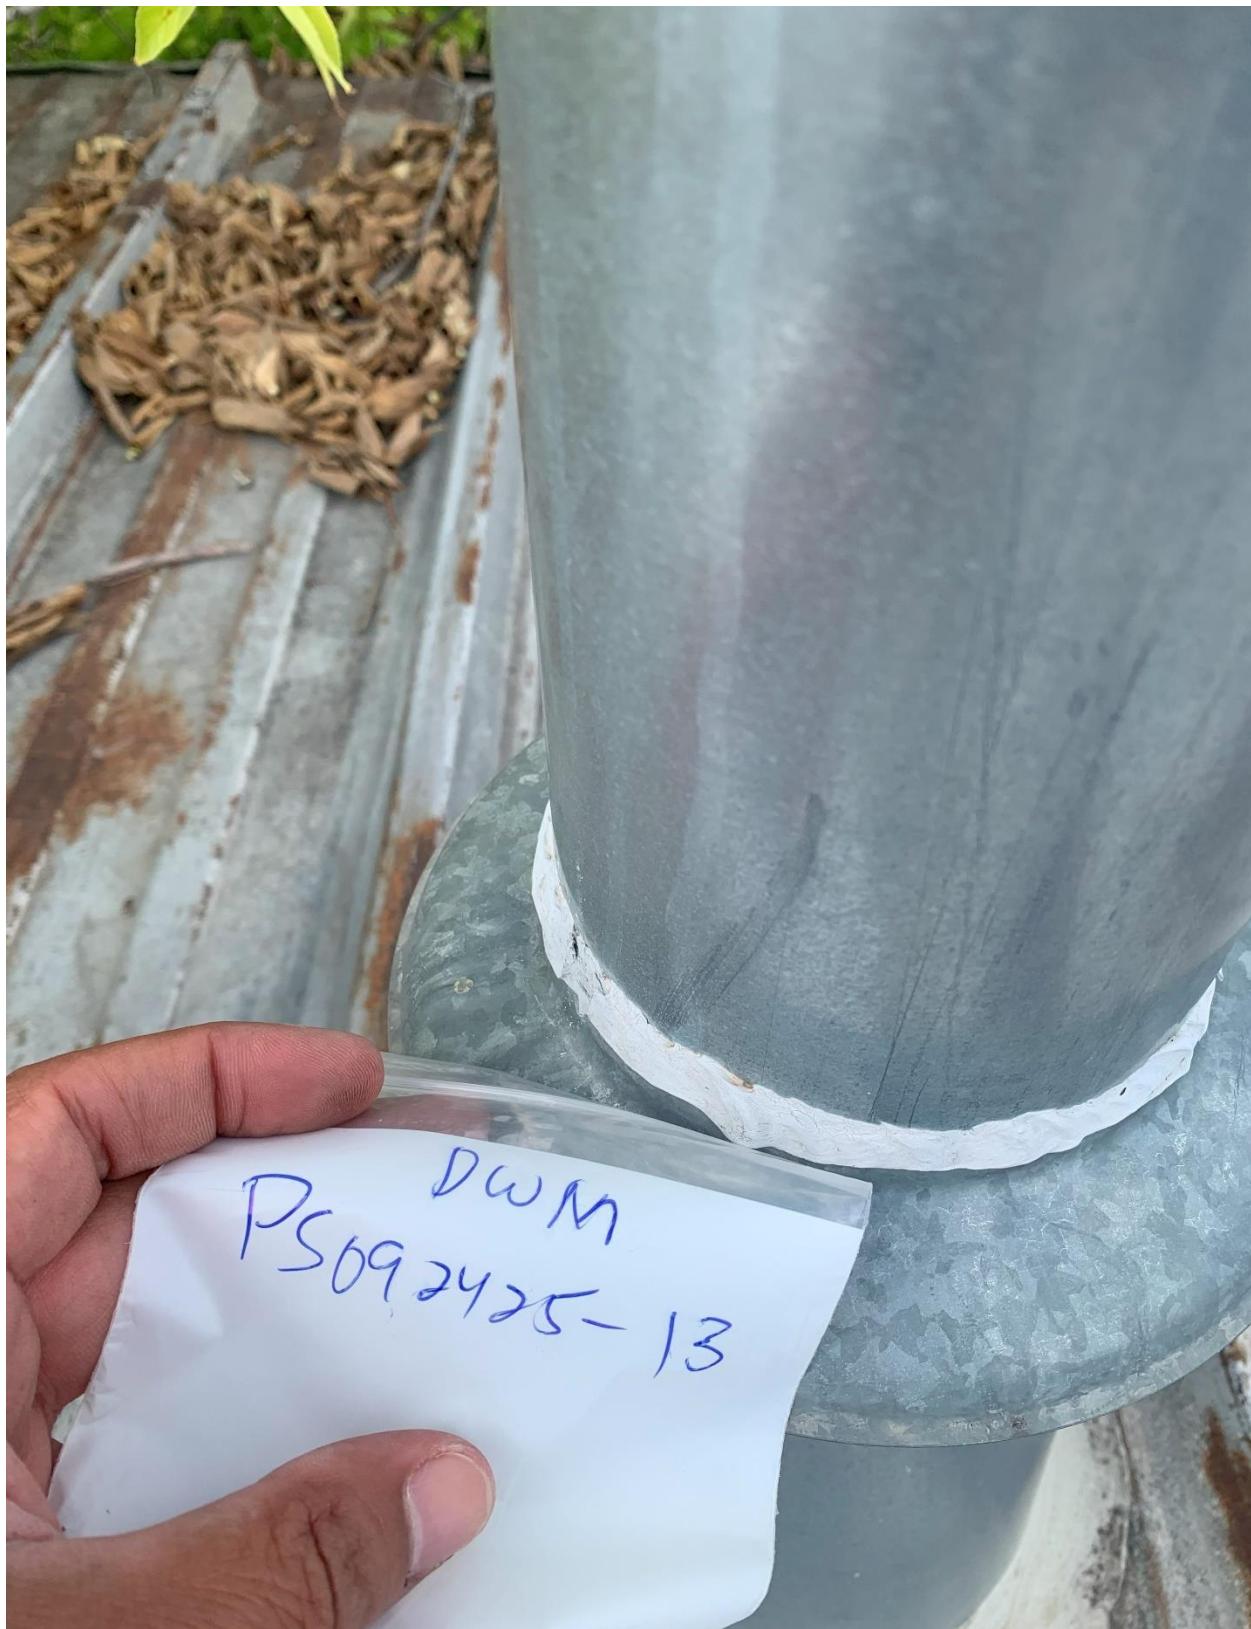
DOW Building – White Caulk on Exhaust Tube – Sample # PS092425-DWM13

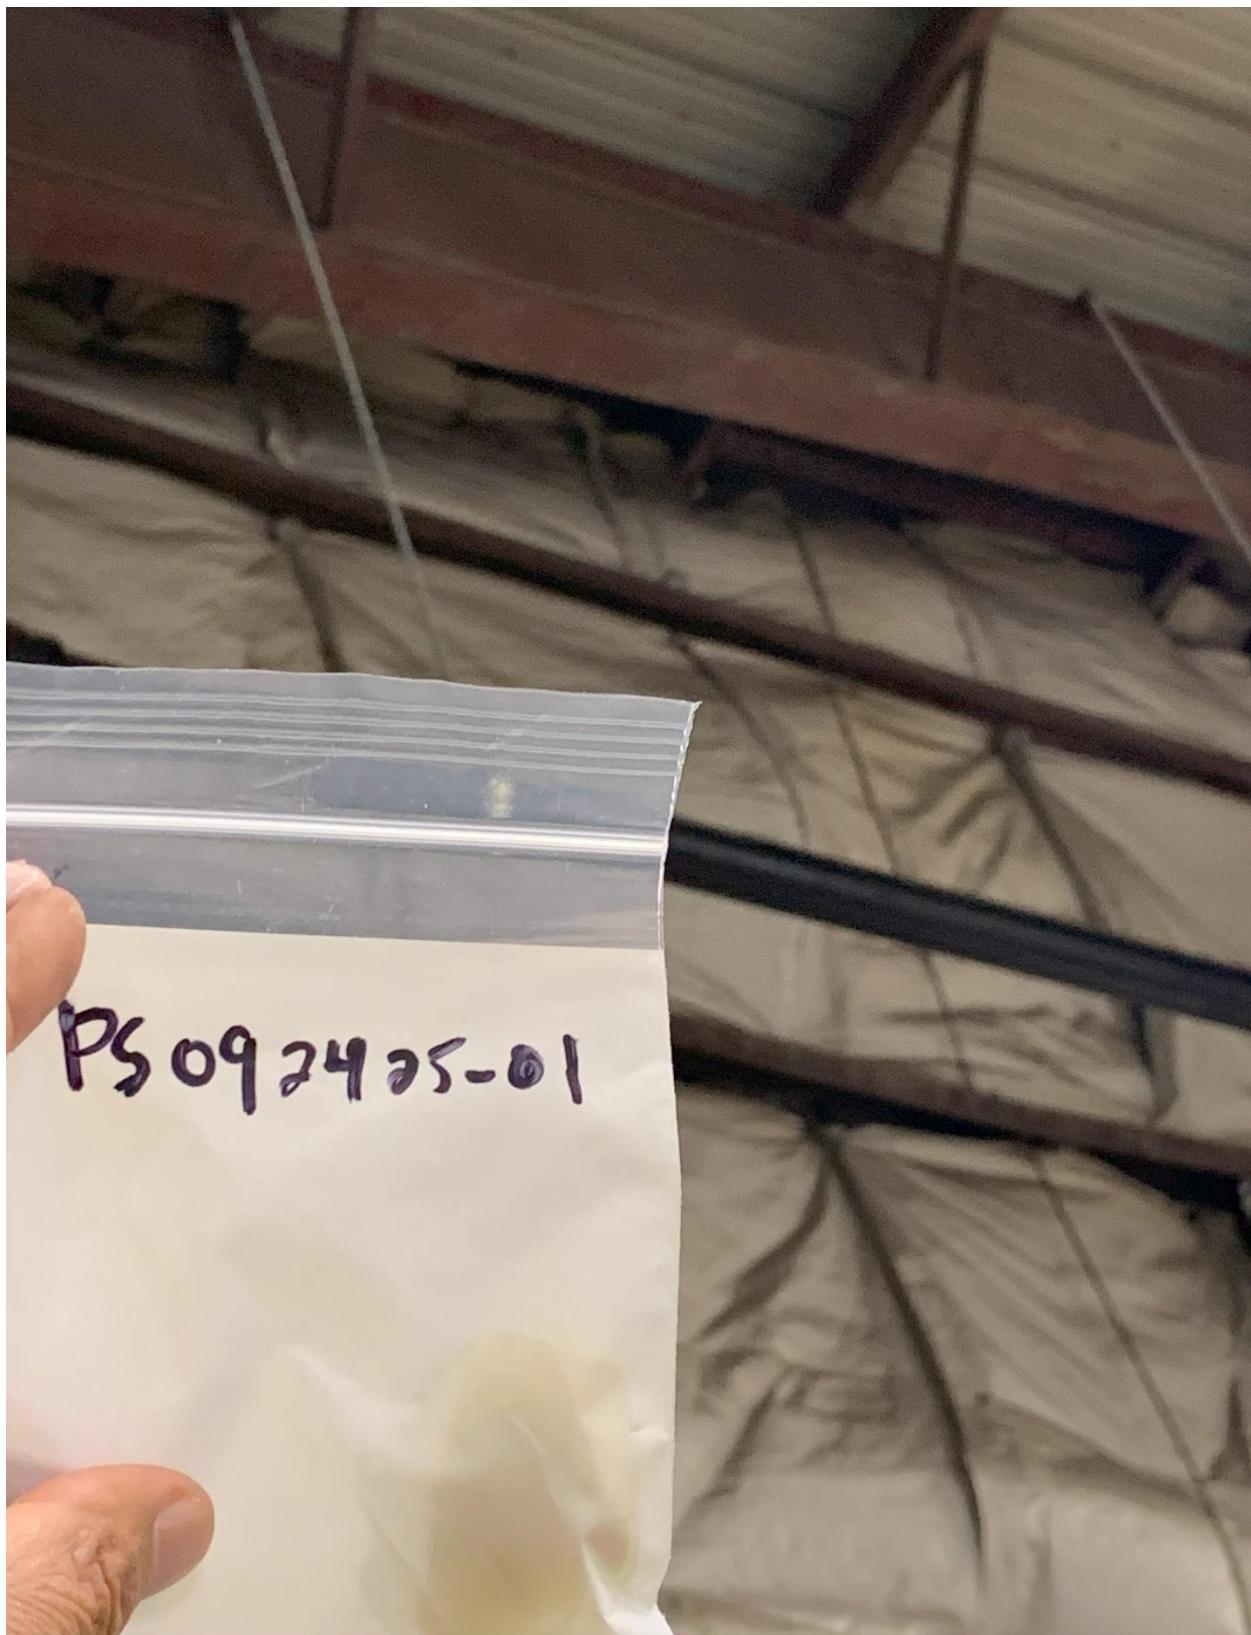
Streets and Sans Building – Wall Insulation – Sample # PS092425-01

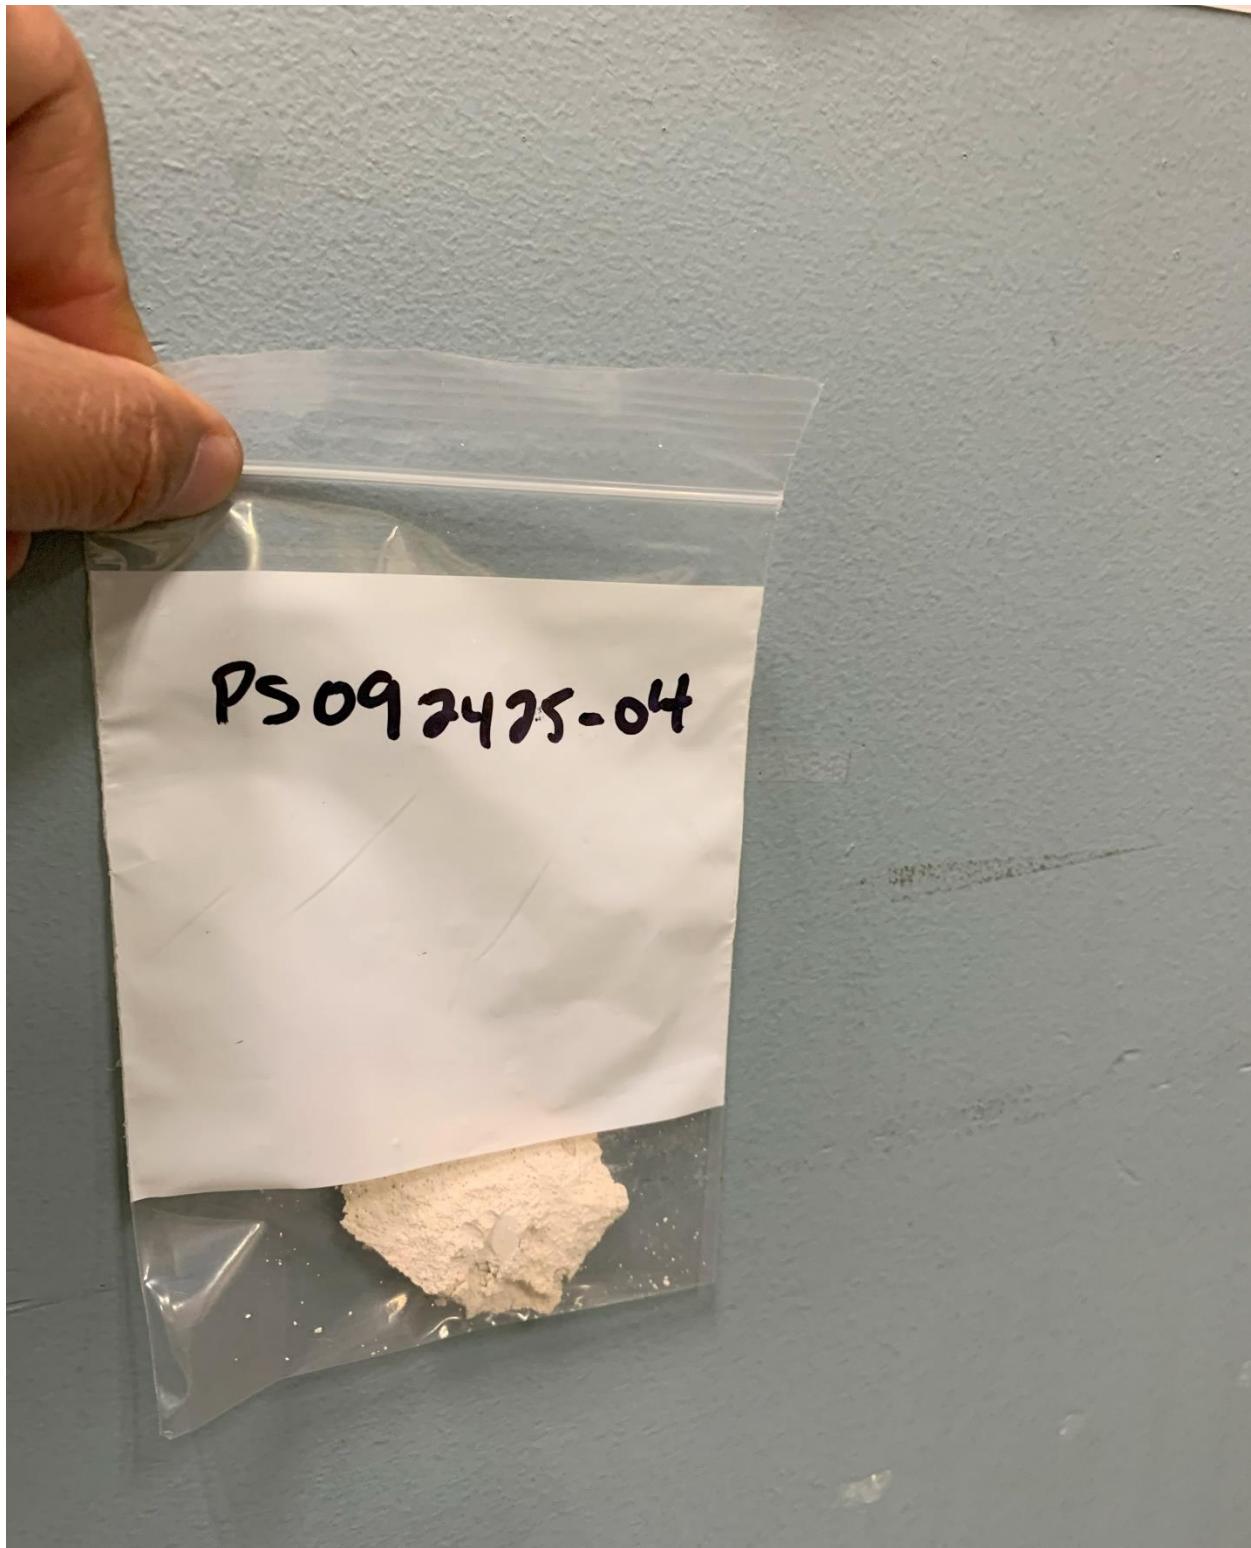
Streets and Sans Building – Drywall – Sample # PS092425-04
