Asbestos Building Inspection

Public Building Commission of Chicago  
Richard J. Daley Center, Room 200  
50 West Washington Street  
Chicago, Illinois 60602

Department of Water Management  
Operations Facility - DOW 04029  
4825 W. Lawrence Avenue  
Chicago, Illinois 60630

October 14, 2025  
TEM Project 77496

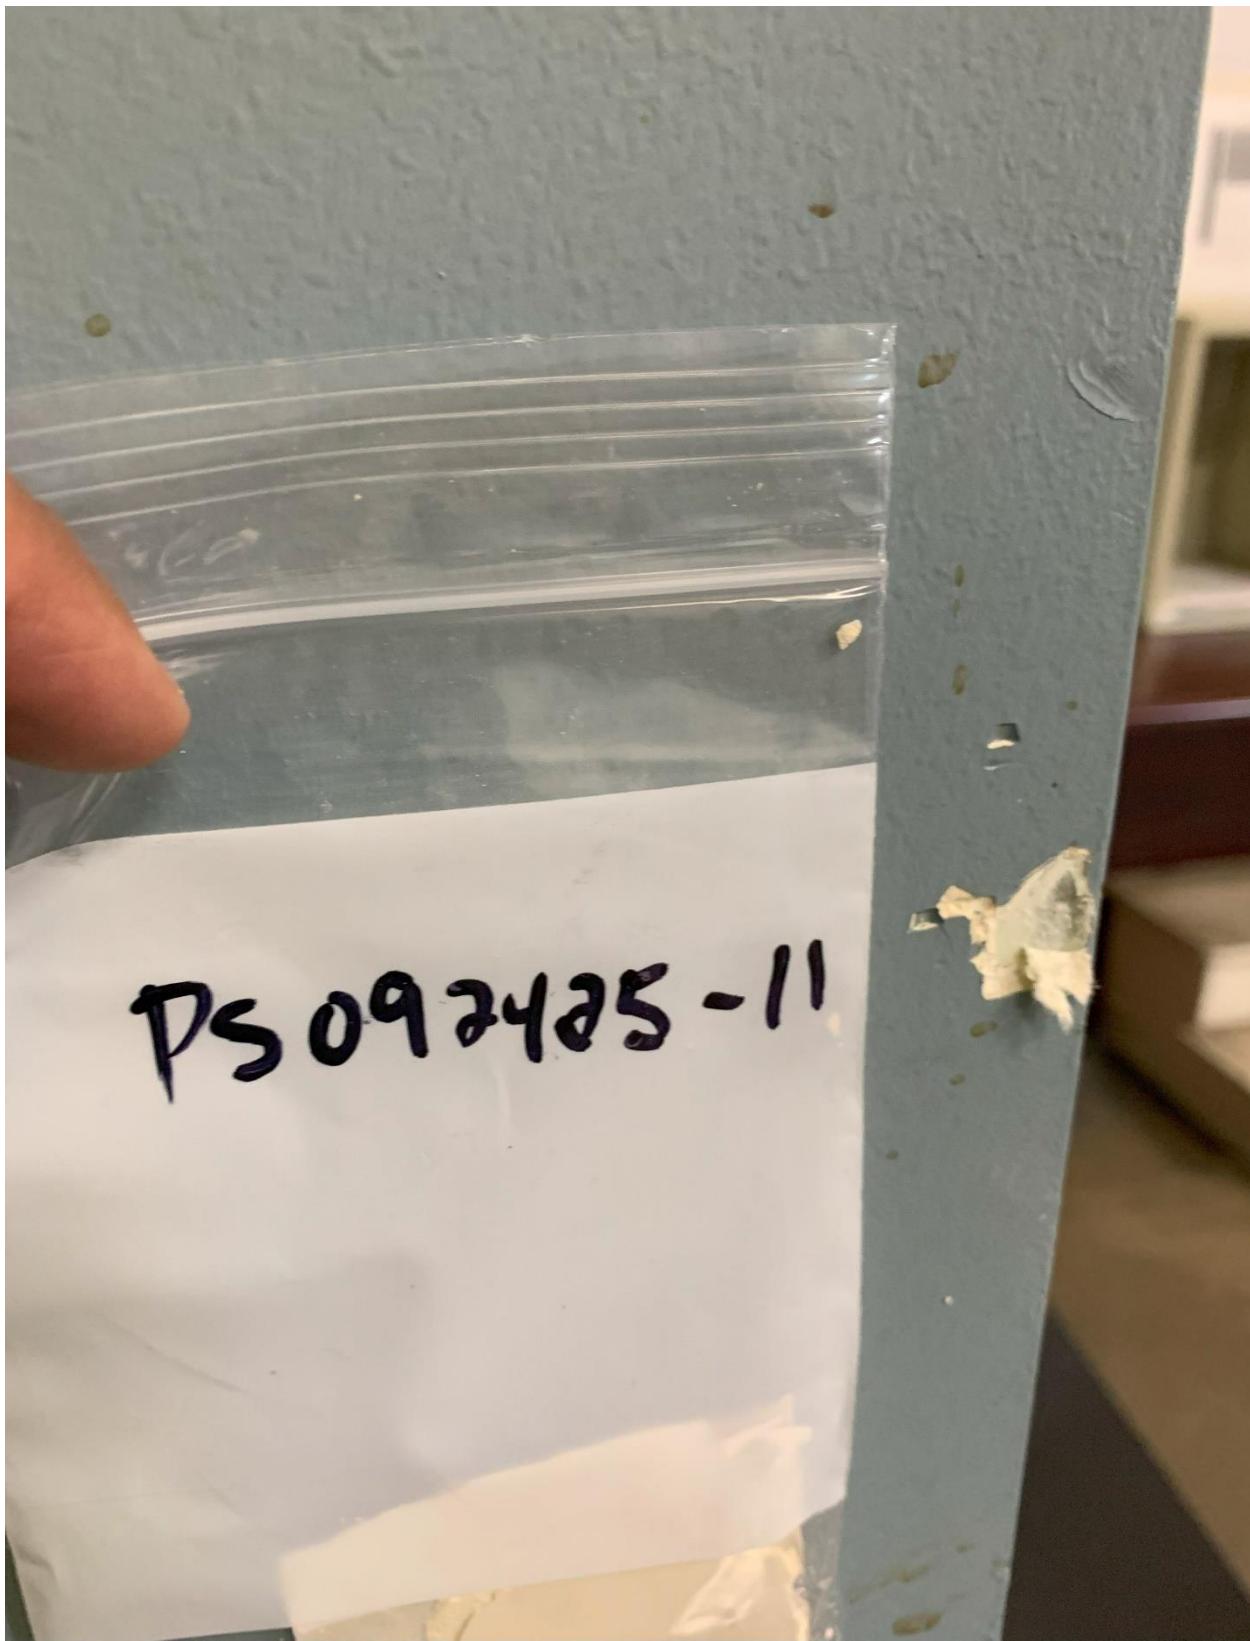
Streets and Sans Building – Drywall Joint Compound – Sample # PS092425-11

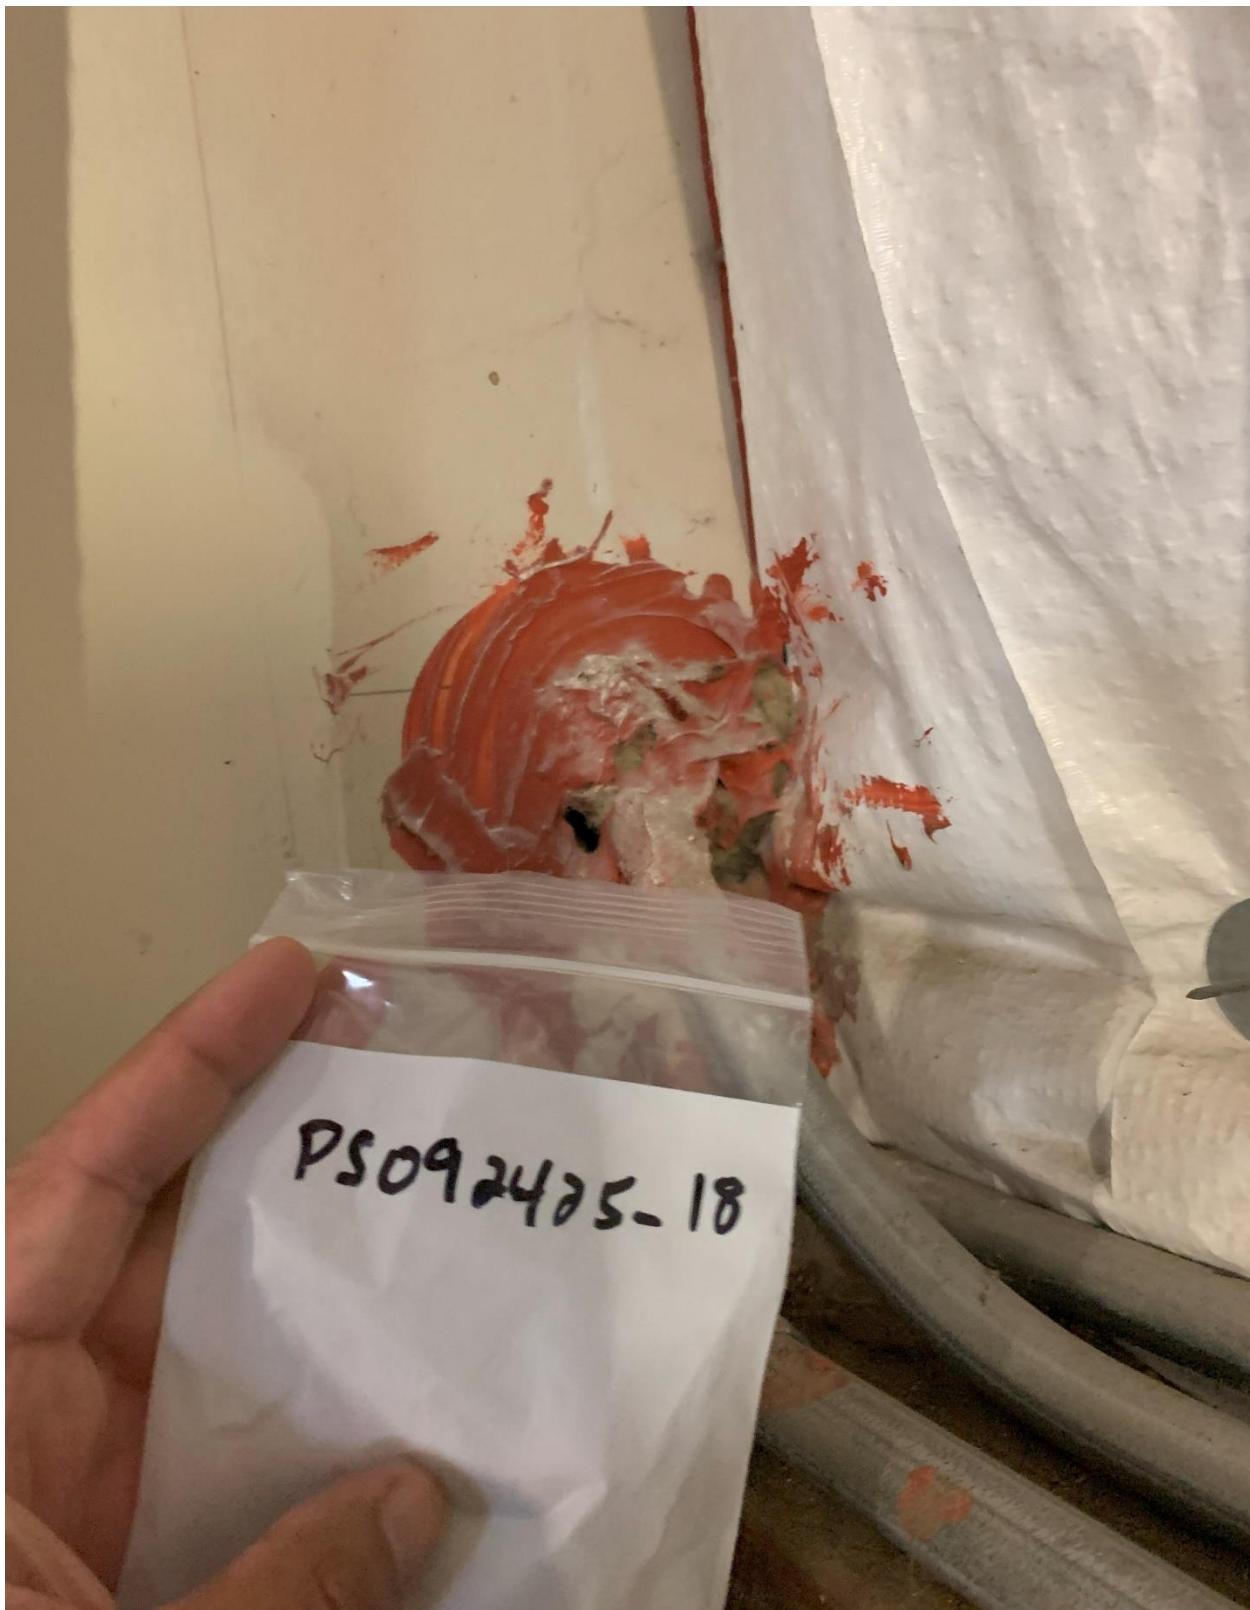
Streets and Sans Building – Red Fire Rated Wall Caulk – Sample # PS092425-18

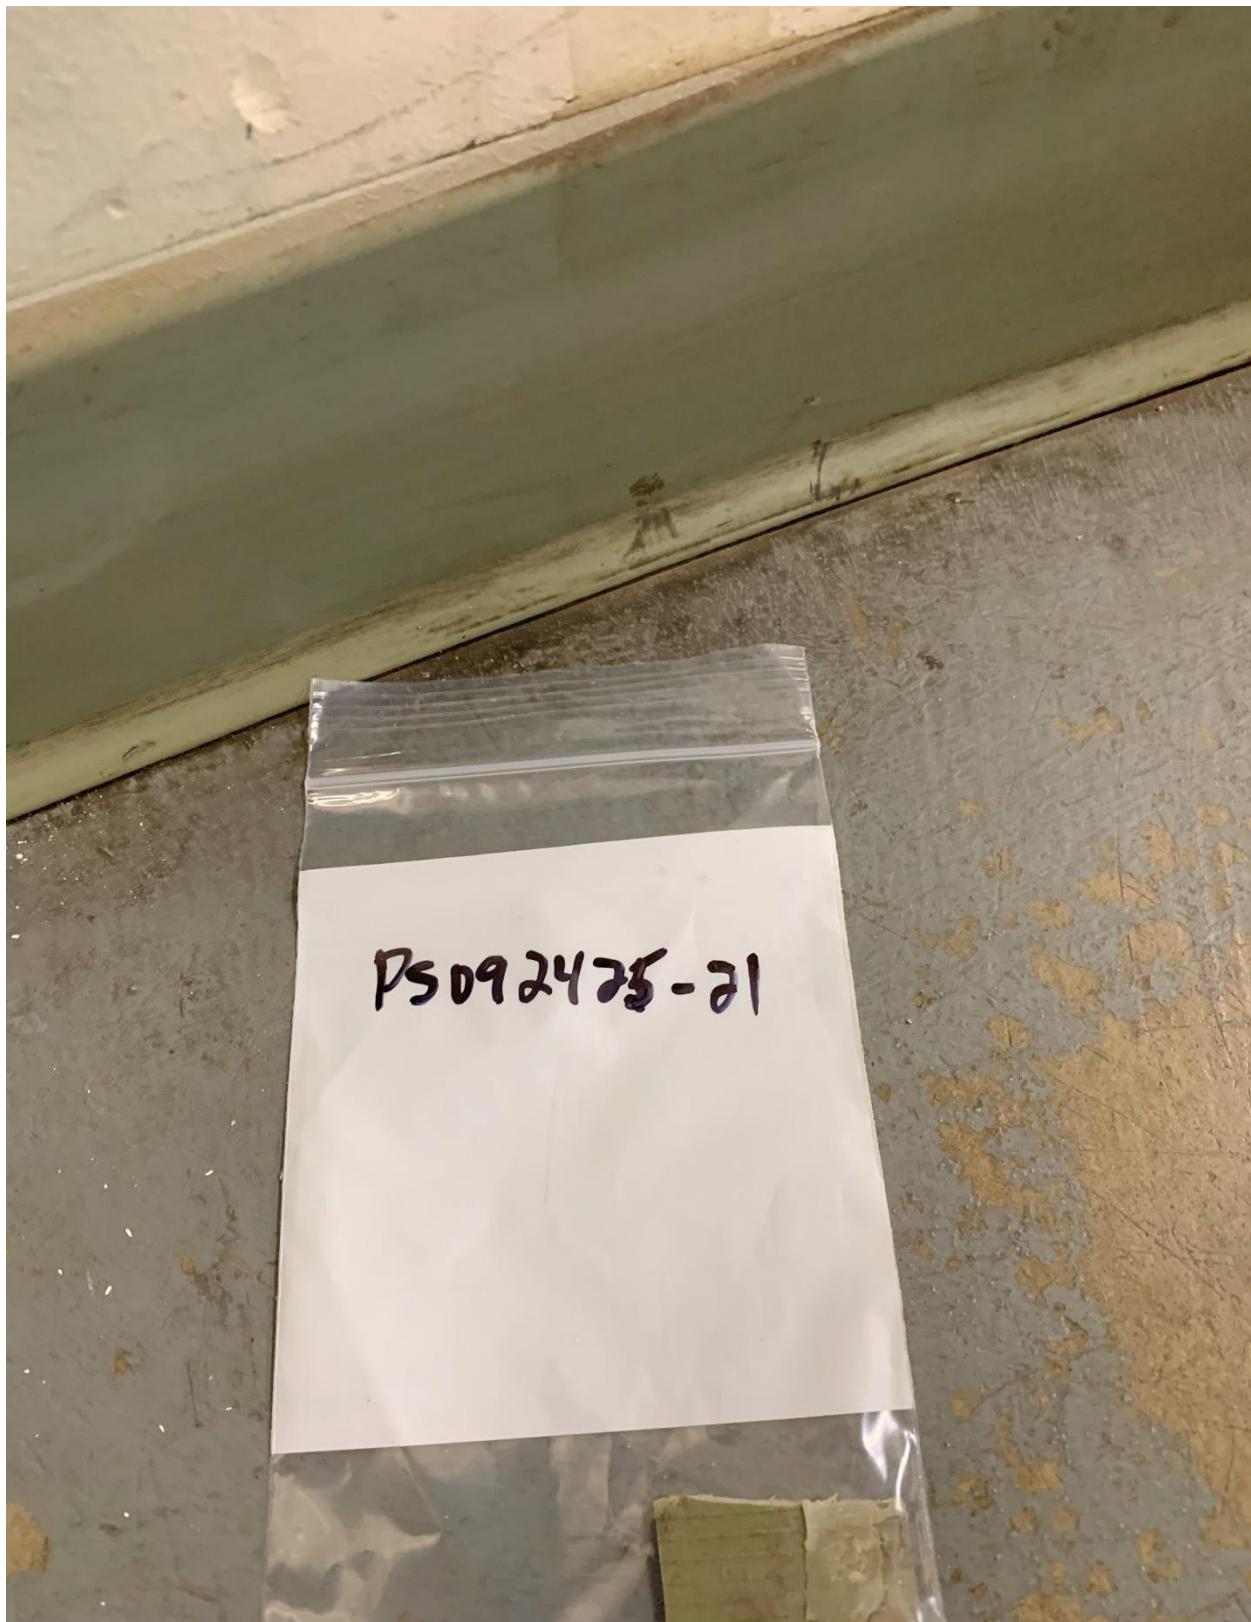
Streets and Sans Building – 4" Grey Baseboard – Sample # PS092425-21

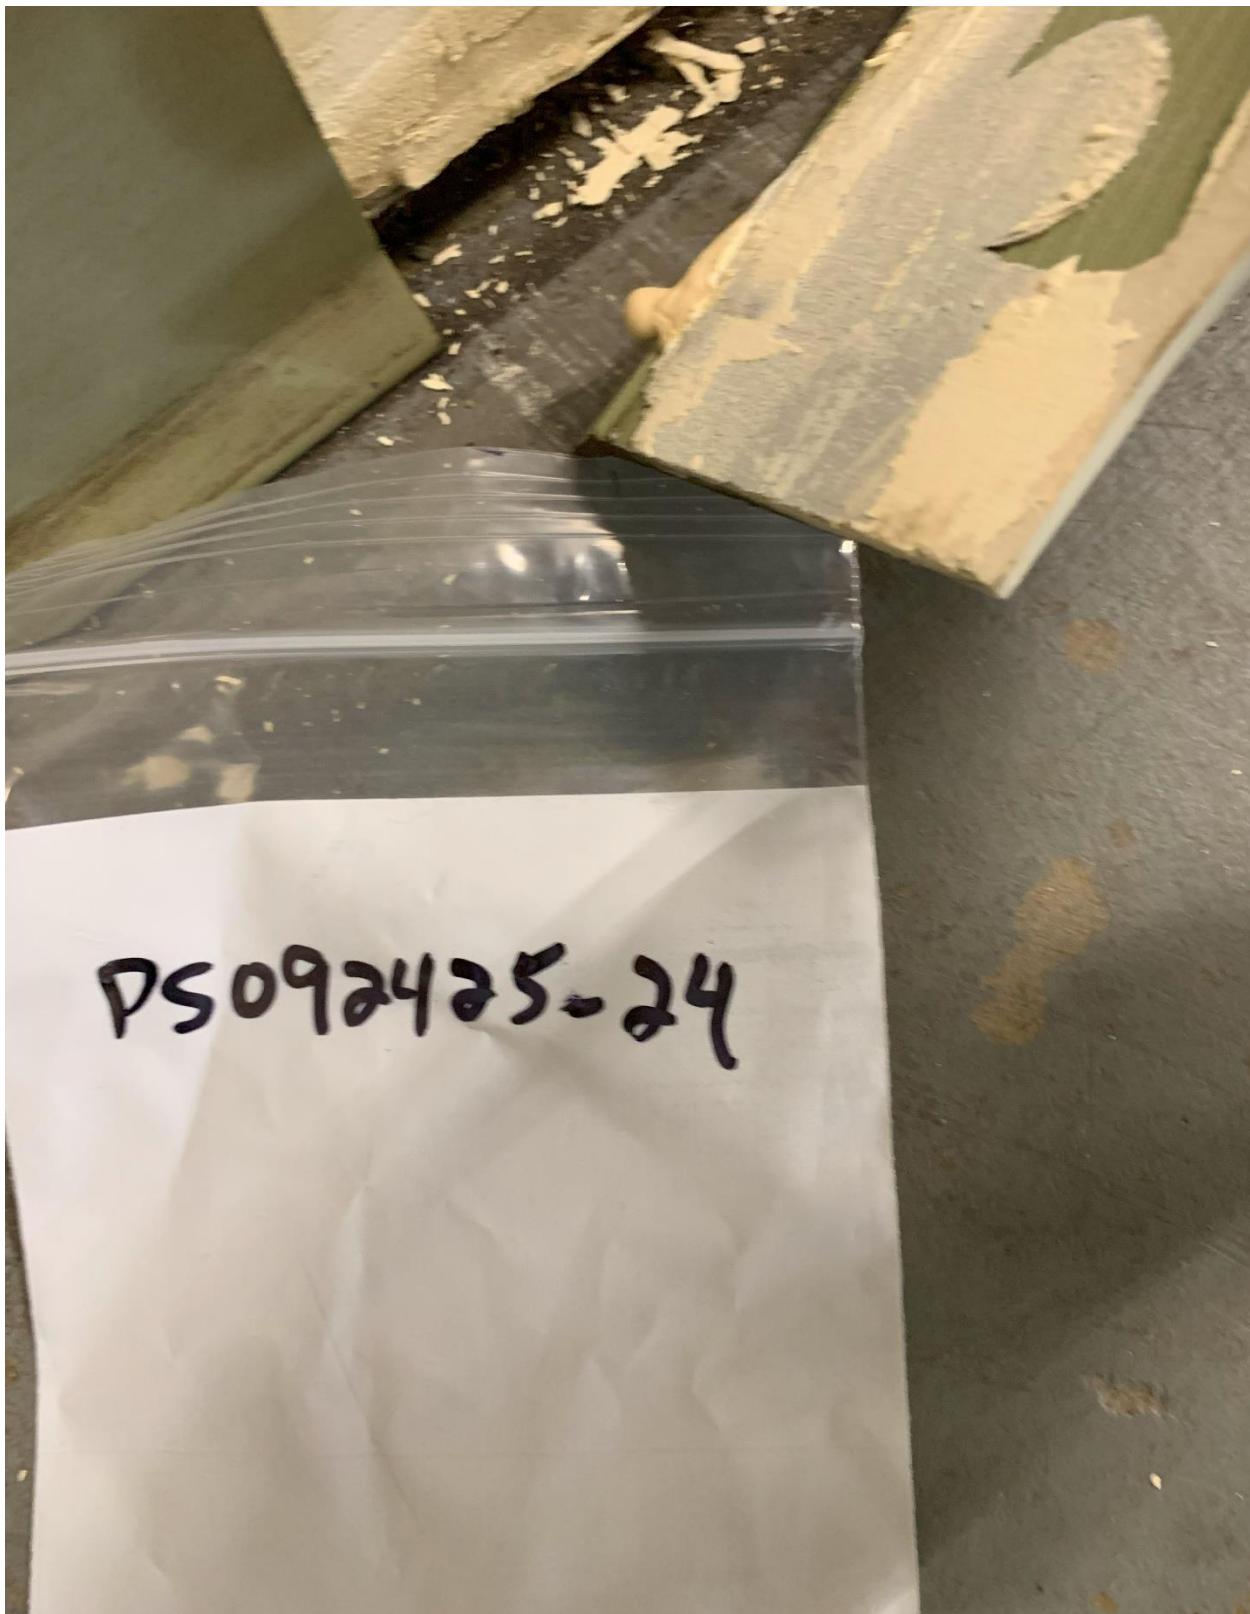
Streets and Sans Building – Adhesive for 4" Grey Baseboard – Sample # PS092425-24

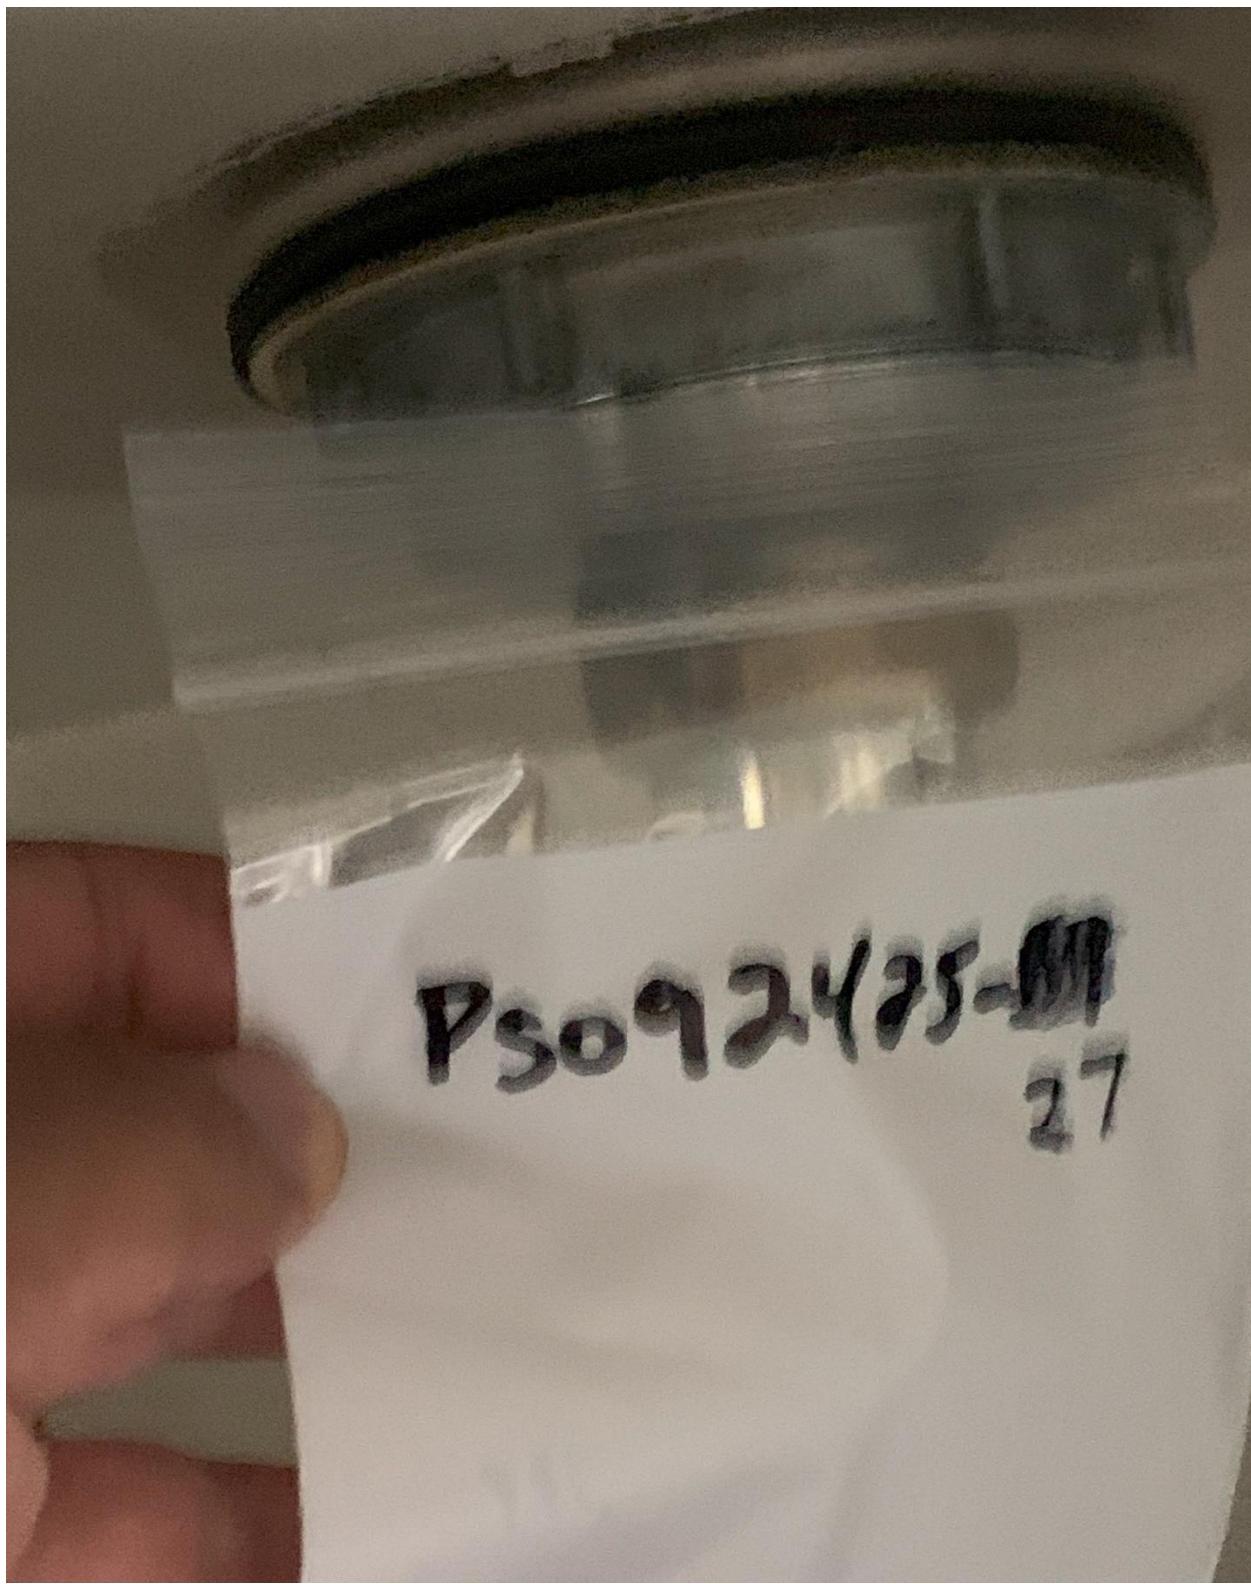
Streets and Sans Building – Off-White Sink Undercoating – Sample # PS092425-27

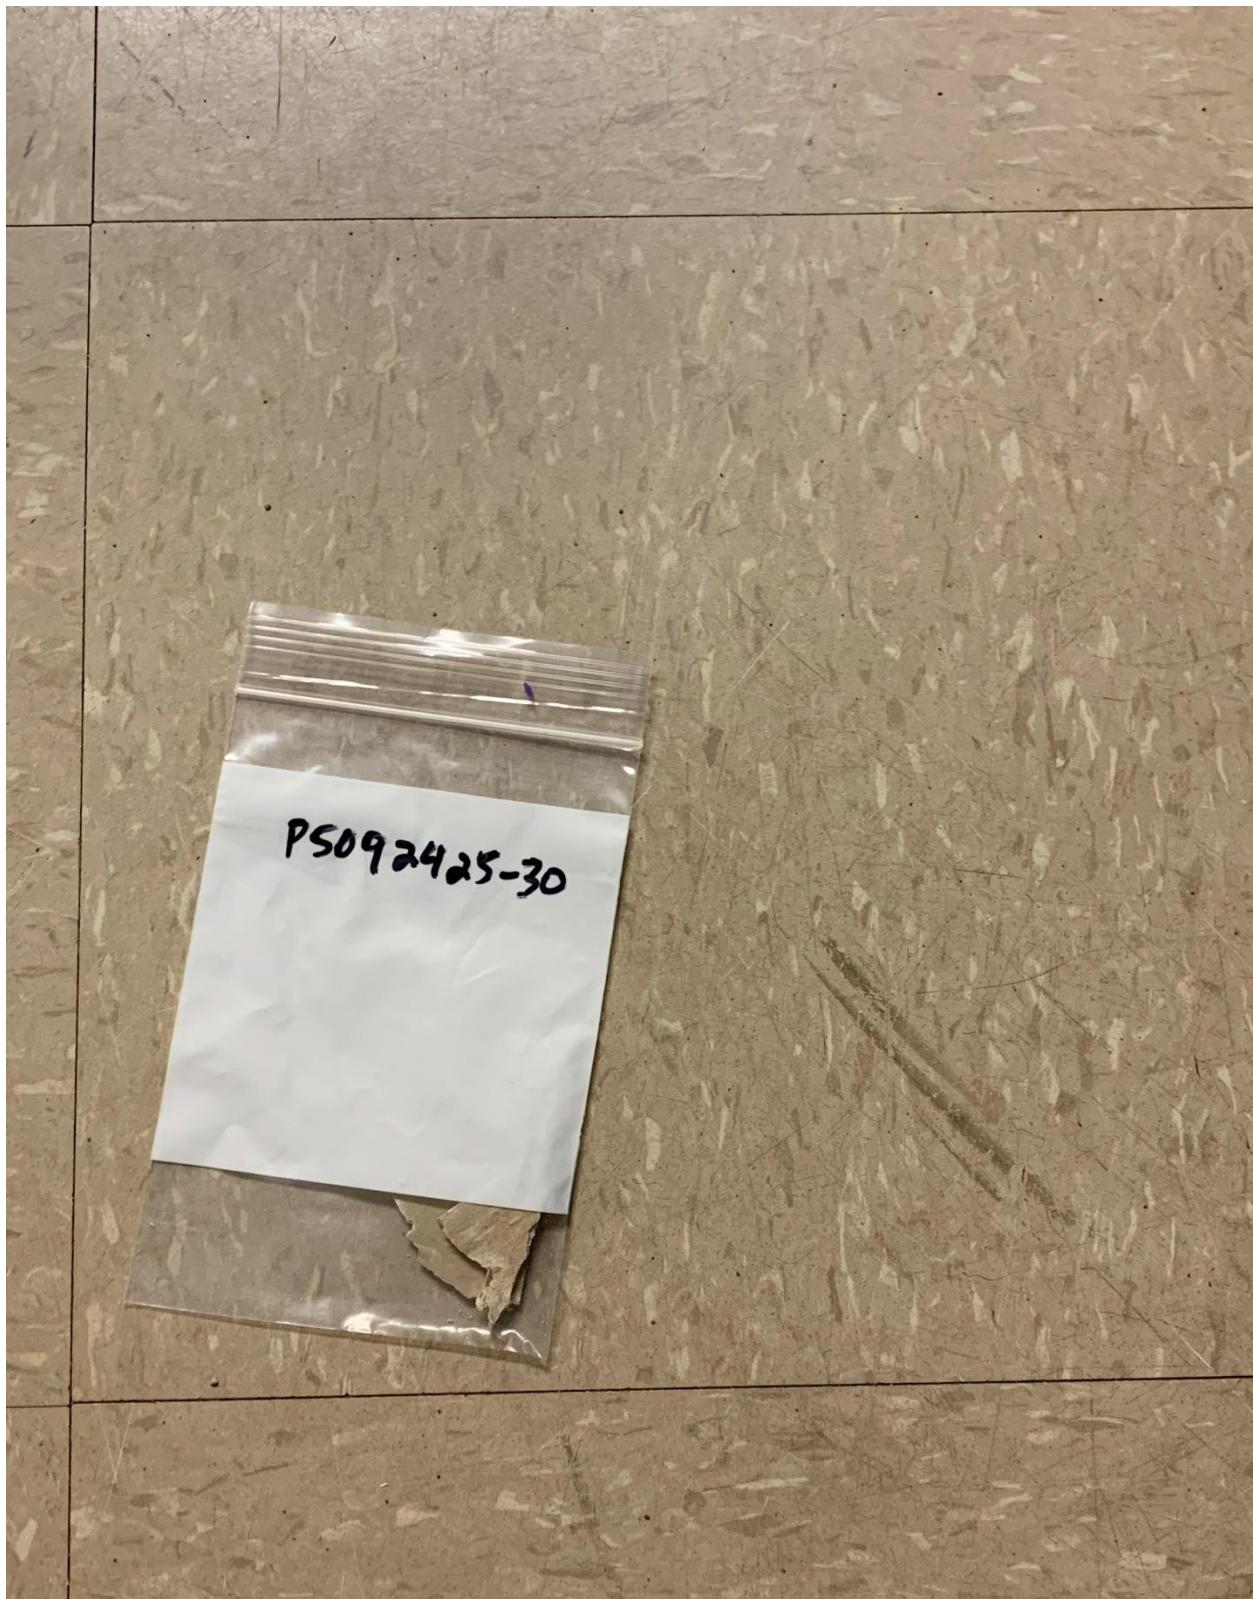
Streets and Sans Building – 12"x12" Light Grey Floor Tile – Sample # PS092425-30

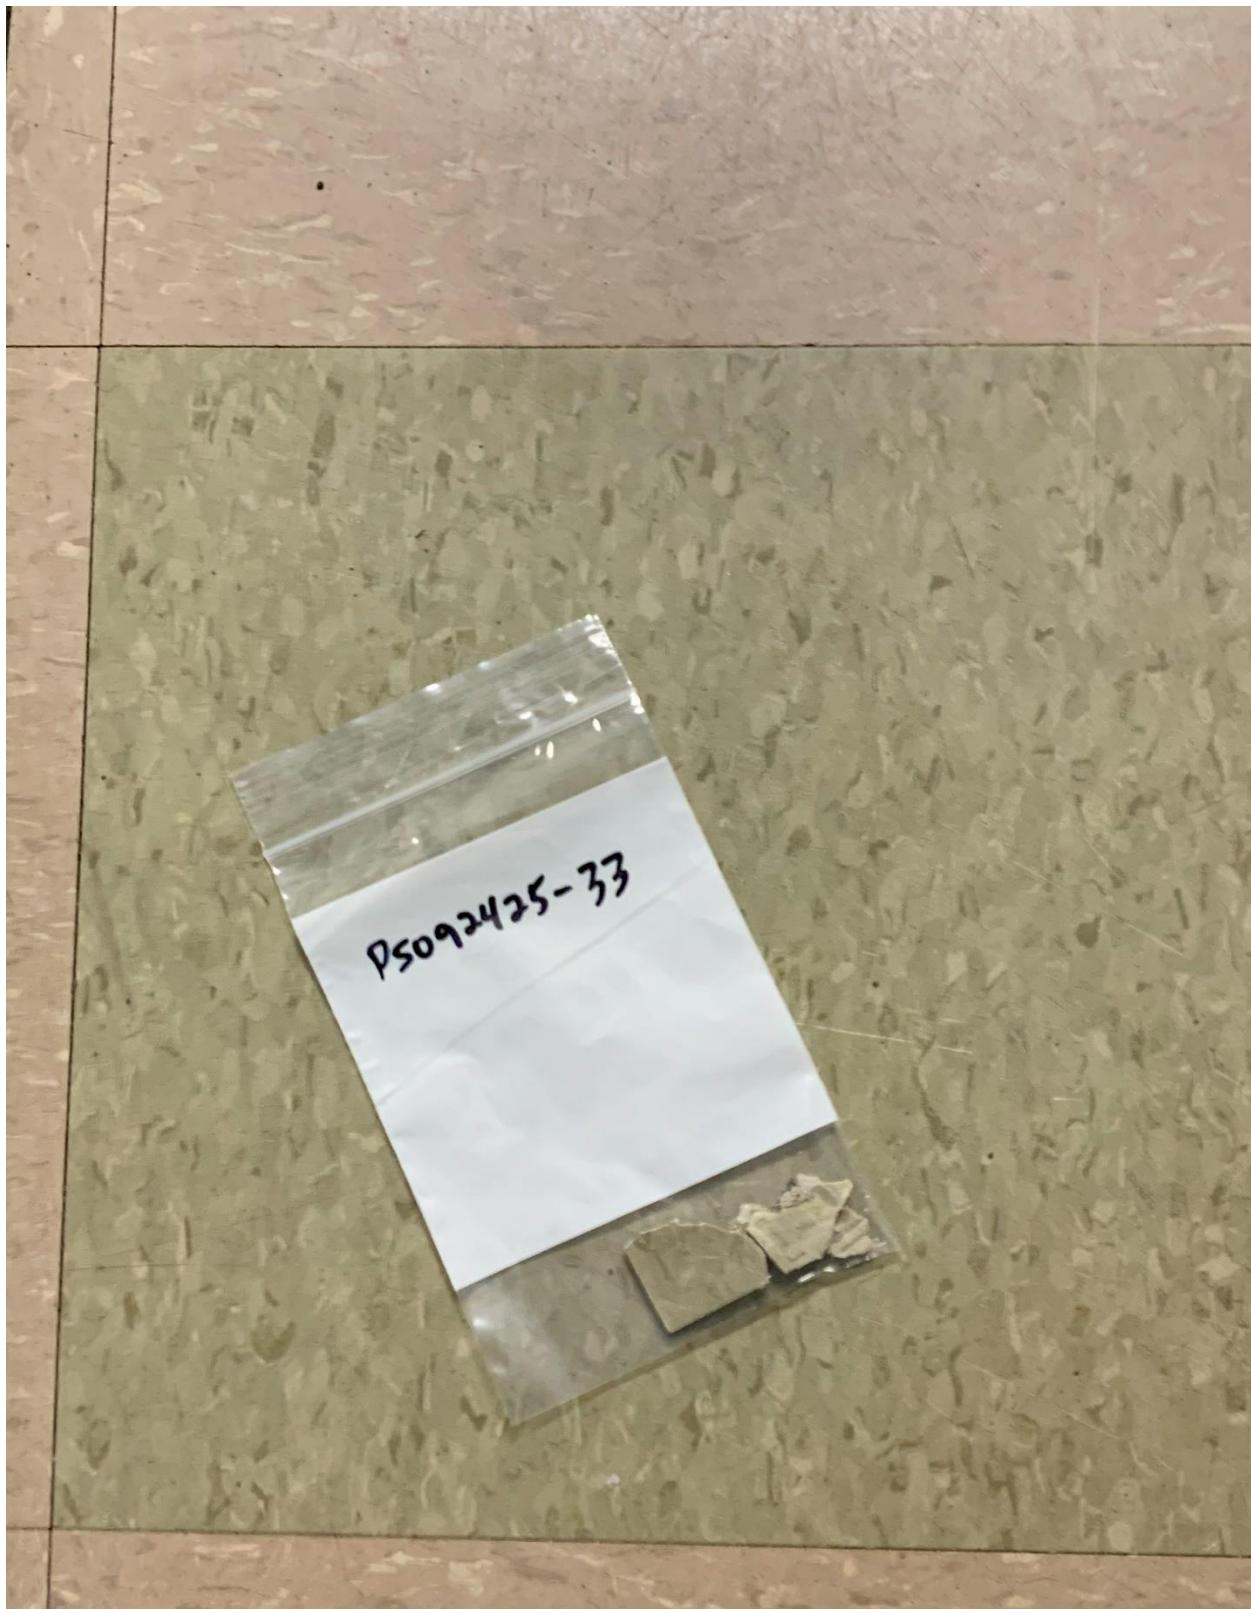
Streets and Sans Building – 12"x12" Light Green Floor Tile – Sample # PS092425-33

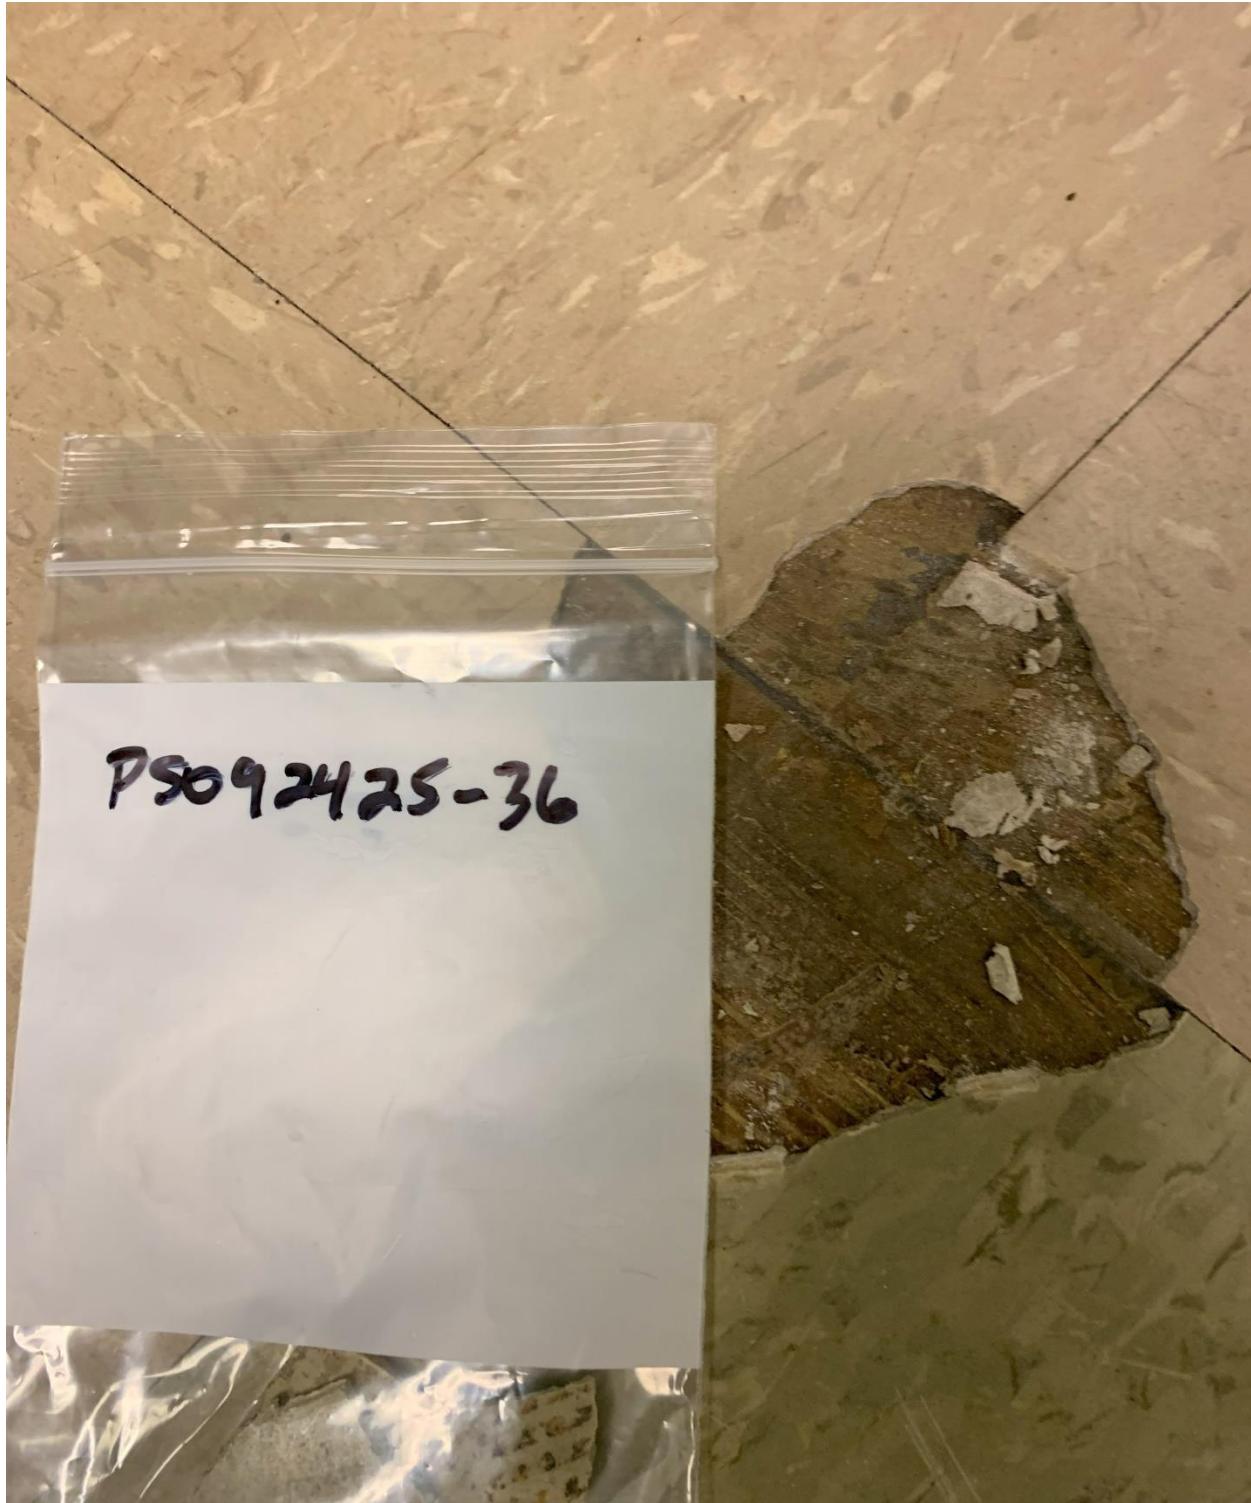
Streets and Sans Building – Mastic for 12"x12" Light Green Floor Tile –

Sample # PS092425-36

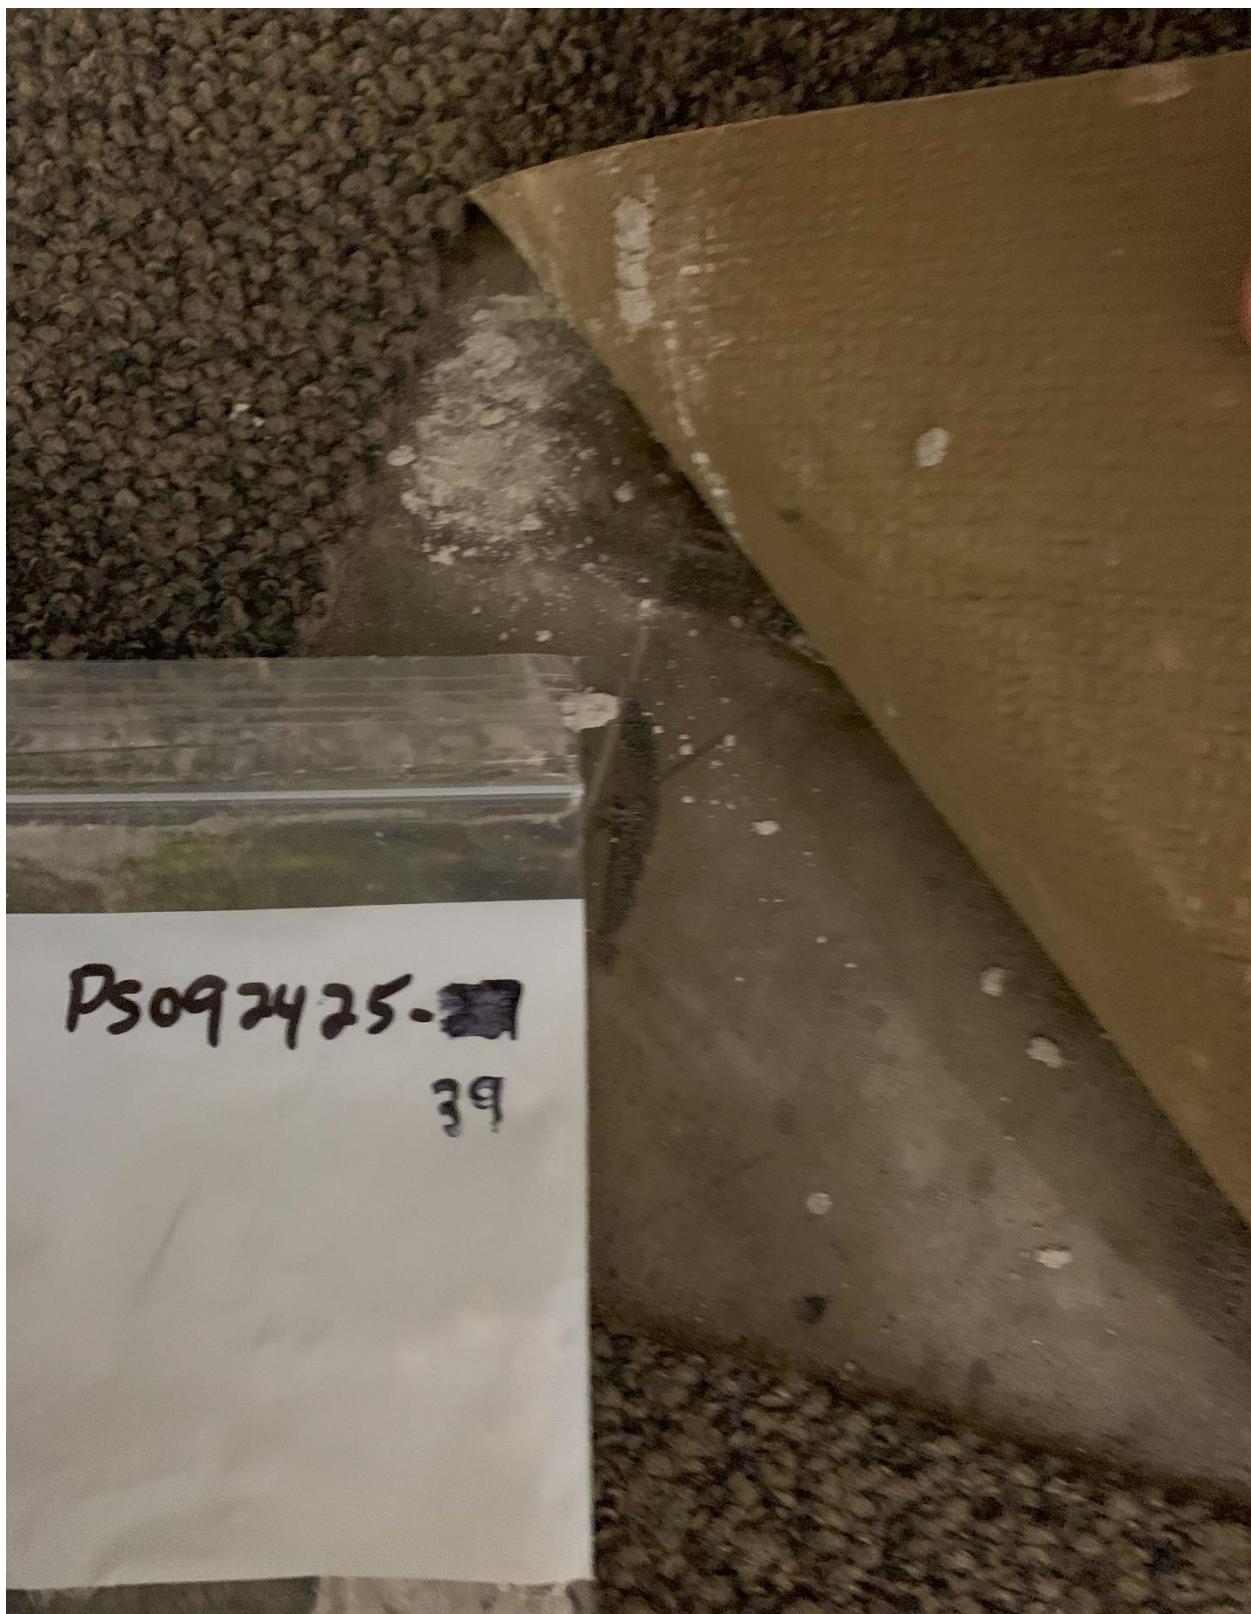
Streets and Sans Building – Carpet Adhesive – Sample # PS092425-39

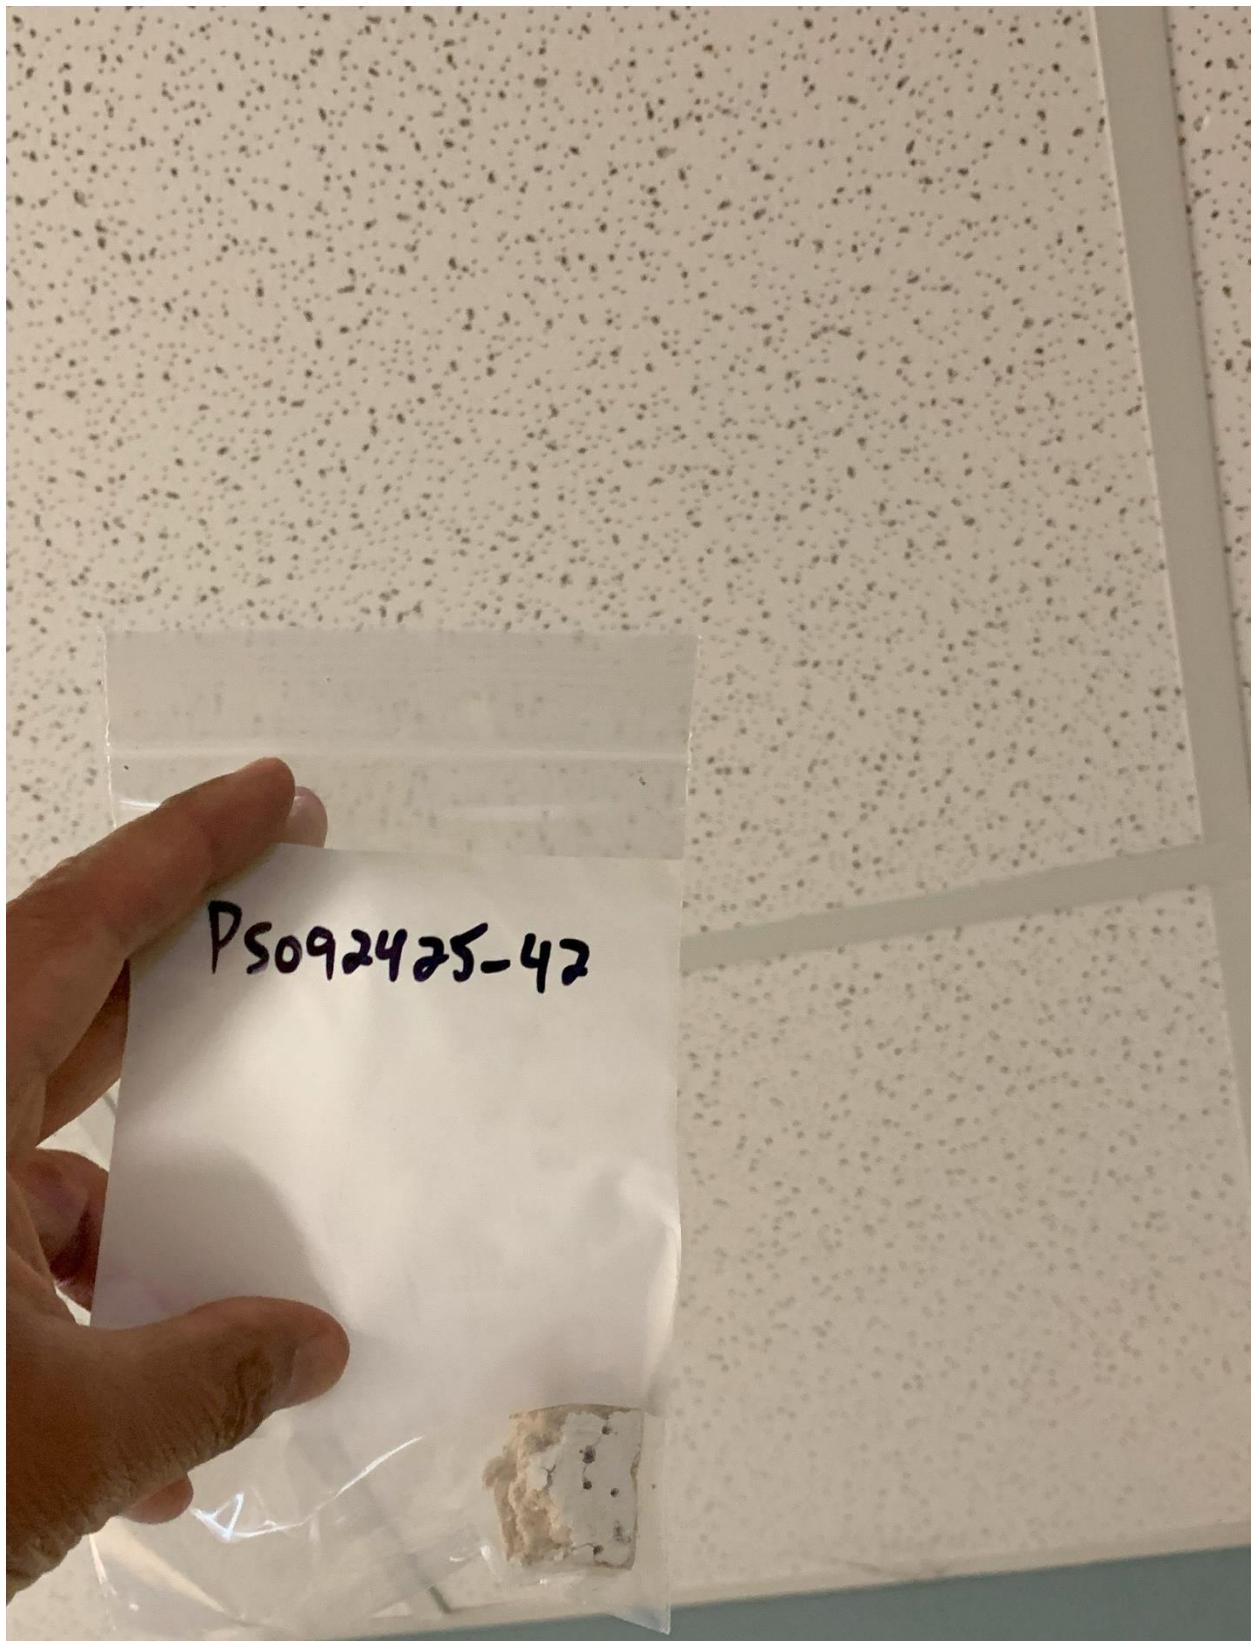
Streets and Sans Building – 2'x4' Speckled Ceiling Tile – Sample # PS092425-42

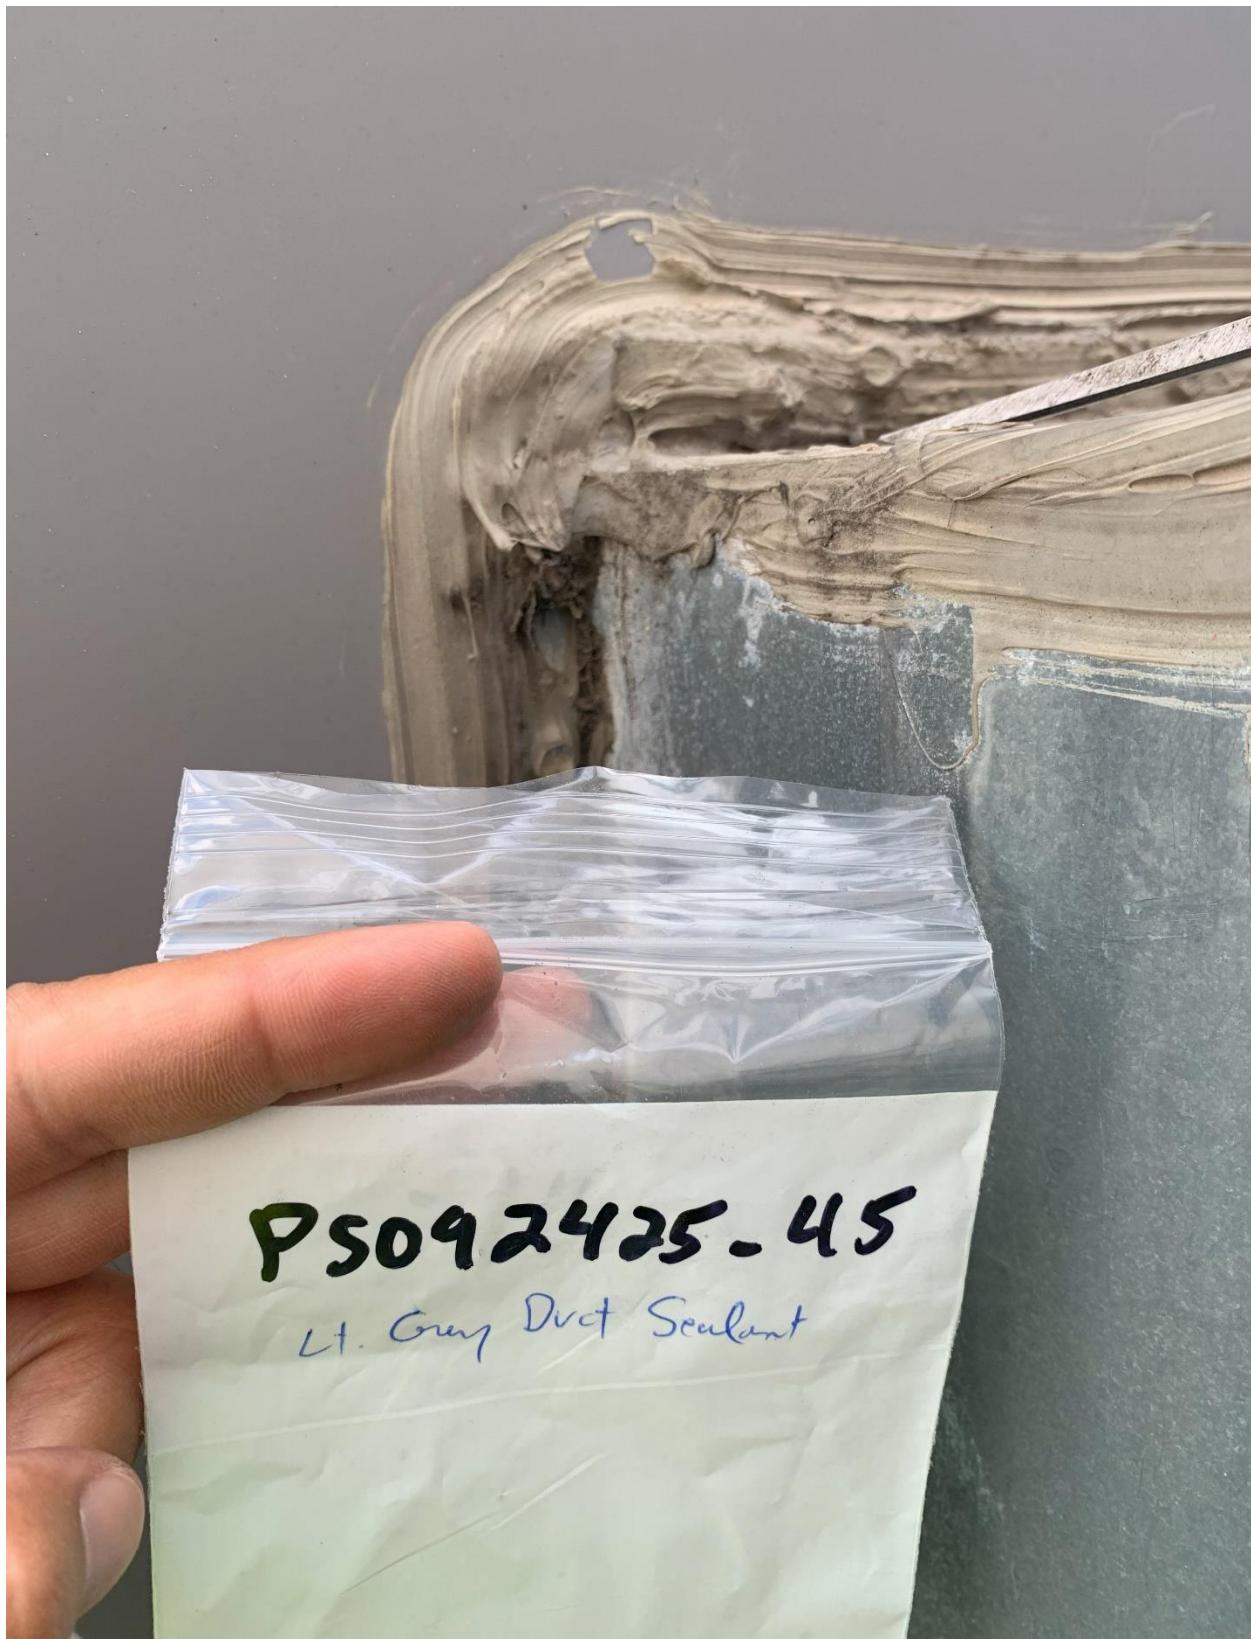
Streets and Sans Building – Light Grey Duct Caulk – Sample # PS092425-45
