Asbestos Building Inspection

Public Building Commission of Chicago  
Richard J. Daley Center, Room 200  
50 West Washington Street  
Chicago, Illinois 60602

Department of Water Management  
Operations Facility - DOW 04029  
4825 W. Lawrence Avenue  
Chicago, Illinois 60630

October 14, 2025  
TEM Project 77496

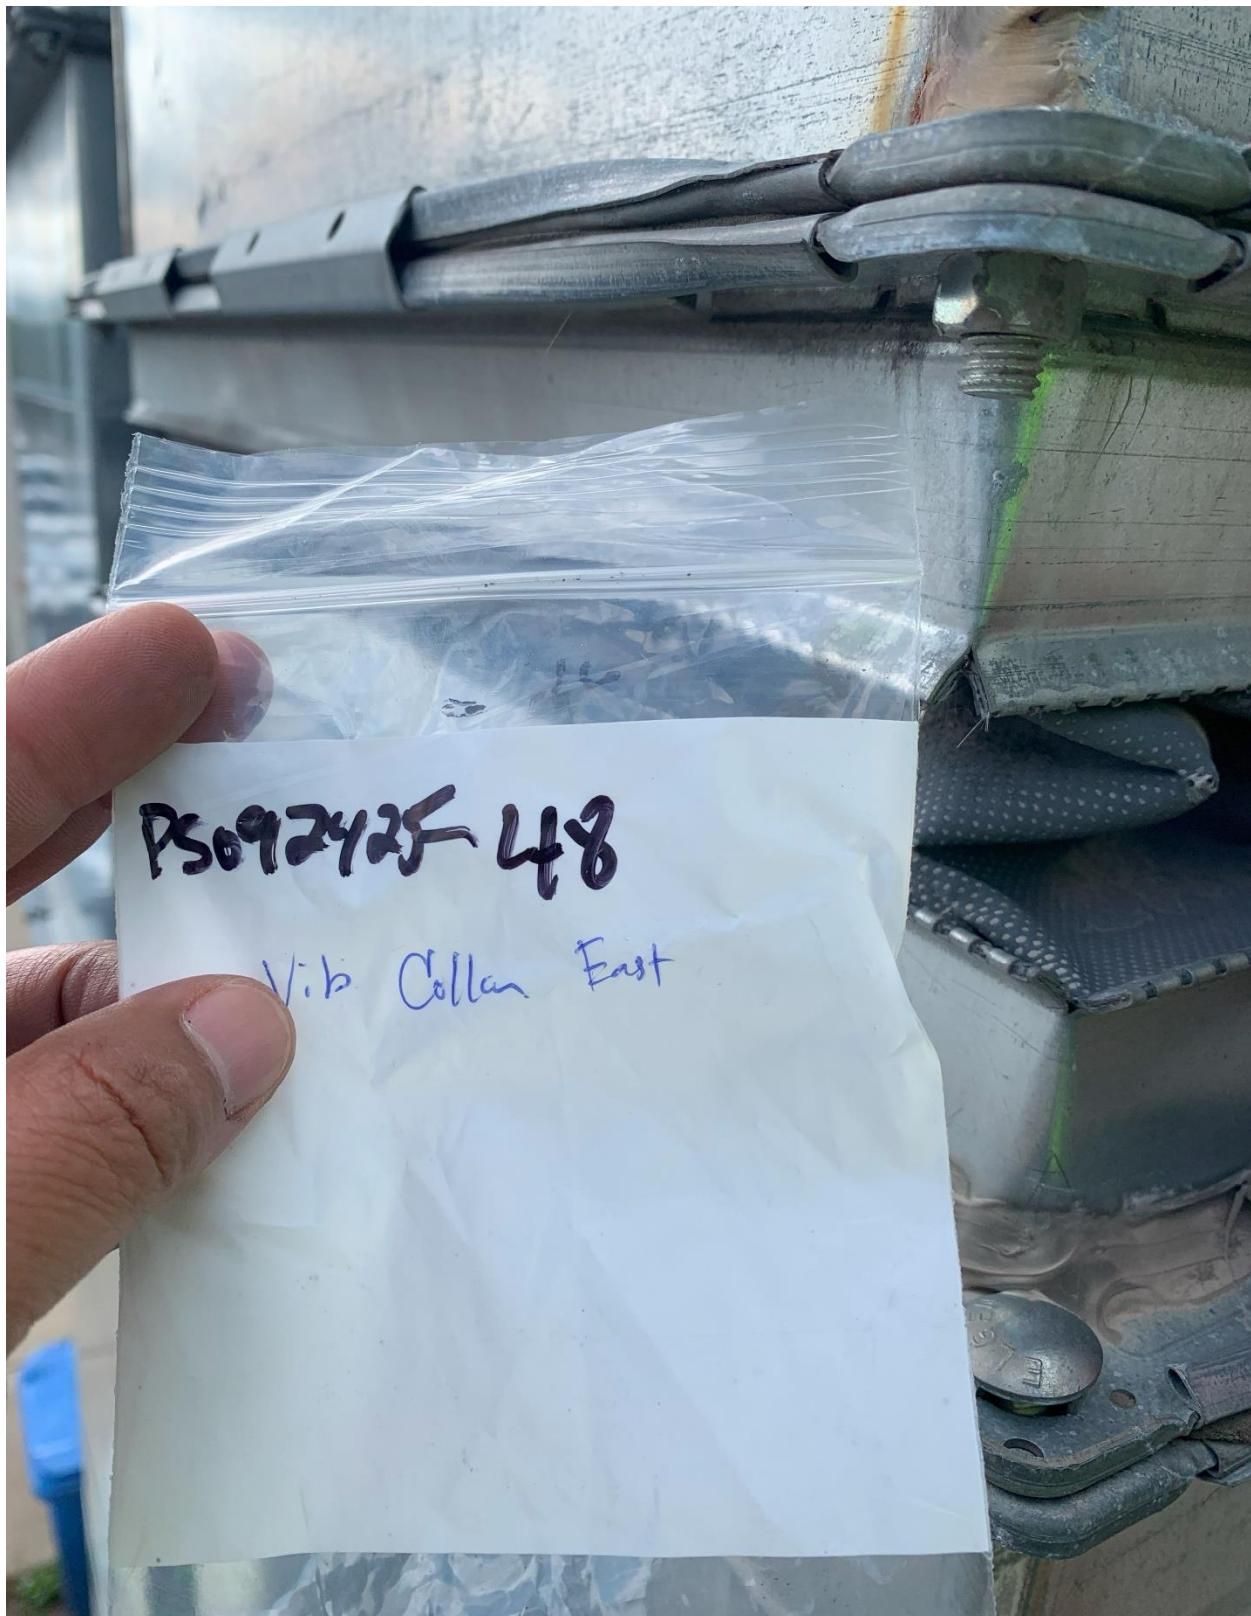
Streets and Sans Building – Vibration Collar – Sample # PS092425-48

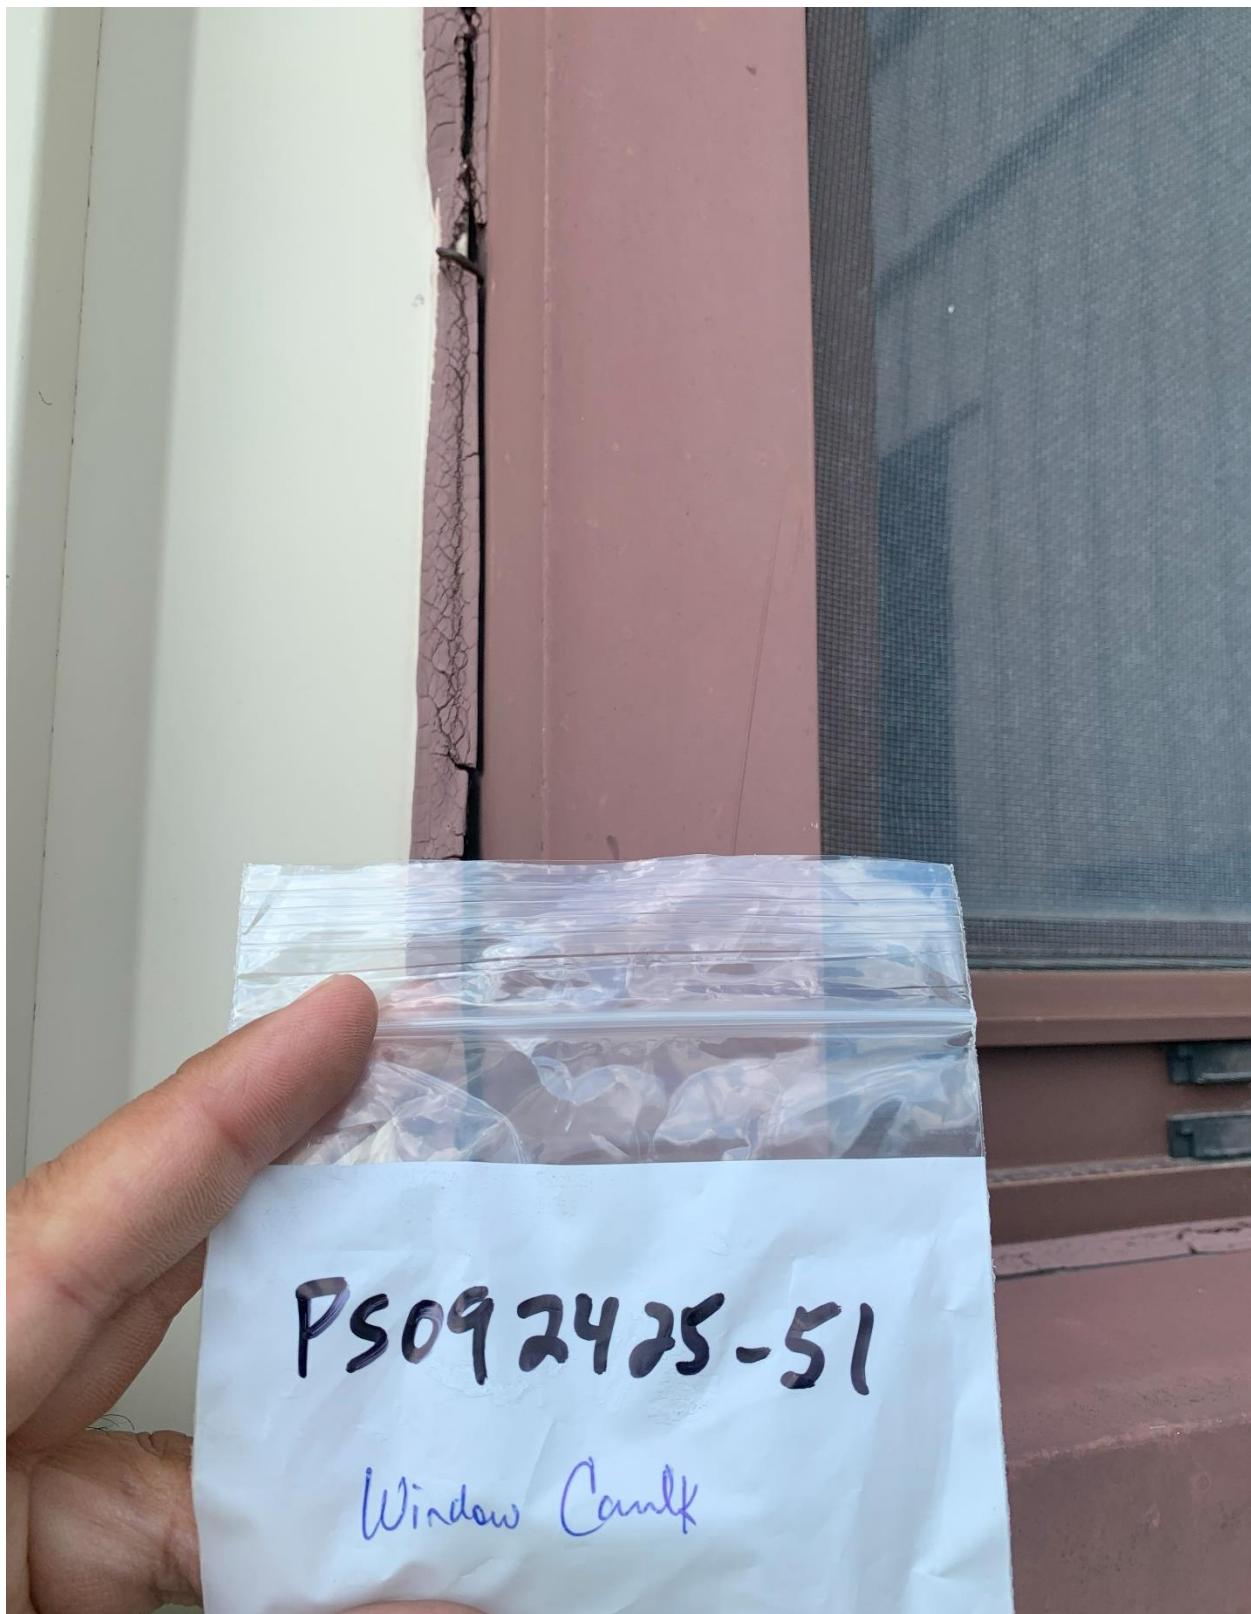
Streets and Sans Building – Window Caulk – Sample # PS092425-51

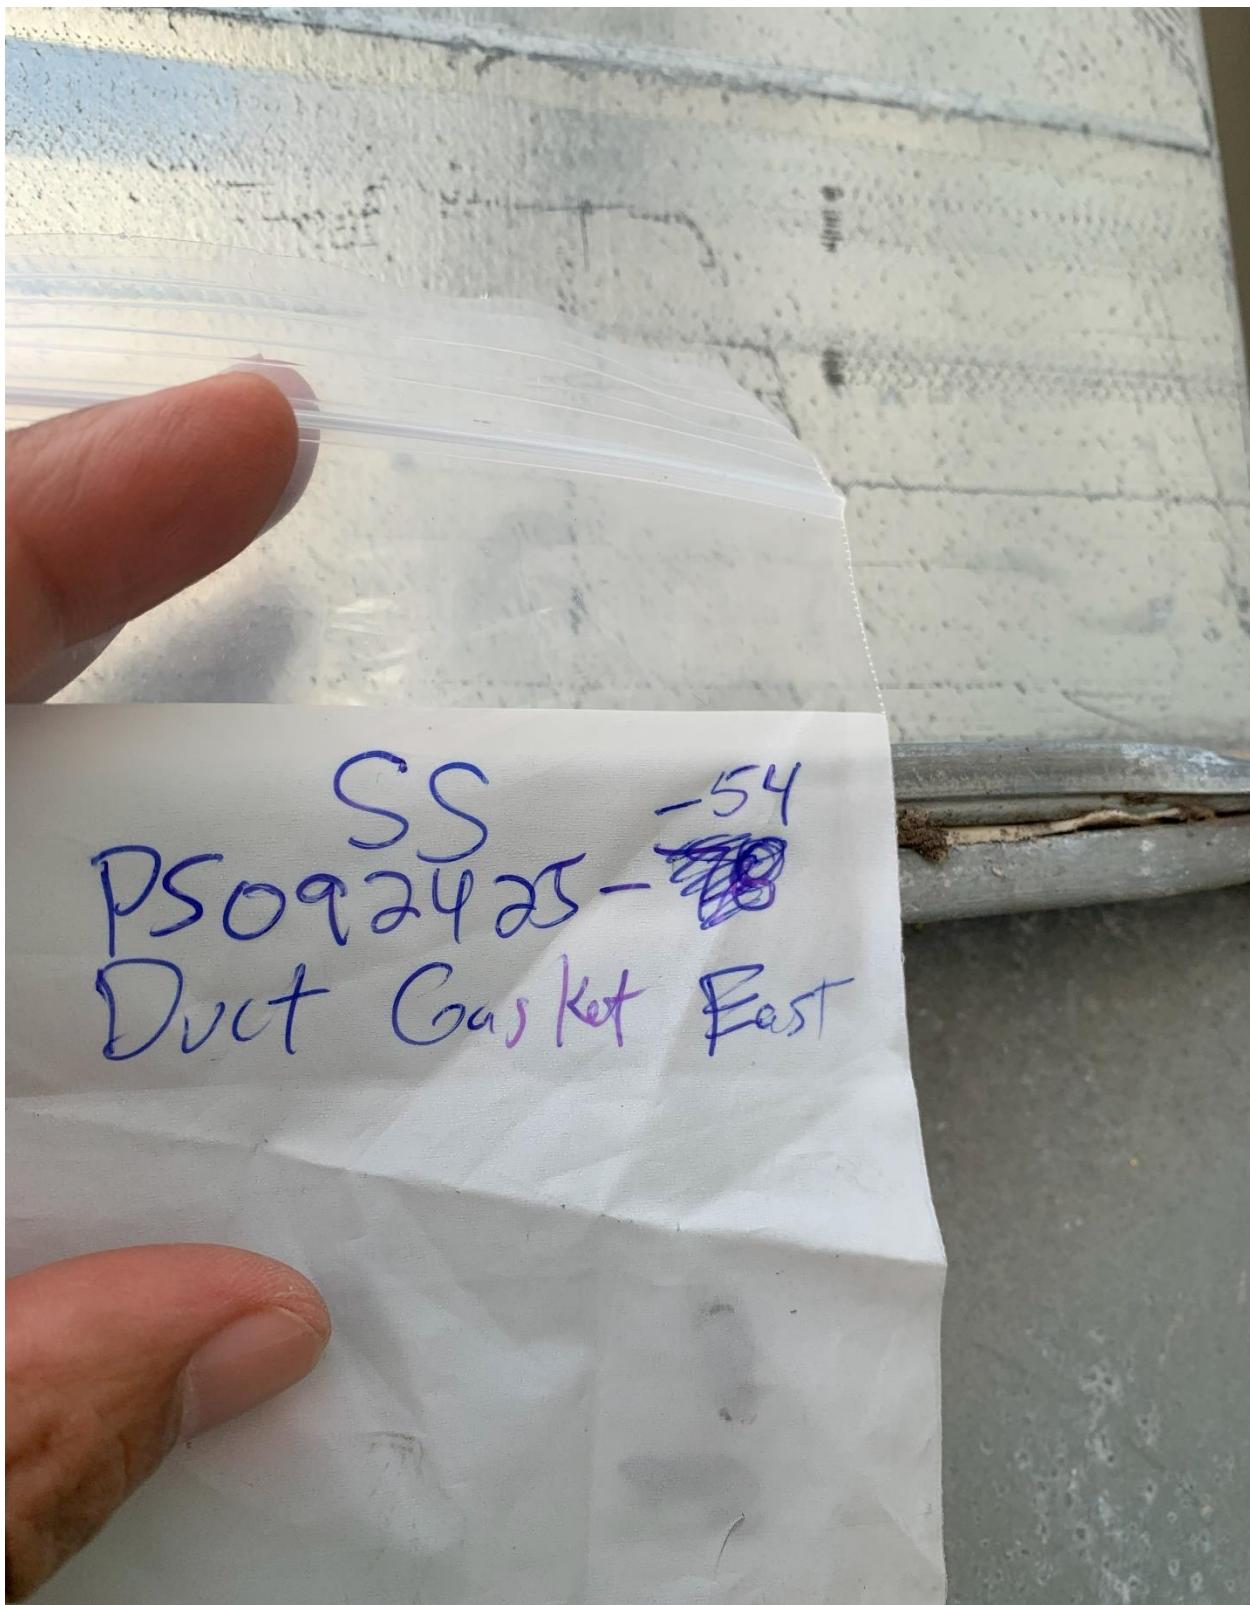
Streets and Sans Building – Light Grey Duct Gasket – Sample # PS092425-54

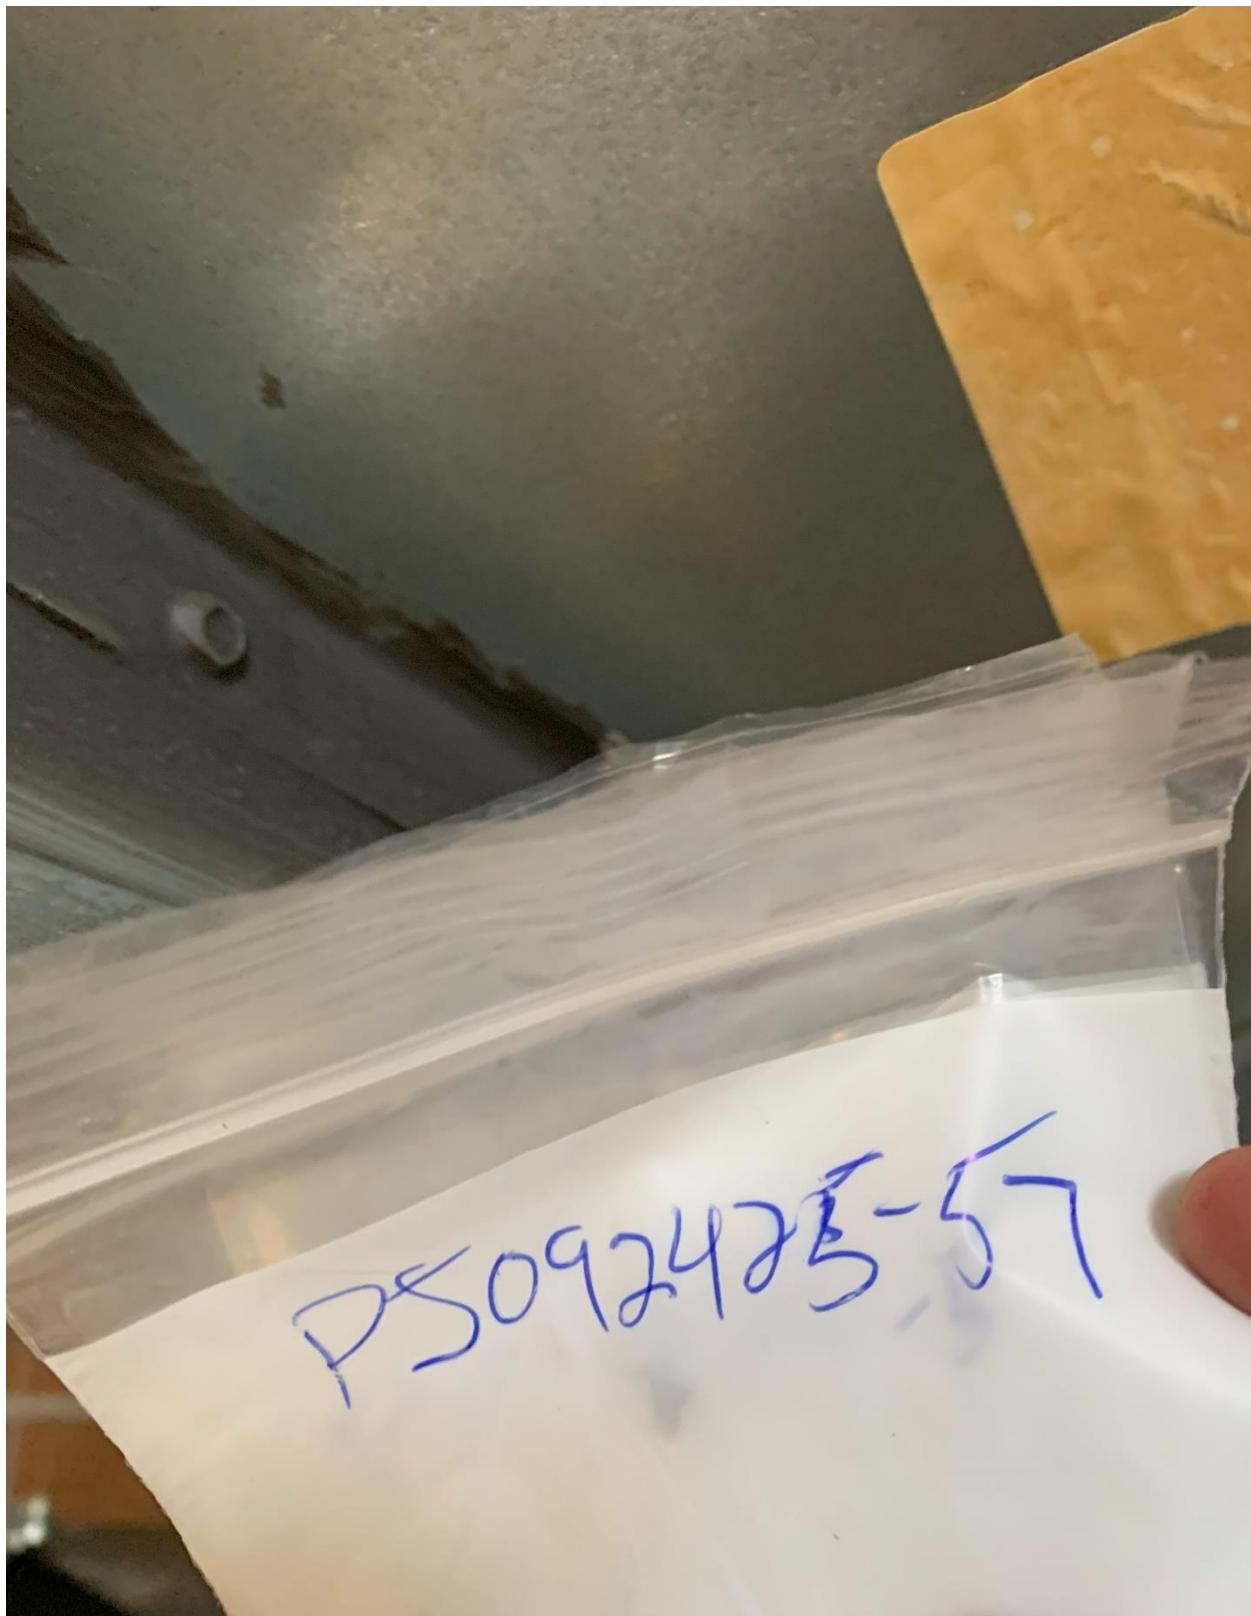
Streets and Sans Building – Dark Grey Duct Caulk Sealant – Sample # PS092425-57

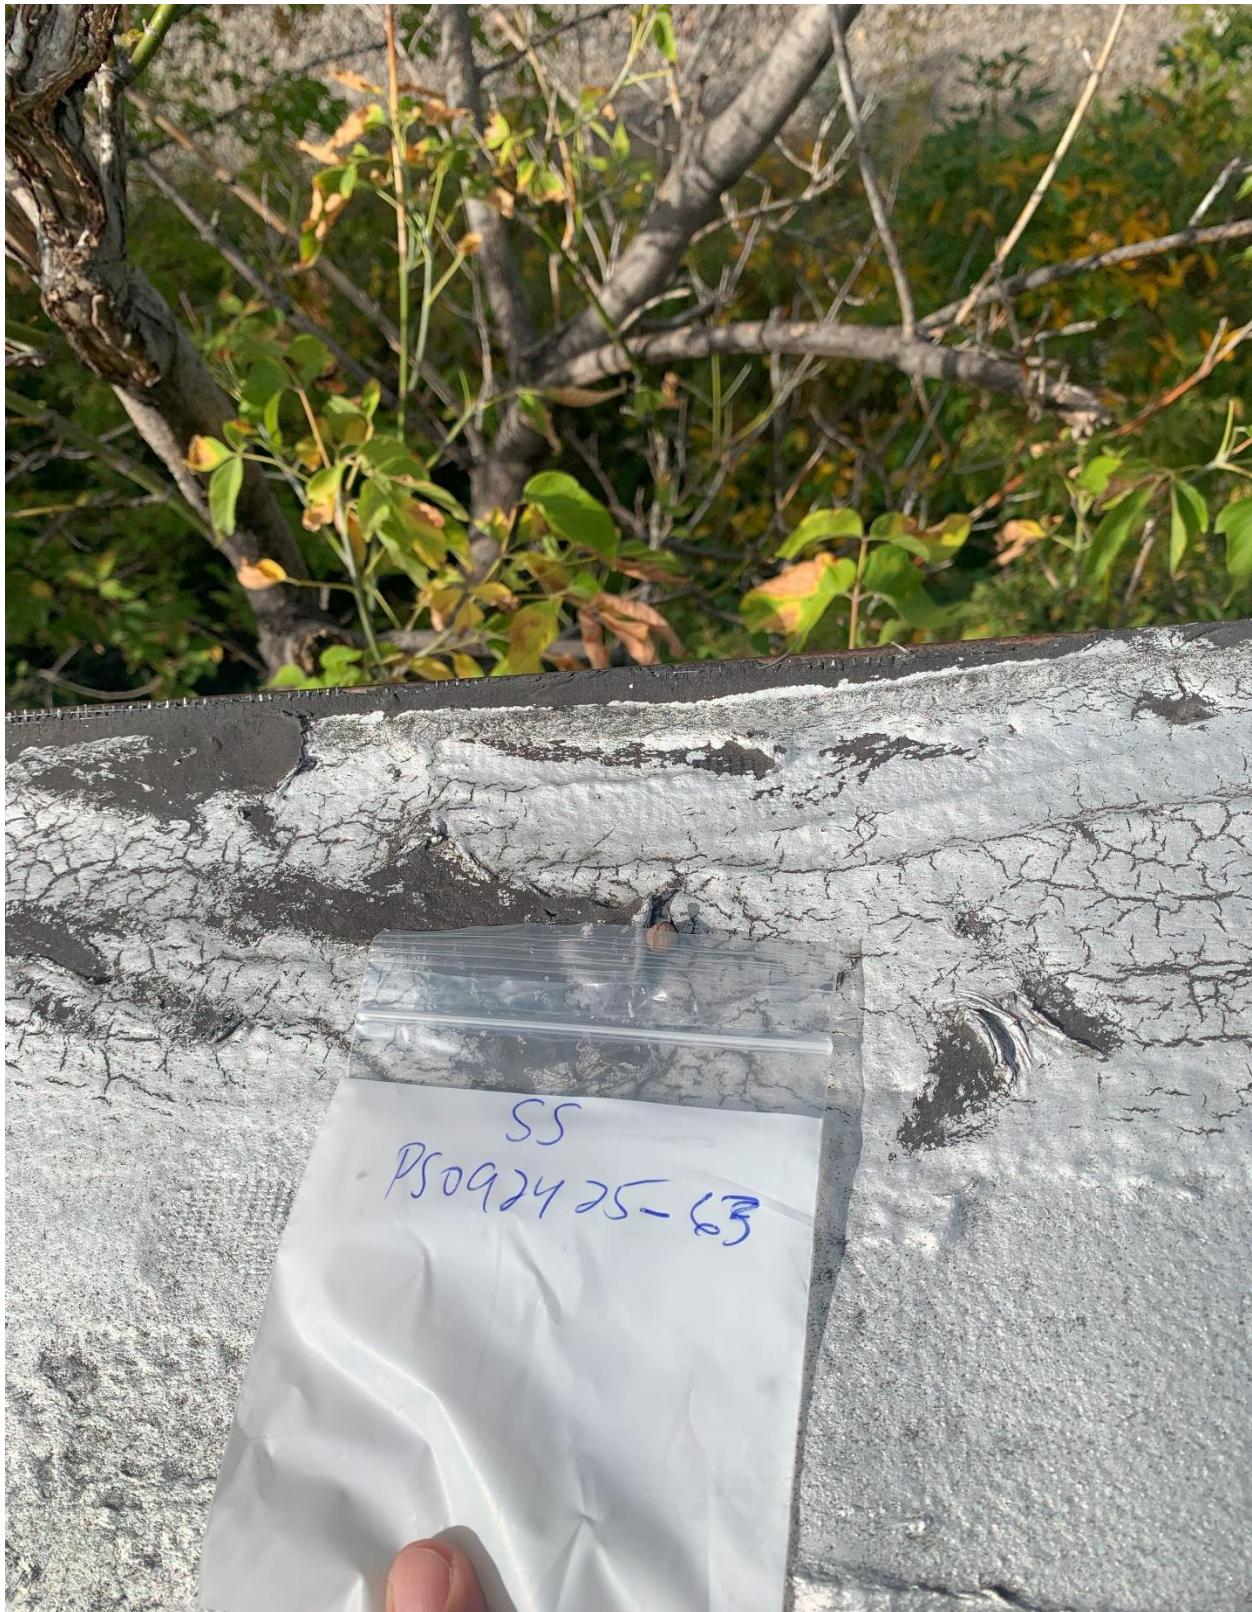
Streets and Sans Building – Roof Flashing – Sample # PS092425-63

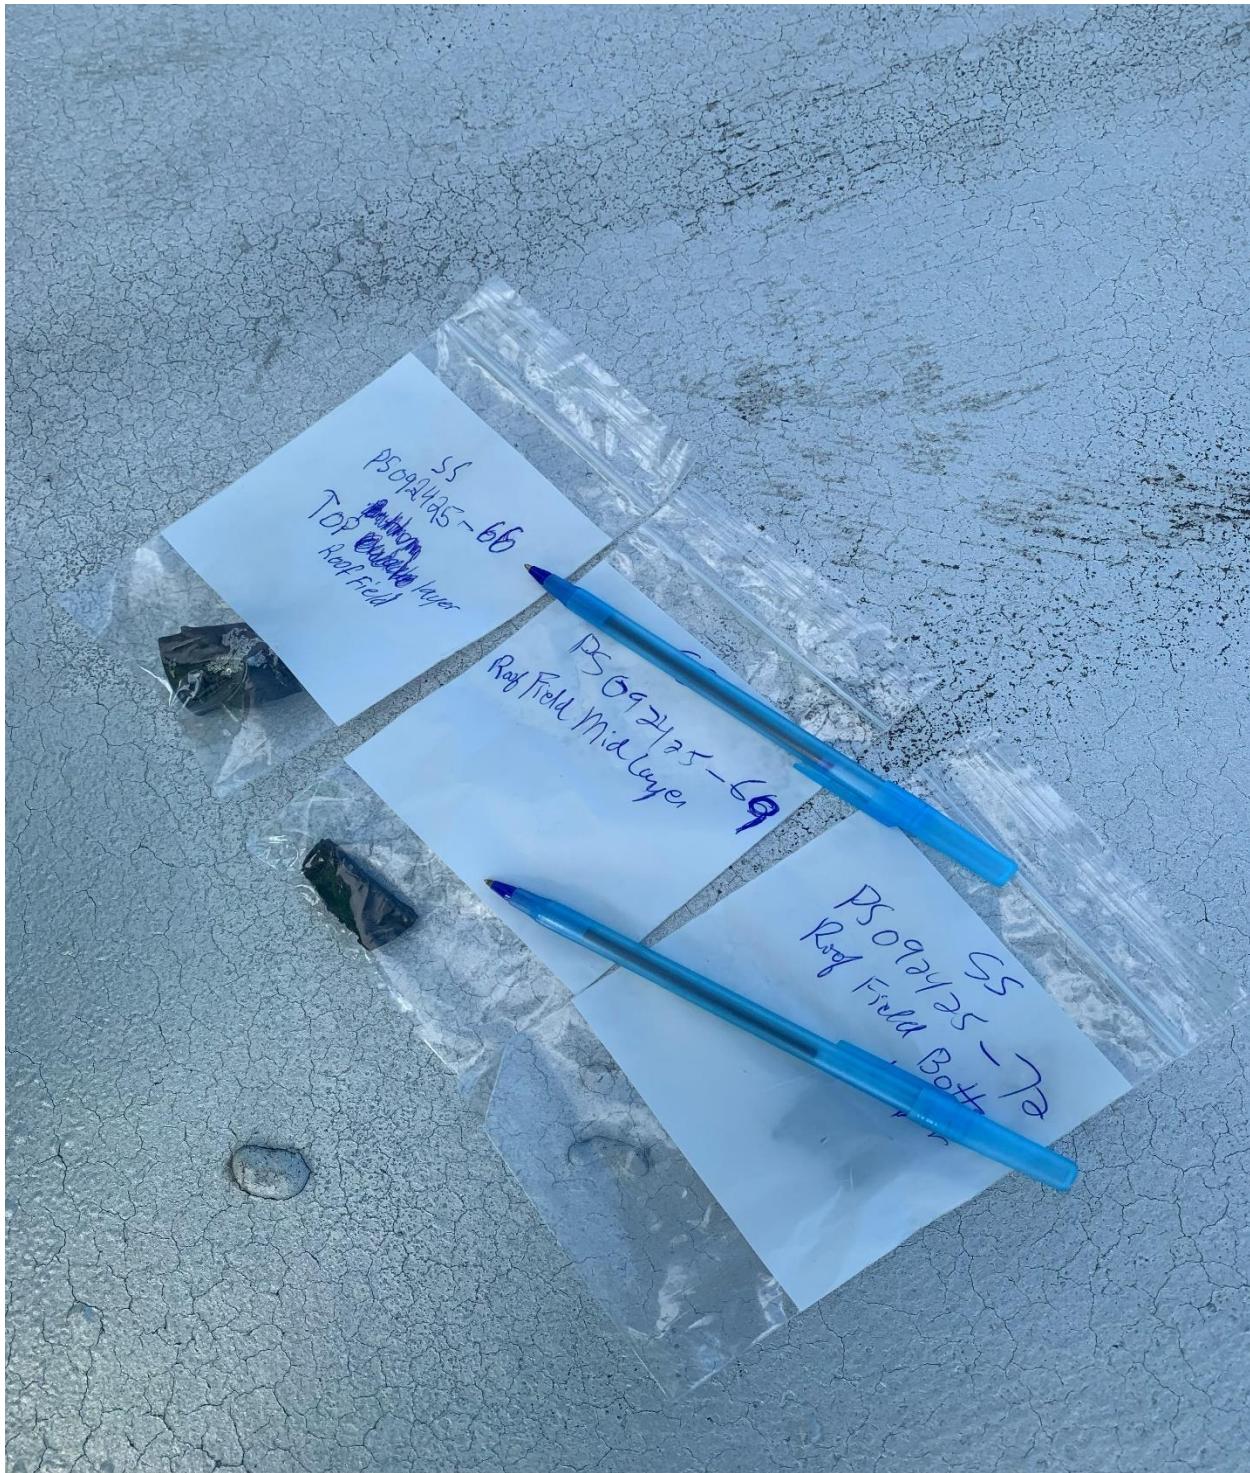
Streets and Sans Building – Roof Field (Top Layer) – Sample # PS092425-66

Streets and Sans Building – Roof Field (Middle Layer) – Sample # PS092425-69

Streets and Sans Building – Roof Field (Bottom Layer) – Sample # PS092425-72

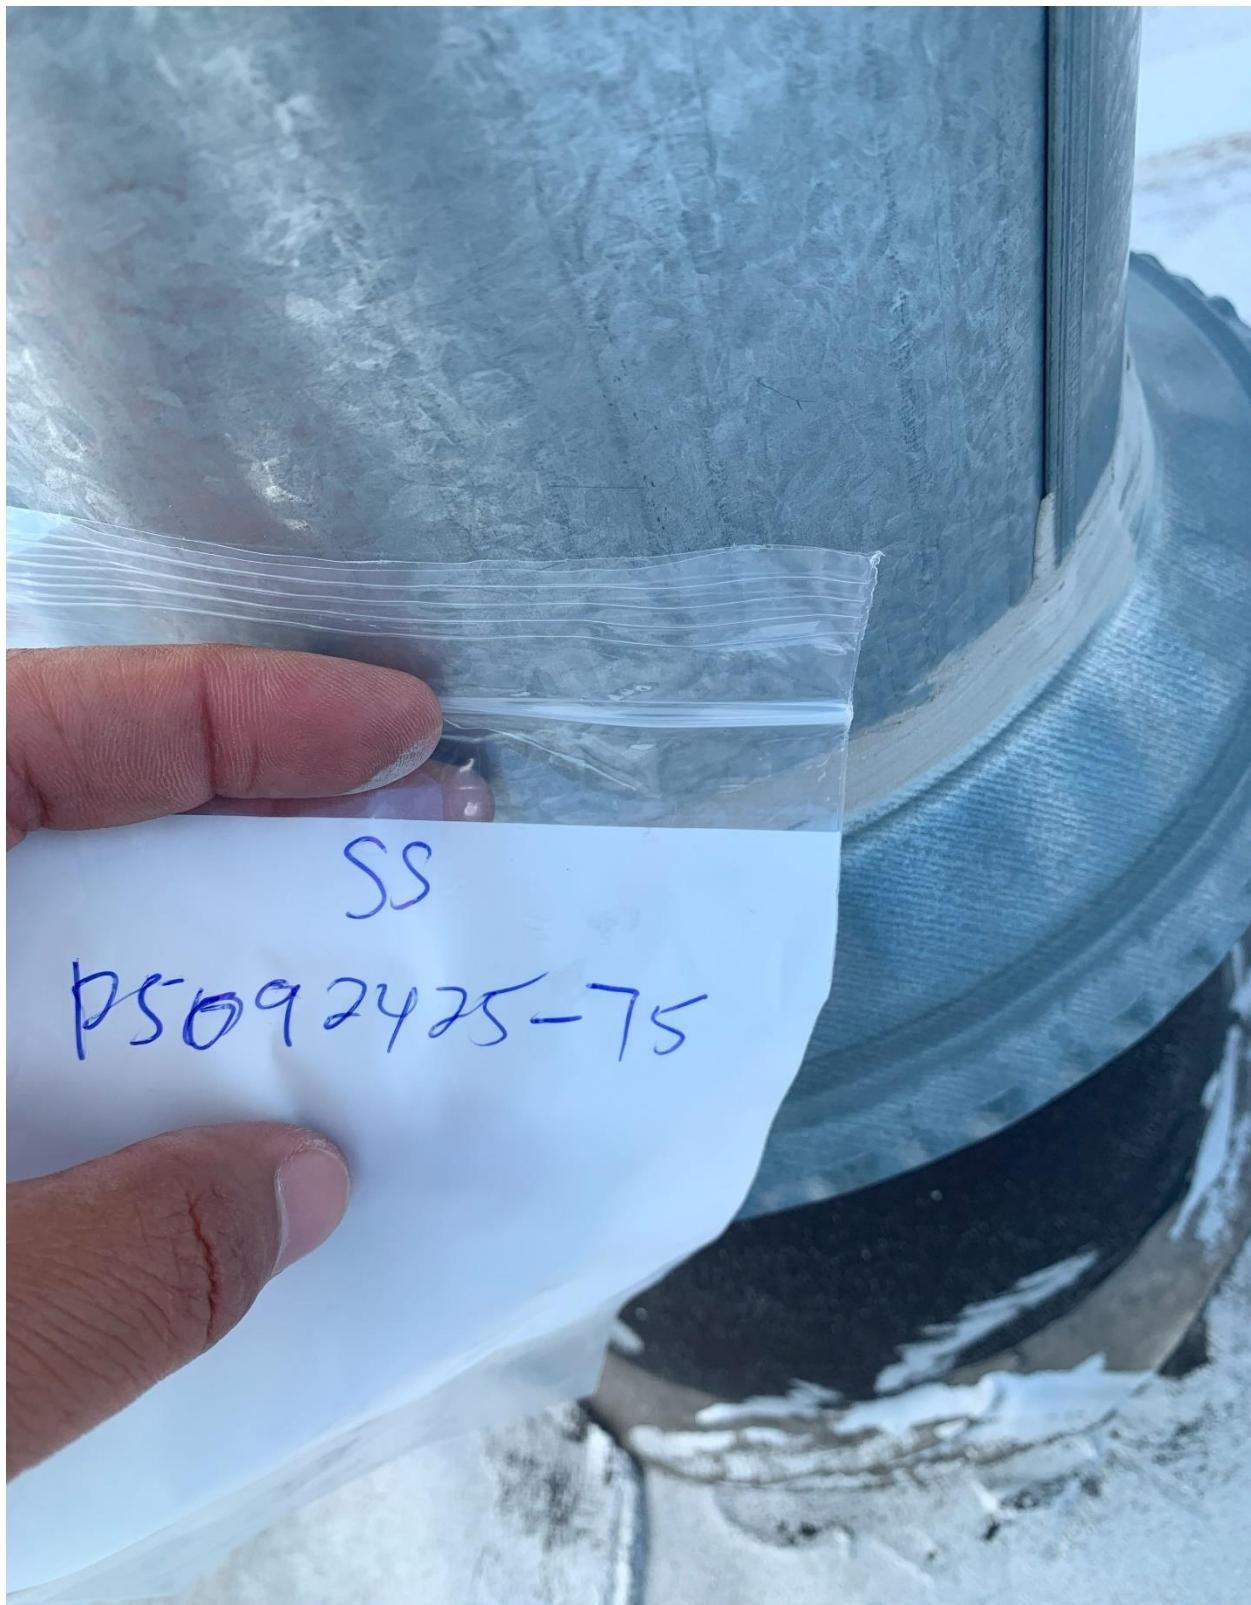
Streets and Sans Building – Light Grey Caulk – Sample # PS092425-75
