Hazardous Materials Survey

Department of Water Management
Operations Facility - DOW 04029
4825 W. Lawrence Avenue
Chicago, Illinois 60630

October 14, 2025
TEM Project 77496

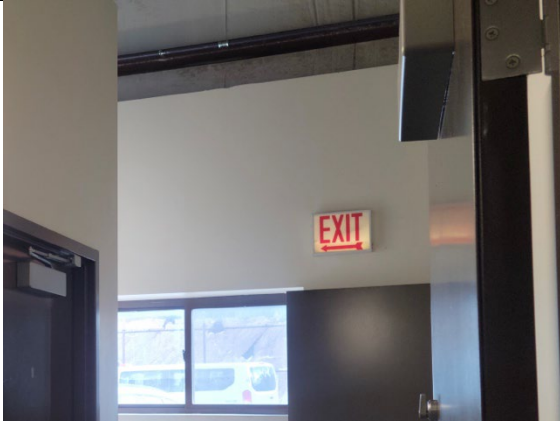
Typical Exit Sign

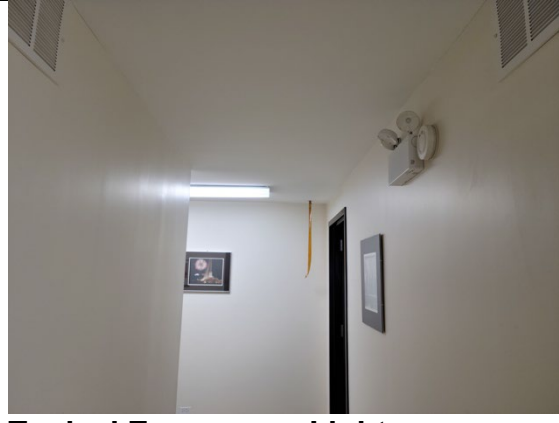
Typical Emergency Light

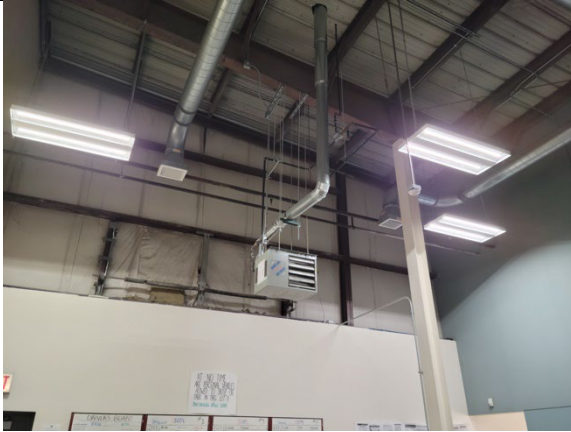
Typical Light Fixture

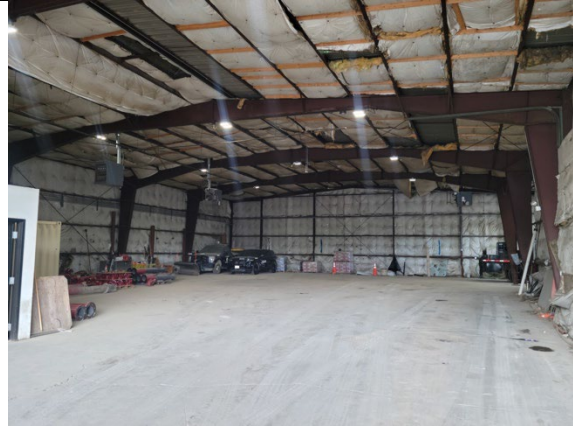
Sodium Vapor Lights

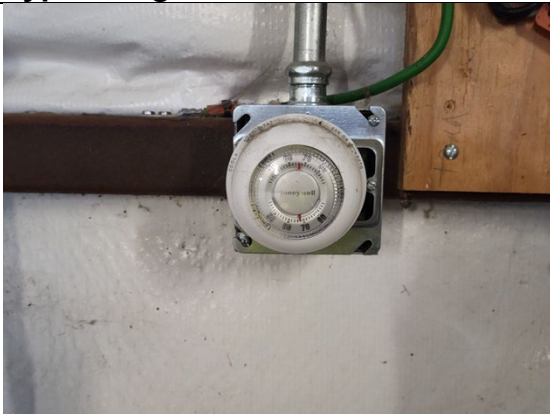
Thermostat

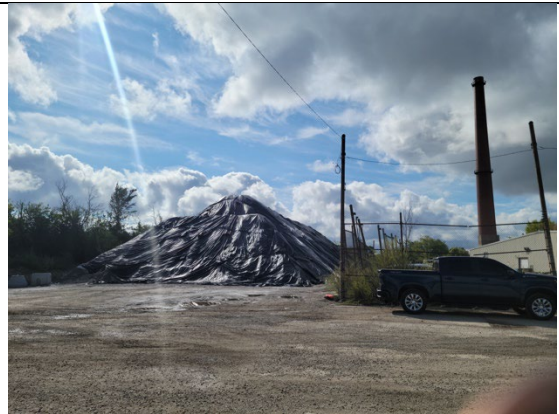
Salt Pile

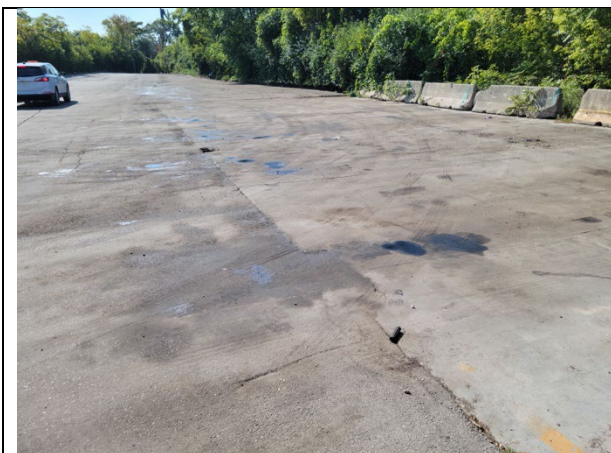
Typical Oil Stain

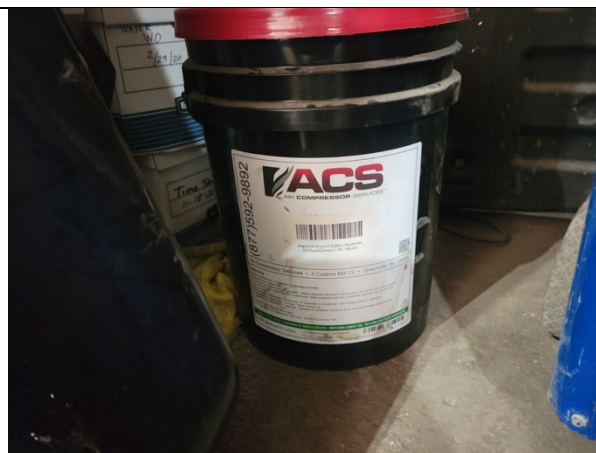
Compressor oil

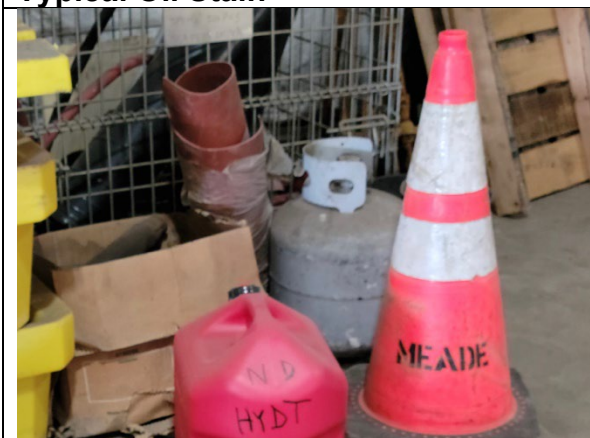
Propane

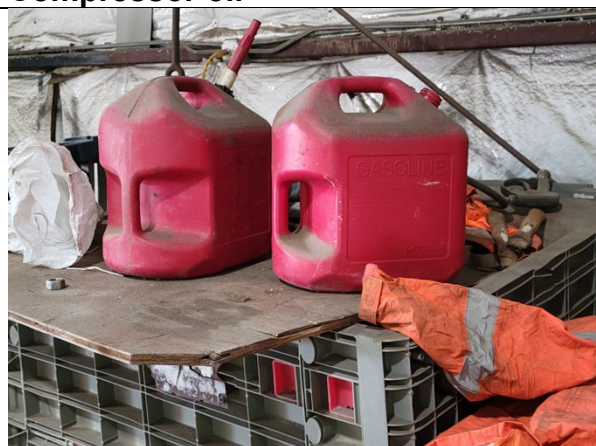
Gasolene Containers

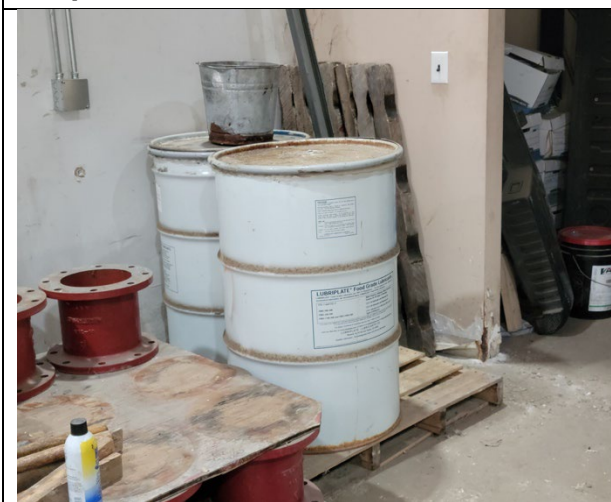
Lubriplate Lubricant

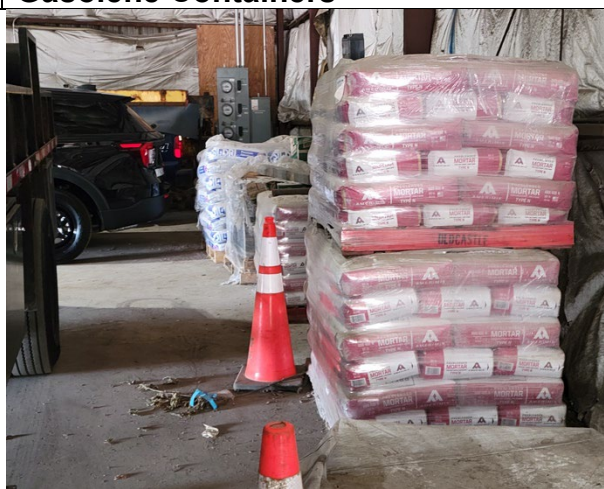
Portland Cement
