PERSHING ROAD BUILDINGS

1869 W Pershing Road, Chicago, IL 60609

5-Year Program 09/02/2021

HARDING MODE JOINT VENTURE

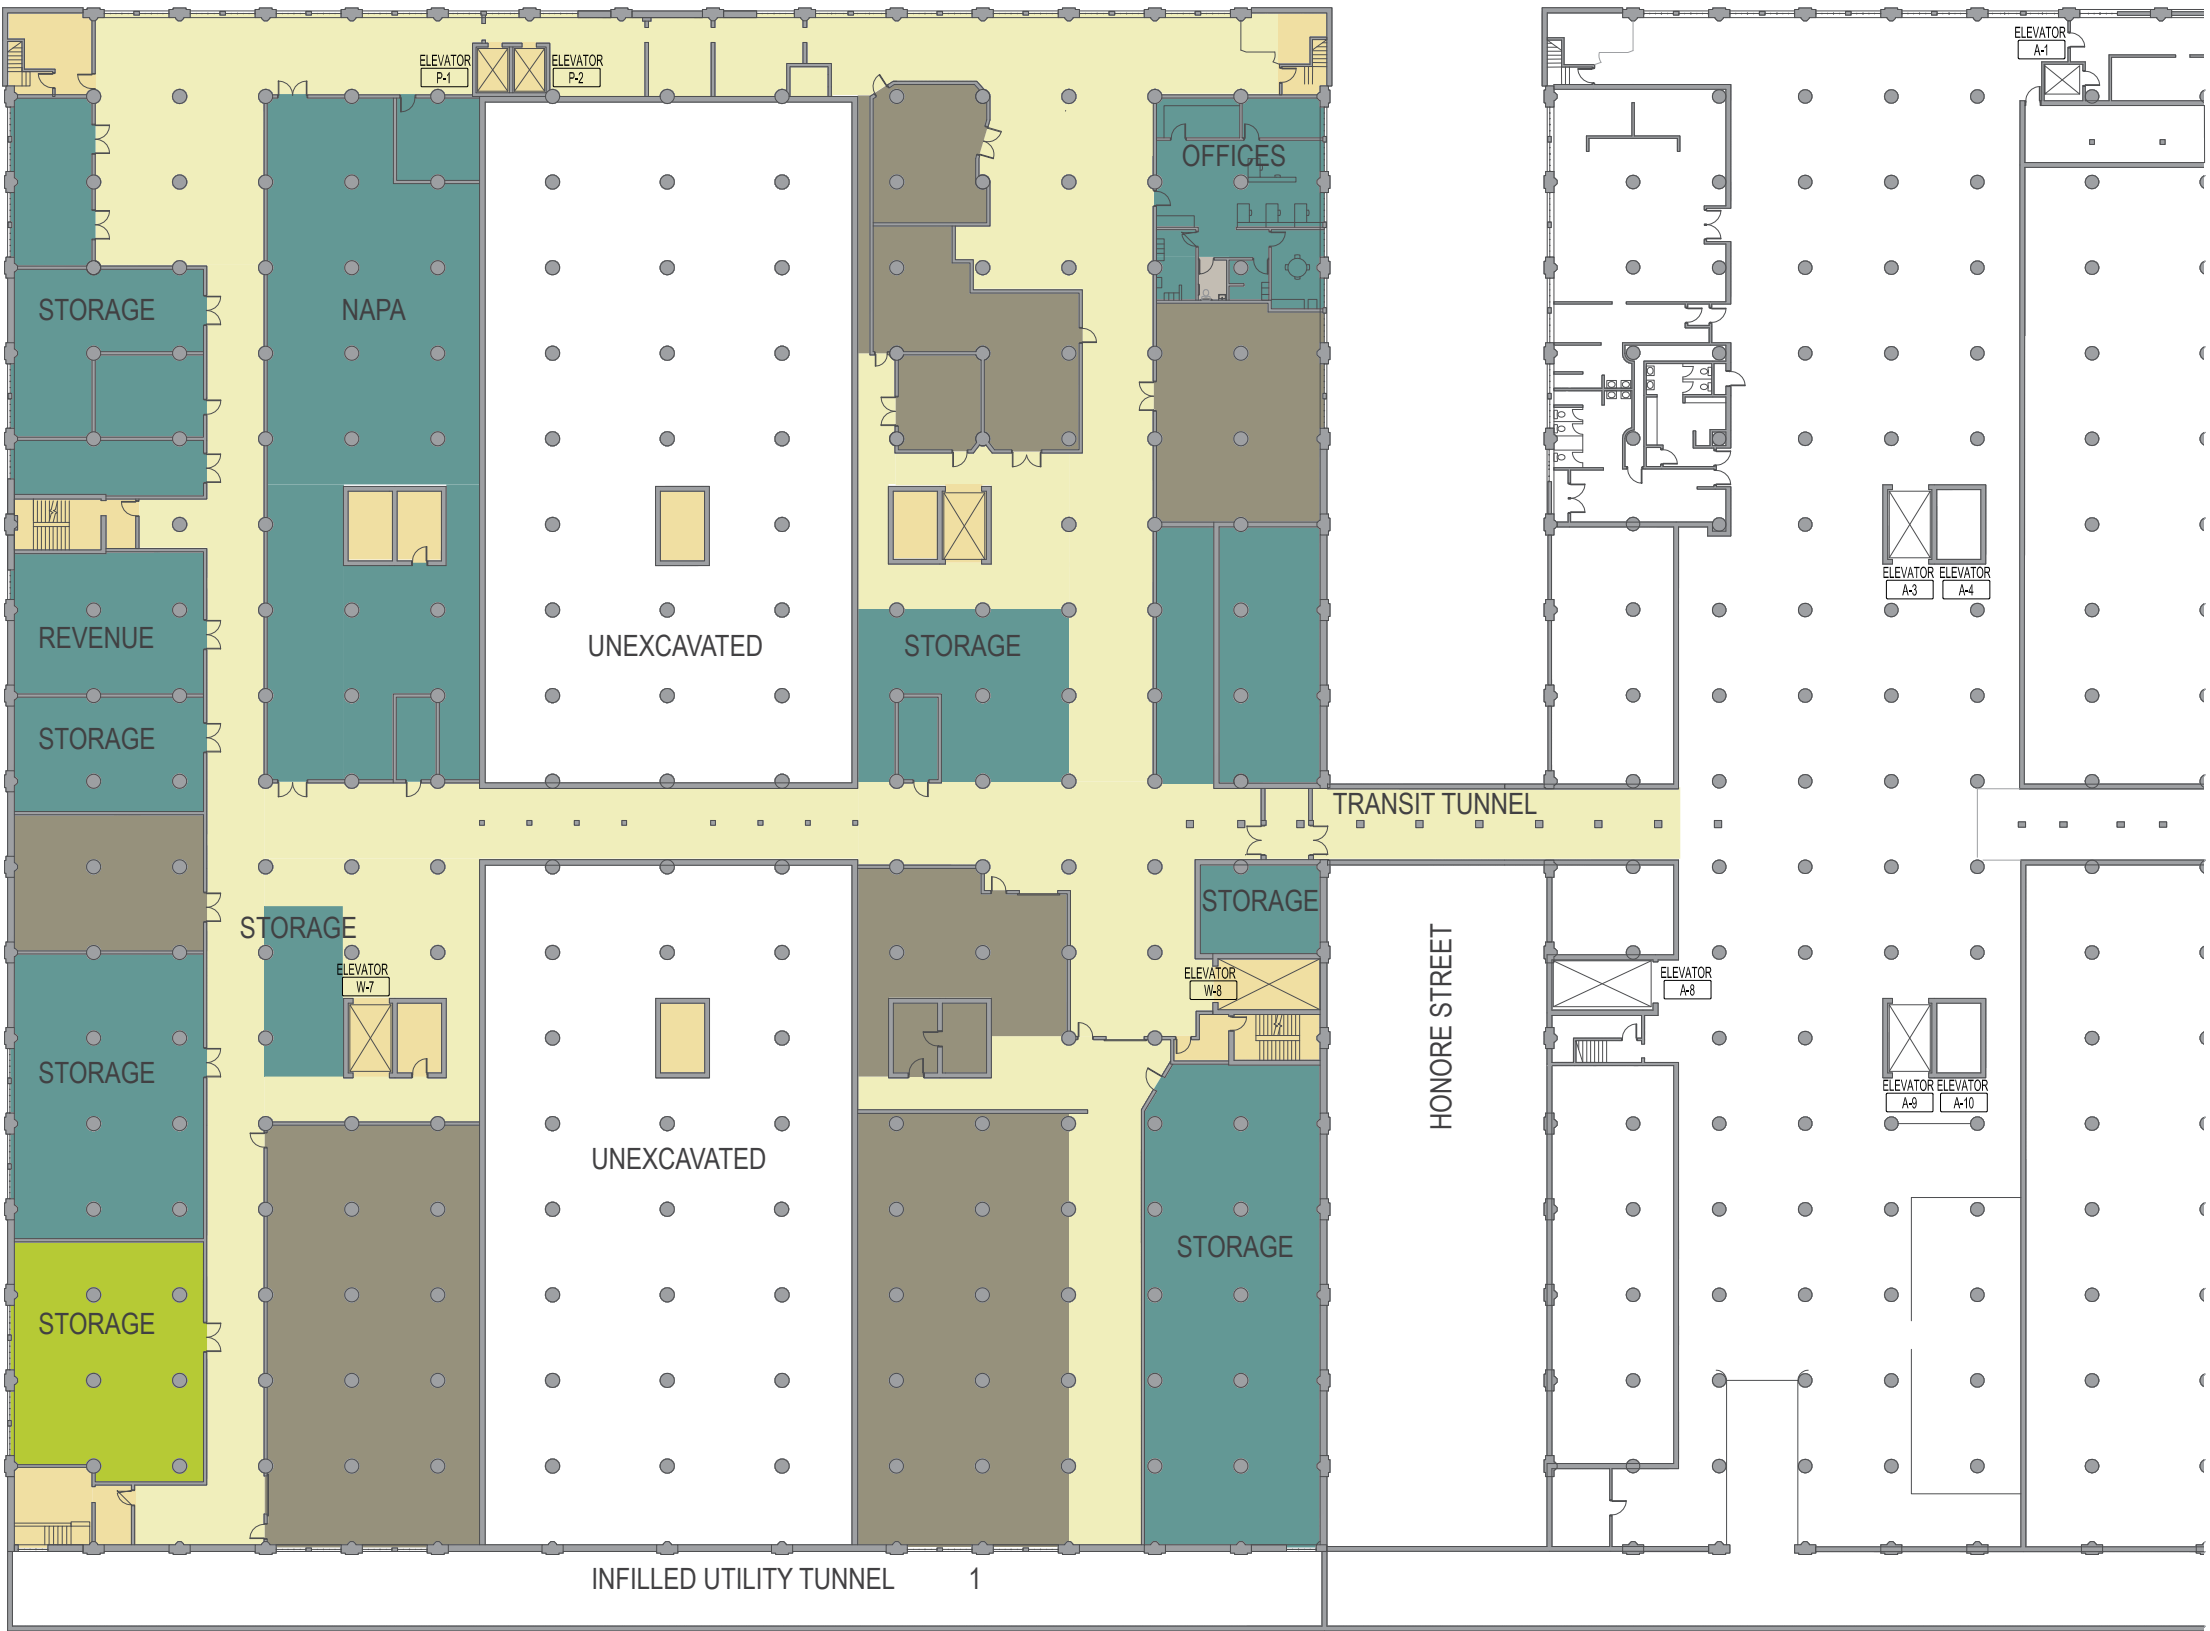
Test Fit Basement Floor Plan

1. Utility tunnel is infilled

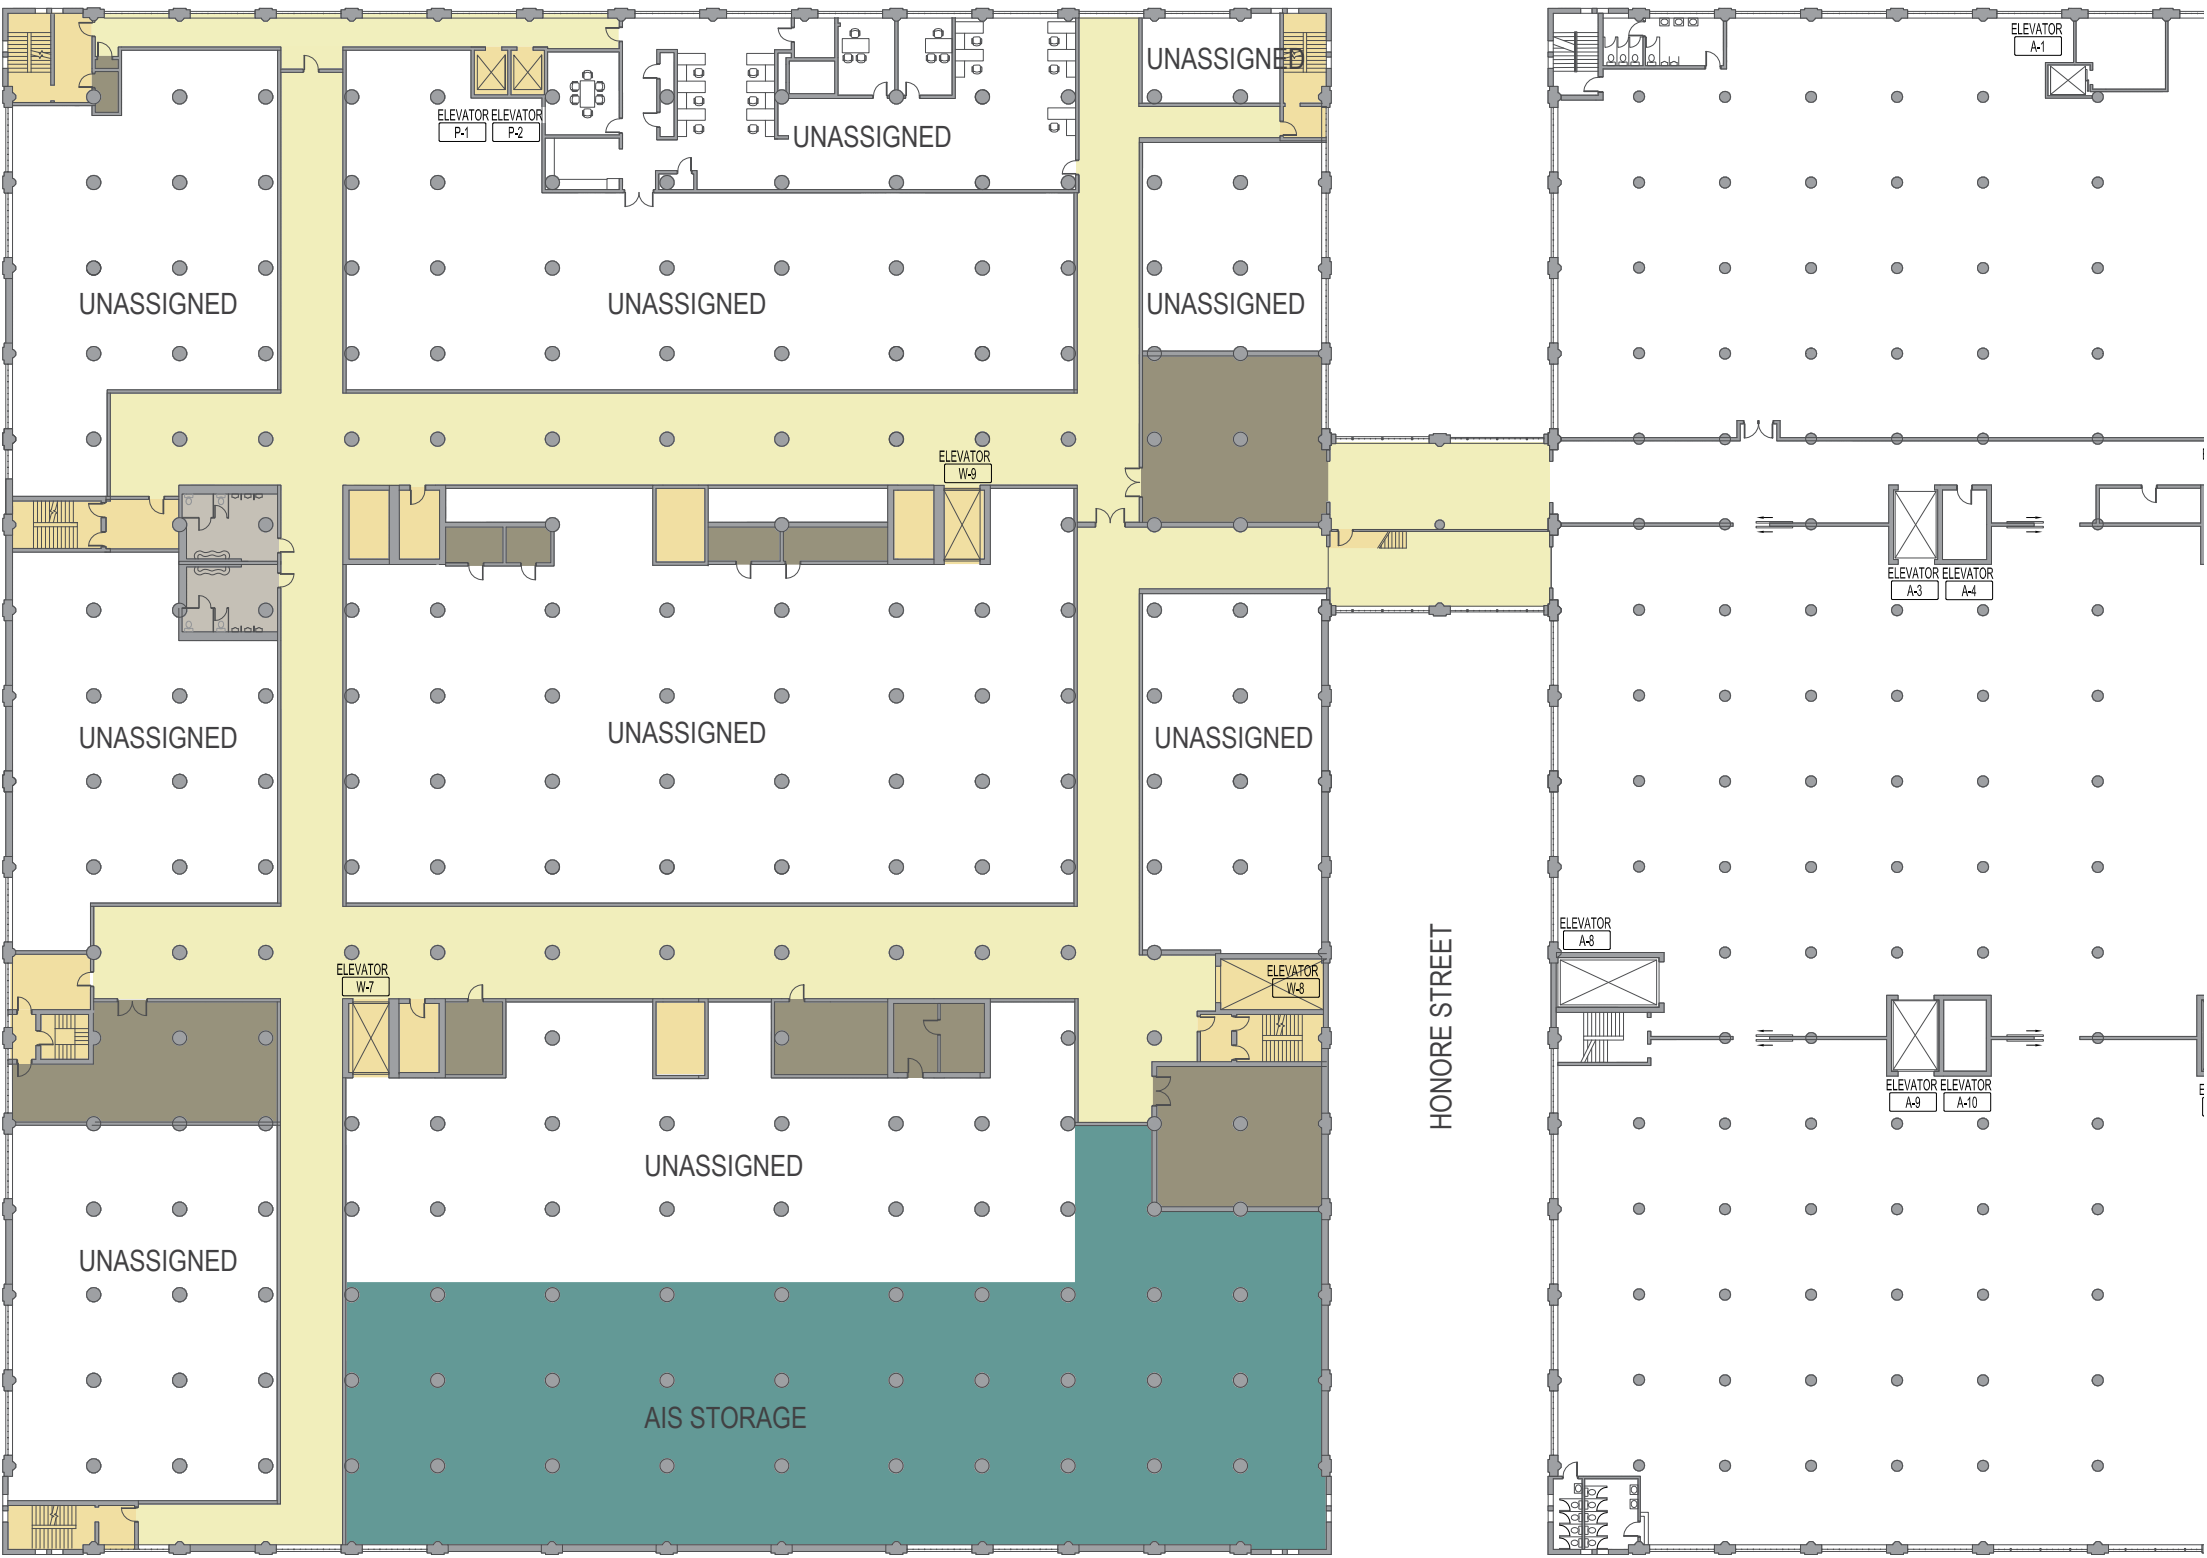
1. Board of Elecations vacates this floor. This creates a floor of unassigned spaces. All corridors are designed for 2 way forklift traffic.
2. Partial AIS storage is relocated to this floor.
3. Circulation network shown is a new optional proposed circulation network for operational efficiency. The existing constrained circulation network could remain.
4. Partial AIS Storage is relocated from the sixth floor.

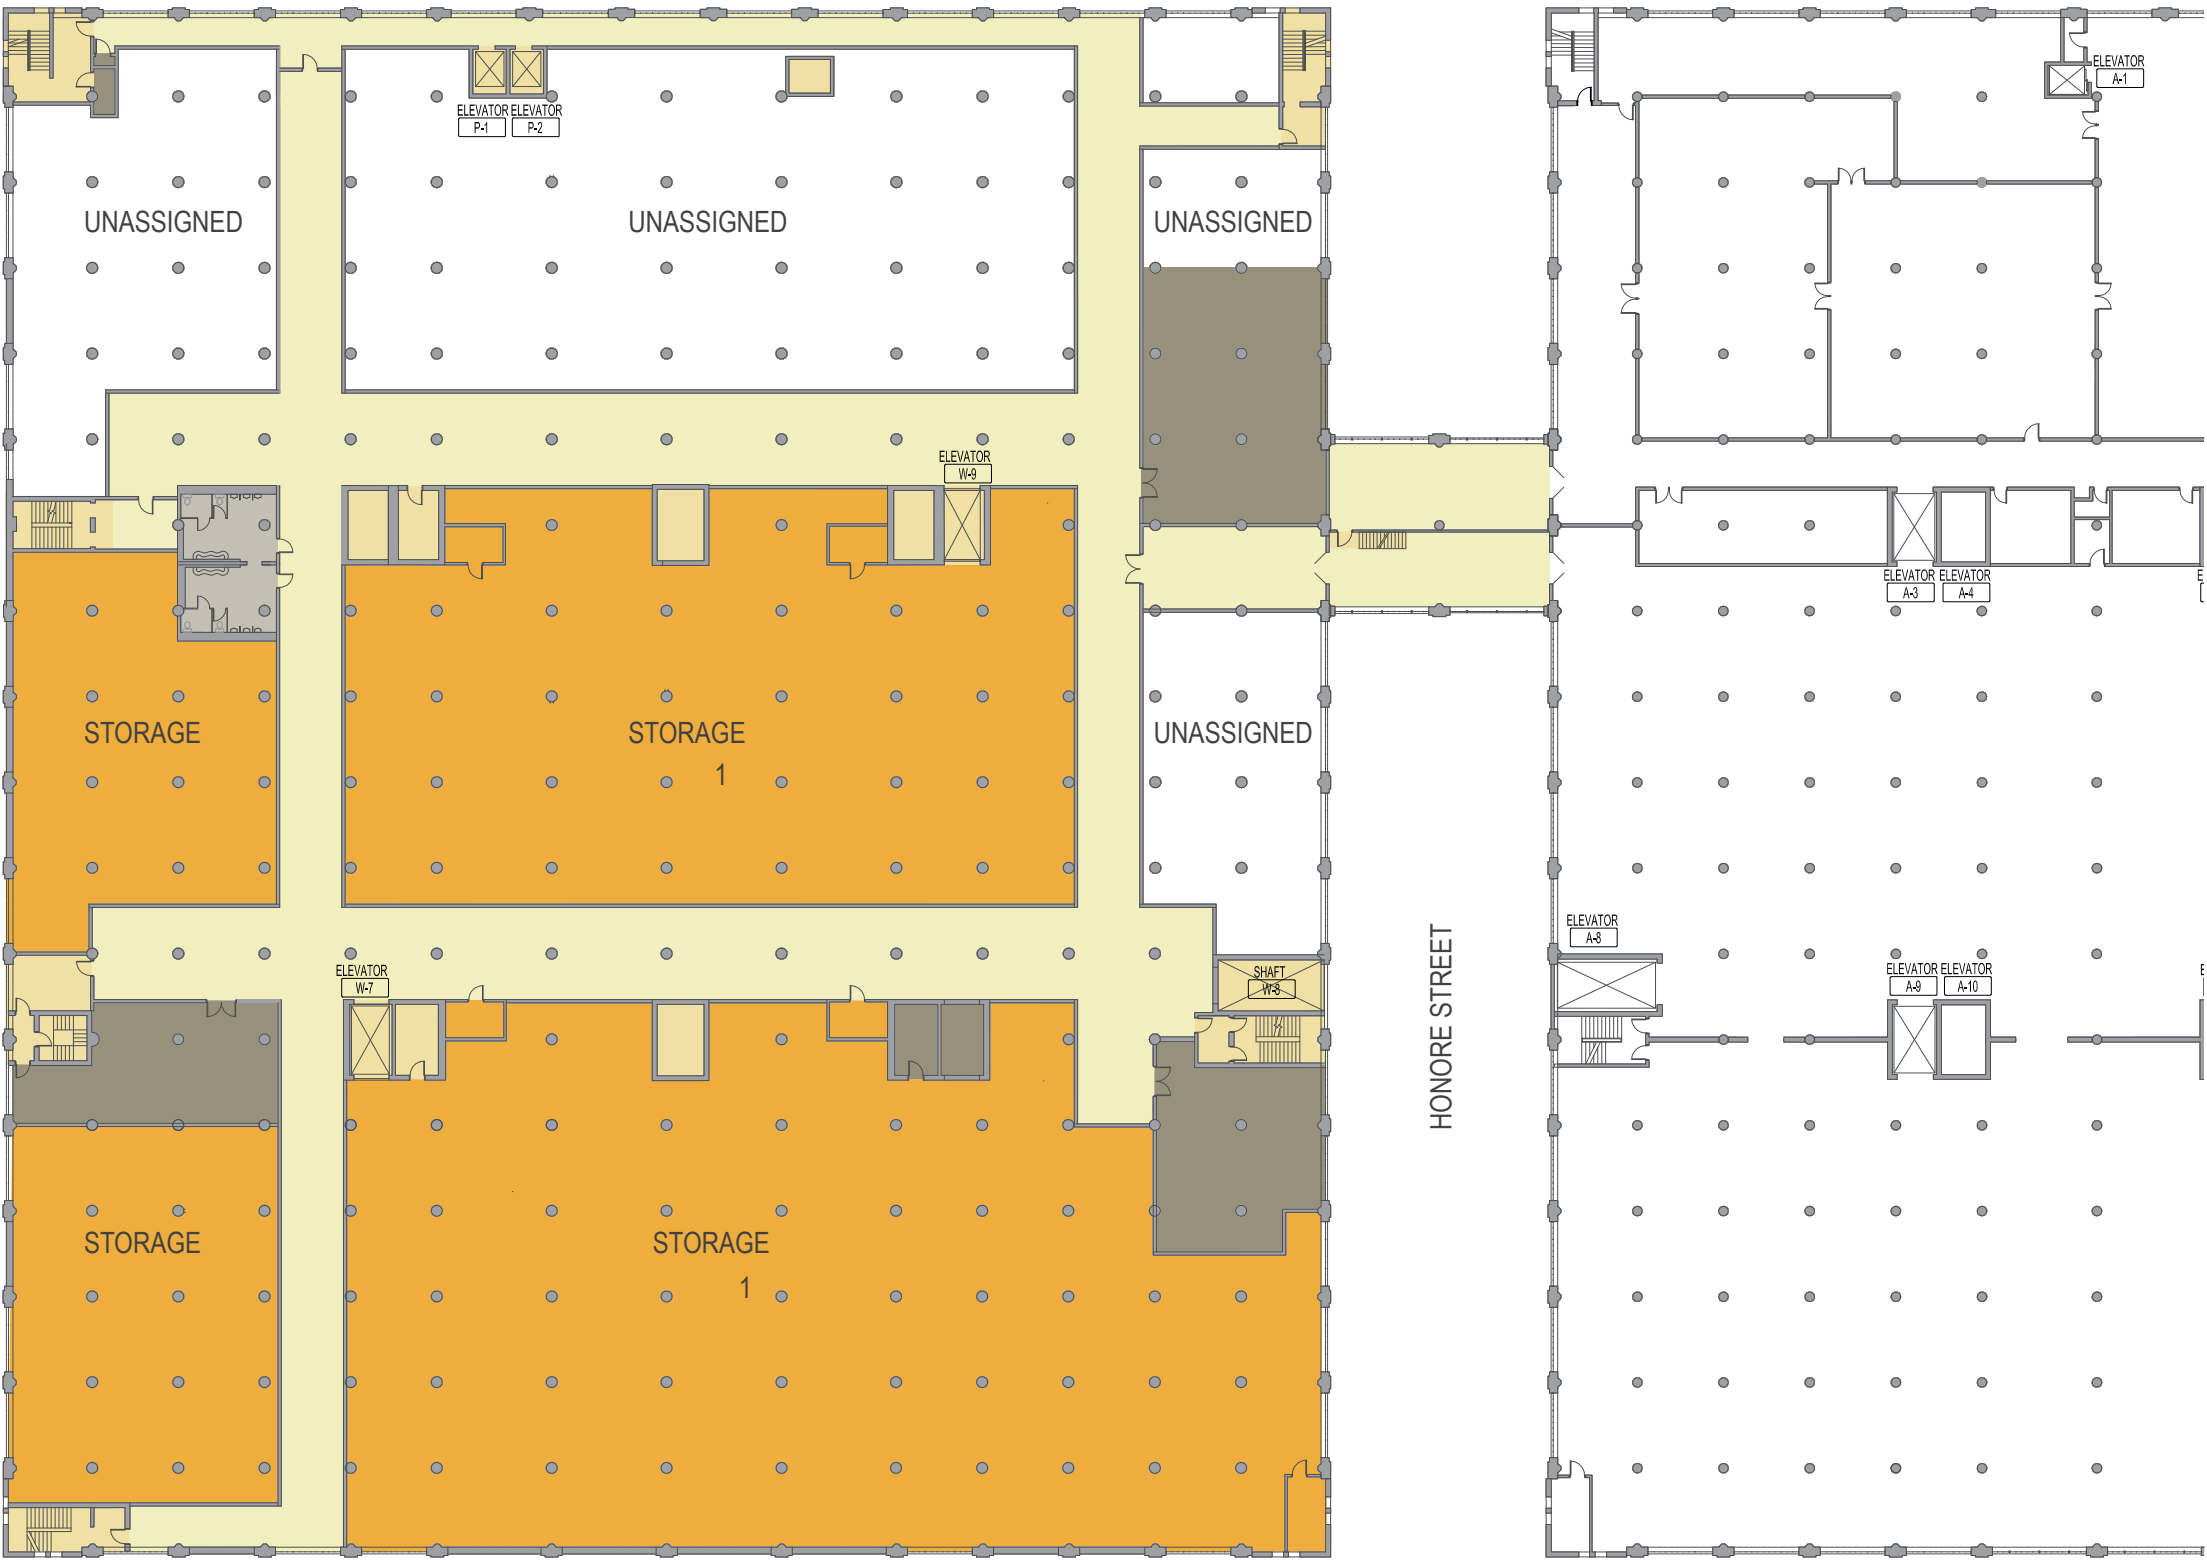
Test Fit Existing Third Floor Plan

1. Board of Elections vacates this floor. Area is renovated for the technical requirements of the Chicago Department of Public Health. CDPH expands to this floor.

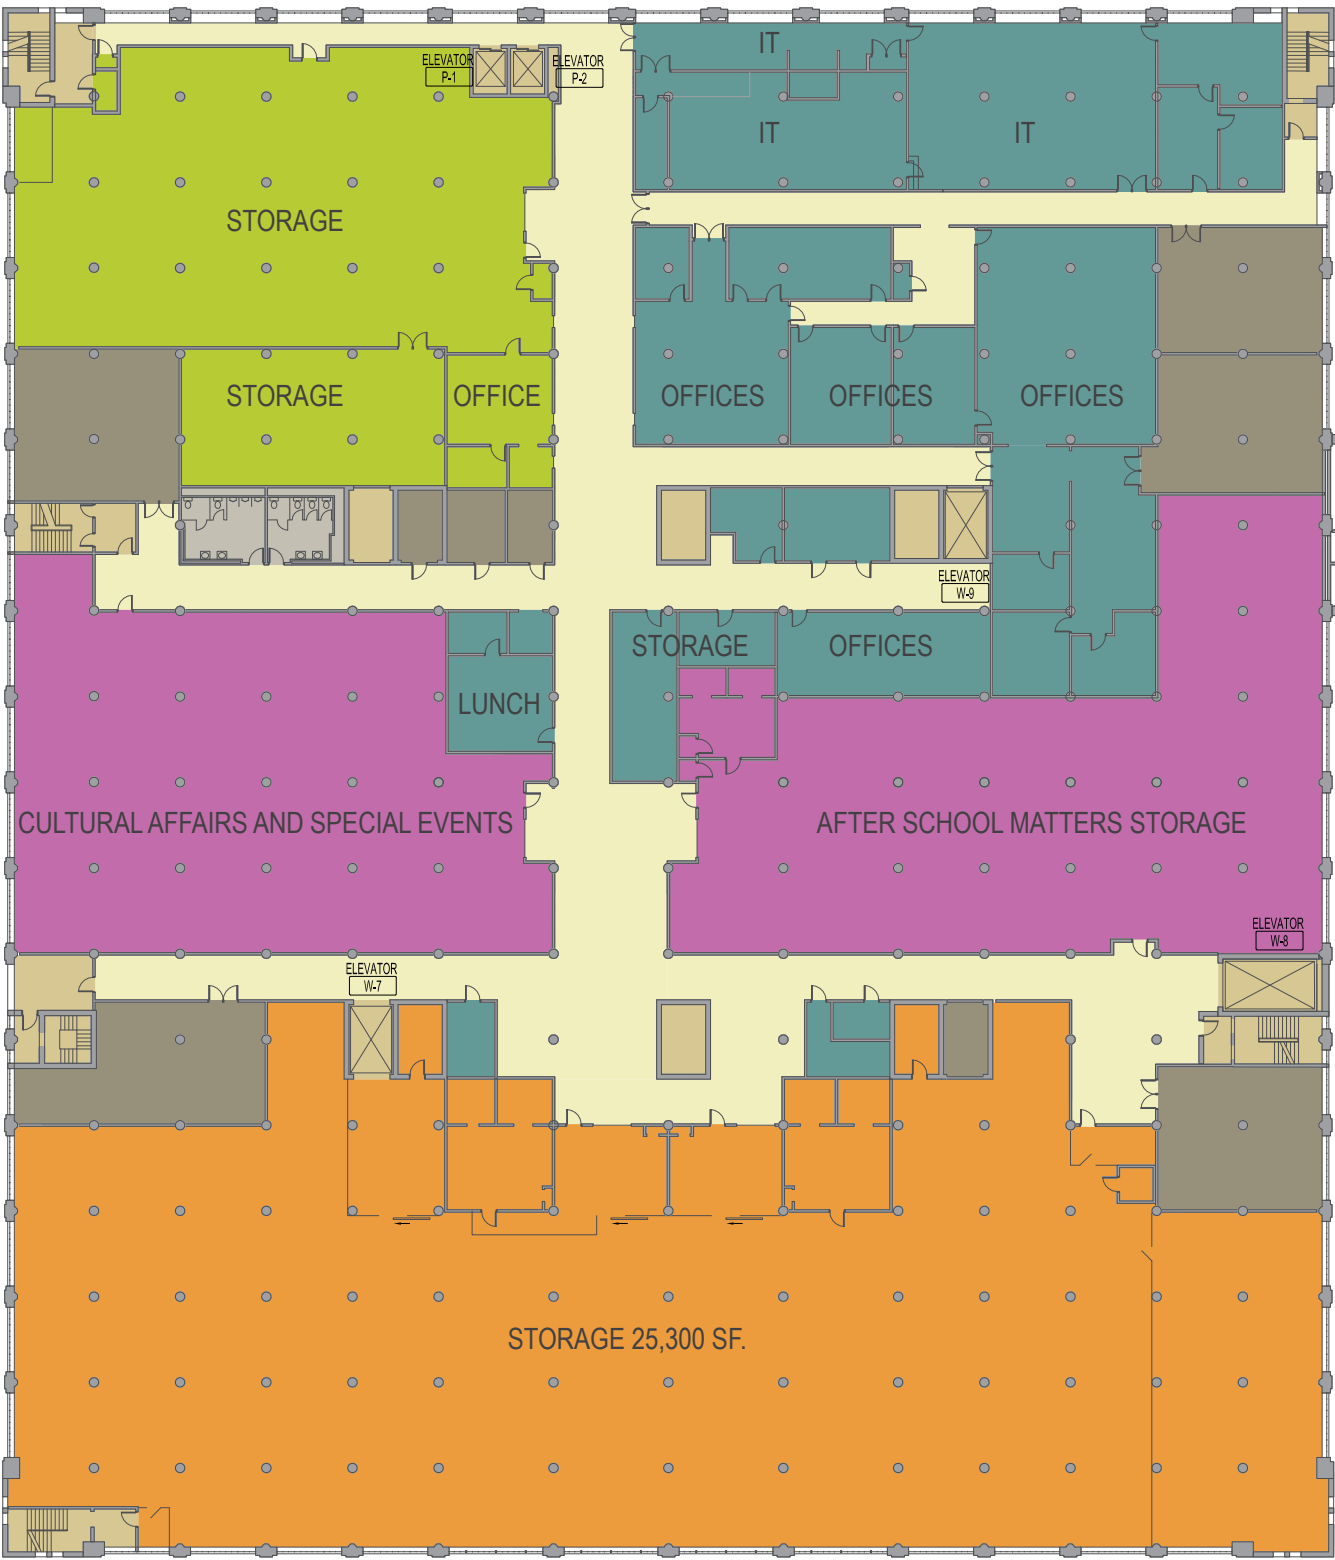
1. No changes on this floor.

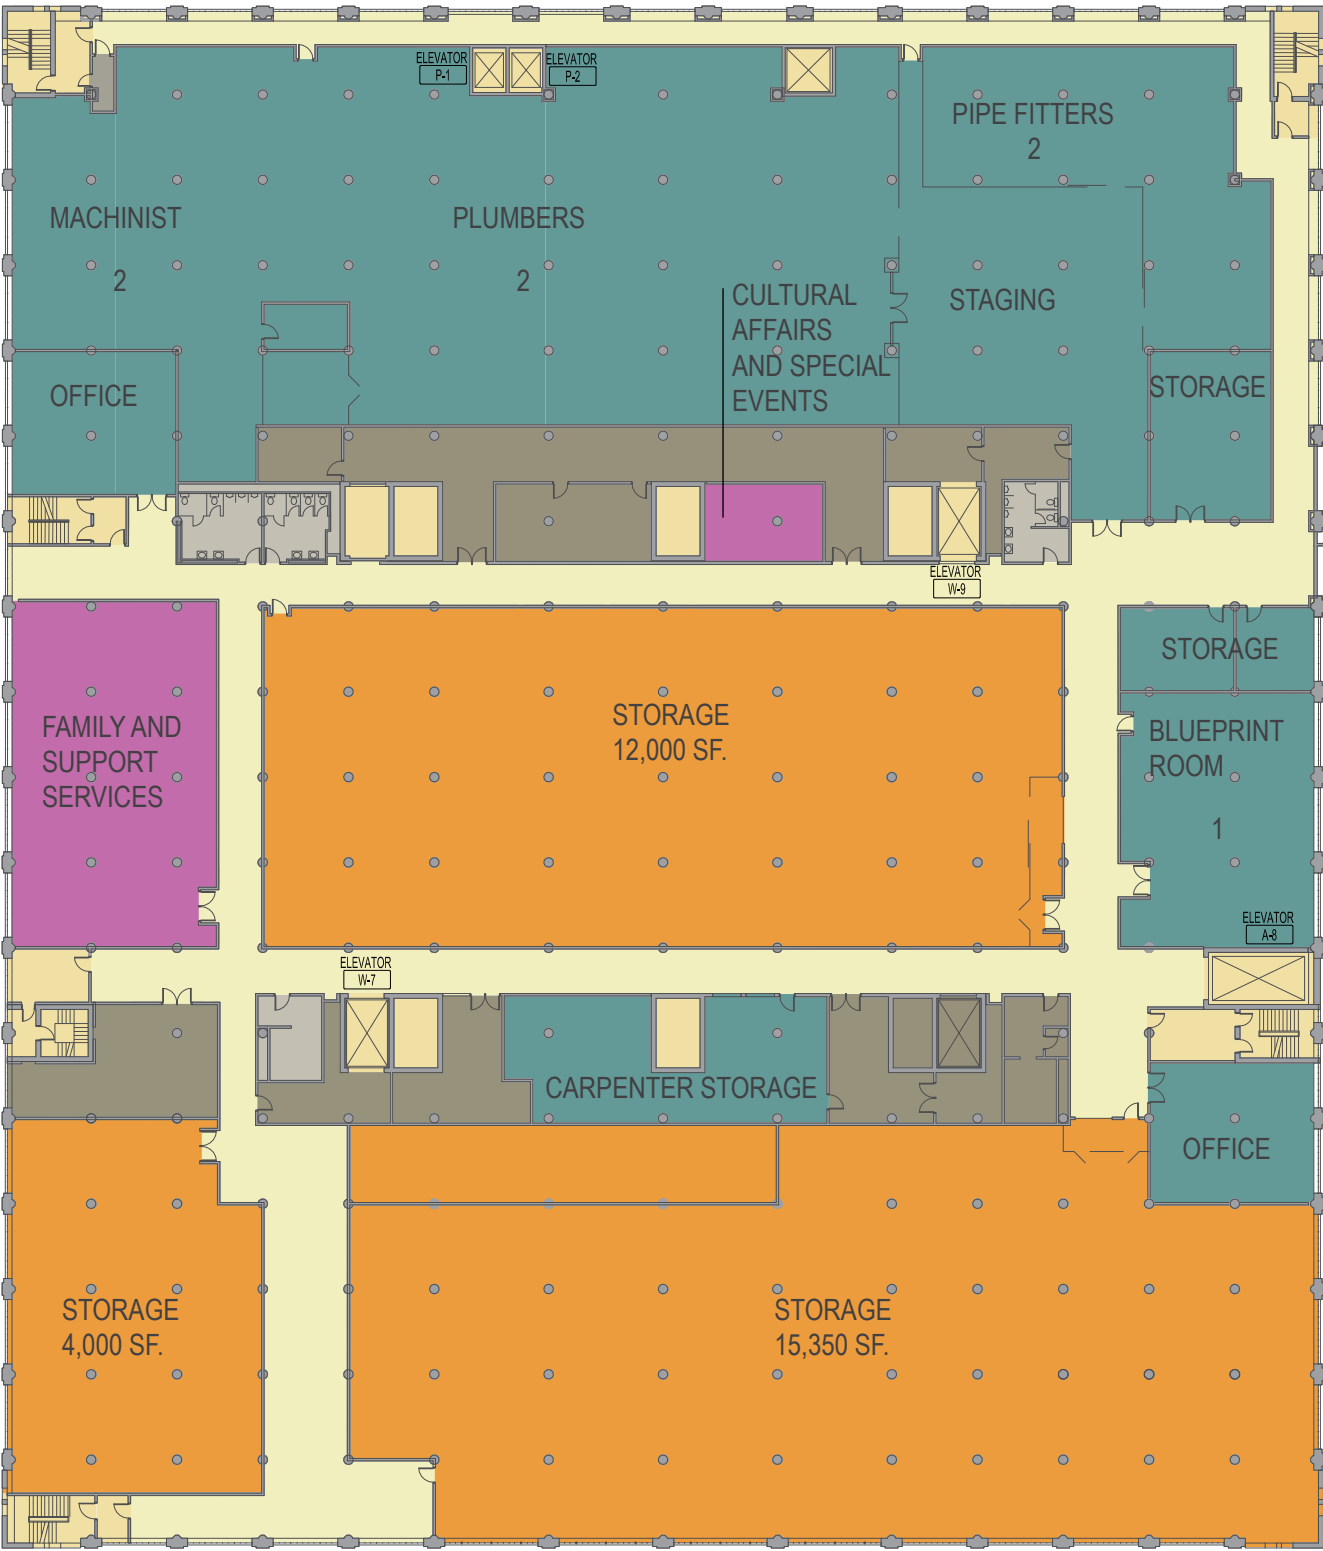
1. Blueprint Room is renovated.
2. Trade Shops are updated to meet current needs.
