JAMES E. MCDADE CLASSICAL SCHOOL

MCDADE CLASSICAL SCHOOL
CONCEPTS + ASSESSMENT

OCTOBER 26, 2018

8801 S. Indiana Ave.
Chicago, IL 60619

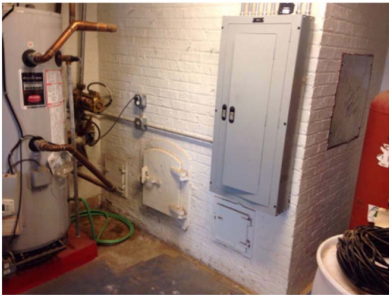
Terracon also observed evidence of an apparent incinerator from the exterior of the building in the vicinity of the mechanical room. Terracon's inability to assess the incinerator is considered to be a limitation of this report; however, is not considered to be a significant data gap. Additional indicators of RECs were not identified with environmentally significant features at the time of site reconnaissance.

Terracon observed the location of a former incinerator in the southwest corner of the mechanical room in the on-site structure. The interior of the incinerator was inaccessible at the time of reconnaissance and is considered to be a limitation of this report.

Photo 1 Incinerator in mechanical room.

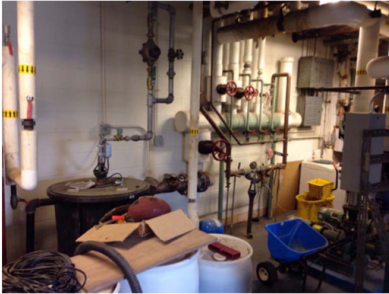
Terracon observed a natural-gas fired boiler system and heat exchange cooling system in the maintenance room of the on-site structure. Evidence of environmentally significant issues were not observed with the components of the HVAC systems.

Photo 2 Plumbing and heating system in mechanical room.

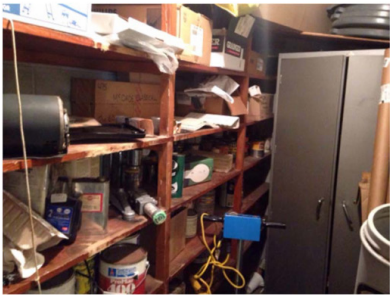
Photo 3 General equipment storage in mechanical room.

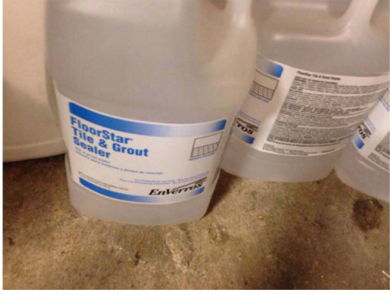
Photo 4 Containers of tile and grout sealer.

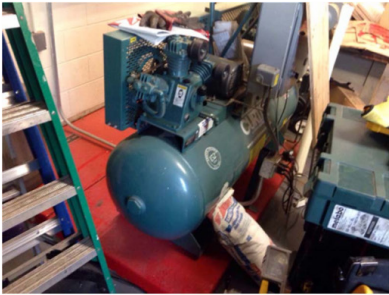
Terracon observed an air compressor with an approximately 50-gallon reservoir in the mechanical room of the on-site structure. The air compressor is a part of the buildings fire suppression system. Evidence of staining or blowdown was not observed on the intact concrete floor surrounding the air compressor. A digitally controlled-mechanical pressurizing unit was also observed in the mechanical room. The pressurizing unit is a part of the site's sprinkler system.

Photo 5 Air compressor in mechanical room.

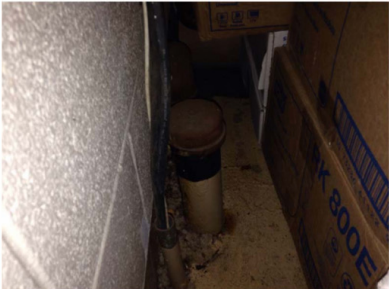
Site features observed during the site reconnaissance include suspect UST piping. Based on observations made during the site reconnaissance, Terracon considers the apparent remnant UST piping in the mechanical room to be indicative of a REC. The observed piping, in addition to the previously identified undocumented and unverified removal of a heating-oil UST in 1999 is considered to be a REC.

Photo 7 Apparent UST piping.

Based on the scope of services, limitations, and findings of this assessment, Terracon recommends additional investigation in the form of a Ground Penetrating Radar and Electromagnetic Survey (GPR/EM) survey and environmental borings/sampling in the location of the former UST system and remaining piping.

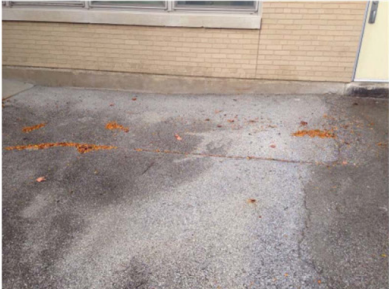
Photo 8 Apparent UST excavation.

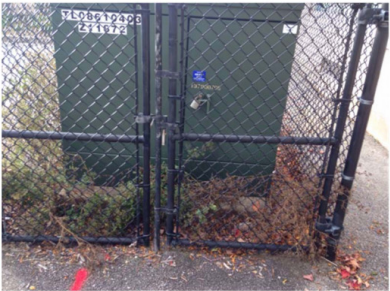
Photo 9 Pad-mounted transformer.

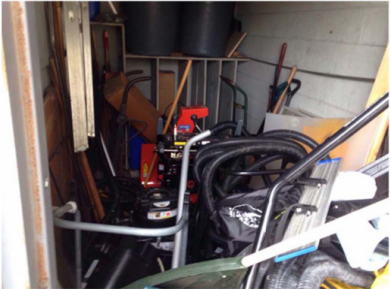
Photo 10 Lawn equipment storage.

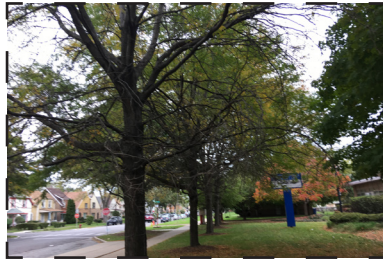
5- 2.1

Figure 5-2.1: Trees in front of school to the west could use pruning to promote continued good health of trees.

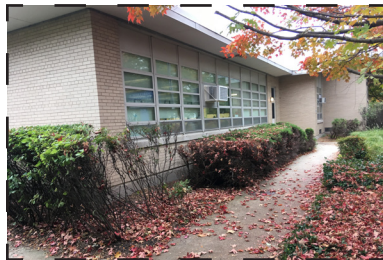
5- 2.2

Figure 5-2.2: Several shrubs are dead in hedge at northwest corner of the school.

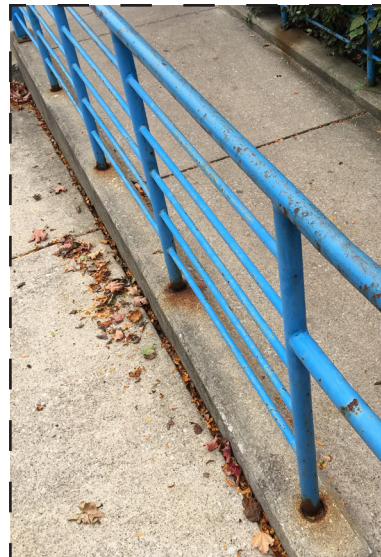
5- 2.3

Figure 5-2.3: Blue railing at main entrance is chipped and railing is rusted. There appears to be no structural issues but properly sanding and repainting is recommended.

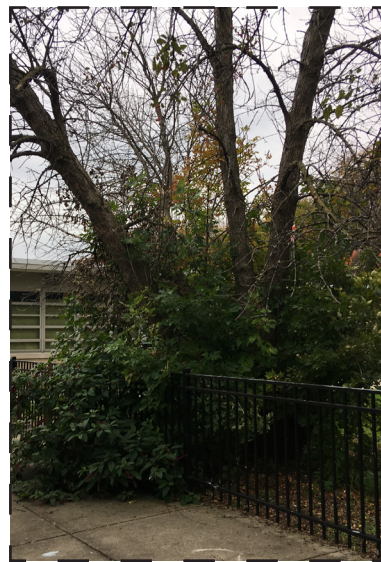
5- 2.5

Figure 5-2.5: The existing Ash tree is just west of the north playground, is dead with sucker and poisonous weed growth beneath. It is recommended to remove the weeds and dead Ash tree, grinding out the stump to a minimum depth of 18”.

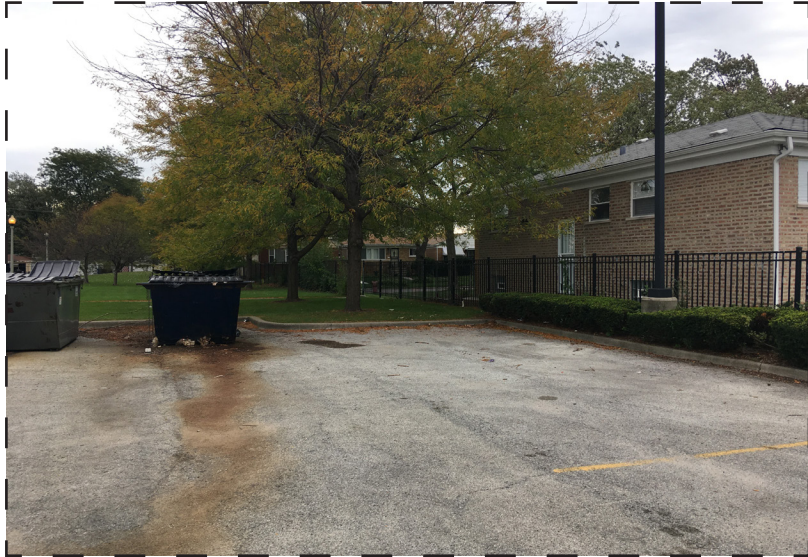
5- 5.1

Figure 5-5.1: There appears to be ample room for the proposed trash enclosure, which should not affect any parking counts.

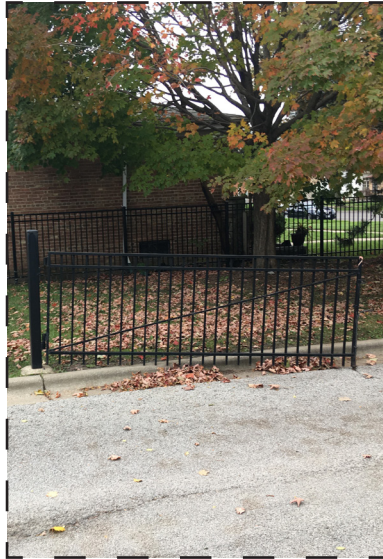
Figures 5- 6.1 and 6.2: The southern swing gate is broken off its hinges. The northern swing gate appears to lean and likely does not operate properly.

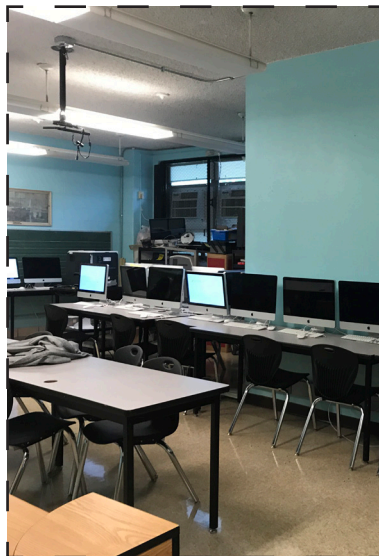
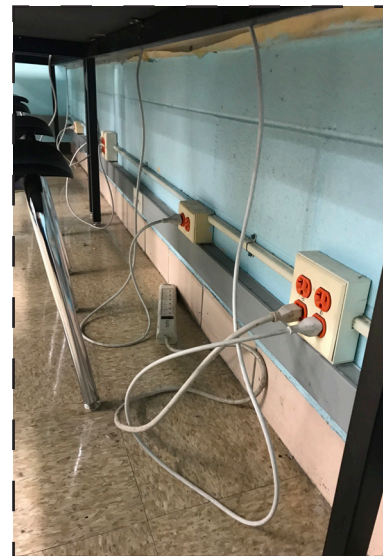
Figures 7 - 4.2 and 4.3

- Address space requirements for new cafeteria & hybrid kitchen.
- Address finishes, lighting, acoustics, power needs, mechanical/ventilation needs for space

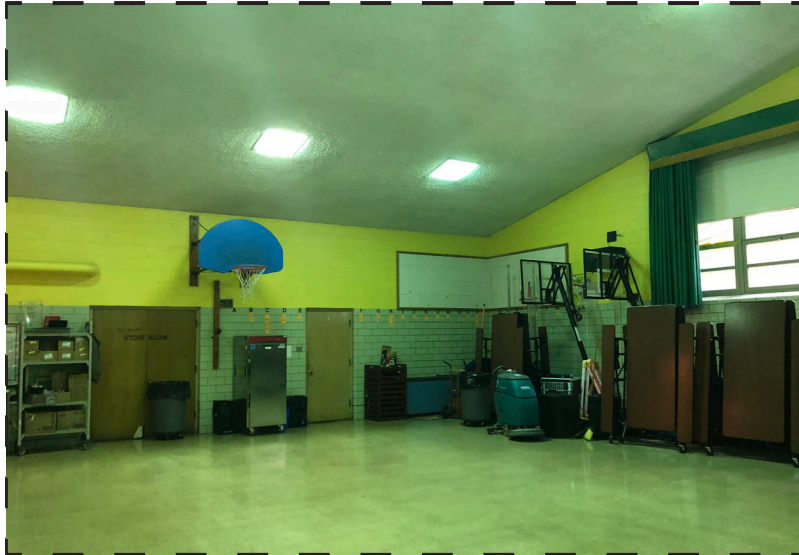
8- 1.1

Existing Kitchen/Cafeteria/Gym

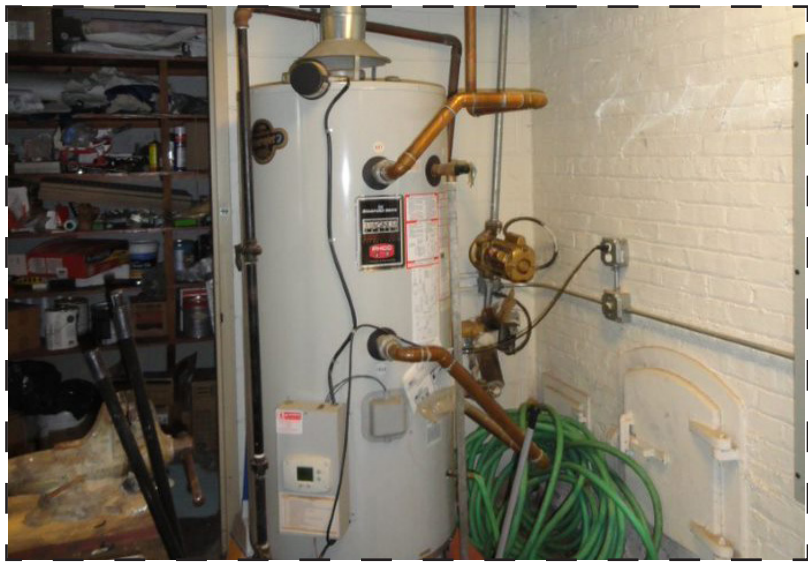
9- 2.2

Existing water heater service and domestic water booster pump.

The existing water heater system has (1) gas fired, tank type water heater, hot water recirculation and recirculating pump. The existing water heater system to be replaced with a condensing, high efficiency tank type unit, sized for the existing and new load.

The existing domestic water booster pump will be replaced. It will be sized to account for additional GPM load requirements and friction loss.

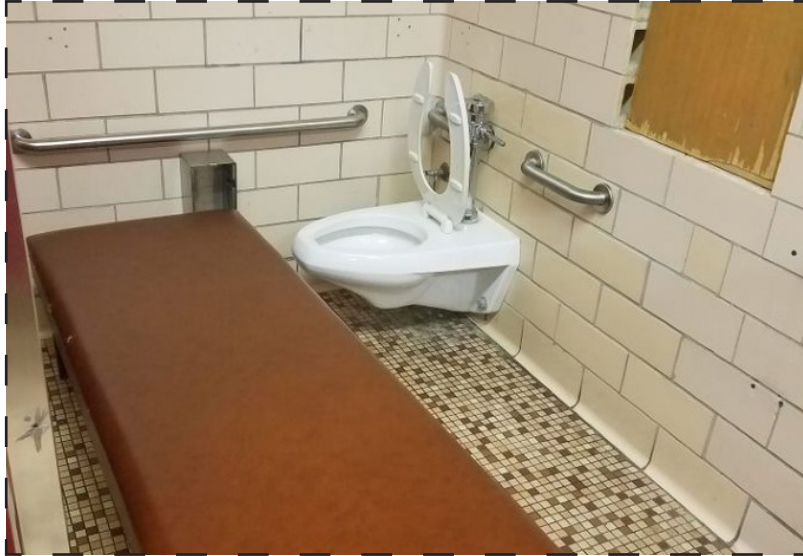
9- 3.1

Existing girls toilet room “ADA”

The existing boys and girls restrooms to be renovated. Recommendation to phase and remodel once new restrooms and functional fixtures can account for the existing occupancy/fixture load. Selective demolition will be required for new domestic water distribution tie-in to new fixtures.

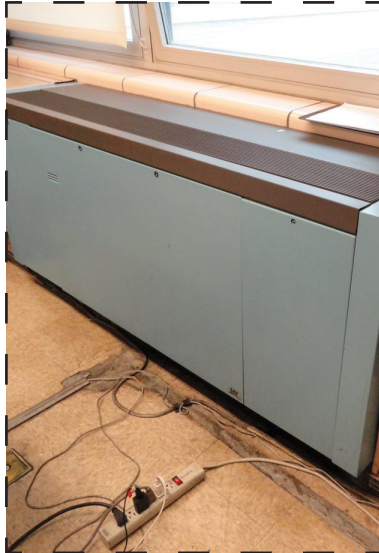
10- 1.1

Figure 10-1.1: Typical induction air unit at each classroom. Units are heating only with outside air intake/grille. They appear original to the building and should be evaluated for proper operation as well as operation with a condensing boiler heating plant.

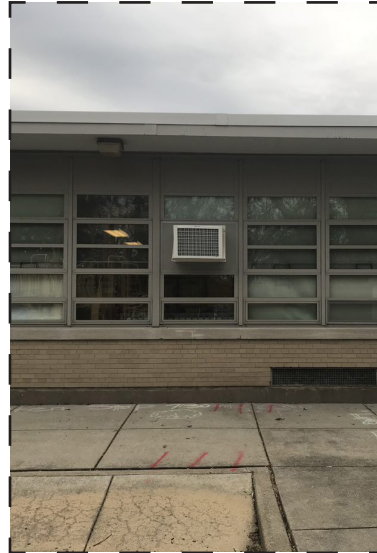
10- 1.2

Figure 10-1.2: Exterior building wall; induction unit outside air intake/grille.

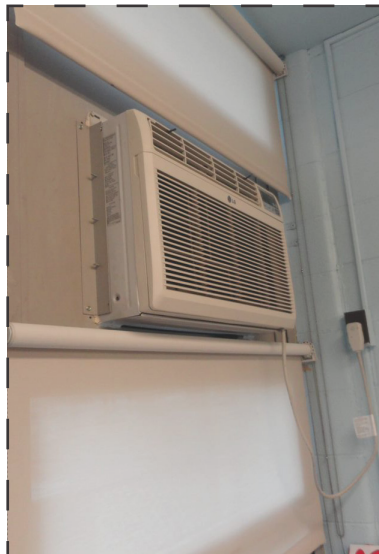
10- 1.3

Figure 10-1.3: Typical window AC unit. Units were installed within the year; 2018.

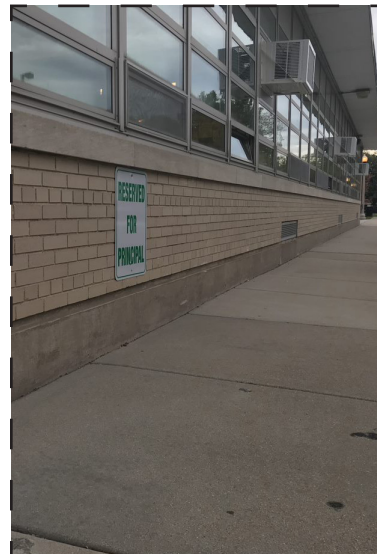
10- 1.4

Figure 10-1.4: Exterior building wall; window AC unit mount.

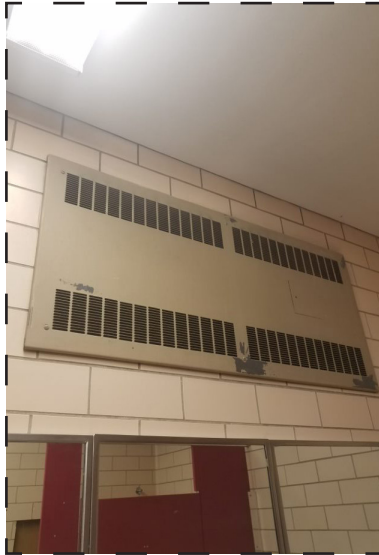
10- 2.1

Figure 10-2.1: Indoor cabinet heater; located in boys toilet room. Similar unit mounted in the girl's toilet room and corridor.

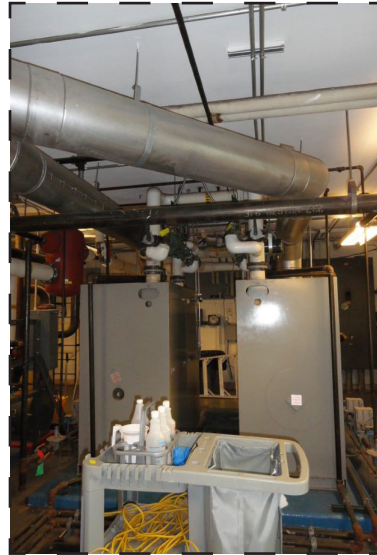
10-2.2

Figure 10-2.2: Existing hot water heating boilers. The boiler name plate states 2006 for year built. The existing plant can either be upgraded to serve the new Annex; the existing boilers would be replaced with larger units and it would be advantageous to consider condensing boilers at this point as well as these units have can be more efficient than the existing boiler in use. This upgrade would include evaluating the existing heating equipment to operate with condensing boiler water temperatures

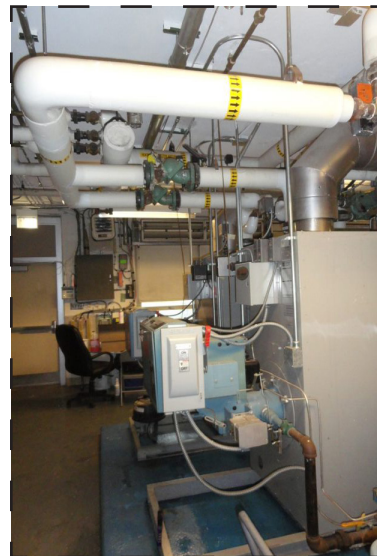
10-2.4

Figure 10-2.4: Heating hot return main header. Should the plant be upgraded, a new header may be required or the existing header would need to be increased. The existing distribution would remain, but an additional branch to serve the new Annex would be required.

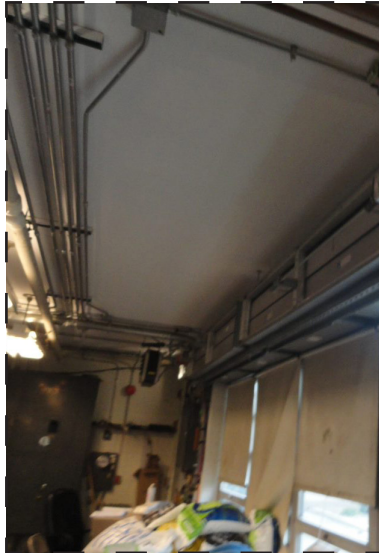
10- 3.1

Figure 10-3.1: Boiler room combustion air intake. There are four louvers that open when the boilers are in operation. It may be possible to keep the existing louvers as shown; these would need to be evaluated further and the design progresses.

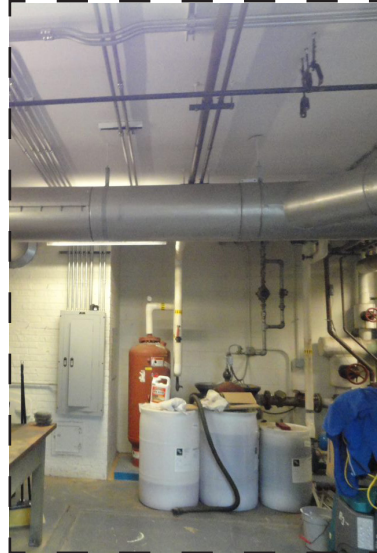
10- 3.2

Figure 10-3.2: Boiler flue. Should the plant be upgraded, the size and material of flue is to be evaluated to operate with condensing boilers.

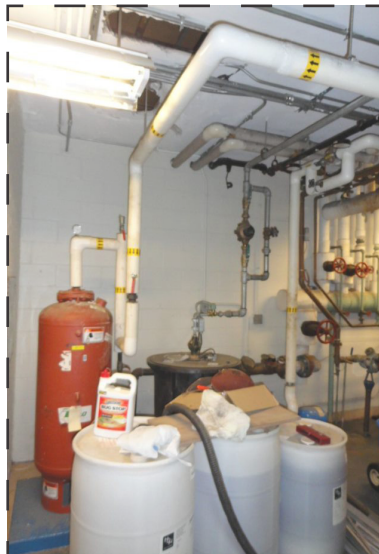
10- 3.3

Figure 10-3.3: Boiler plant ancillary equipment; expansion tank, pressure fill, and chemical treatment. Equipment to be evaluated based on plant modifications as required.

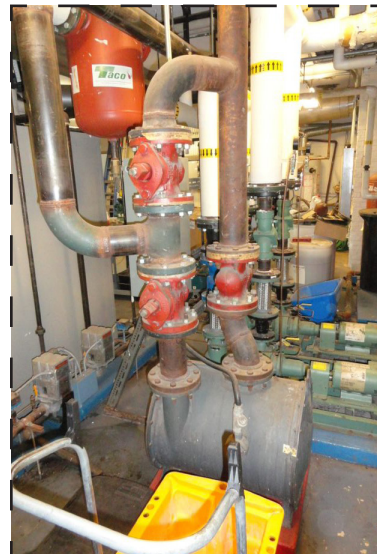
10- 3.4

Figure 10-3.4: Existing natural gas boosters. It is recommended that a functional test of the gas boosters be performed to determine the need for the boosters. A new connection would be recommended downstream of the boosters to serve the new Annex equipment.

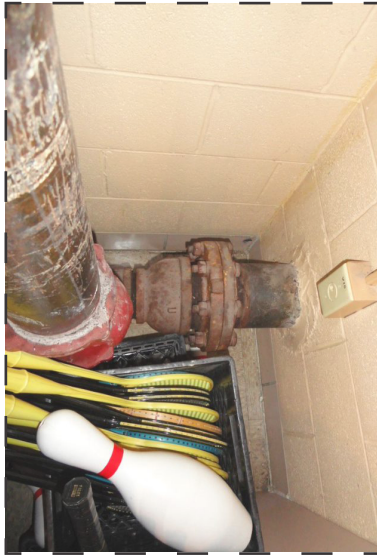
10- 4.1

Figure 10-4.1: Existing incoming natural gas service from utility. Assumed to be low pressure (~7 in.wc.).

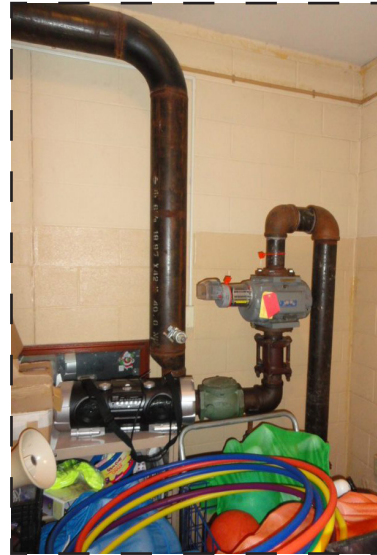
10-4.2

Figure 10-4.2: Existing incoming natural gas meter.

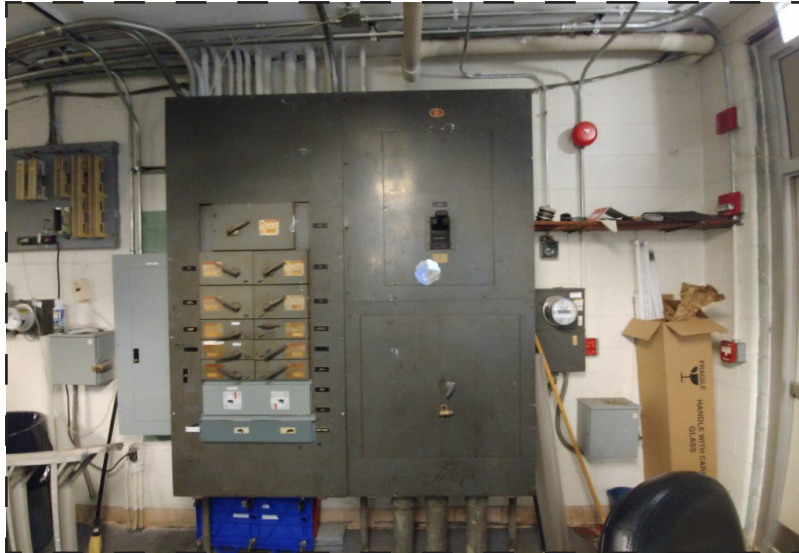
11- 1.1

There are no reported issues with nuisance tripping within the building; however, given the age of the main circuit breaker and presumed lack of maintenance it can't be ascertained that it is still operating properly. We recommend that the main circuit breaker be replaced and the rest of the main distribution having a full set of testing and maintenance performed on it. The existing fused switches should either be replaced with new or replaced with circuit breakers.

Figure 11-1.1: Existing main distribution with one section for incoming feeders and the 800AF/400AT main breaker; and another section for loads. Besides newer circuit breakers installed during recent work, the equipment itself is old and building original. It is not likely that the main breaker has been maintained and exercised and there's a possibility that it does not operate properly anymore. There is limited capacity to install additional loads and the anticipated power draw for the new warming kitchen may exceed the rating of the board. Should CPS not want the warming kitchen to be fed from the annex, the existing main distribution will require upgrades to accommodate the new loads. Note: the existing feeders for the older equipment use cloth wire without grounding conductors; these will need to be replaced under this option.

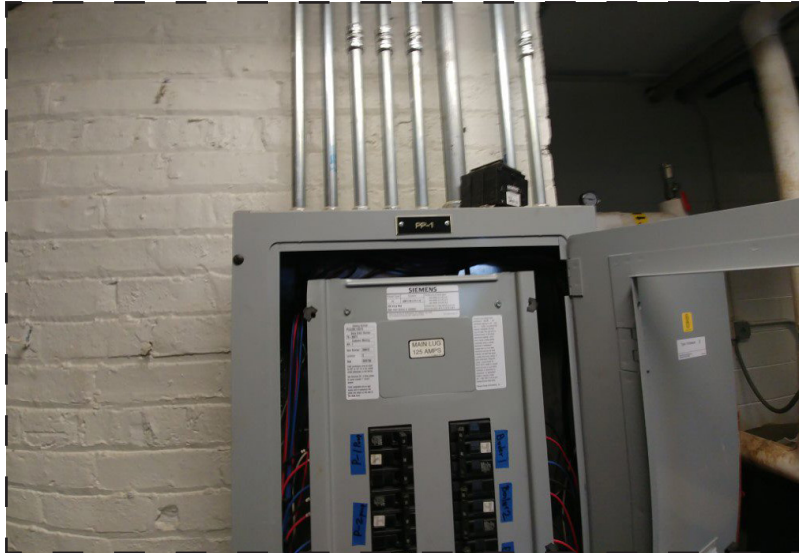
11- 2.1

Figure 11-2.1: Typical power panel that appears newer. No major work should be required if there are no known issues beyond standard maintenance.

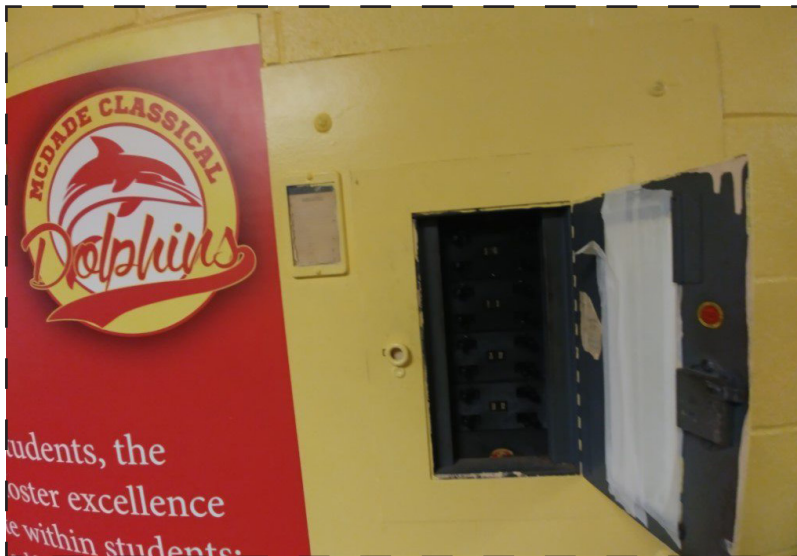
11- 3.2

Figure 11-3.2: Typical panels in the hallway serving the interior of the building. With a few exceptions, these panels are significantly old and likely use cloth wiring and have no equipment grounding conductors. Phased replacement for panels and associated incoming and branch feeders is recommended for planning of the building's long-term.

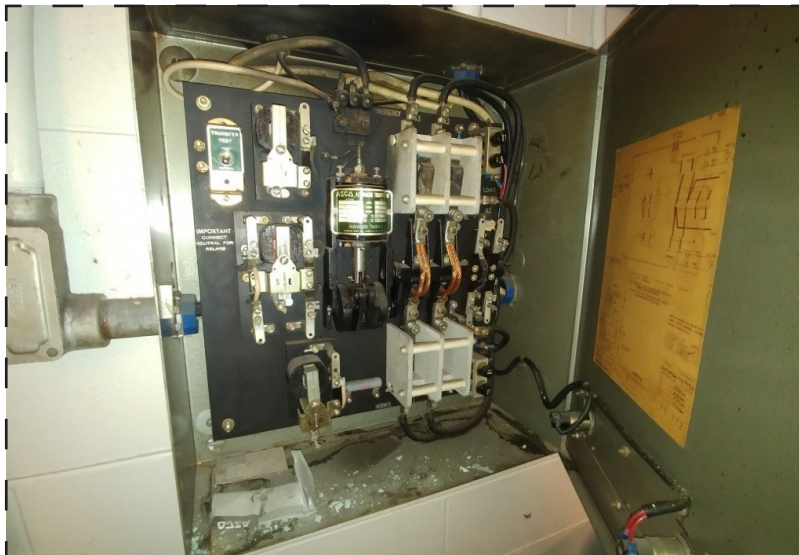
11- 4.2

Figure 11-4.2: Existing ATS. For this section, the point of interest is the presence of cloth wiring and no equipment grounding conductors. While other equipment was not able to be opened, it is expected that the older distribution equipment shares similar conditions. We strongly recommend phased replacement of the building's feeders to replace the cloth wiring and provide equipment grounding conductors; this should be coordinated with our recommended replacement of the panelboards itself.

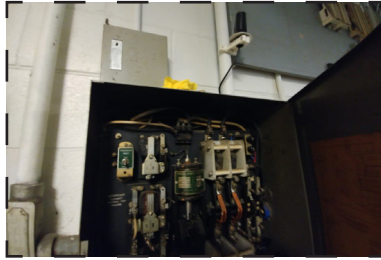
11- 6.1

Figure 11-6.1: Existing ATS. This is a building-original system and no longer appears to serve the actual emergency loads in the building. One feeder goes to a Ryan Box that seems to serve small security loads, the other could not be traced at this time. This transfer switch should be removed with its loads transferred to normal power, providing a UPS system if standby power is desired.

Given the age of the transfer switch and its not serving any emergency loads—emergency lights, exit signs, and fire alarm—we recommend for its removal. Any loads currently served by it should be re-served by existing normal power, or be provided with small UPS units if some

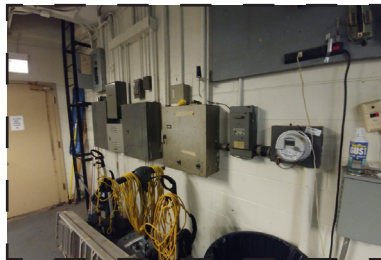
11- 6.2

Figure 11-6.2: Meter for the incoming “emergency” service.

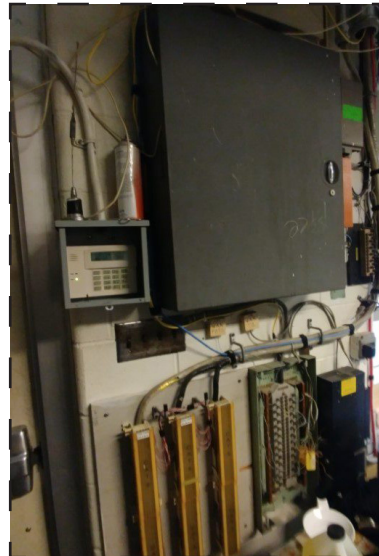
11- 6.3

Figure 11-6.3: Security and IT loads that is suspected to be fed by the transfer switch. These should be re-fed by the normal power system, providing a small UPS system if standby power is desired.

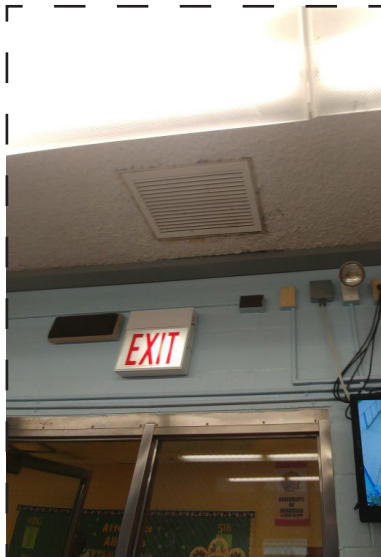
11- 6.4

Figure 11-6.4: Typical existing exit sign. Per provided documentation these appear to be around 10-15 years old. Regular testing shall be provided to ensure that the batteries are still able to hold the required run-time. CPS may elect to replace these signs one-for-one in coordination with the annex construction to provide a common style throughout the building.

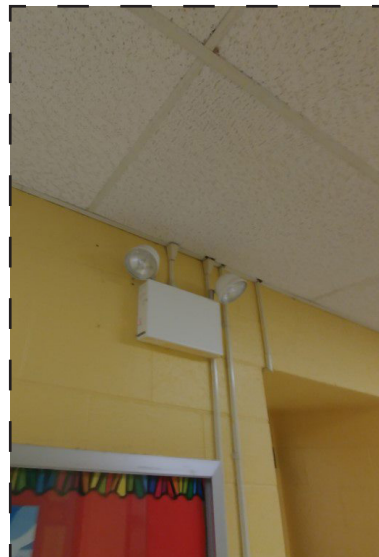
11- 6.5

Figure 11-6.5: Typical existing EBU units. Per provided documentation these appear to be around 10-15 years old. Regular testing shall be provided to ensure that the batteries are still able to hold the required run-time. CPS may elect to replace these EBU's one-for-one in coordination with the annex construction to provide a common style throughout the building.

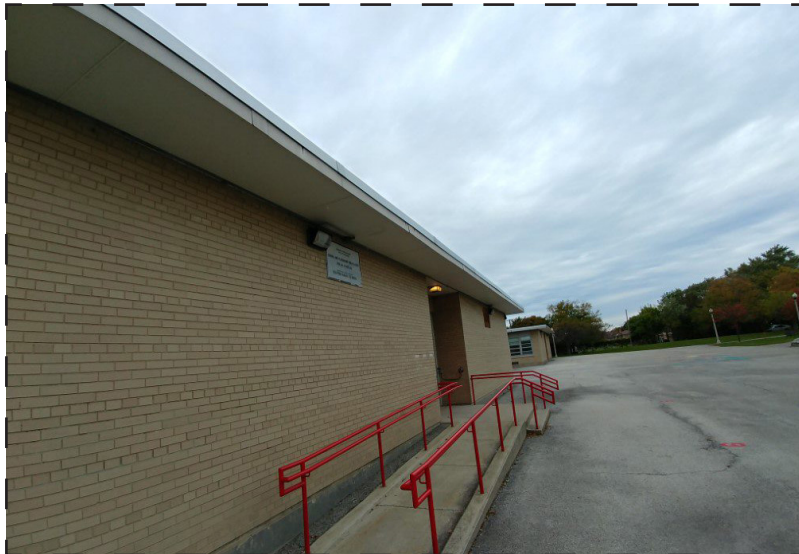
11- 9.2

Existing site lighting consists of building-attached lights and pole-fixtures. Most if not all these fixtures appear to be HID type. The building-attached lights had those at the building entrances on and those elsewhere off (presumably to come on at night). Some of the pole lights appeared to be on despite the daylight hours and many have a significant build-up of leaves inside the luminaire. We recommend the replacement of the HID fixtures with more efficient LED fixtures. With the construction of the new annex and the need for more centralized lighting controls, we recommend that the exterior lighting be integrated into the new lighting control system at some point in the future.

Figure 11-9.2: Existing building attached lighting. Those at the entrances were on, while those elsewhere were off (presumably to turn on at night). These older HID fixtures should have a phased replaced with new LED.

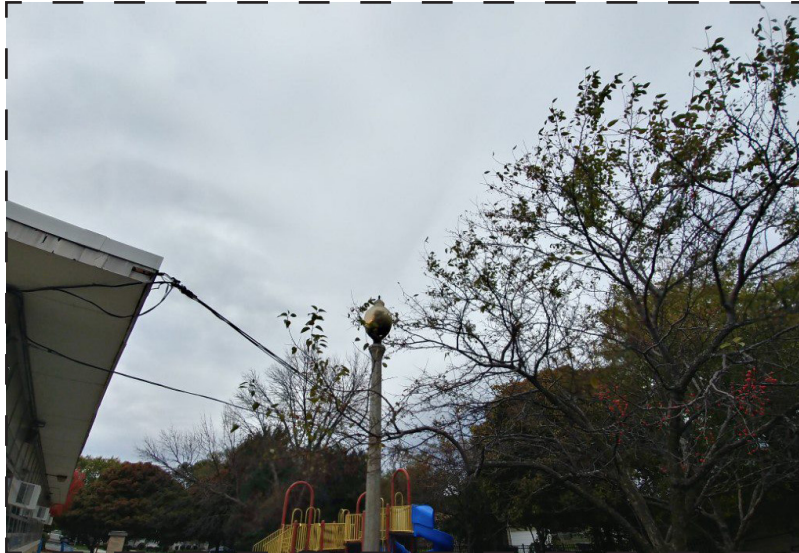
11- 10.1

Figure 11-10.1: Existing outdoor acorn style lights. While the concrete base appears to be in good shape, the same cannot be said of the luminaires. Some of these were on despite it being day-time, and many had their luminaires filled with debris. Given their poor condition, we recommend the replacement of the heads with new LED to coincide with the annex construction. Newer LED heads at a minimum should be used for any relocated or new poles installed as part of the project.

Some of the existing poles will need to be relocated or removed to accommodate the footprint of the annex. Relocated fixtures are recommended to have their luminaires replaced, preferably with LED.

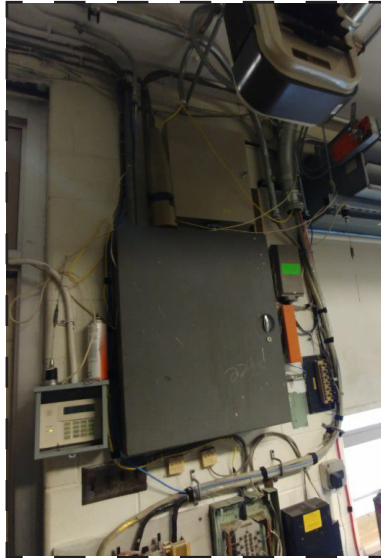
11- 12.1

Figure 11-12.1: Telecom service entrance. CPS should confirm existing capacity and its ability to handle the additional loads to the annex, unless the MDF is intended to be moved to the annex.

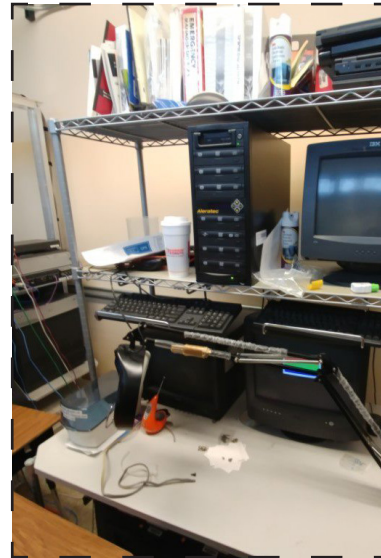
11- 12.2

Figure 11-12.2: Existing first floor MDF room. The closet itself is inconveniently within the computer lab, but otherwise appears to be in good working condition without noted issues. CPS should determine if this shall sub-feed the annex's IDF room, become a sub-service to a new MDF room in the annex, or keep the two IT services separate.

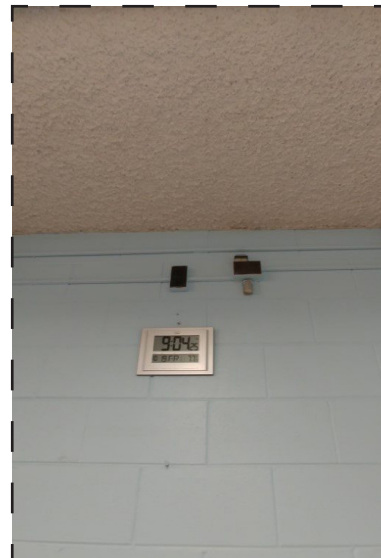
11- 12.5

Figure 11-12.5: Typical clock. The building clocks are not connected to a master system, instead having separate power via hard-wired connection or battery. However, they do have an external communication for time-setting.

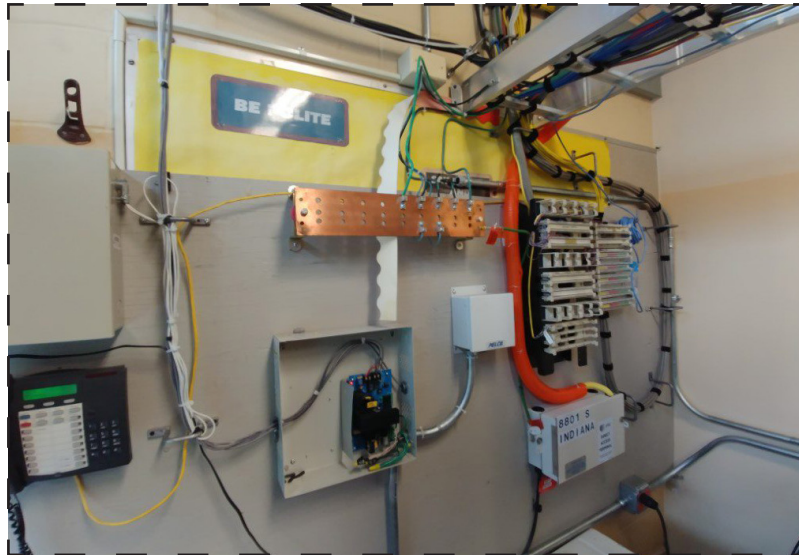
11- 14.1

Figure 11-14.1: Ground bus bar with connections in the MDF room.

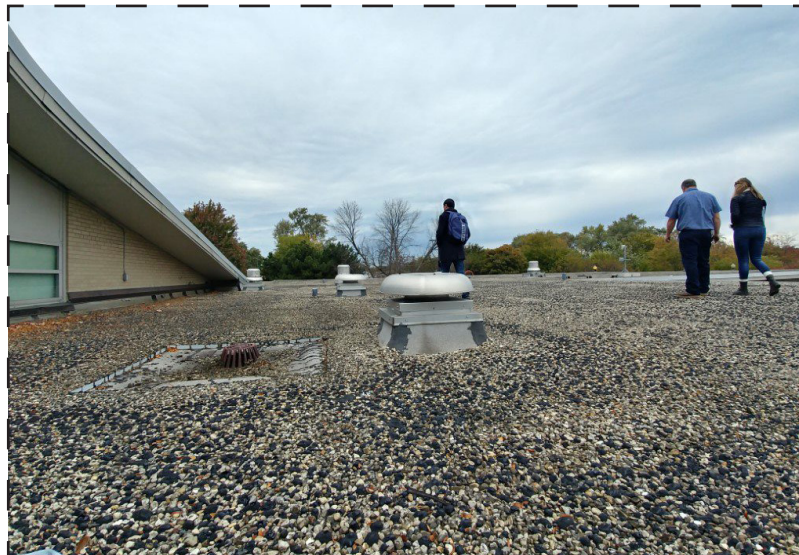
11- 14.2

Figure 11-14.2: Roof lacks lightning protection, but the building likely does not require it.

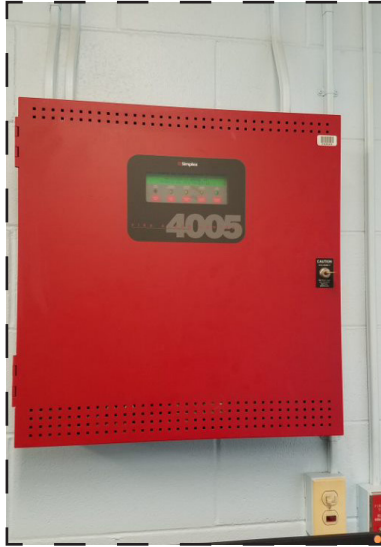
11- 16.1

The system has not been upgraded since original construction. While it appears to be in working condition, the entire system is showing signs of age. Moreover, the fire alarm control panel has been discontinued. At the time of the survey, there were no trouble or supervisory alarms indicated on the control panel. According to the building engineer, the school has not had any nuisance alarms. Existing conventional heat detectors and manual pull-stations are well past their rated life and are in a dire need of replacement throughout the original building. These devices are not supervised by the FACP and there is no way to tell, without a manual test, if the detector or pull-station is operable. Existing notification appliances that are part of the conventional system are also well past their rated life and need replacement.

Figure 11-16.1: Existing Simplex conventional (non-addressable) fire alarm control panel. The fire alarm panel was installed in 2001 and has been discontinued by the manufacturer. Also, it is unmonitored by a central monitoring station. We strongly recommend for the replacement of the system in anticipation for the annex construction.

It is highly recommended to upgrade the entire fire alarm system with a new fully addressable fire alarm system along with new notification devices and fire alarm annunciator panel in the existing building. The system shall comply with the City of Chicago Class-I fire alarm system requirements. The upgraded system can be used to serve the same types of devices in the new annex (e.g. heat detectors, audio/visual devices, pull stations). New NAC panels shall be installed to provide circuits for notification appliances, including a separate NAC panel for the annex.

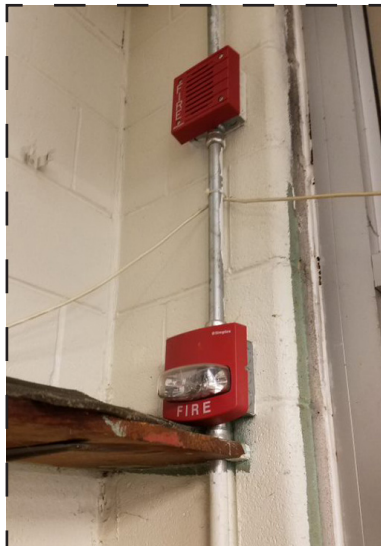
11- 16.3

Figure 11-16.3: Existing fire alarm horn/strobe installed in the original building as part of the conventional fire alarm system. It is passed its rated life and should be replaced regardless if the recommended addressable system upgrades are implemented.
