# EXHIBIT M – TEST PIT INVESTIGATION REPORT

**Re: Test Pit Investigation  
Proposed Engine Company 115 – Site B  
Northwest Corner of W. 119<sup>th</sup> St. & S. Morgan St.  
Chicago, Illinois 60643**

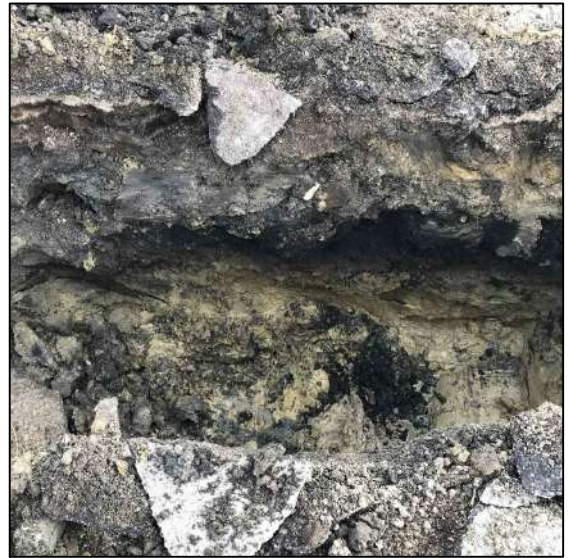
10: TP-9, view east

9	Southern EMI Zone	3.5' East-West 15' North-South ~5' depth	41 40.712 N -87 38.878 W 41 40.714 N -87 38.852 W	Approximately 6" asphalt underlain with black silty CLAY with light brown SAND at 3'. Broken foundation material and storm drain found at 3'. No noticeable odors.

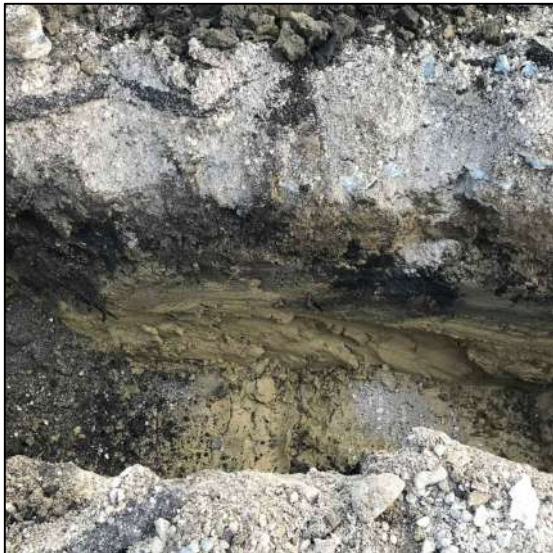
11: TP-10, view east

10	GPR East Zone	3.5' East-West 15' North-South ~5' depth	41 40.717 N -87 38.837 W 41 40.720 N -87 38.836 W	Approximately 6" asphalt underlain with black silty CLAY with light brown SAND at 3'. Broken blue stained concrete at 2'. No noticeable odors.
11	GPR East Zone	3.5' East-West 20' North-South ~5' depth	41 40.720 N -87 38.832 W 41 40.723 N -87 38.824 W	Approximately 6" asphalt underlain with black silty CLAY with light brown SAND at 3'. Broken blue stained concrete at 2'. No noticeable odors.
12	GPR East Zone	3.5' East-West 30' North-South ~5' depth	41 40.724 N -87 38.823 W 41 40.723 N -87 38.818 W	Approximately 6" asphalt underlain with black silty CLAY with light brown SAND at 3'. Broken brick at 2'. No noticeable odors.
13	GPR West Zone	3.5' East-West 40' North-South ~5.5' depth	41 40.732 N -87 38.875 W 41 40.834 N -87 38.862 W	Approximately 6" asphalt underlain with black silty CLAY with light brown SAND at 3'. Wood flooring and brick debris at 2-3, with perched water'. 6-9" metal pipe (possible relic water main) running perpendicular to trench at north end. No noticeable odors.
