EXHIBIT M – TEST PIT INVESTIGATION REPORT

**Re: Test Pit Investigation
Proposed Engine Company 115 – Site B
Northwest Corner of W. 119th St. & S. Morgan St.
Chicago, Illinois 60643**

Exhibit I: Test Pit Location Map
Proposed Engine Company 115 - Site B
Northwest Corner of W. 119th St. & S. Morgan St.
Chicago, Illinois 60643

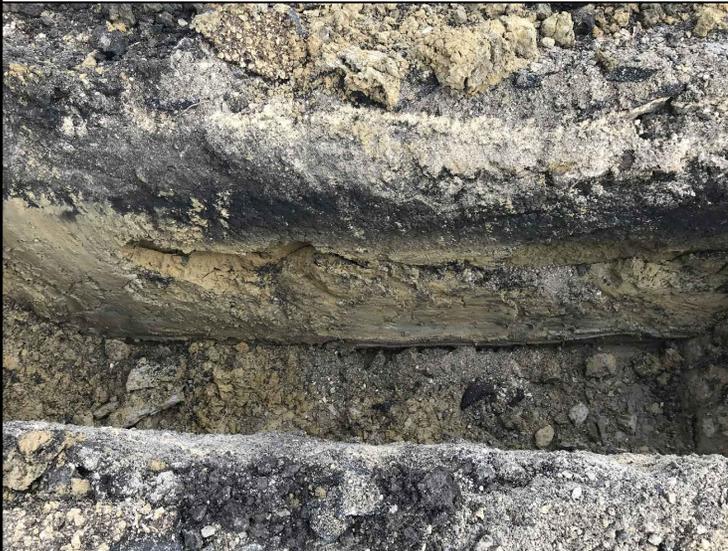
17: TP-14, view west

| 14 | GPR West Zone | 3.5' East-West 40' North-South ~5.5' depth | 41 40.726 N -87 38.871 W 41.40.742 N -87 38.871 W | Approximately 6" asphalt underlain with black silty CLAY with light brown SAND at 3'. Brick foundation at 2-3' with perched water. No noticeable odors. |

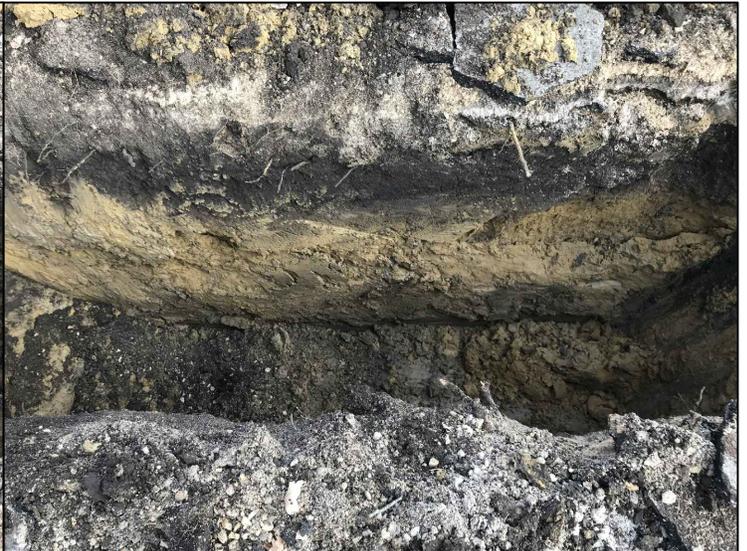
18: TP-15, view east

| 15 | Northern EMI Zone | 3.5' East-West 20' North-South ~5' depth | 41 40.740 N -87 38.827 W 41 40.743N -87 38.828 W | Approximately 6" asphalt underlain with black silty CLAY with light brown SAND at 3'. Broken brick at 2'. No noticeable odors. |
