XXXXXXXXXX- Juvenile Detention Center Upgrades

Project Address: 3900 S California Ave., Chicago Illinois

Investigation – HVAC, ELECTRICAL, PLUMBING, FIRE PROTECTION & FIRE ALARM AND
TELECOMMUNICATION

OBSERVATIONS AND CONCLUSIONS OF OBSERVED

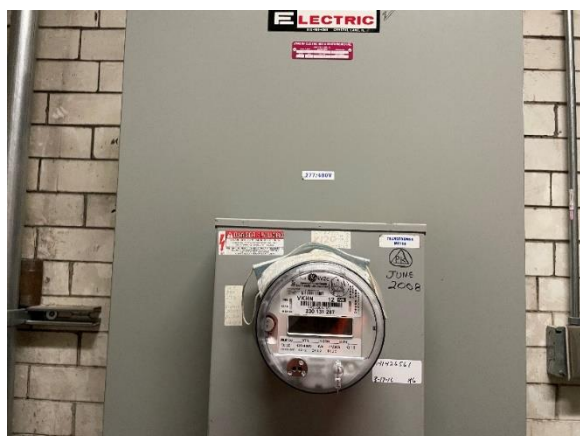
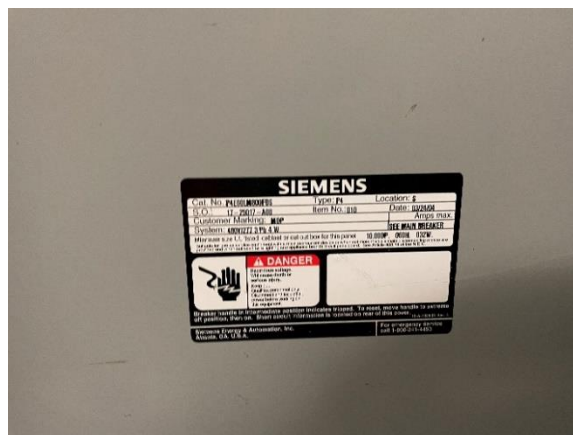
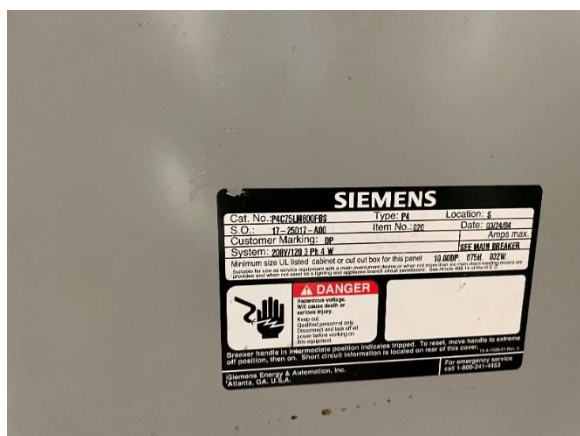
Interior Lighting are fluorescents. recent lighting standards would mandate replacement with energy efficient LED lighting.

During the site visit the Elevator is in working condition, problems with controls will be address with manufacturer to provide the correct spare parts needed.

1. Existing Electrical infrastructure are in good condition, And sufficient for the electrical load served.
2. A new power and controls wiring will be provided for the HVAC equipment that will be replace. Replace circuit breaker
3. Areas (restrooms) that will be part of the renovations a new light fixture will be required.
4. Existing lightings are fluorescent current code will require energy efficient LED lighting to meet the energy standards.

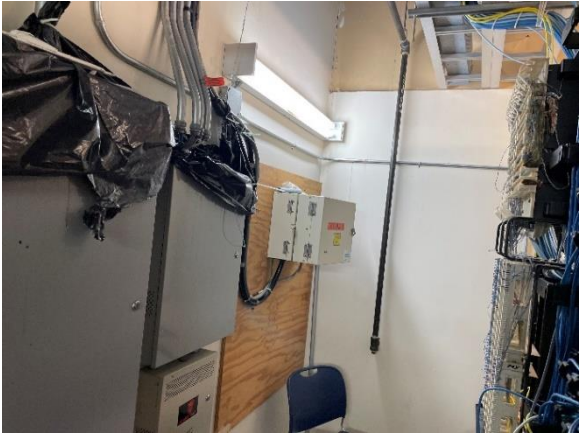
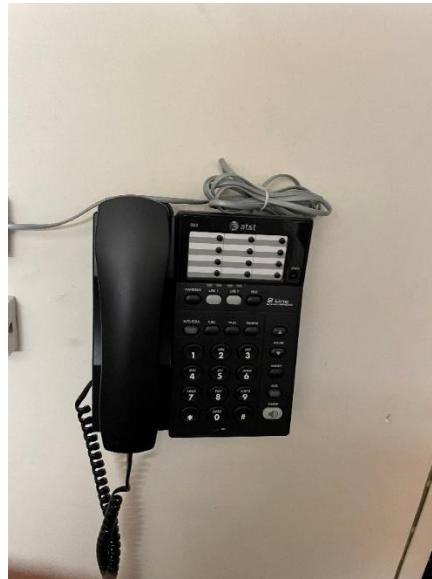
The telecommunication infrastructure is provided by AT&T. electrical devices and connections are in good condition.

No hardware and software upgrade required, unless instructed.
