Management Report

The HOH Group, Inc.
Juvenile Intervention Center
3900 South California Avenue, Chicago, IL

Prepared For
The HOH Group, Inc.

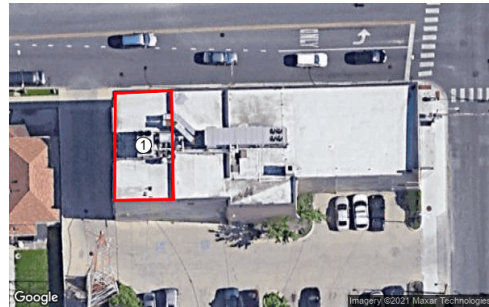
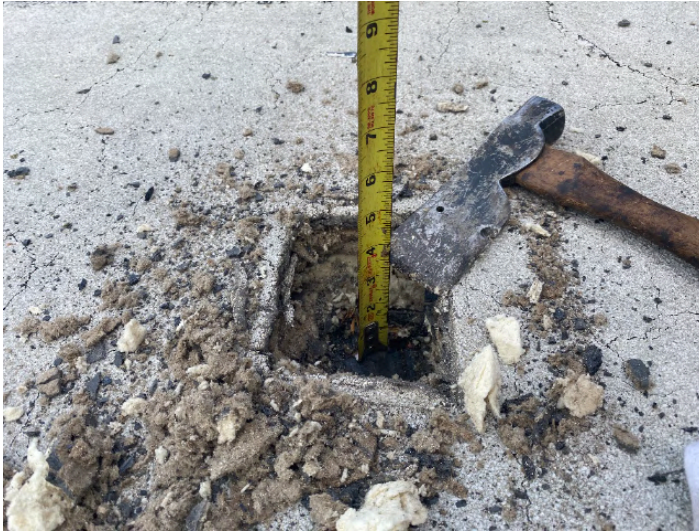
Test Cut 3
Wood Deck
Red Rosin
Base Sheet
2-ply Asphalt Felt Vapor Retarder
Polyiso Insulation
Perlite Coverboard
Modified Bitumen Roof System
White Acrylic Coating
Total 3-1/4" Thickness

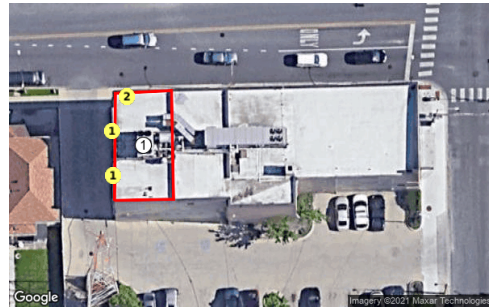
Modified Bitumen - Sheet Metal- Gutter straps (Emergency)

The gutter straps are not installed properly. They should not be installed on the roof under the roof membrane.

This deficiency needs to be monitored and repaired as needed.

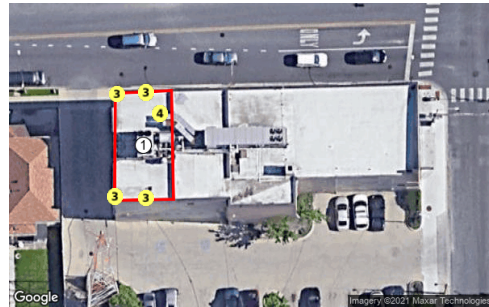
General - Masonry- Masonry defective (Emergency)

The masonry on the parapet walls are absorbing water and infiltrating the roof system.

The roof membrane should wrap completely over the top of the parapet walls.

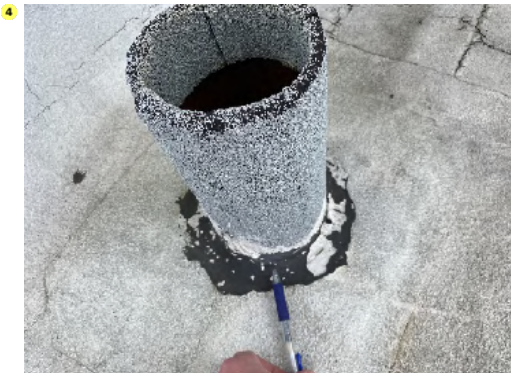
Modified Bitumen - Penetration- Plumbing vent lead flashing base (Emergency)

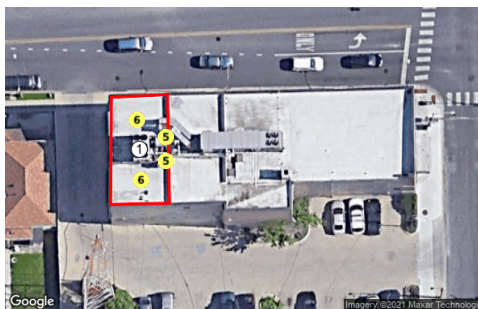
Modified Bitumen - Penetration- Improper Pipe Penetration Flashing (Emergency)

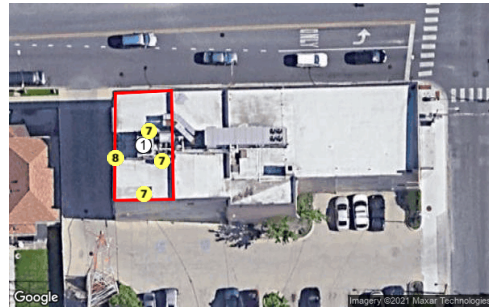
Modified Bitumen - Loose Debris (Emergency)

Loose debris has a high probability of blowing around on the roof and causing damage to the waterproofing membrane.

Remove loose debris from roof area.

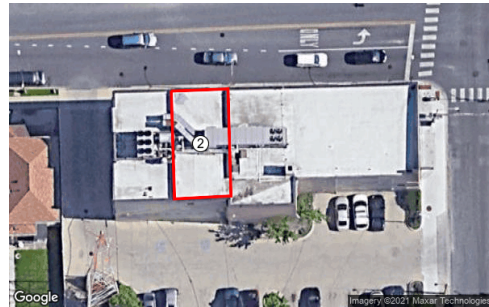
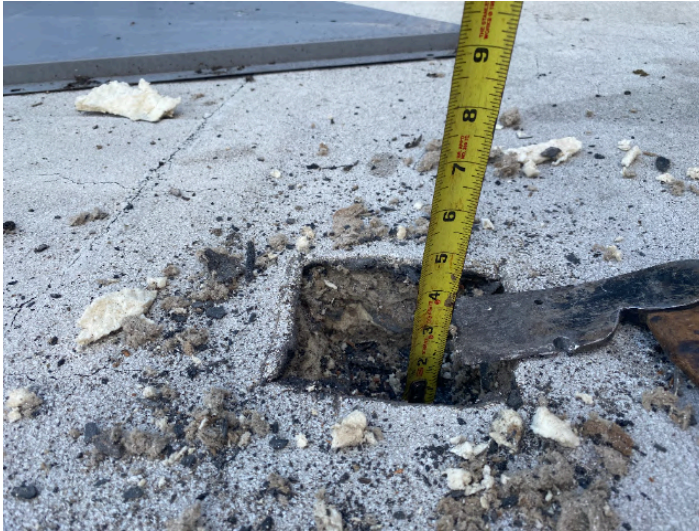
Test Cut 2
Wood Deck
Red Rosin
Base Sheet
2-Ply Asphalt Felt Vapor Retarder
Polyiso Insulation
Perlite Coverboard
Modified Bitumen Roof System
White Acrylic Coating
Total 3-1/4" Thickness

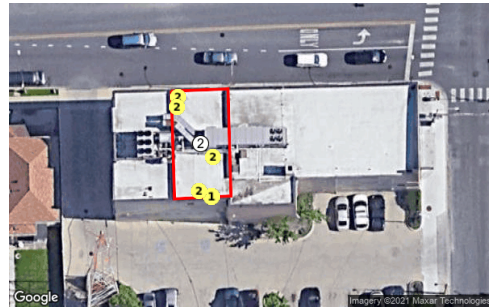
Sheet Metal - Sheet metal- coping joint. (Emergency)

The sheet metal coping joint caulking has failed.

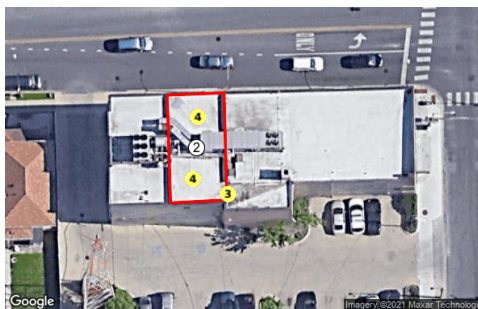
Modified Bitumen - Membrane- Puncture or Tear in Membrane (Emergency)

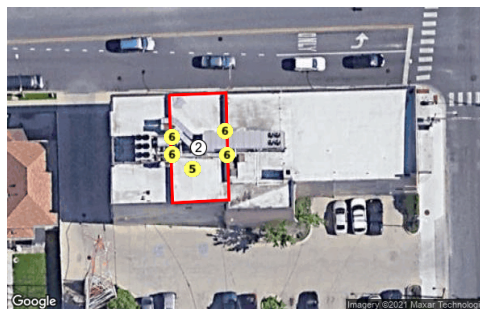
Modified Bitumen - Membrane- Puncture or Tear in Membrane (Emergency)

The area surrounding the deficiency will be cleaned. A proper repair will be performed using compatible materials for the roof membrane type.

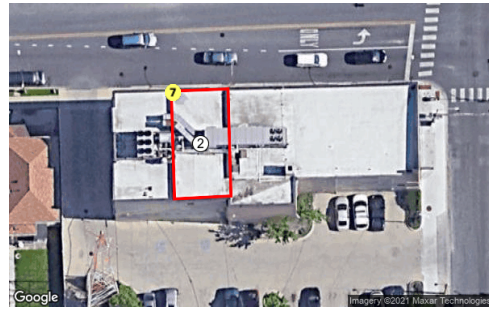
Modified Bitumen - Termination bar caulking. (Emergency)

Termination bar caulking is failing.

The caulking will be replaced in the failing areas with a 1 part polyurethane caulk.

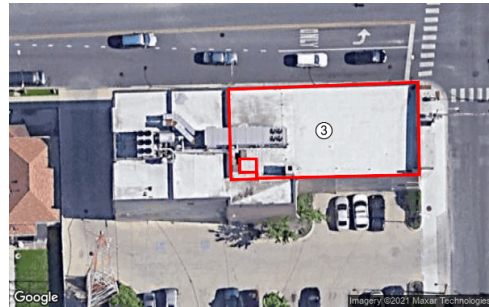
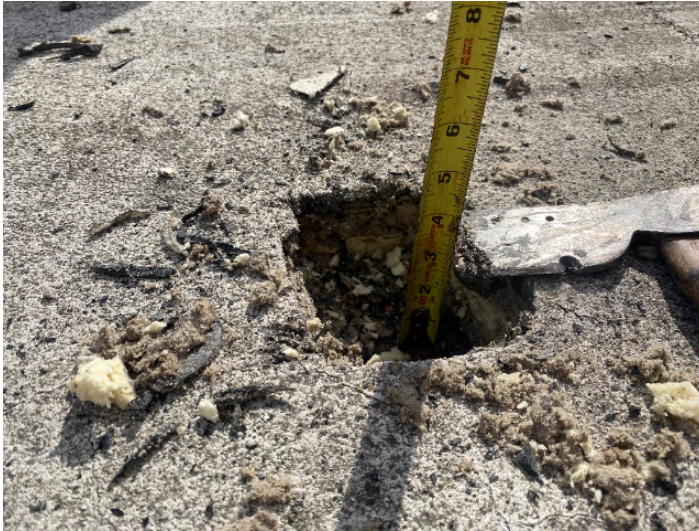
Test Cut 1
Wood Deck
Red Rosin
Base Sheet
2-ply Asphalt Felt Vapor Retarder
Polyiso Insulation
Perlite Coverboard
Modified Bitumen Roof System
White Acrylic Coating
Total 3-1/4" Thickness

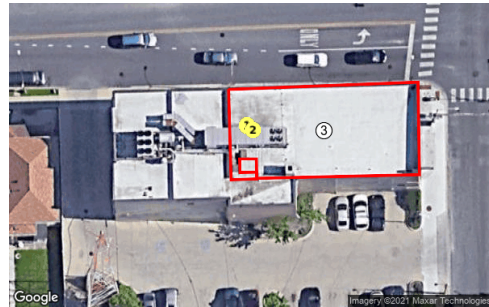
Modified Bitumen - Membrane- Ponding (Emergency)

Ponding will lead to the premature failure of the roof membrane. This area needs to be monitored for deterioration.

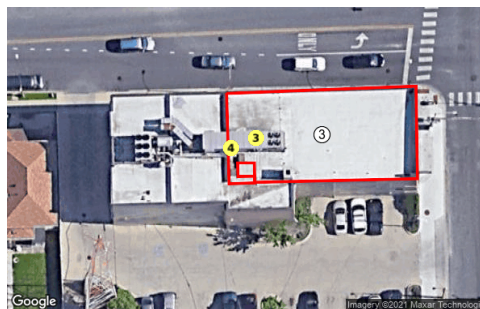
General - Oxidation or Rust (Emergency)

As the galvanized coating breaks down and the metal is exposed to the elements, oxidation or rust will take over and reduce the materials integrity.

Depending upon the level of corrosion, the metal may be able to be restored. A rust-inhibiting paint should be utilized.

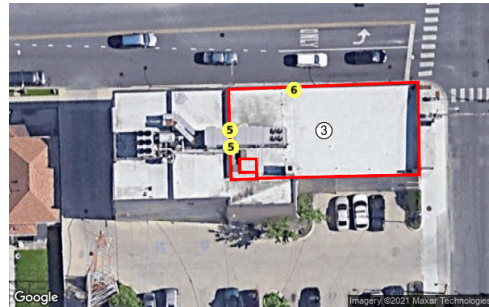
Modified Bitumen - Penetration- Improper Pipe Penetration Flashing (Emergency)

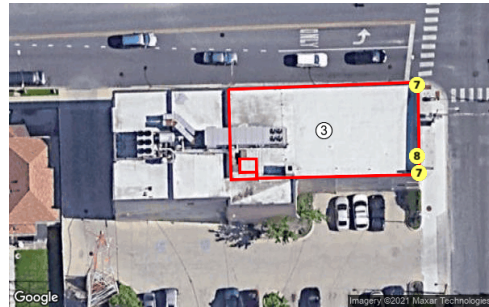
General - Masonry- Masonry defective (Emergency)

The masonry on the parapet walls are beginning to deteriorate.

The roof flashing membrane should wrap up over the top of the parapet walls to stop water infiltration.

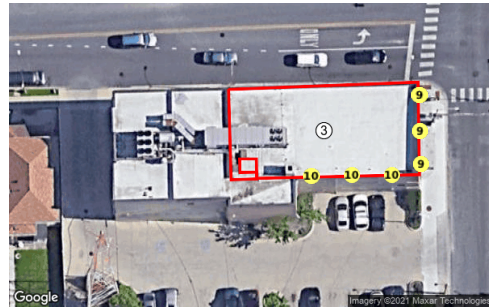
General - Masonry- Masonry defective (Emergency)

The masonry on the exterior walls are deteriorated and need to be repaired. Portions of the walls have exposed wood beams which may have originally been part of a sign structure.

Remove the exposed wood and repair the walls.

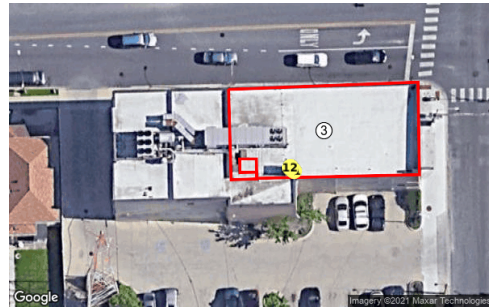
Modified Bitumen - Membrane- Membrane seam open (Emergency)

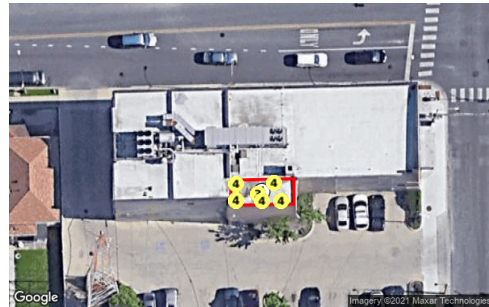
Modified Bitumen - Membrane- Ponding (Emergency)

Ponding has lead to the premature failure of the roof membrane.

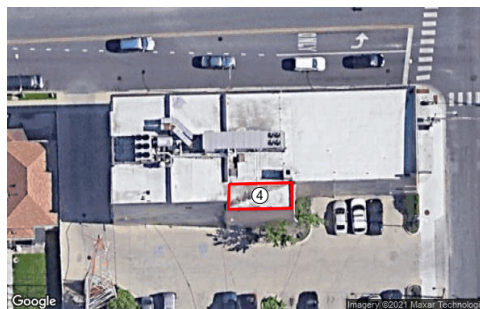
Membrane: F
 Flashings: F
 Sheet Metal: C

The existing roof has reached the end of its serviceable life. The field membrane has failed due to ponding water. It is likely due to flashing height restrictions with the Center and East Roofs that tapered insulation was never installed. A-1 recommends the installation of an expansion joint curb installed between the Center Roof and the Stairway Roof to alleviate this issue. The Center Roof would then require a new wall scupper for drainage. Looking at satellite imagery, the roof was installed likely in 2005. A-1 recommends a complete tear-off and replacement. The roof is actively leaking.

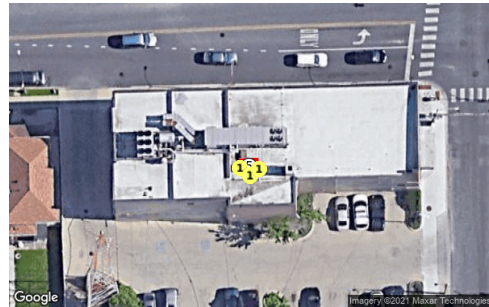
Modified Bitumen - Sheet Metal- Gravel stop missing. (Emergency)

The gravel stop is missing.

The gravel stop will be installed where missing.

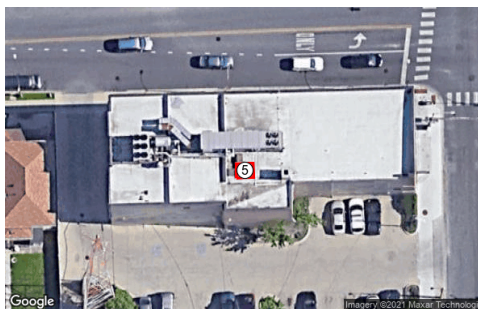
Membrane: D
Flashings: D
Sheet Metal: F

The existing roof is reaching the end of its serviceable life. The field membrane is cracking. Perimeter metal edge was never installed. Looking at satellite imagery, the roof was installed likely in 2005. A-1 recommends a complete tear-off and replacement.
