2021-F326-REN CIP- Lakeview Health Center Renovations

Project Address: 2849-61 N. Clark St., Chicago Illinois

Investigation – HVAC, ELECTRICAL, PLUMBING, FIRE PROTECTION & FIRE ALARM AND TELECOMMUNICATION

### OBSERVATIONS AND CONCLUSIONS

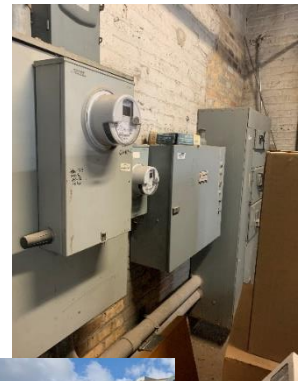
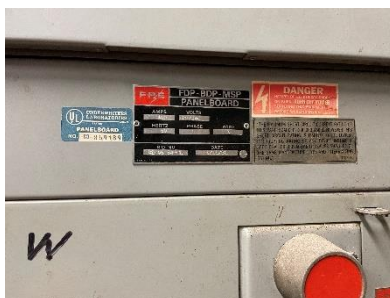
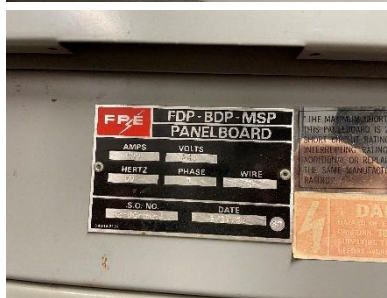
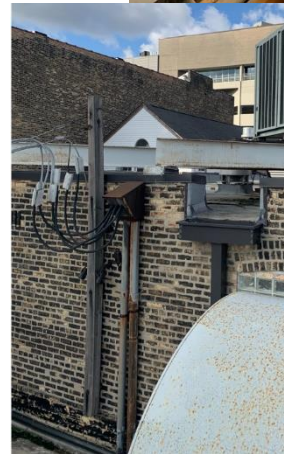
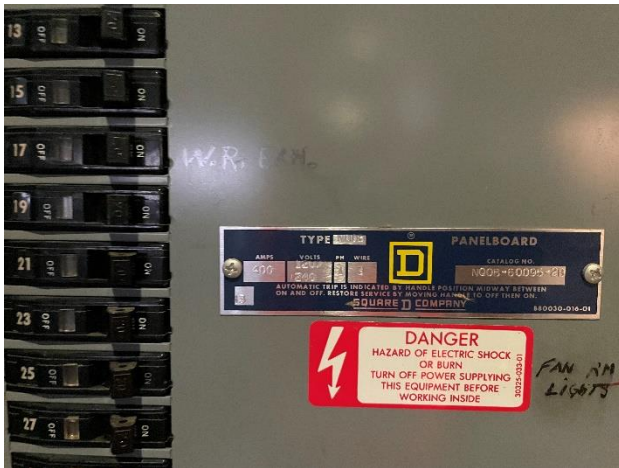
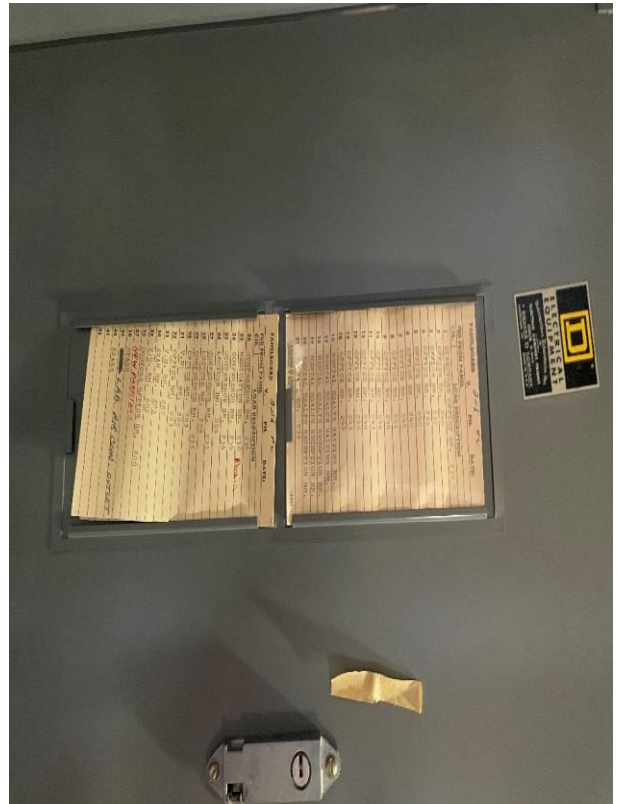
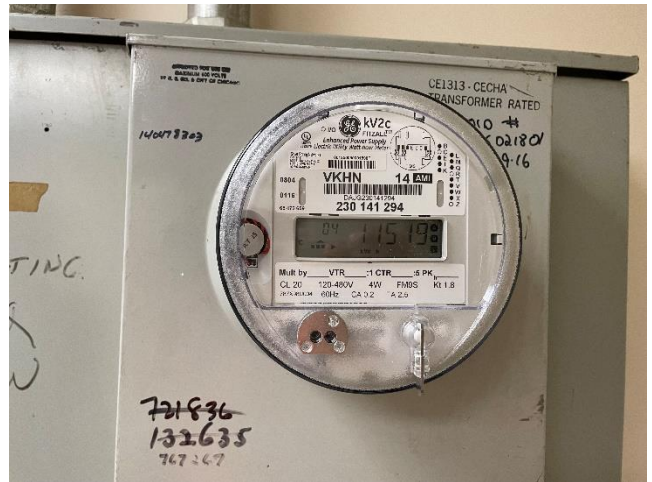
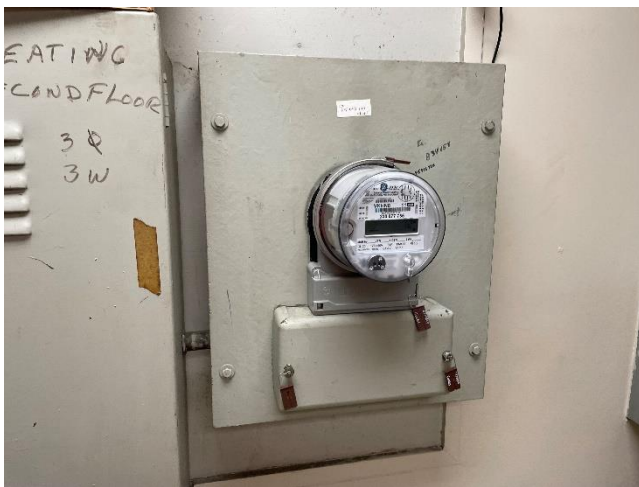
Incoming Service enters the building thru the electrical utility room east of the building distribution panels are old serve by a main 800Ampere and 600Ampere

A power panels and light panels are located in various rooms serving HVAC, compressors, lightings, receptacle, emergency lighting, telecommunications and various medical equipment in the building.

1. Due to the uncertainty surrounding the power distribution panels, it is recommended that a power distribution study be performed in order to gauge the usability of the existing system, and to determine which breakers should be replaced, if any. In addition, it is also recommended that a maintenance test be performed in accordance with National Electrical Testing Association standards by means of MTS guidelines.

2. Adding a new elevator will result to upgrade the service entrance panel and the meters should also be replaced.
3. A new power and controls wiring will be provided for the HVAC equipment that will be replace.

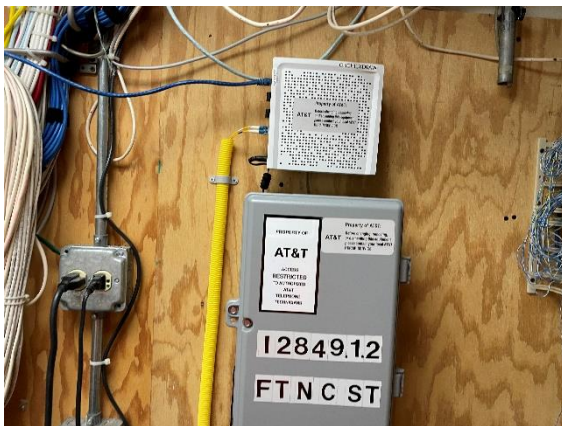
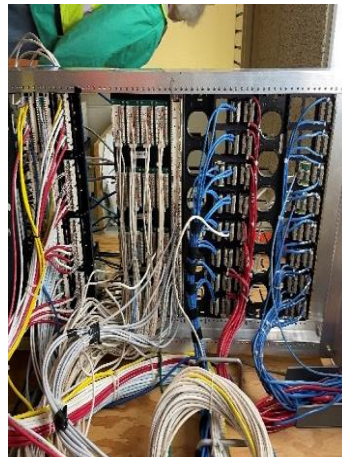
The telecommunication infrastructure is provided by AT&T. electrical devices and connections are in working condition.

No hardware and software upgrade required, unless instructed.
