### Management Report

The HOH Group, Inc.  
Lakeview Health Center  
2849 North Clark Street, Chicago, IL

**Section:** Main Roof  
**Size:** 10178  
**Overall Grade:** D

**Inspection Date:** 10/20/2021  
**Inspector:** David Marcinkowski

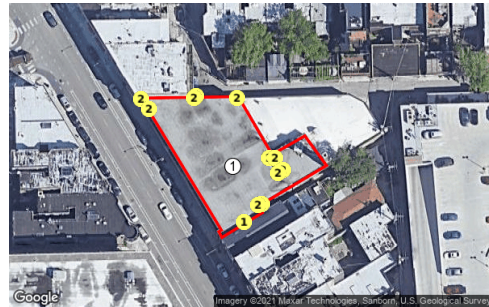
### Modified Bitumen - Flashing- The flashing lap open (Emergency)

An open flashing lap will result in a roof leak and possible insulation damage.

We will clean and seal the open lap to ensure water tightness.

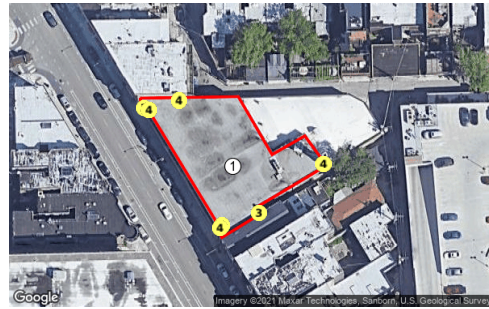
### General - Masonry- Masonry defective (Emergency)

The masonry on the parapet walls are deteriorated and need to be repaired.

The masonry should be repaired.

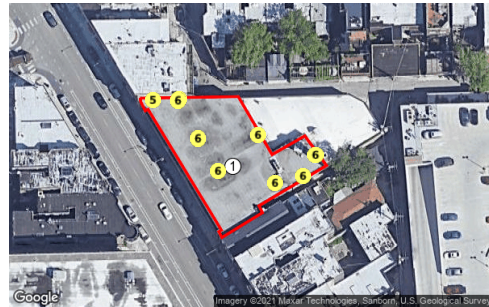
### Sheet Metal - Expansion Joint Open (Emergency)

Sheet metal cap was not properly designed as an expansion joint and is deformed.

Install a new sheet metal expansion joint cap.

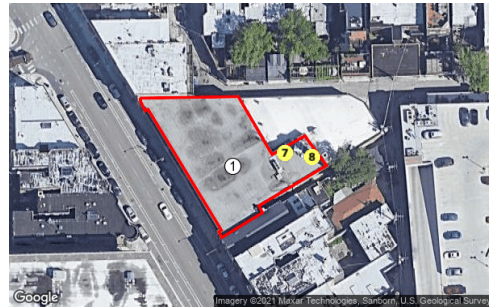
### Modified Bitumen - Walk pads missing (Emergency)

Walkpad are needed to protect the roof membrane.

We will install new walkpads.

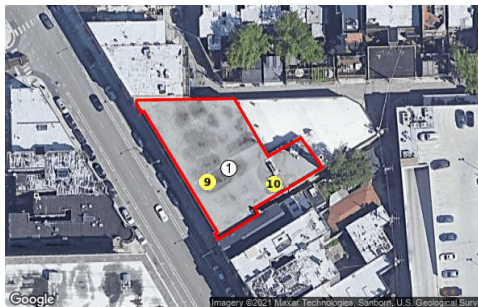
### Modified Bitumen - Membrane- Puncture or Tear in Membrane (Emergency)

A puncture or tear has been discovered in the roof membrane.

The area surrounding the deficiency will be cleaned. A proper repair will be performed using compatible materials for the roof membrane type.

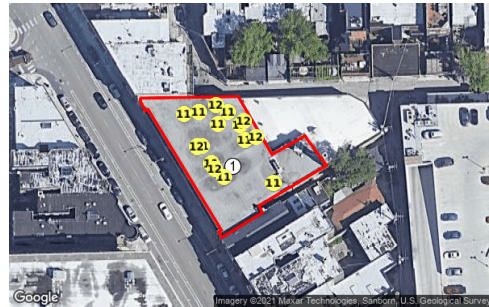
### Modified Bitumen - Membrane- Ponding (Emergency)

Ponding of water on the roof.

Ponding will lead to the premature failure of the roof membrane.

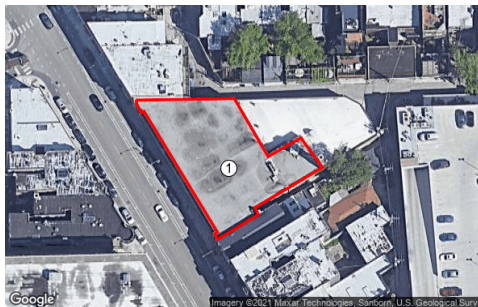
Membrane: D  
 Flashings: D  
 Sheet Metal: C

The existing roof is reaching the end of its serviceable life. The lack of tapered insulation has lead to ponding and the premature deterioration of the roof membrane. Numerous leaks have been reported inside. Flashings are beginning to open, even those that have previously been repaired. Satellite imagery was unable to verify when the last roof was installed. A-1 recommends a complete tear-off and replacement.

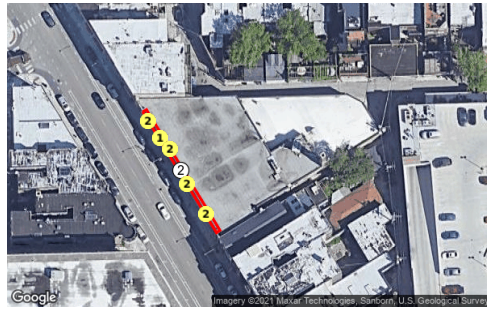
### Shingles - Shingles are damaged (Emergency)

Shingles showing signs of visible damage

Shingles will be removed and replaced with new,

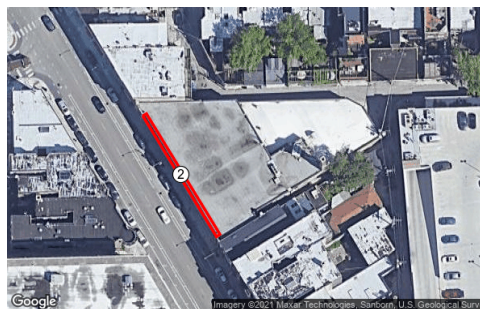
Membrane: D  
 Flashings: C  
 Sheet Metal: C

The existing roof is reaching the end of its serviceable life. Shingles are becoming worn and beginning to cup. Significant shingle damage is apparent in one area. The roof could only be overserved from street level at the time of inspections. Satellite imagery was unable to verify when the last roof was installed. A-1 recommends a complete tear-off and replacement. Please note that the street lights may have to be moved for this work to take place.
