Public Building Commission  
**North Park Village – Chapel Building F**  
**Chicago, IL**  
Preliminary Property Condition Assessment  
October 21, 2021

This Property Assessment of the North Park Village Chapel Building F was prepared by KOO LLC at the request of the Public Building Commission of Chicago for the purpose of informing decisions on the potential renovation or restoration of the building. The Chapel building is located at 5801 N. Pulaski Road F. Completed in the 1930's, and originally part of the Municipal Tuberculosis Sanatorium (M.T.S.), the building is a Chapel and is currently closed.

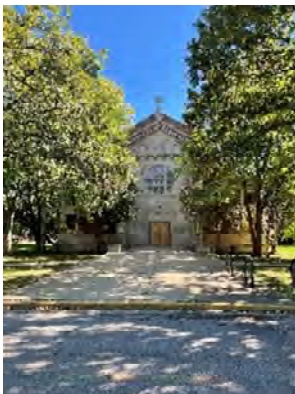
3.1.2 Overall review of site access and egress were not part of the scope of this report. The chapel in general is accessed from main access road and sidewalks of North Park Village.

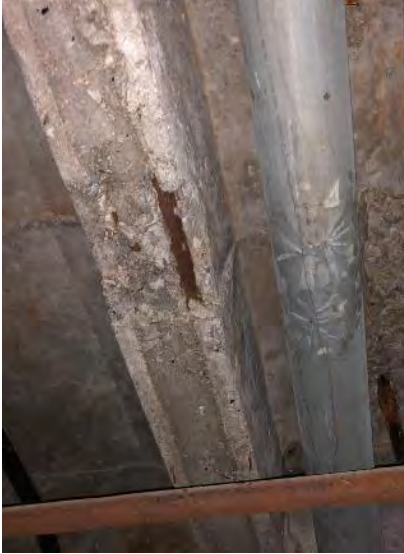
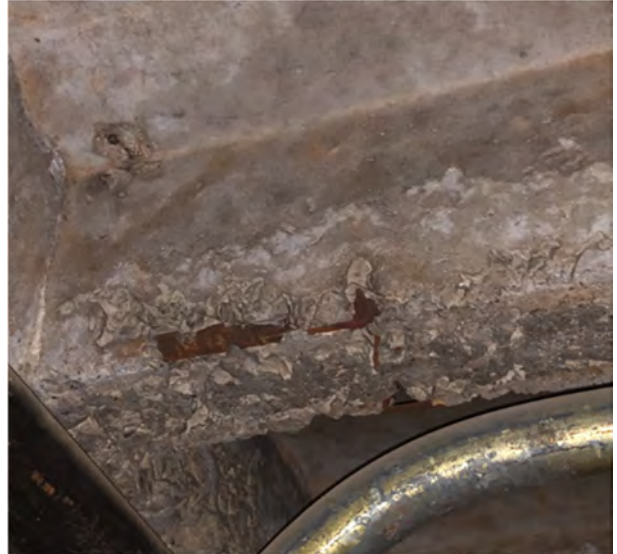
3.2.1.2. First floor framing above basement is composed of concrete slab on concrete beams

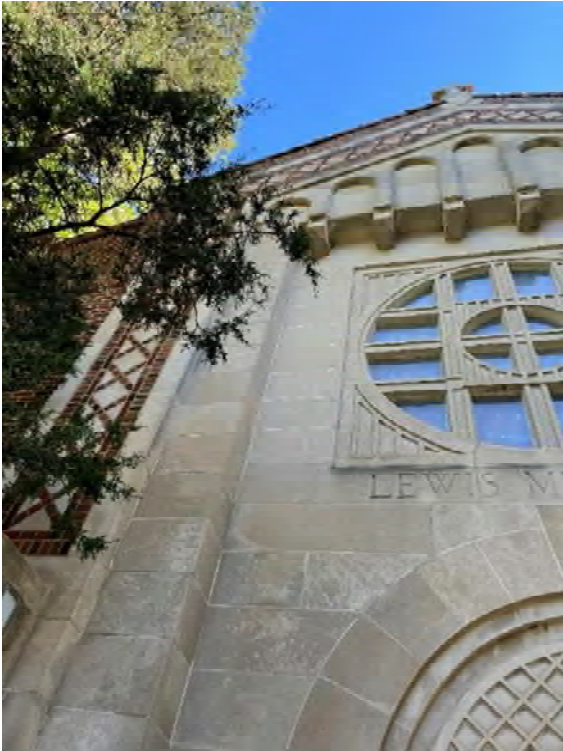
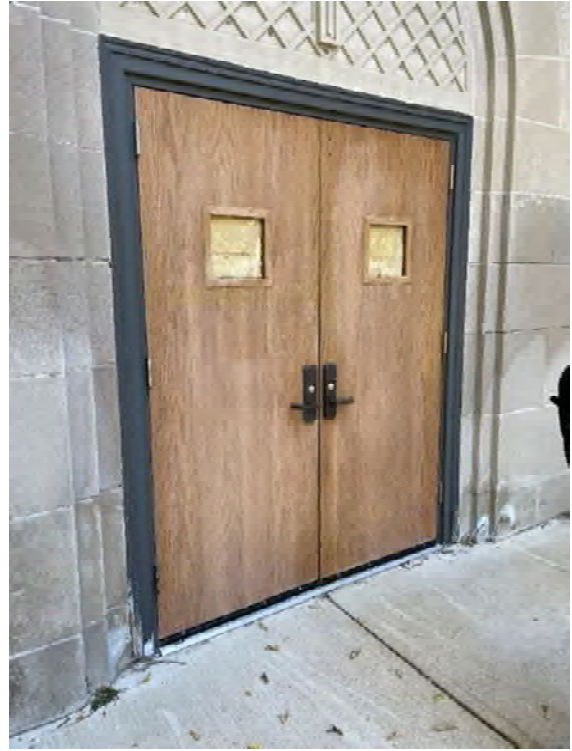
3.2.2.1 Exterior Limestone in the front façade is in a good condition

3.2.2.2 Front door / main entrance is in good condition and secure

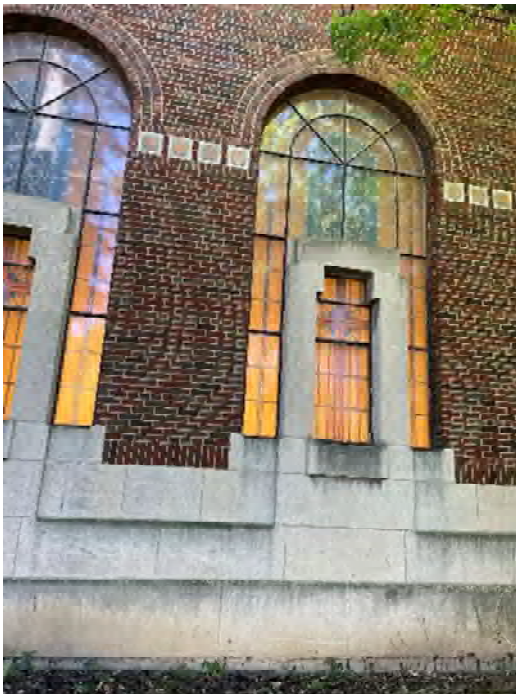
3.2.3.3 Existing stained-glass windows with limestone inlay elements

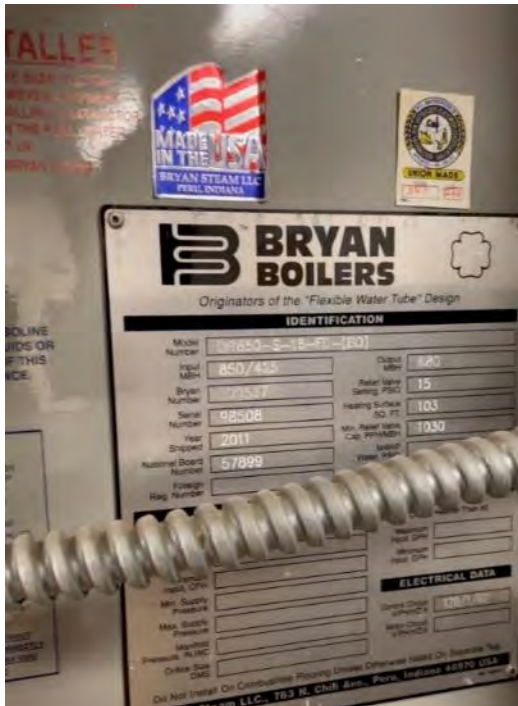
The building is heated via a steam boiler and steam radiators throughout. The boiler is a Bryan Boiler model DR850 capable of 680 MBH output and was installed in 2011. The boiler is relatively new and in good working condition.

3.3.2.1 Nameplate of existing steam boiler in basement.

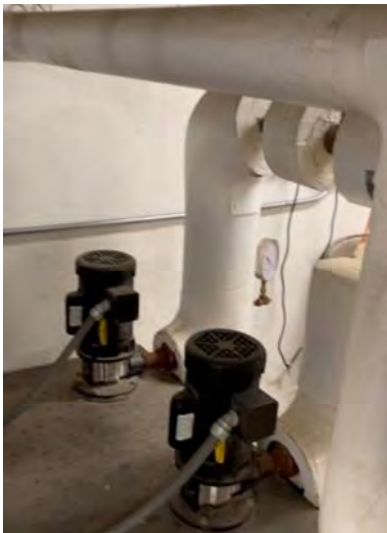
A condensate return station appears relatively new and in good working condition. The building engineer noted the heating system is working well in this building. A new combustion air intake damper and steam unit heater serve the basement mechanical room and appear in good working condition.

3.3.2.2. Existing condensate return station in basement.

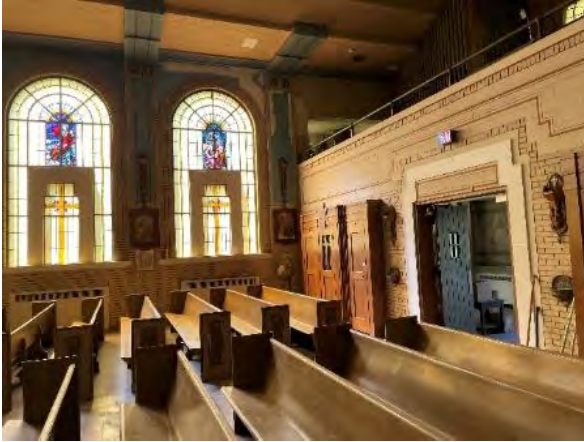
3.4.1.1.1 Church Pews are in good condition.

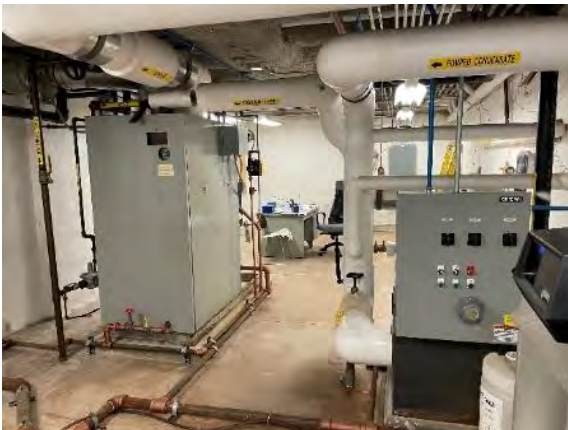
3.4.1.2.7 Mechanical equipment is in good condition.
