Lead-Based Paint Building Inspection

Department of Water Management
Operations Facility - DOW 04029
4825 W. Lawrence Avenue
Chicago, Illinois 60630

October 14, 2025
TEM Project 77496

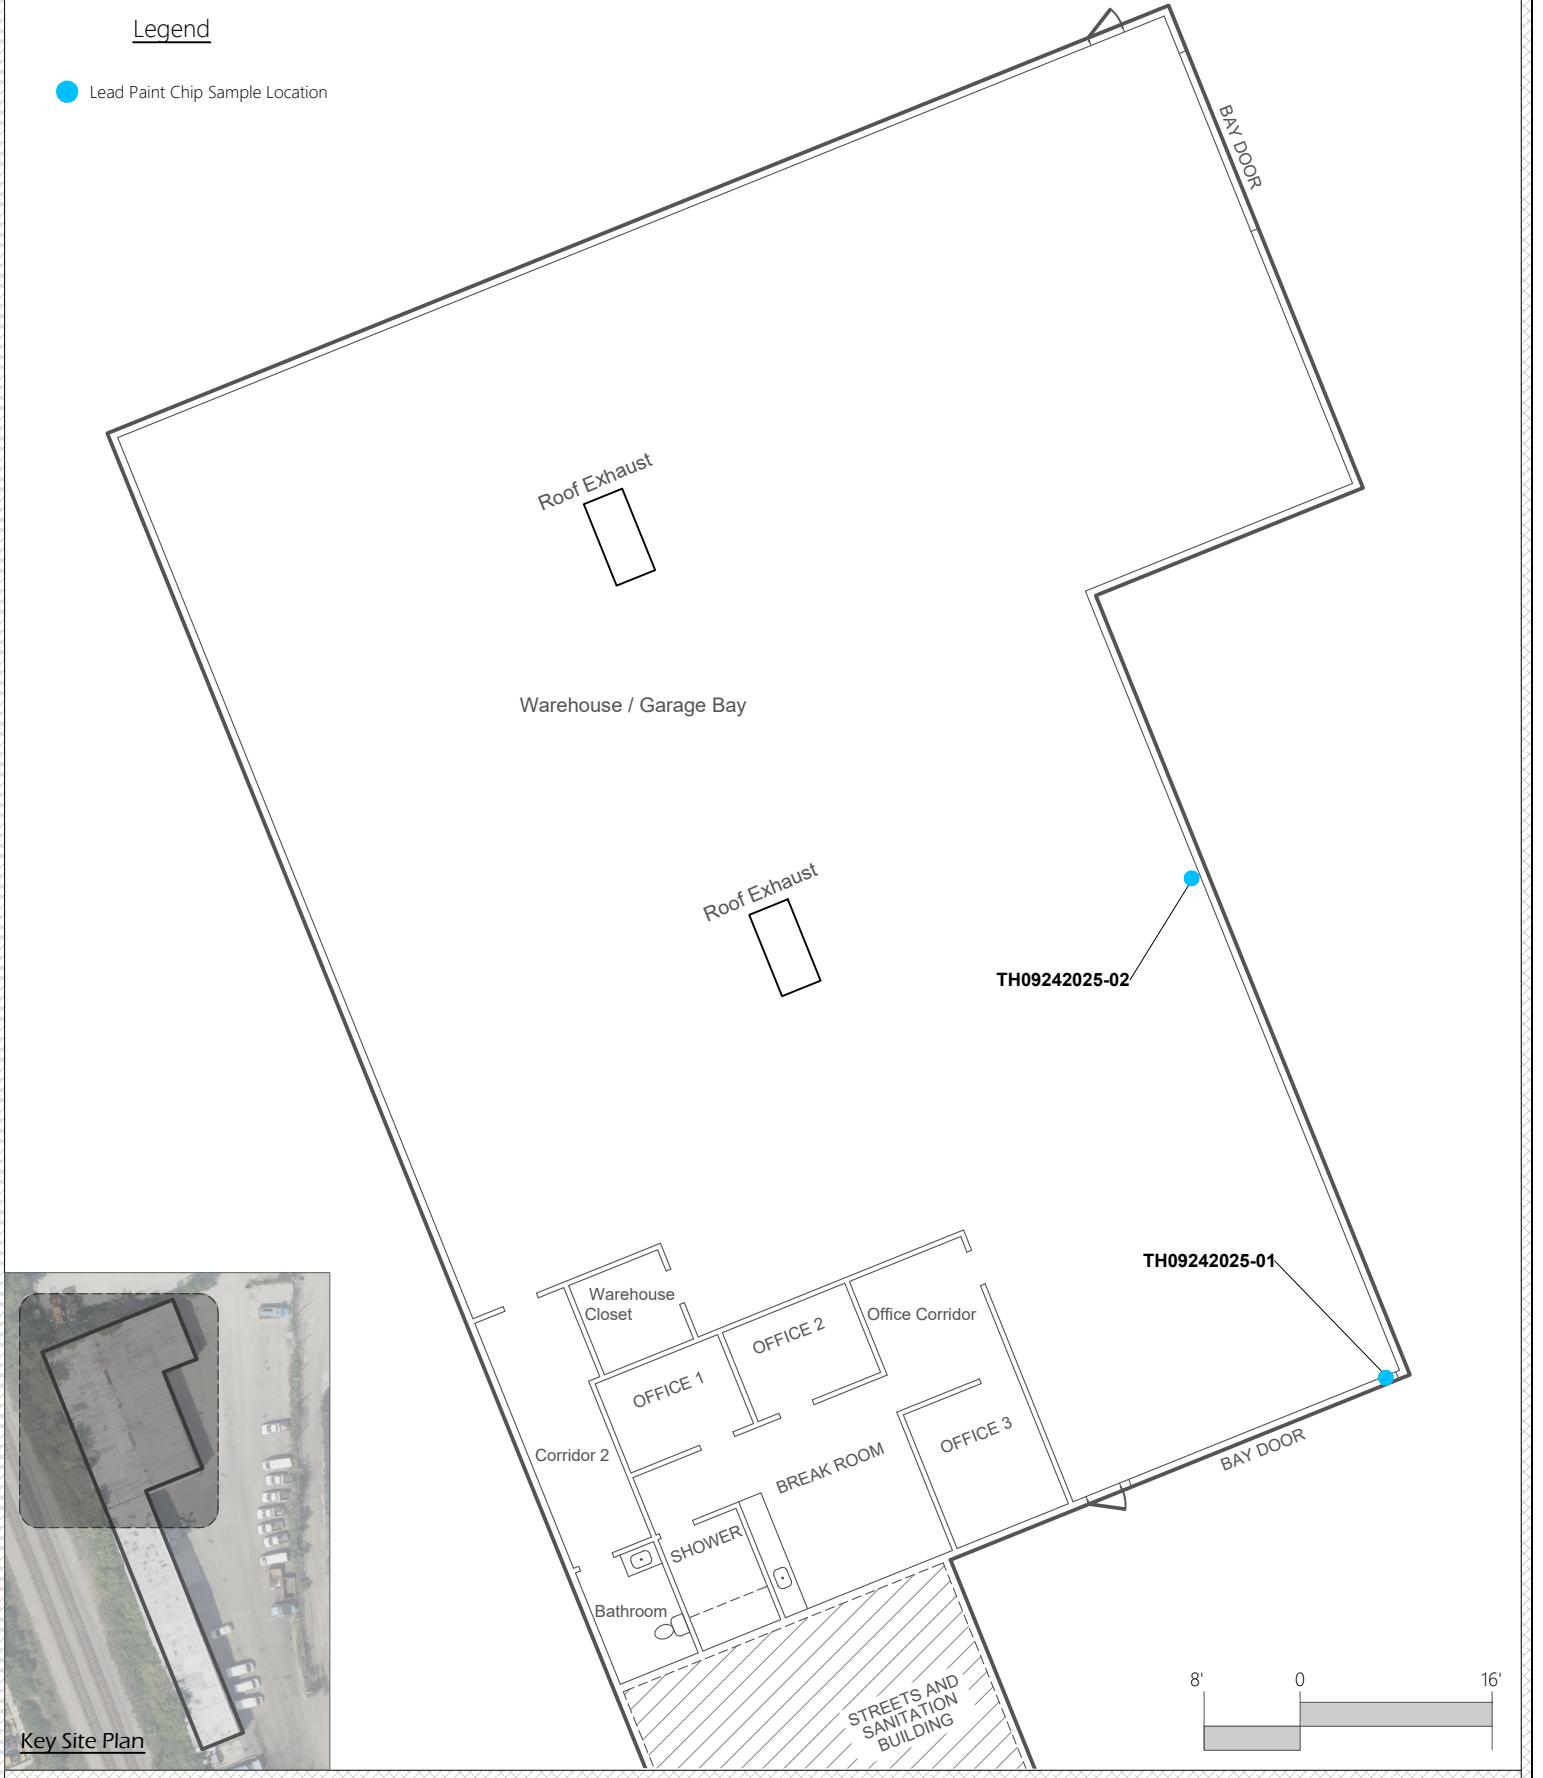
Figure 2

● Lead Paint Chip Sample Location

West Lawrence Avenue Lead Survey
Chicago, IL 60630

APPENDIX A	Selective Asbestos Testing Result Tables
APPENDIX B	EMSL Analytical, Inc., Laboratory Reports and Chain of Custody
APPENDIX C	EMSL Analytical, Inc., Laboratory Accreditations
APPENDIX D	TEM Environmental, Inc., Personnel Licenses and Certifications
APPENDIX E	Paint Chip Sample Location Drawing

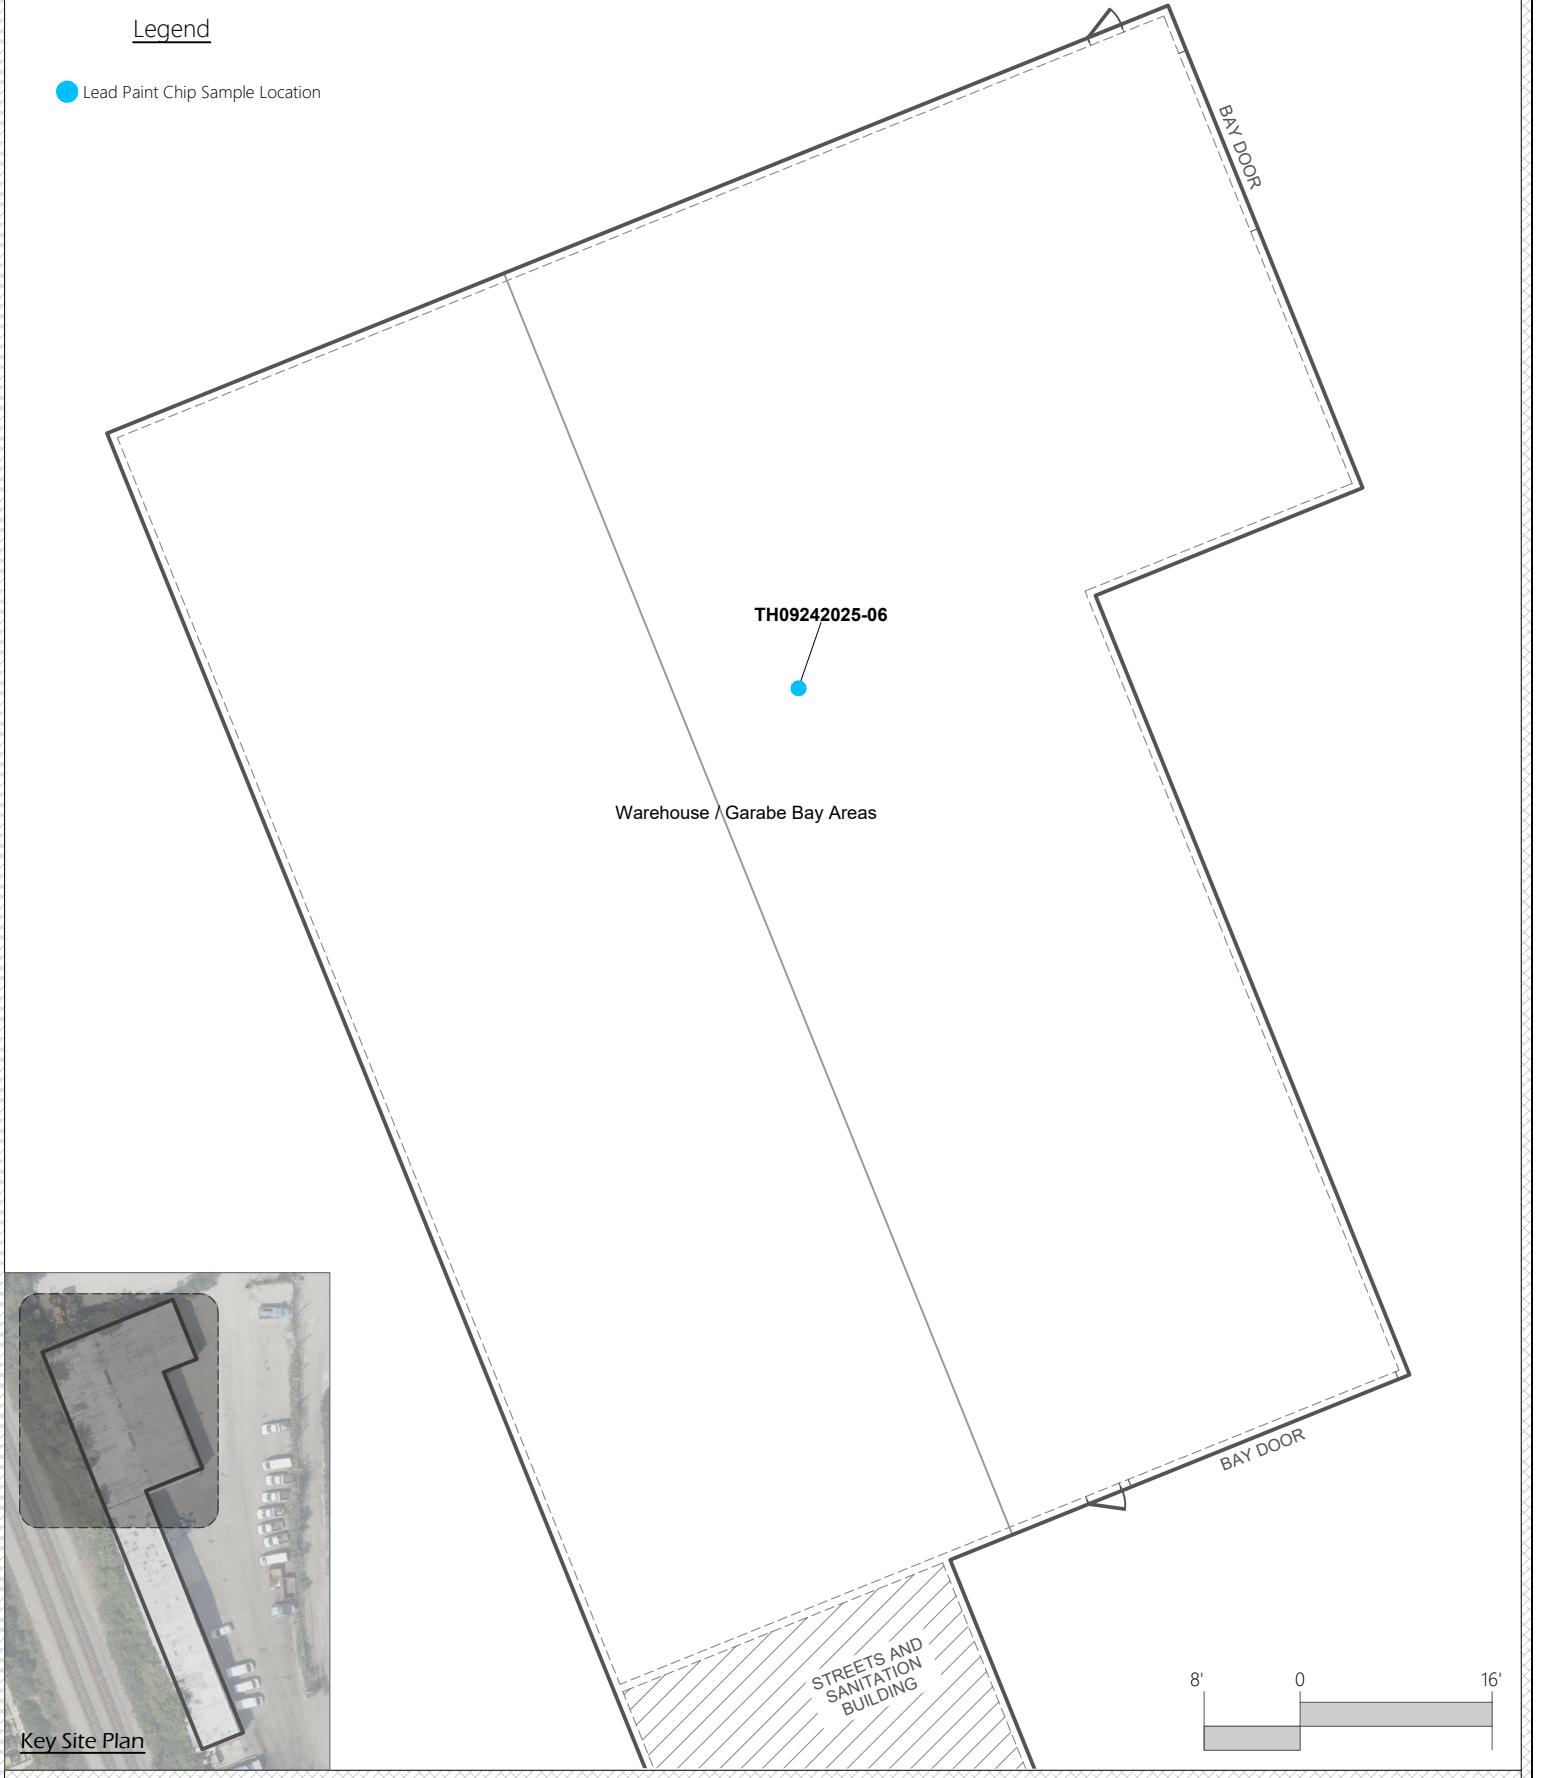
Figure 6

● Lead Paint Chip Sample Location

West Lawrence Avenue Lead Survey
Chicago, IL 60630
