**EXHIBIT L – GROUND PENETRATING RADAR & ELECONTROMAGNETIC INDUCTION SURVEY**

**Re: Ground Penetrating Radar & Electromagnetic Induction Survey  
Proposed Engine Company 115 – Site B  
Northwest corner of S. Morgan St. and W. 119<sup>th</sup> St.  
Chicago, Illinois 60643**

# Subsurface Investigation for Storage Tanks/Anomalies

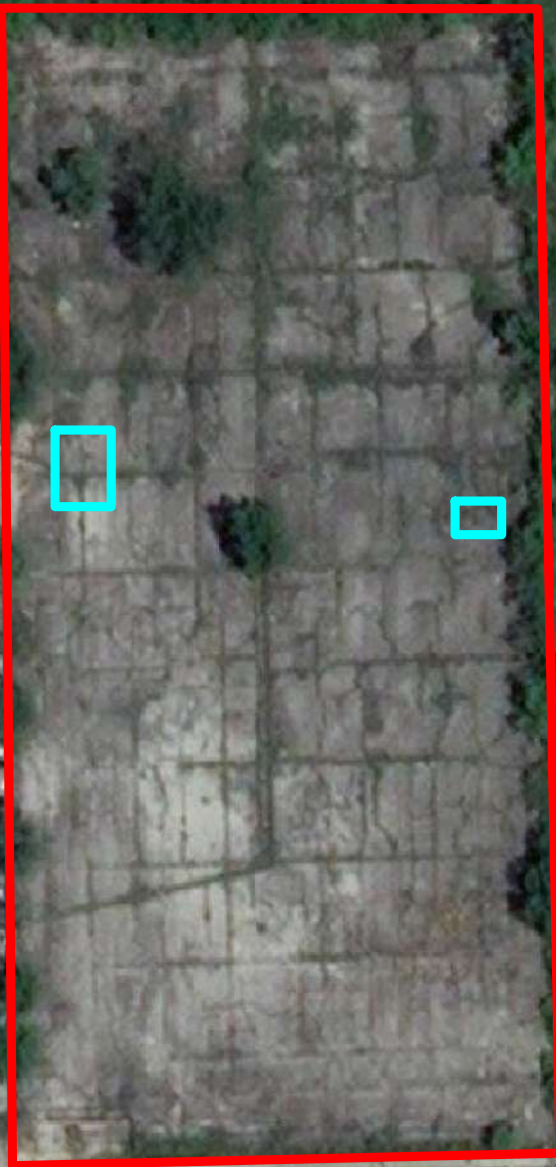
**Exhibit I: GPR Survey Map**  
Proposed Engine Company 115 - Site B  
Northwest Corner of W. 119th St. & S. Morgan St.  
Chicago, Illinois 60643

The GPR report provided by GPRS did identify two areas of possible debris or previous excavation. These areas are summarized in the following table. In addition, the EMI report indicated several areas of high conductivity and density throughout the Site. The EMI anomaly locations are presented in **Exhibit II**.

GPR Anomalies				
Anomalies	Approximate Size	Location	Observations	Recommendation
1	40' north-south x 30' east-west	West-central area of Site.	Possible soil change or previous excavation	Advance test pit to assess nature of soil change.
2	17.5' north-south x 24' east-west	East-central area of the Site.	Possible soil change or previous excavation	Advance test pit to assess nature of soil change.

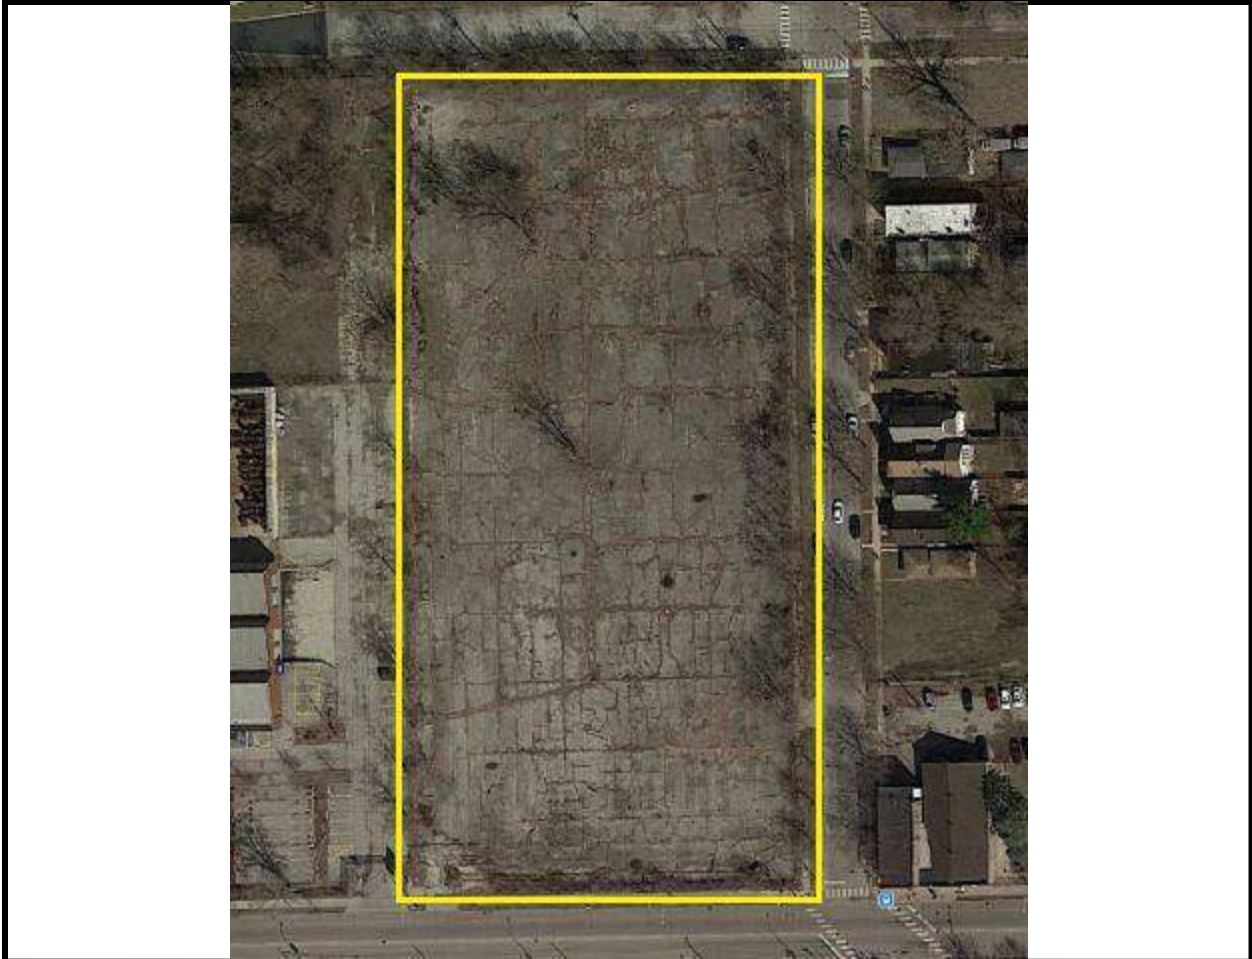
Scan Area Outlined in Yellow

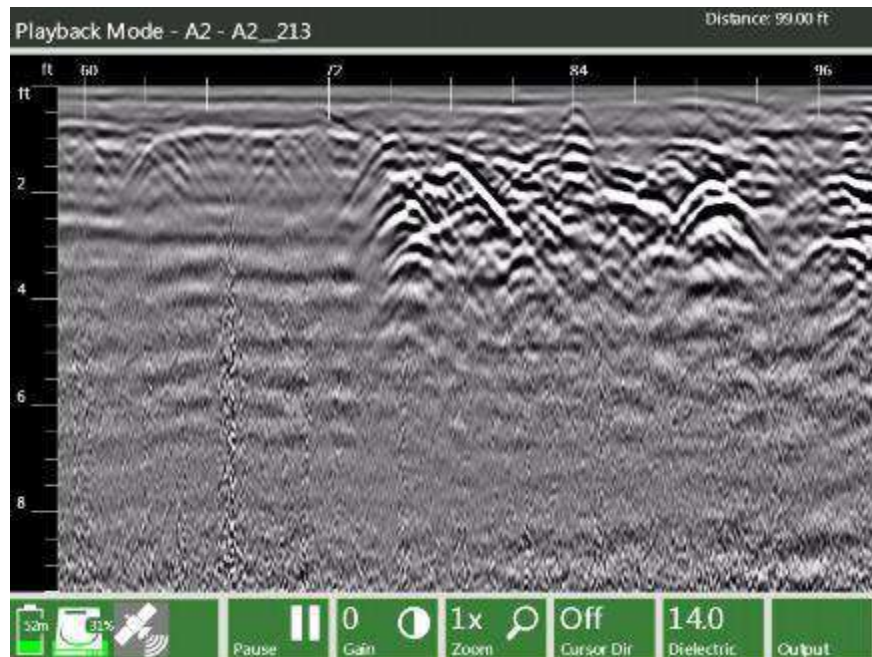
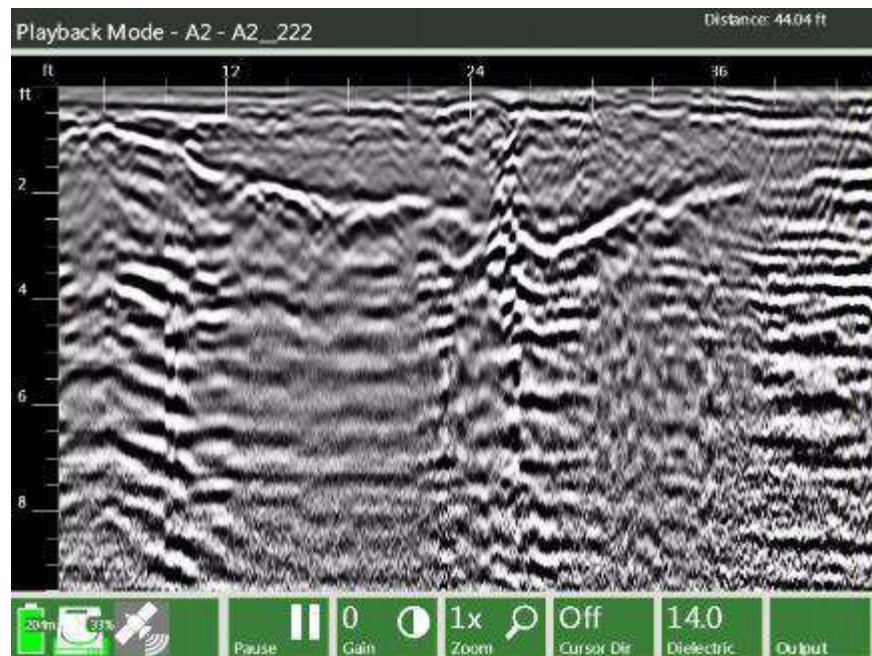
GPR data screenshot

GPR Data Screenshots of possible debris or previous excavation. Further investigation may be required.

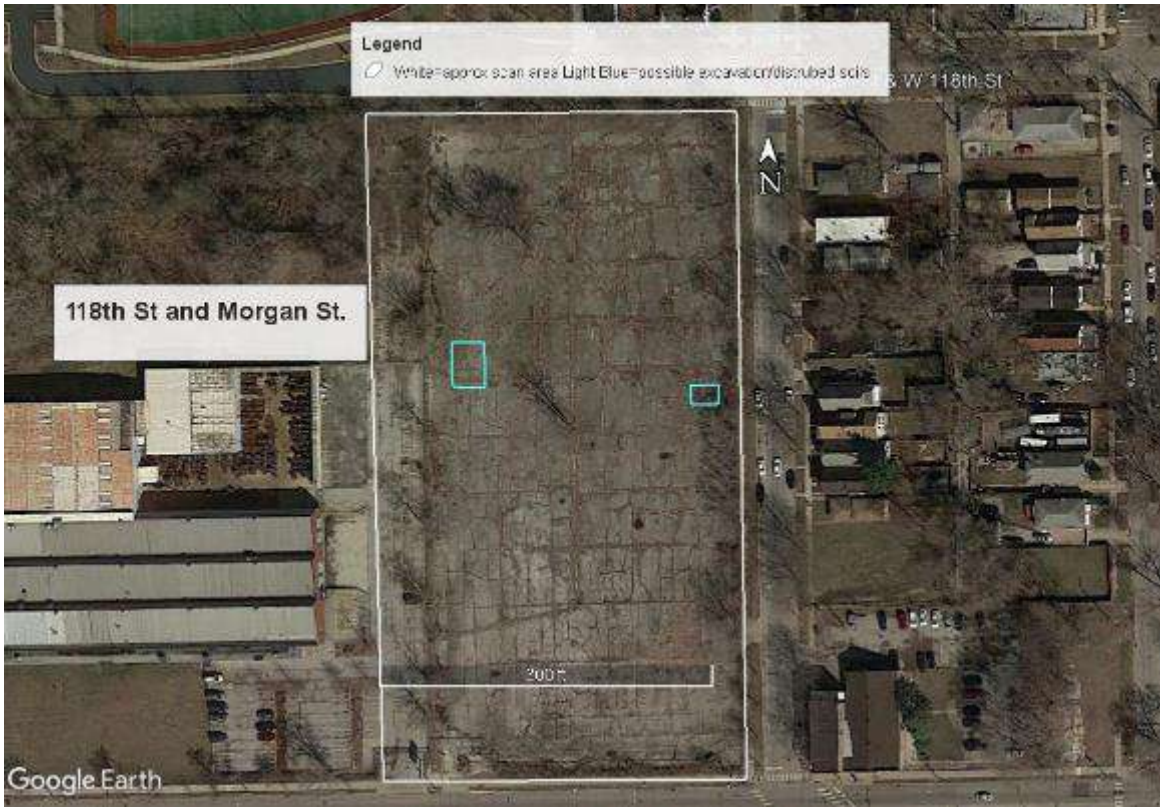
We found that the soil allowed for maximum GPR depth penetration of 3.5' in most areas. We were able to locate utilities such as site lighting and some storm lines using either the GPR or RD. GPRS did not locate water, gas or communication within the scanned area. **The site was scanned in attempt to locate evidence of utilities and for other significant anomalies near boring locations. Once all of the target areas were scanned, GPRS was able to locate anomalies that would be consistent of possible soil change or previous excavation. GPRS was NOT able to locate anomalies that would be consistent of possible UST with the GPR.** Further investigation may be required. GPRS located what we were able to locate given site conditions/obstructions, scanning constraints and equipment limitations.

Overview of findings

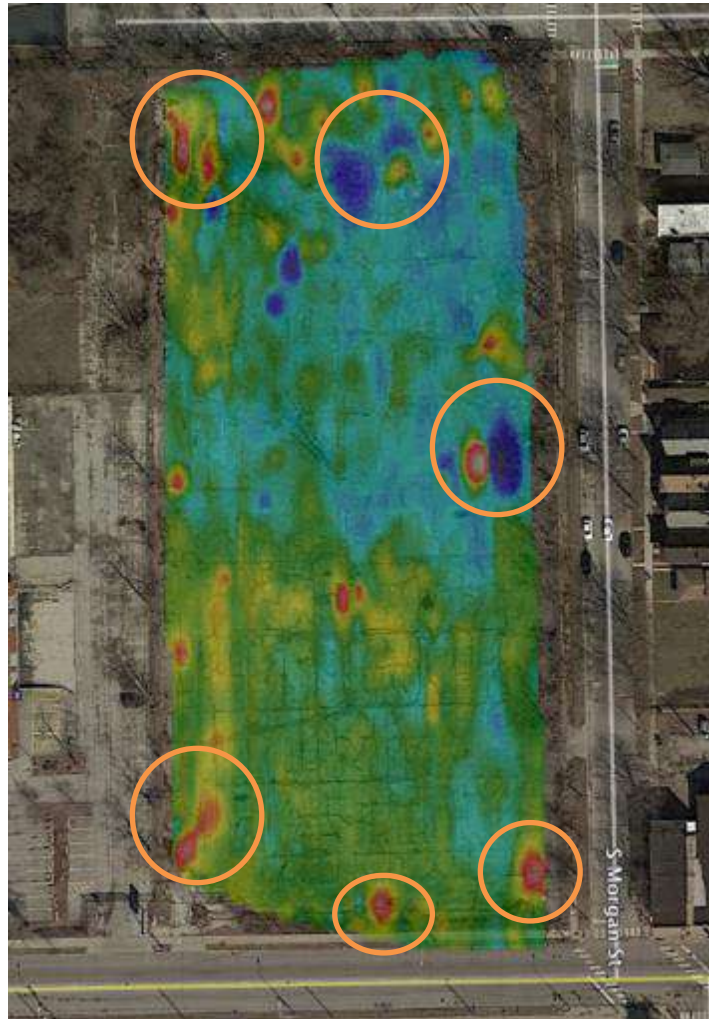
GPRS scanned the area with Electromagnetic Induction equipment, and the following conductivity maps represent the data collected from the scanning process (approximately 3'-6' deep). These conductivity maps provide information as it relates to the conductivity of the area(s) scanned. GPRS is providing this information for your interpretation. GPRS will simply point out the areas of higher conductivity (circled in red). It is the responsibility of the customer to further analyze/investigate the information provided. There may be limited data from the EMI due the buildings obstructing the GPS if present

EMI Data
