PERSHING ROAD BUILDING
1769 W Pershing Ave, Chicago, IL 60609
Facility Evaluation Report 07/09/2021

HARDING MODE JOINT VENTURE

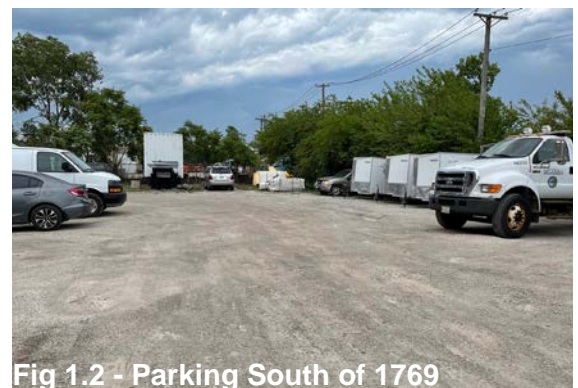
Fig 1.2 - Parking South of 1769

The parking lot area is approximately 150' x 600'. The parking lot is fully asphalt paved at the west portion of the lot and generally in good condition, however the east side of the lot is primarily an unpaved gravel lot and some areas are in poor condition. The west portion of the parking lot has visible striping, however the east side of the lot is not striped.

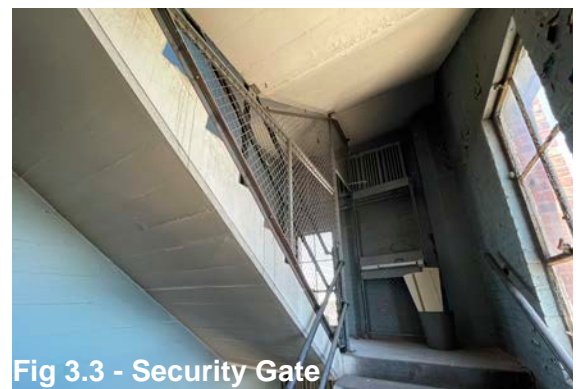
Fig 3.3 - Security Gate

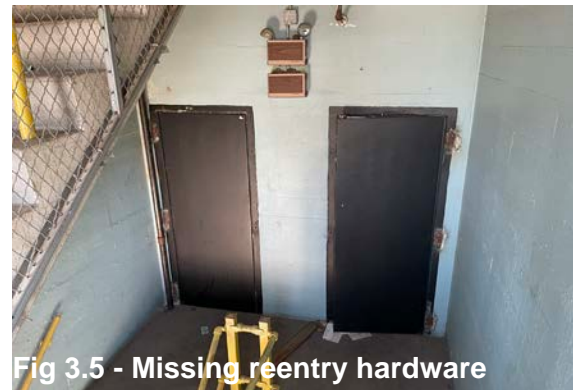
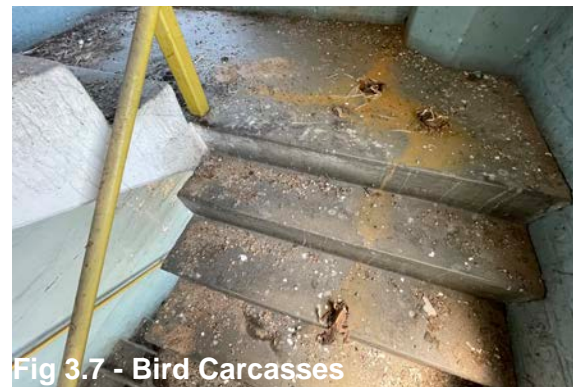
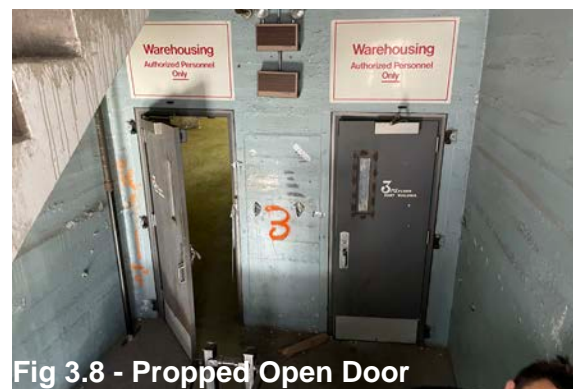
- Stair E: Located at the southeast corner of the building, this stair connects all levels. The stair, slab and enclosure construction are entirely of concrete. At the basement, the stair is open to the landing at grade level. A partition at the grade landing provides a rated enclosure. A door facing to the east provide exiting for this stairwell, but due to plant overgrowth the stair cannot be exited. A 34" wide rated door protects openings at all levels. At the 4th floor there is no re-entry hardware from the stairs, at the first floor there is a security gate preventing access to floors above, which will need to be removed if stair is to be used. The stairwell was filled with bird carcasses (fig 3.7) and excrement and requires significant abatement. The interior handrail and guardrail at top of stair do not comply with minimum code requirements at areas where fall distance exceed 8'.

- Stair F: Located at the west side of the building between the center and south area firewalls, this stair connects all levels. The stair, slab and enclosure construction are entirely of concrete. The stair is enclosed at all levels to basement, with a pair of 30" wide rated doors protecting openings at levels two through six, and a single 34" door at the first floor and basement. This stair is the 'main stair' for the facility and has hardware at both sides of doors throughout. A security gate is located at the 4th to 5th floor intermediate landing that would need to be removed. During the assessment doors at all levels were propped open (fig 3.8). The interior handrail and guardrail at top of stair do not comply with minimum code requirements at areas where fall distance exceed 8'.

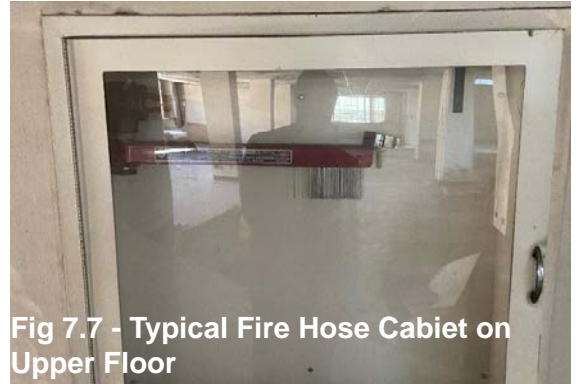
Fire protection 1-1/2" hose valves are located though-out the building, on all floors, at or near stairwells and at the core interior. The valve cabinets appear to be fed from a 2" riser. Most cabinets are missing hoses and fire extinguishers (fig 7.6 & 7.7)

Fig 7.7 - Typical Fire Hose Cabinet on Upper Floor

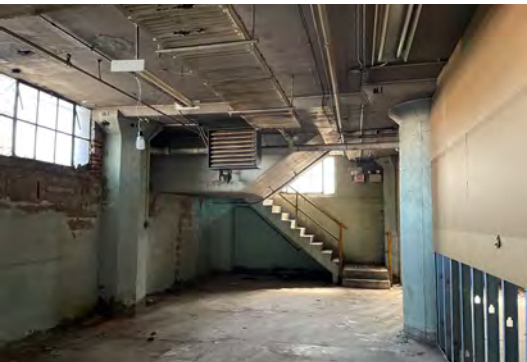
A - Stair B without enclosure

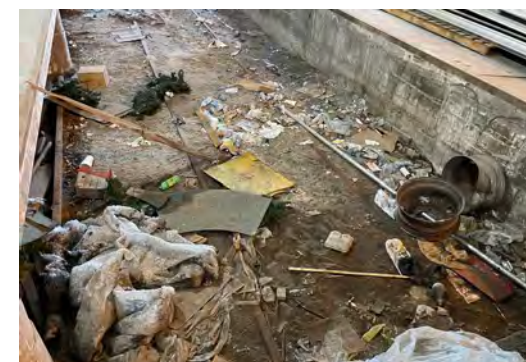
B - Rubbish at loading dock

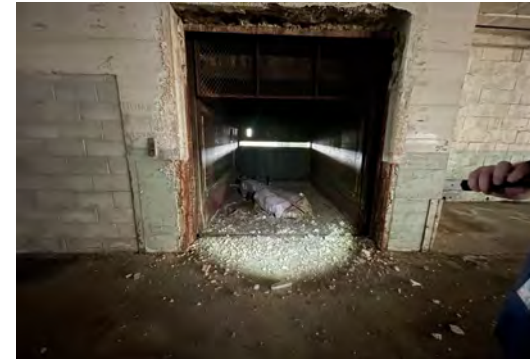
B - Deteriorated Lintel Elevator 9

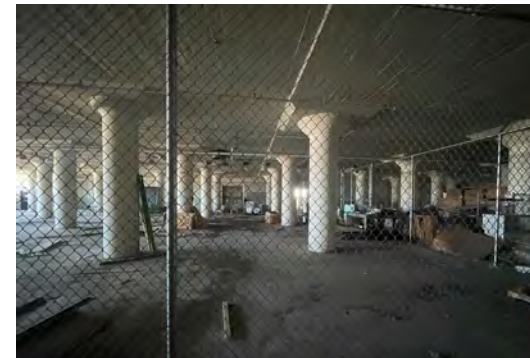
D - Chain Link Fenced Area and rubbish

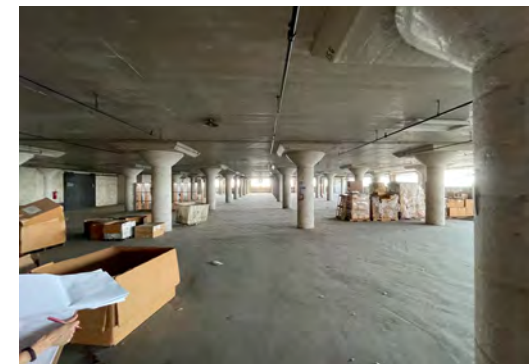
A - Rubbish at south of floor

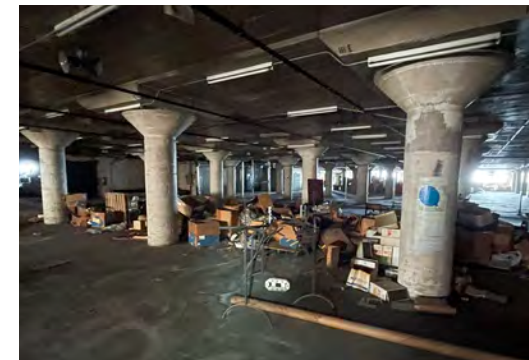
C - Trash at center portion of floor

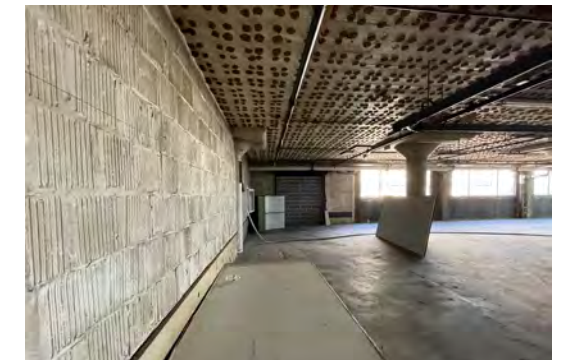
D - Masonry fill at existing bridge

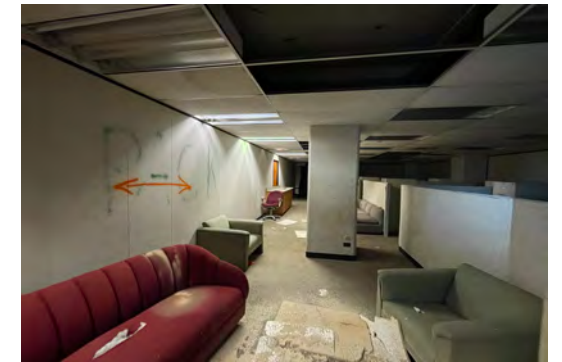
B - Interior Buildouts and abandoned furnishings

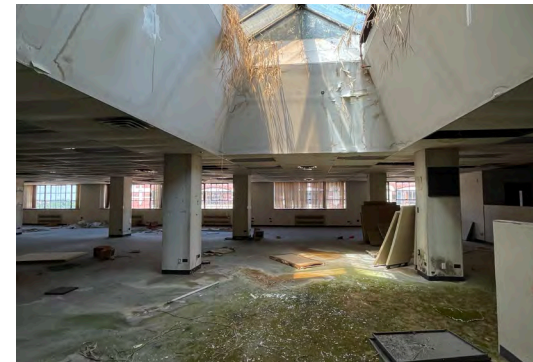
A - Moss growing at floor areas below skylights

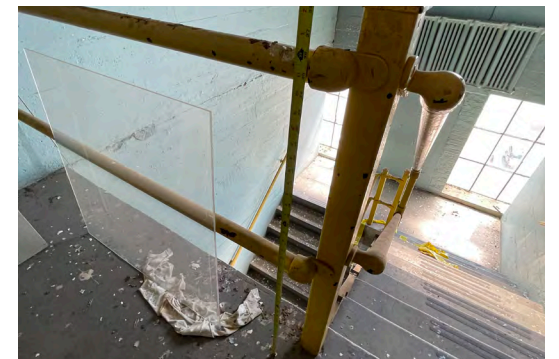
H - Guardrail at Stair C

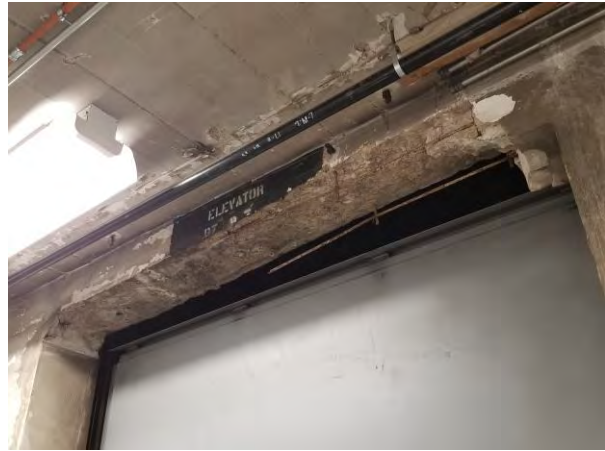
The building structure was generally in good condition. On Level 6, we observed a hole in the roof concrete slab, where the concrete had been removed, but the rebar was still intact and visible. We also observed a concrete beam above the Elevator B-6 opening that appeared to have been cut. Some of the bottom bar reinforcement and stirrups in the cut beam were visible. Generally, on Level 6, we observed several locations of concrete spalling and exposed, rusted rebar. Typically, when reinforcing is exposed to water and rusts it expands. The forces that result from the rusting cracks and eventually spalls the concrete cover. The majority of the locations of rusted rebar and spalled concrete were around skylights. It appeared that there had been leaks in the past, which caused the rebar to rust and concrete to spall. At the time of our visit, we did not observe any leaks, possibly the roof and skylights had been repaired and the water damage rusting and spalling occurred some time ago.

Cut Beam at Elevator B6

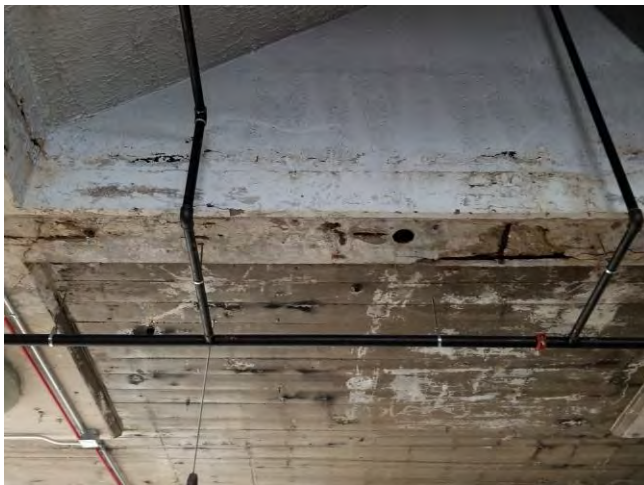
Exposed Rebar around Skylight

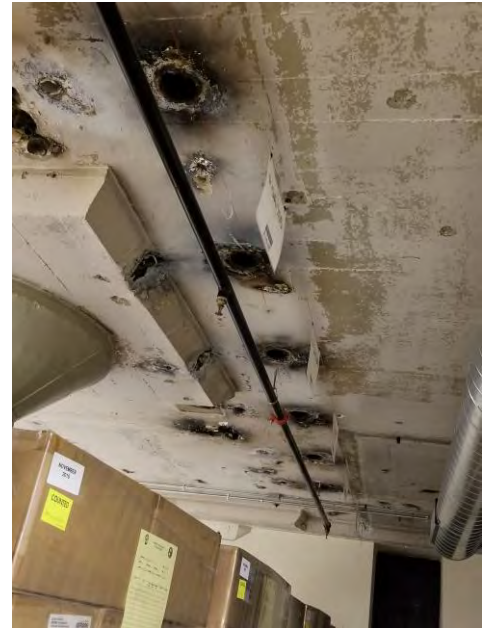
Levels 1 to 5 of 1869 W. Pershing were in relatively good condition. There were many existing cores through the concrete structure for plumbing and other utilities. Some cores occurred through column capitals. The cores reduce the strength of the concrete slabs. Cores through the column capitals and drop panels reduces the shear and flexural strength of the slab/column connection. We observed several locations where there were cracks in the floors. We did not see these cracks telegraphing through to the underside of slab in the locations we checked. There are many causes for concrete surface cracks, such as initial shrinkage cracks that enlarged over time due to overloading of the slab by heavy equipment, or long-term deflection of the slab due to creep. The surface damage cracks may also have occurred from the forklifts and equipment that were driven over the slab.

Plumbing Cores Through Concrete Slab

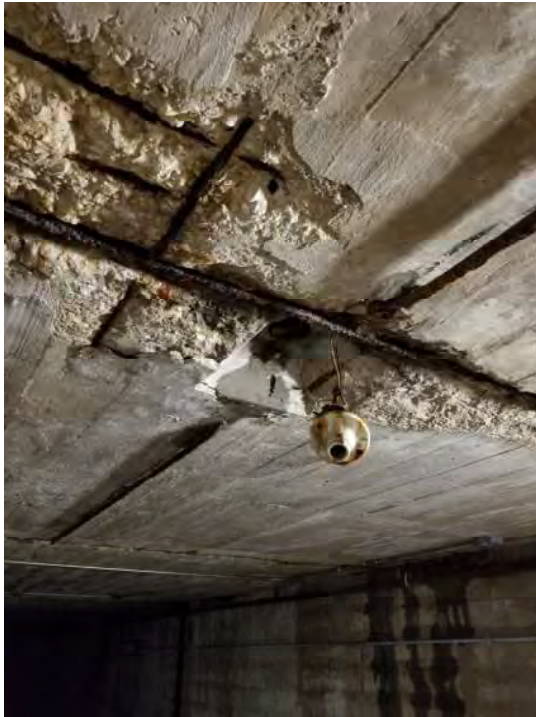
Exposed Rebar in Tunnel Slab
