PERSHING ROAD BUILDING
1869 W Pershing Ave, Chicago, IL 60609
Facility Evaluation Report 07/30/2021

HARDING MODE JOINT VENTURE

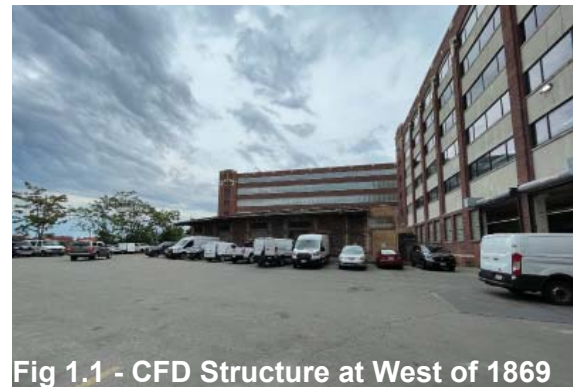
The subject property is located on the south side of Pershing Road, and was constructed as a portion of warehousing and manufacturing facilities for the US Army dating to approximately 1920. The property is bound by a CDOT parking lot to the east, a materials yard and rail yard to the south, additional warehouse buildings to the west and Pershing Road to the north. The subject building is located as the westernmost of three identical warehouse buildings owned by the City of Chicago. Between the 1869 building and 1819 building to the east, an asphalt paved drive provides access to the asphalt parking lot at the south side of the property and loading docks for both the 1819 and 1869 buildings. At the west side of the property is a brick and asphalt drive that provides access to the parking area south of the carpenter shop building. The parking lot extends from the east edge of 1769 to the west face of 1819 where a one-story Chicago Fire Department structure is located to the south of 1869 Pershing, with additional parking and loading between the CFD building and one-story carpenter shop building. (fig 1.1)

Fig 1.1 - CFD Structure at West of 1869

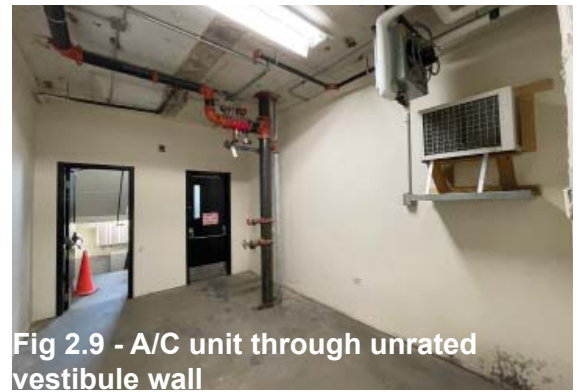
to be removed as they were on floors 2-4 once the proper rated vestibules are completed. (fig 2.8) At the fifth floor a window A/C unit has been installed through the unrated vestibule wall from the office to the north. (fig 2.9) At the landing at the 2nd 3rd and 4th floors a louver/plenum assembly from the AHU outside air intake/exhaust extends into the space, and there is no rated separation for the shaft as required. At the 4th through 6th floors the stairwell is missing identification signage. Doors from the vestibule at some levels had card readers and were locked, and at some floors were locked or hardware function was set so that no reentry was possible, and doors were propped open at several levels. At the fifth floor level a fire alarm communication phone has been installed. Lighting and exit lighting are provided at all levels. The interior handrail and guardrail at top of stair do not comply with minimum code requirements at areas where fall distance exceed 8'.

Fig 2.9 - A/C unit through unrated vestibule wall

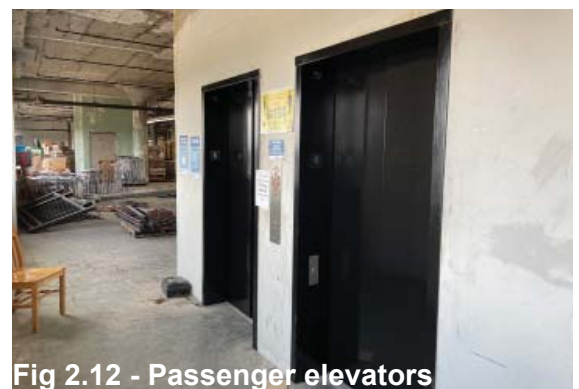
- Passenger Elevators P1 and P2 (fig 2.12): The passenger elevators are located adjacent to each other at the north side of the building and serve floors one through 6. Key card access is required to control the elevator. The elevators have fire control overrides, and phone call buttons at the interior, and generally appear to be code compliant. An elevator consultant would need to review all controls to ensure conformance with latest Chicago Conveyance Code requirements.

Fig 2.12 - Passenger elevators

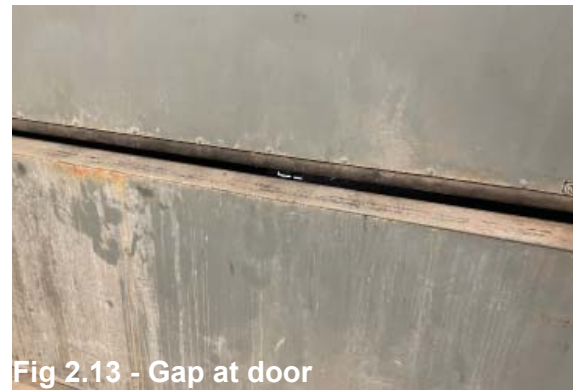
Fig 2.13 - Gap at door

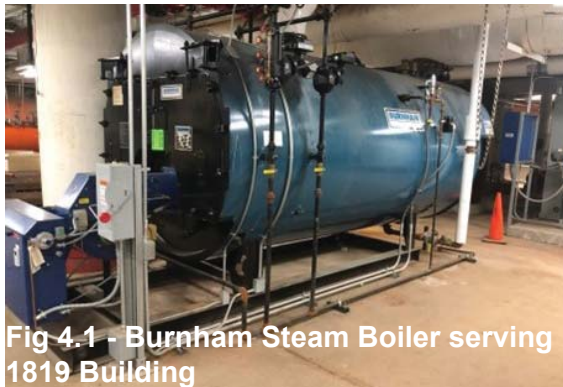
Fig 4.1 - Burnham Steam Boiler serving 1819 Building

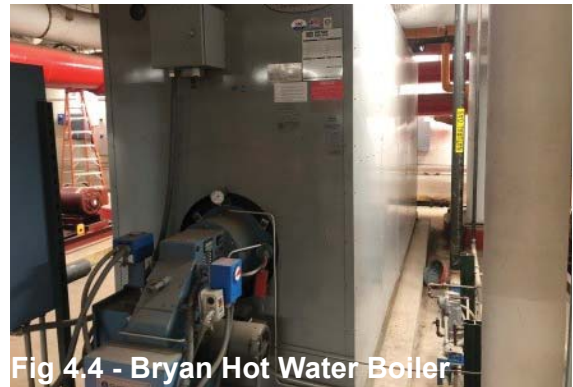
The building is heated by a central hot water boiler plant in the basement of the building. The plant consists of (3) 6720 MBH Bryan hot water boilers (fig 4.4). (2) of the boilers were manufactured in 2006, the third boiler is manufactured in 2010. Armstrong VFD controlled pumps (fig 4.5) are used to circulate the hot water throughout the building's air handling units/unit heaters/finned-tube radiators. The heating plant's aforementioned equipment appears to be in good working condition.

Fig 4.4 - Bryan Hot Water Boiler

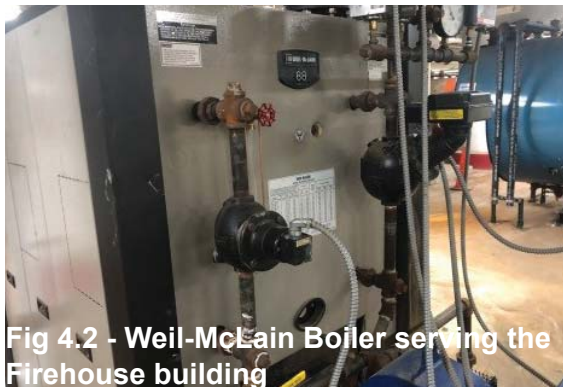
Fig 4.2 - Weil-McLain Boiler serving the Firehouse building

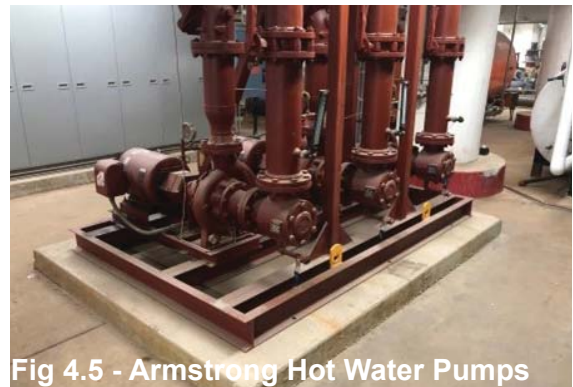
Fig 4.5 - Armstrong Hot Water Pumps

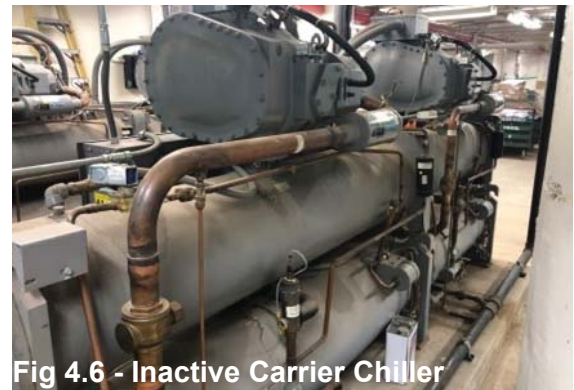
The building's cooling load is handled by a water-cooled chiller plant in the basement of the building. The plant currently contains (4) chillers, (2) Carrier chillers (CH-1 & CH-2) installed/manufactured in 2006 (fig 4.6) and (2) Trane Chillers (CH-3 & CH-4) installed/manufactured in 2010 (fig 4.7). All (4) chillers are tied into the same central system, CH-1 & CH-2 are mostly inactive due to control operation difficulties, CH-3 & CH-4 currently handle the building's cooling load. The cooling tower is installed on the roof of the building; the cooling tower was manufactured in 2006 by Marley (fig 4.8), was installed with CH-1 & CH-2 in and currently serves CH-3 & CH-4. The cooling tower's control panel and associated fan VFDs can be found on the 6th floor. Armstrong VFD controlled pumps circulate the chilled water to the air handling units throughout the building. The cooling tower is drained every winter therefore cooling is not available during winter season. The aforementioned plant equipment appears to be in good working condition.

Fig 4.6 - Inactive Carrier Chiller

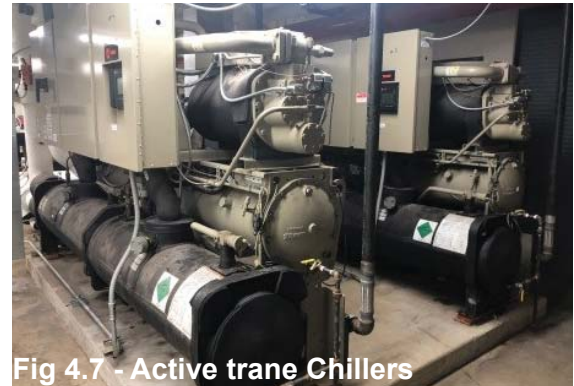
Fig 4.7 - Active trane Chillers

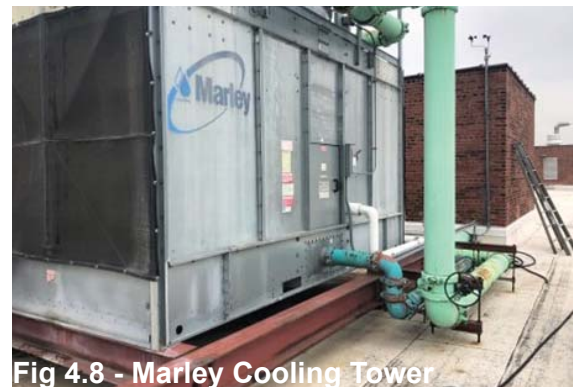
Fig 4.8 - Marley Cooling Tower

- At the time of replacing the fill we recommend the installation of a cold-water basin liner and possibly a liner on the interior fill area casing sheets. This liner will protect the steel from further corrosion. The only time to do this is when replacing the fill.

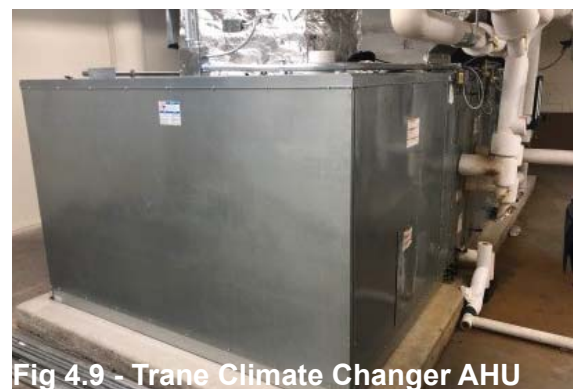
The AHUs serving the basement-3rd floor are installed and manufactured in 2006; meanwhile the 4th floor units are installed and manufactured in 2010. The units are manufactured by Trane and are the Climate Changer model and are in good operating condition (fig 4.9).

Fig 4.9 - Trane Climate Changer AHU

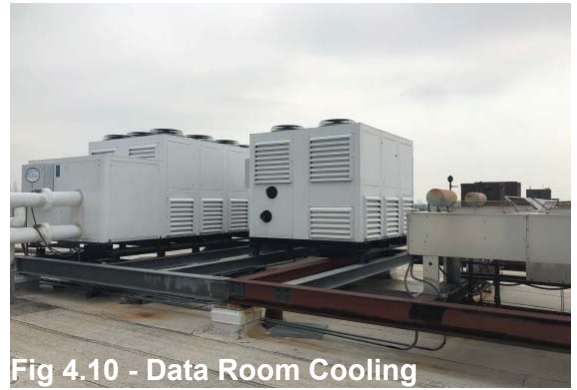
The roof contains multiple roof mounted exhaust fans. The main toilet stack is served by a central roof exhaust fan. Liebert cooling equipment is also installed on the roof for the data room on the 4th floor. (fig 4.10) A remote radiator for the building's emergency generator is also installed on the roof.

Fig 4.10 - Data Room Cooling

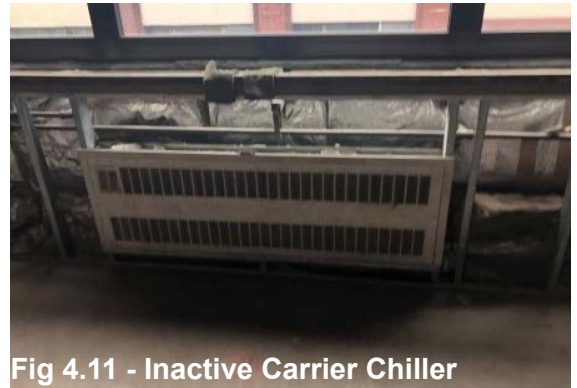
Both floors are used for storage. The 5th floor is heated but the 6th floor is neither heated nor cooled. The 6th floor contains steam perimeter heating that has been abandoned (fig 4.11). The building engineer has never had issues with the lack of heat on the 6th floor. Ventilation air is not required per code for the current occupation classification (unoccupied/inactive storage). If the space is to be built-out for different purposes in the future, mechanical ventilation is required to be supplied to occupied spaces in accordance with Section 18-28-403 of the Chicago Building Code. The minimum supply and exhaust ventilation rates for different space types is provided in Table 18-28-403.3. The code section also specifies that a minimum of 1/3 of the required ventilation air comes from the outdoors. The ventilation rates for the different space types noted in this building are as follows:

Fig 4.11 - Inactive Carrier Chiller

- Perform a full mechanical tune up. Change gear oil or belts. Check fan pitch and that all hardware is torqued down to the factory settings.
- Demolish abandoned steam heating equipment on the 6th floor, tie in to the future connection hot water stubs and install finned-tube radiators to handle the floor's heating load.

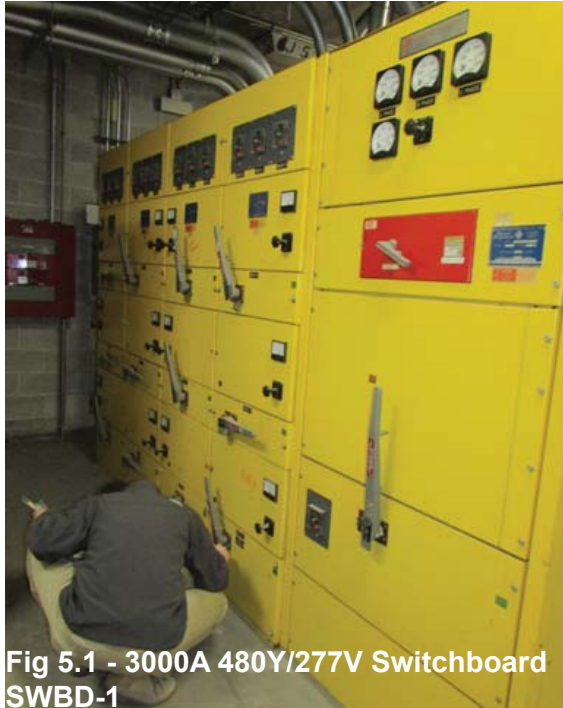
There is COMED vaults located in the building basement adjacent to main electrical room which provides power connection to (3) switchgears. First one is 3000A 480Y/277V 3ph 4W switchgear (SWBD-1) located in main electrical room at the basement level (fig 5.1). This switchgear mainly serves large mechanical equipment (e.g. HVAC, pumps) and buildout areas including 4th floor Data Center and Health Dept. Second switchgear is 3000A 208Y/120V 3ph 4W (SWBDE) and it's located in the same room (fig 5.2). It provides 208Y/120V power for branch circuiting and general use equipment serving east half of building. Third switchgear is 3000A 208Y/120V 3ph 4w (SWBDW) and it's located on the 1st floor. It provides 208Y/120V power for (5) elevators, fire house and general lighting serving west half of building. The equipment is in working condition and appear to be well maintained but have limited spare capacity.

Fig 5.1 - 3000A 480Y/277V Switchboard SWBD-1

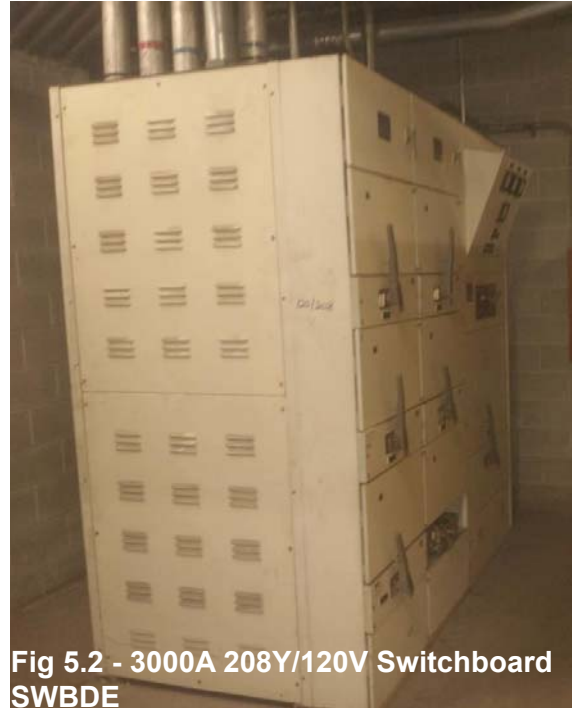
Fig 5.2 - 3000A 208Y/120V Switchboard SWBDE

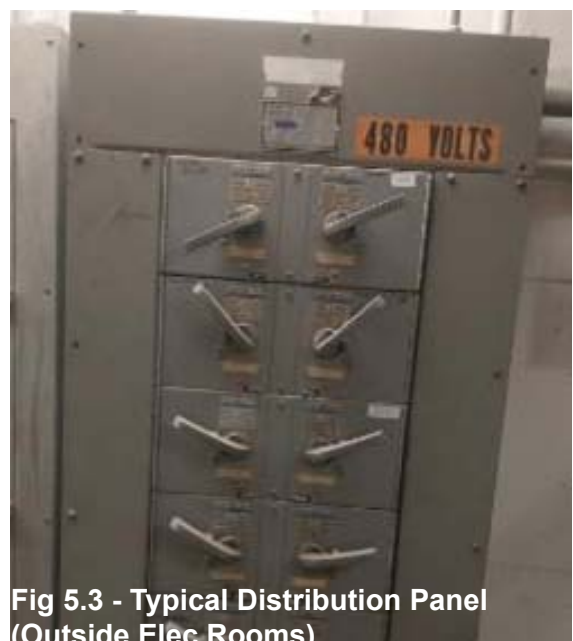
In general, all major mechanical and plumbing equipment (HVAC, pumps, boilers etc.) is fed from 480V, 3Ph, 4W distribution panelboards. Lighting, general receptacles, some miscellaneous controls and smaller equipment are fed from 120/208V branch panelboards. Mainly distribution and branch panelboards have been located throughout the building in designated electrical rooms, mechanical spaces and riser locations. Overall panels are in fair, working condition but there are a few panels (basement to 4th floor) with missing or removed front cover and all "live" wiring and bussing is exposed. It was observed that panels in similar deteriorated condition and possibly abandoned are more prevalent on 5th and 6th floors. (fig 5.3 - 5.8)

Fig 5.3 - Typical Distribution Panel (Outside Elec Rooms)

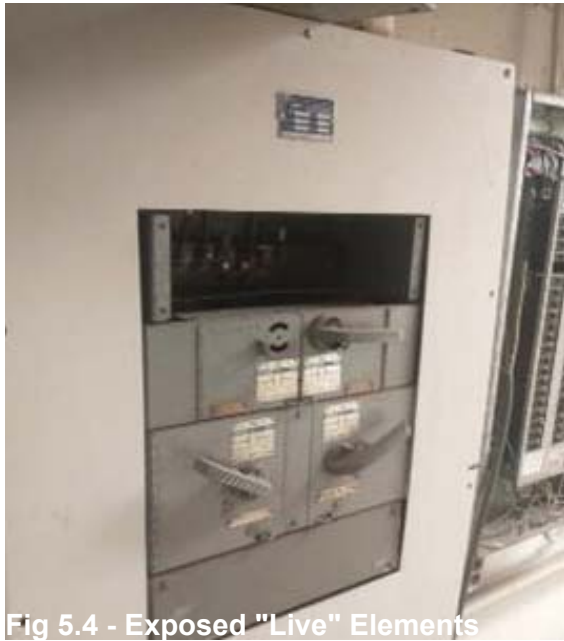
Fig 5.4 - Exposed "Live" Elements

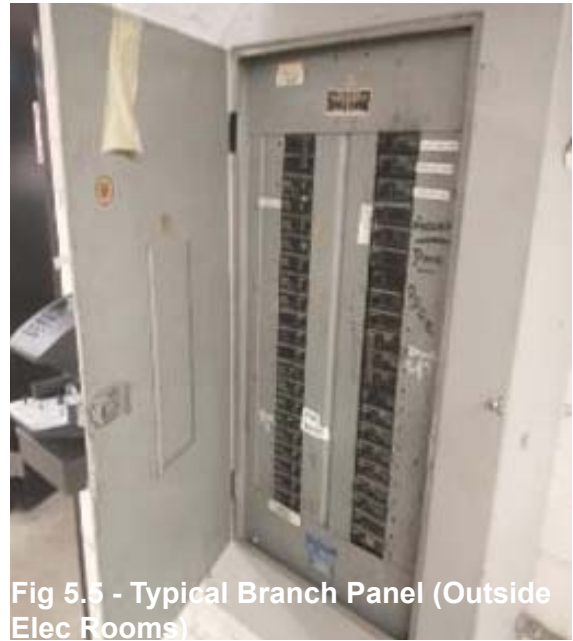
Fig 5.5 - Typical Branch Panel (Outside Elec Rooms)

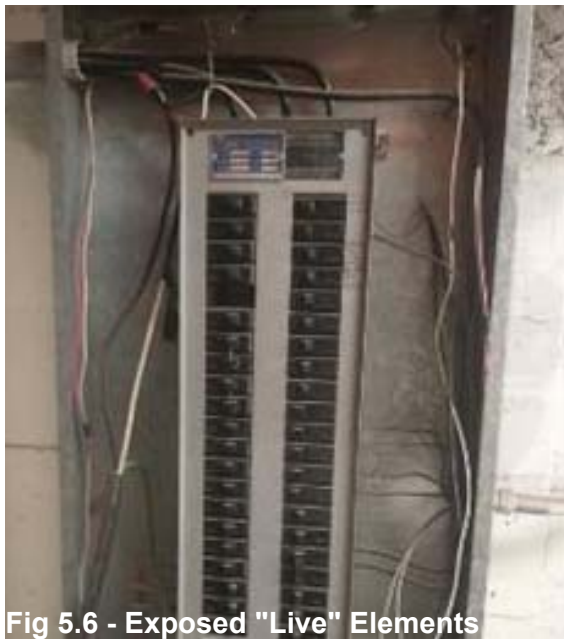
Fig 5.6 - Exposed "Live" Elements

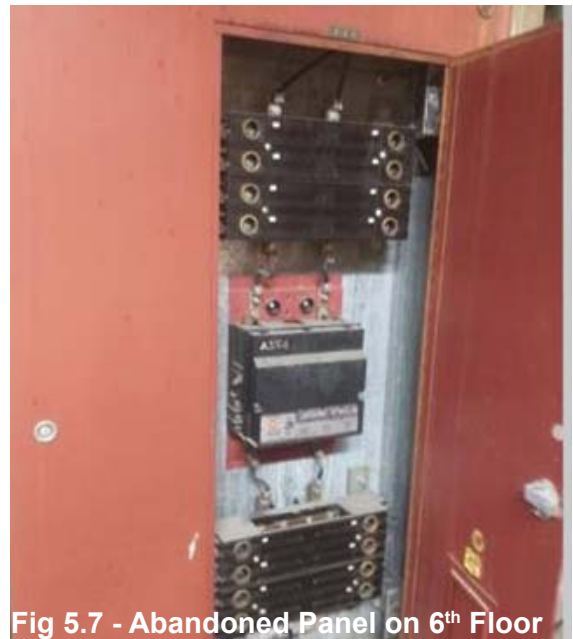
Fig 5.7 - Abandoned Panel on 6th Floor

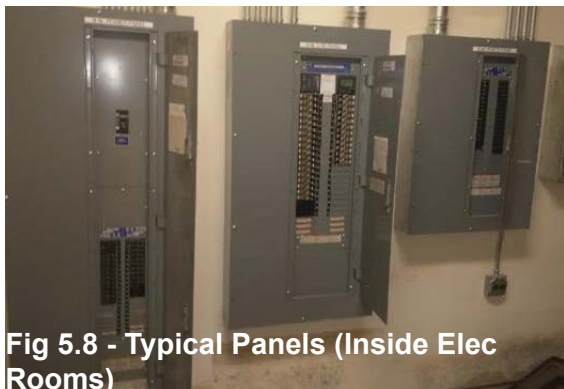
Fig 5.8 - Typical Panels (Inside Elec Rooms)

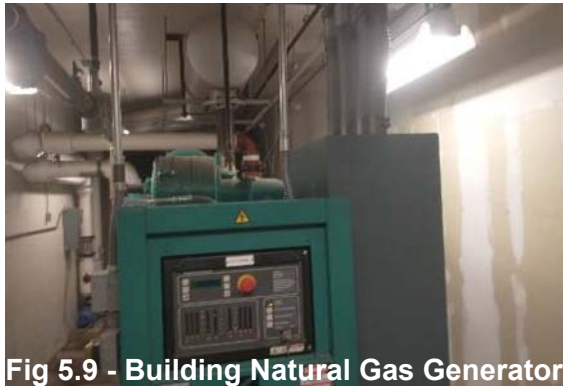
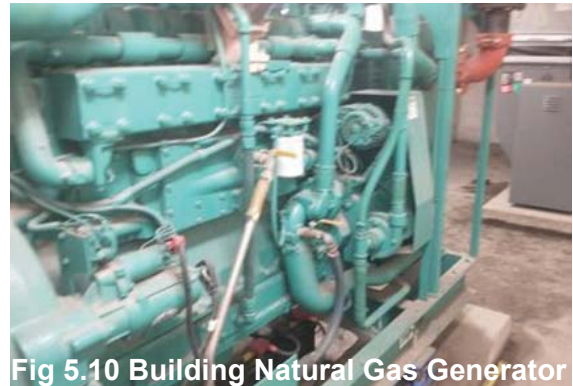
Fig 5.9 - Building Natural Gas Generator

It is recommended to have the building natural gas generator condition professionally inspected, tested and life expectancy assessed since it is over 15 years of age. (fig 5.9 -5.12)

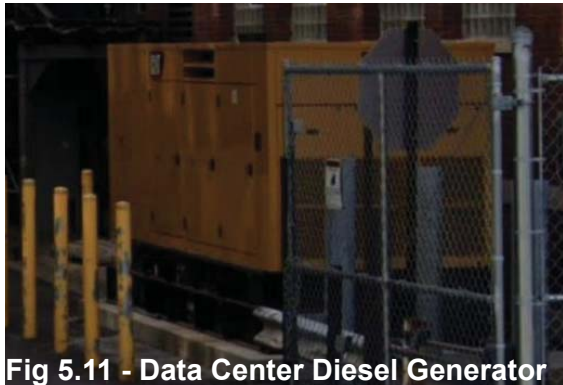
Fig 5.11 - Data Center Diesel Generator

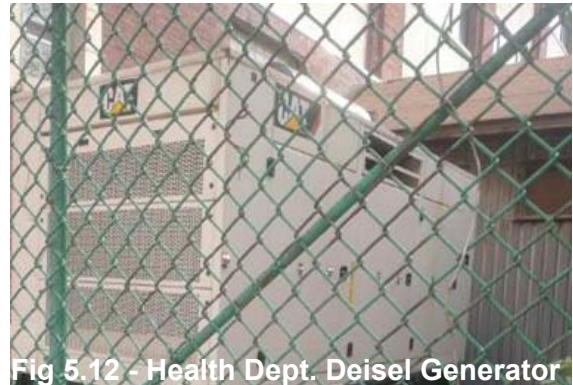
Fig 5.12 - Health Dept. Deisel Generator

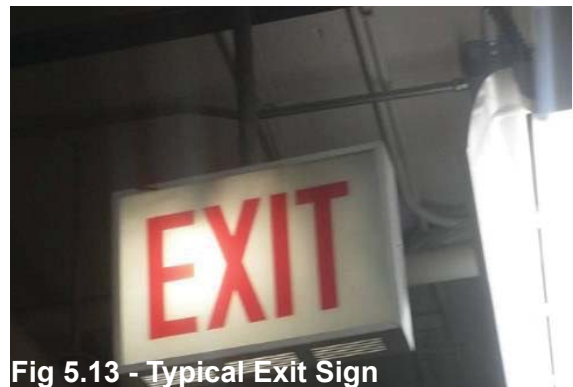
Most of exit signs and light fixtures connected to emergency circuits are working and are in fair condition and coverage is adequate. (fig 5.13)

Fig 5.13 - Typical Exit Sign

It is recommended to replace existing fluorescent type exit signs (approximately 300) and light fixtures connected emergency power source with energy efficient LED type to meet current energy Code which will reduce maintenance costs associated with replacing fluorescent lamps and ballasts and saves energy.

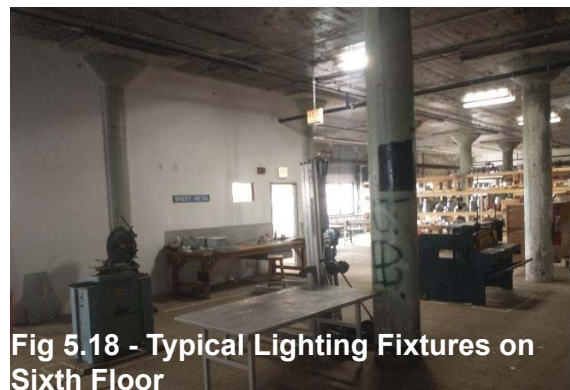
Existing interior lighting largely comprised of 4-foot suspended non-dimmable fluorescent strip lights. The light fixtures are mostly in fair condition, but are in good condition for buildout areas and on the 4th floor. (fig 5.14 -5.18)

Fig 5.18 - Typical Lighting Fixtures on Sixth Floor

It is recommended to replace existing fluorescent type light fixtures (approximately 5000) with energy efficient dimmable LED type to meet current energy Code and will reduce maintenance costs associated with replacing fluorescent lamps and ballasts and saves energy.

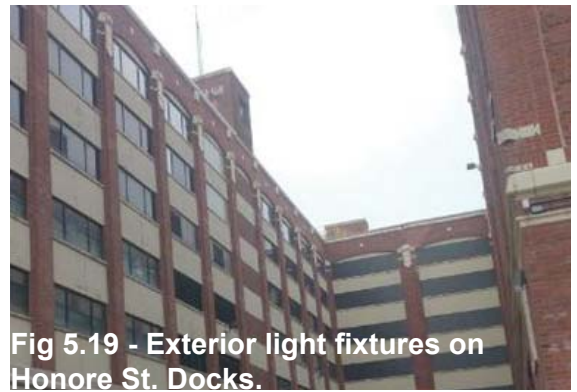
The building perimeter is lit by a combination of HID high mount metal halide flood lights and HID metal halide wall pack lights. Fixtures are in fair to poor condition. Street lighting serves as light source at front of building on Pershing street. Wall pack lighting fixtures (with integral photocell control) serving west side of building are in fair to poor condition and there is no security flood lights or security lighting for the generator located at southwest corner of building. High mount flood lights on west side of building and adjacent building serve the exterior dock area on Honore street and wall packs serve the covered area of docks located closer to Pershing road. Lighting behind the building is limited to one high mount LED flood light (good condition) above the dock and one HID metal halide wall pack at the alley behind the building and the fire house. (fig 5.19-5.22)

Fig 5.19 - Exterior light fixtures on Honore St. Docks.

- Replace existing non-LED flood and wall pack lighting fixtures with new LED fixture and provide new control to meet energy Code. (Approximately 3 flood lights and 10 wall packs)
- Add security lighting coverage at alley and for generator at southwest corner of building. (Approximately 5 wall packs)

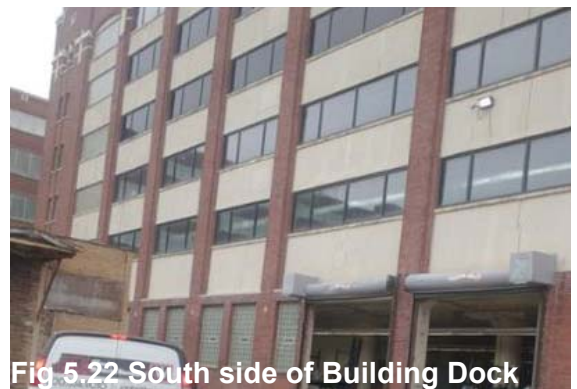
Fig 5.22 South side of Building Dock

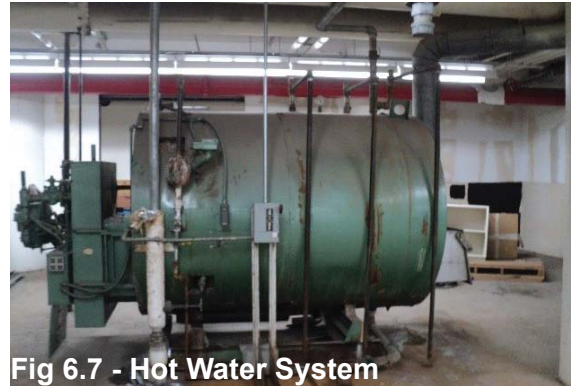
Fig 6.7 - Hot Water System

Hot water is supplied to each of the 6 stories, across all buildings, through the connecting walkways at floors 2, 3, and 6. The domestic hot water return line is located in the ceiling of the lower level. Domestic water has been cut off to the 6th floor of this building. (fig 6.7)

- Code compliance:
 - Replace all missing and damaged hot water piping insulation.
- Recommendations:
 - The existing boiler (the equipment tag is messing, we can't confirm the size of the boiler) was working at time of observation; however, it does not seem to be in good condition. Provide prevision for replacing in near future
 - Replace all existing galvanized domestic hot water piping.

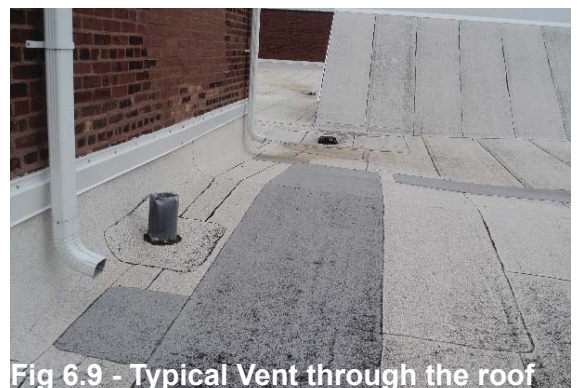
Fig 6.9 - Typical Vent through the roof

Some of the plumbing vents through the roof do not meet the requirement in the Chicago Building Code to terminate a minimum of 12" above the roof surface. (fig 6.8 - 6.10)

- Code compliance:
 - Extend roof vents to code required 12" height above the finished roof
- Recommendations:
 - Test pump and high-water alarm/switch for functionality. Replace the pipe gasket.
 - Cap the abandon 4" sanitary piping at ceiling of 4th floor where the AHU-15 located. The dead end shall not exceed 2'-0".

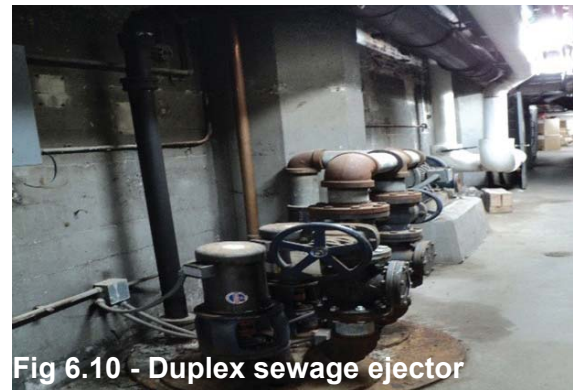
ejector pump was observed to be in working condition. The pit cover was observed to be in poor condition, the pipe gaskets must be missing or damaged as a strong odor can be sensed around the pit. All electrical connections appear to be connected. Functionality was not confirmed but was reported to be working.

Fig 6.10 - Duplex sewage ejector

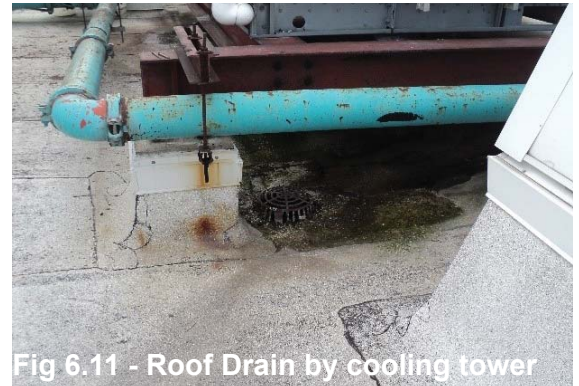
The storm piping was observed to the extent feasible when exposed. Per existing As-Built drawings the storm piping from the roof drains travels vertically to the basement level. Horizontal runs only occur at the lower level. No roof drain clogs or backups were observed or reported, however, the roof drain by the exiting cooling tower is clogged and cause the water ponding on the roof. (fig 6.11)

Fig 6.11 - Roof Drain by cooling tower

- Recommendations:
 - Rod and televise existing storm leaders from roof drains to lower-level wyes. Provide Owner and A/E representatives with a Plumber's report with all findings, obstructions and damage. Provide 1" thick insulation with jacket on all horizontal storm runs to foundation wall.

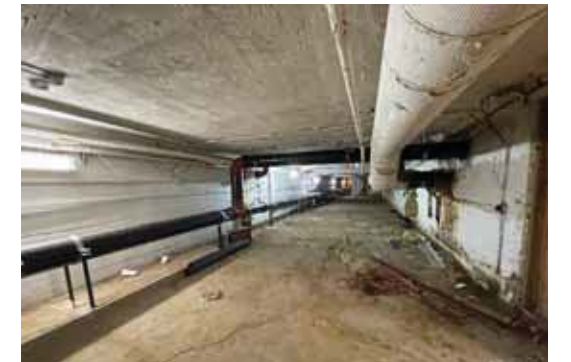
D - South Tunnel spalling

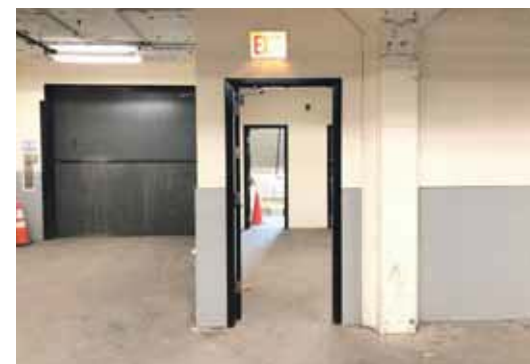
A - Condition of column S14 at Exit 5

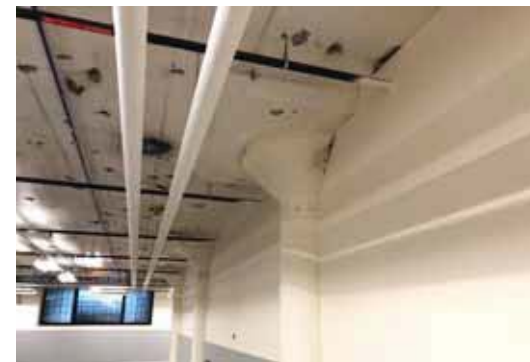
C - Condition of column D16

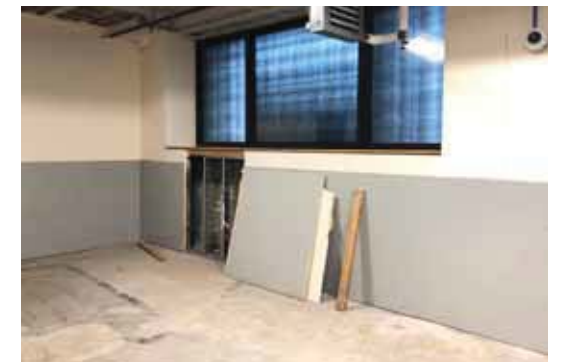
D - Damaged wall assembly

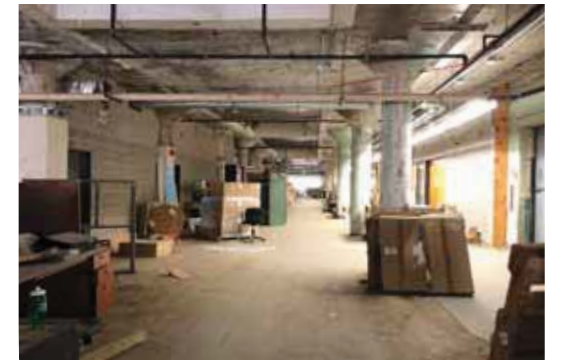
C - Stored material at Exit 2

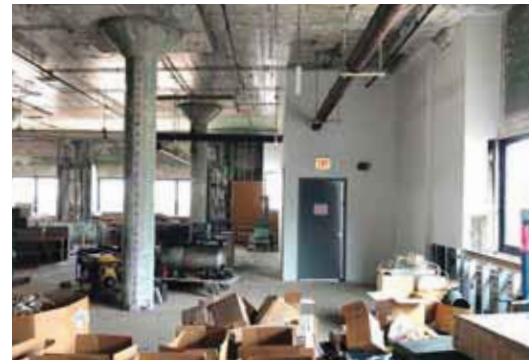
D - Stored materials in front of bathroom

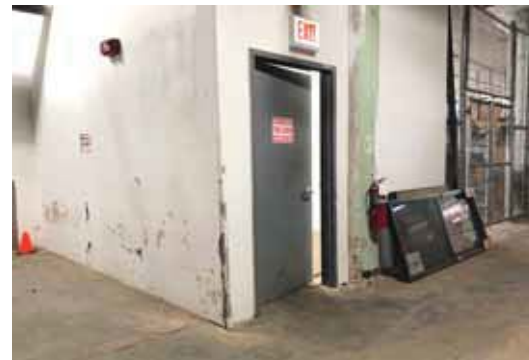
F - Stored materials in front of Exit 7

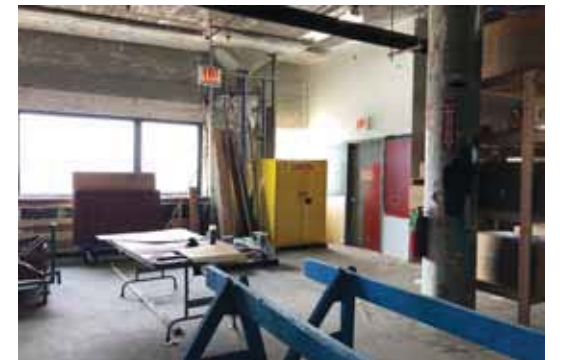
G - Stored materials in front of Exit 5

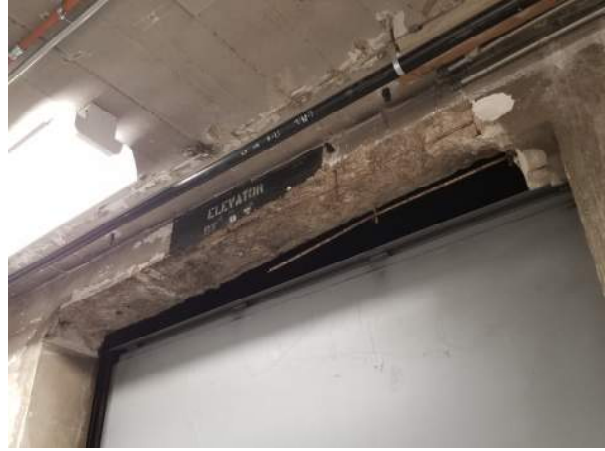
The building structure was generally in good condition. On Level 6, we observed a hole in the roof concrete slab, where the concrete had been removed, but the rebar was still intact and visible. We also observed a concrete beam above the Elevator B-6 opening that appeared to have been cut. Some of the bottom bar reinforcement and stirrups in the cut beam were visible. Generally, on Level 6, we observed several locations of concrete spalling and exposed, rusted rebar. Typically, when reinforcing is exposed to water and rusts it expands. The forces that result from the rusting cracks and eventually spalls the concrete cover. The majority of the locations of rusted rebar and spalled concrete were around skylights. It appeared that there had been leaks in the past, which caused the rebar to rust and concrete to spall. At the time of our visit, we did not observe any leaks, possibly the roof and skylights had been repaired and the water damage rusting and spalling occurred some time ago.

Cut Beam at Elevator B6

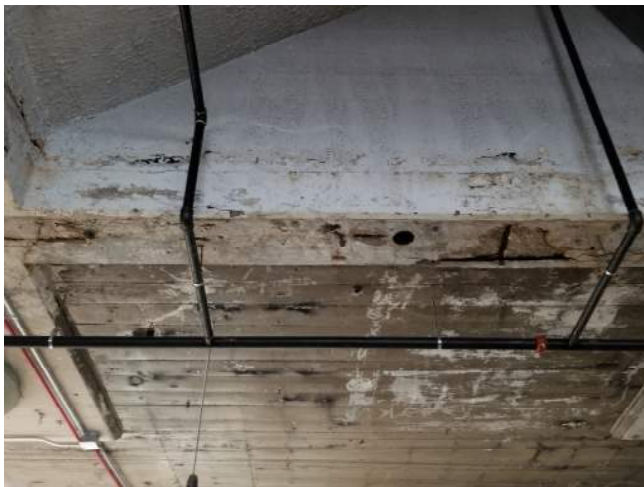
Exposed Rebar around Skylight

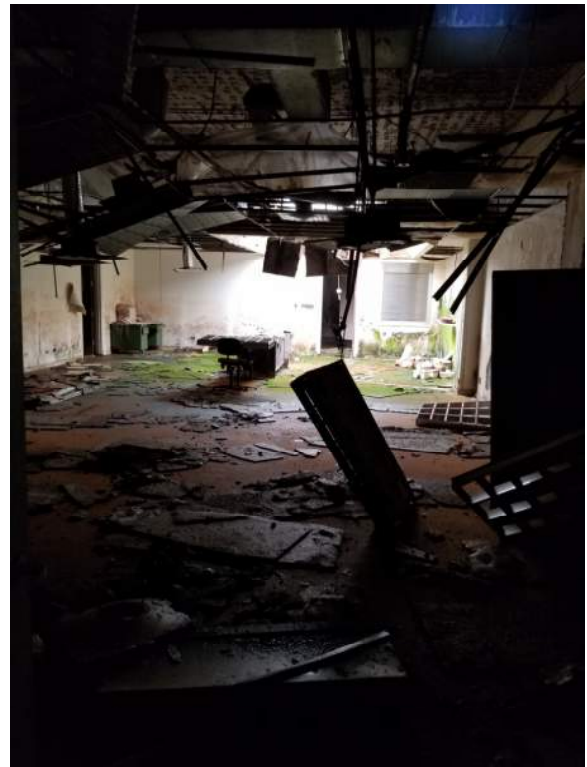
There was widespread water damage to the roof slab of the 1769 W. Pershing building. There were active leaks at all skylight locations. At least 1/3 of the bays observed across the entire roof structure had some sort of active leak or visible corrosion. There were other areas of the roof that were not visible due to a dropped ceiling. There was extensive mold across the 6th floor, with moss and plants growing under the skylights where there was direct sunlight. Much of the carpeted floor was moist, so much of the concrete slab below is constantly being exposed to moisture.

***Overall condition of all elements
on Level 6***

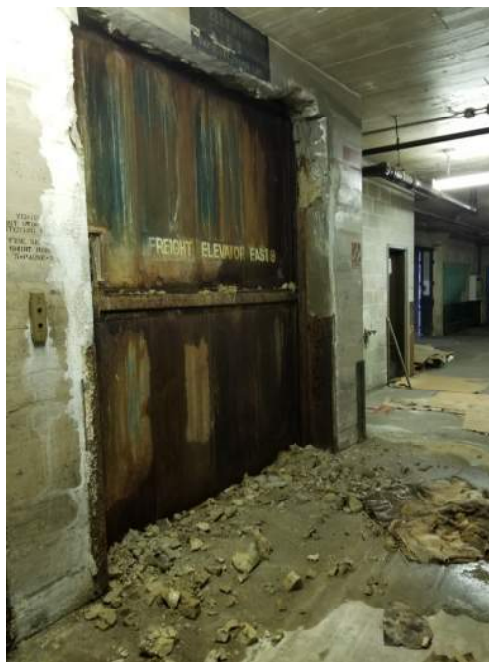
Elevator 9 South Door

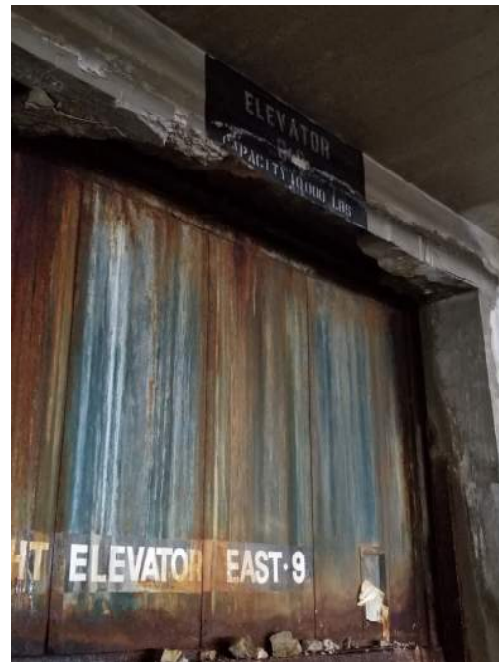
Elevator 9 North Door

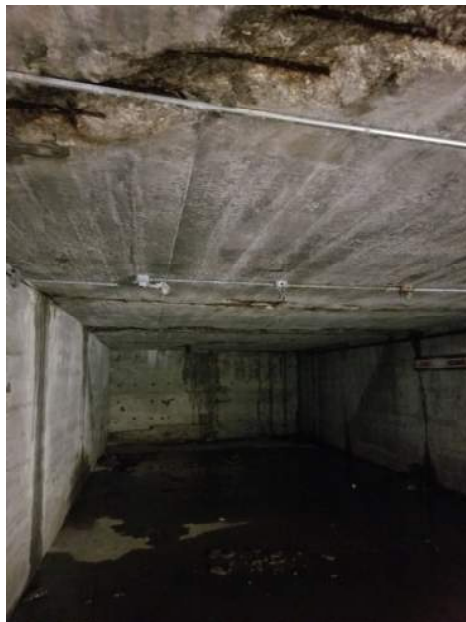
In the tunnel of the 1769 W. Pershing building, we observed the same areas of rusted rebar in the slab occurring at approximately 10' on center that we observed in the 1819 W. Pershing building. There were visible leaks within the tunnel and many areas of deteriorated slab reinforcement. There was also cracking, spalled concrete, and rusted rebar in the interior face of the basement wall.

Tunnel, Looking East

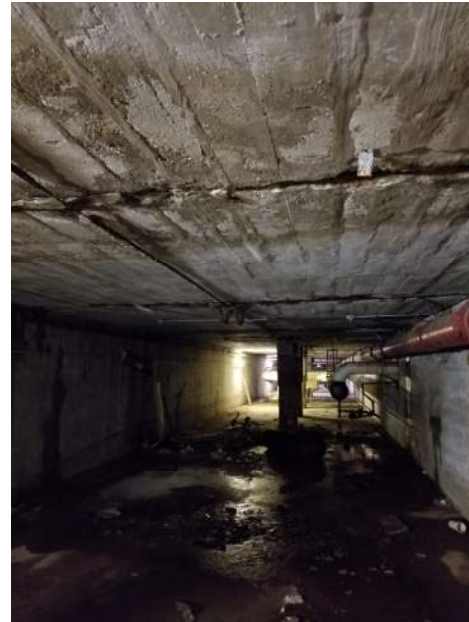
Tunnel, Looking West

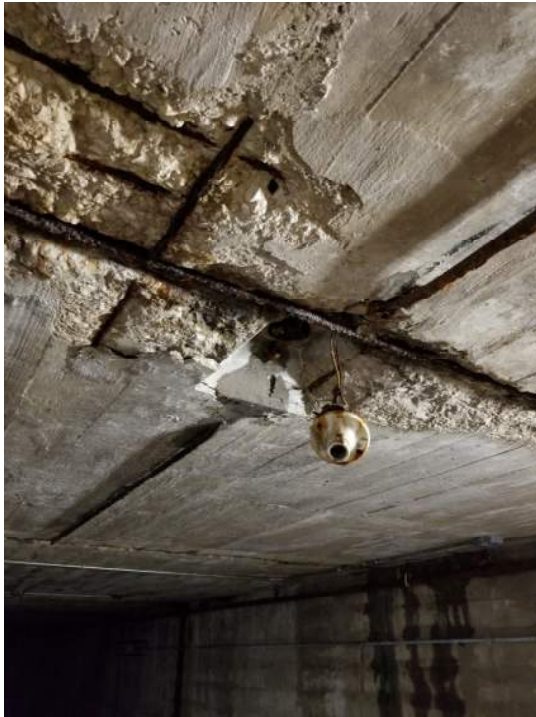
Exposed Rebar in Tunnel Slab
