Public Building Commission
North Park Village – Gymnasium Building B
Chicago, IL

Preliminary Property Condition Assessment
October 21, 2021

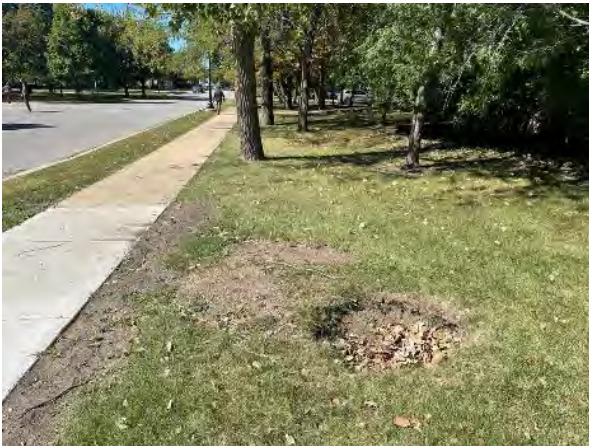
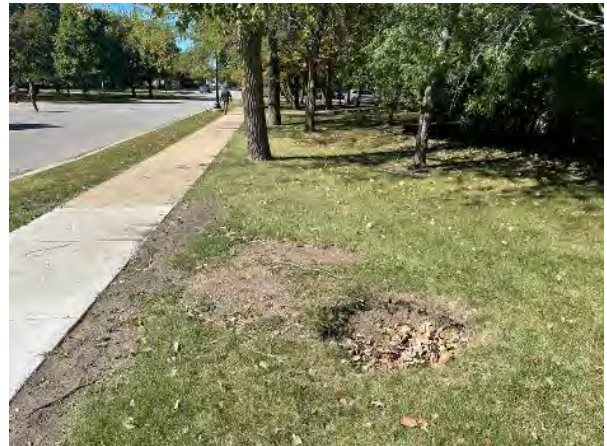
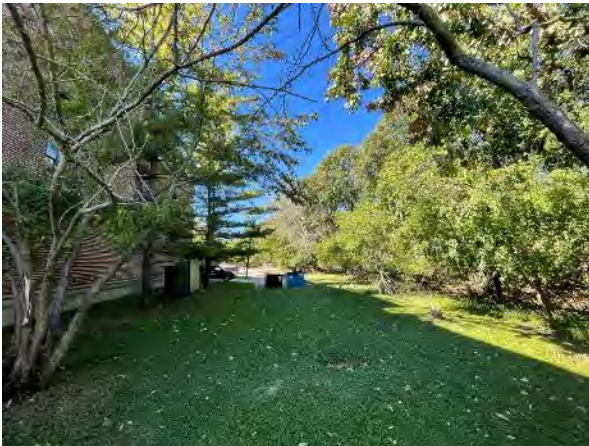
3.1.2.1 Several ~2' dia. ~8" deep holes exist in the southern and northern frontage.

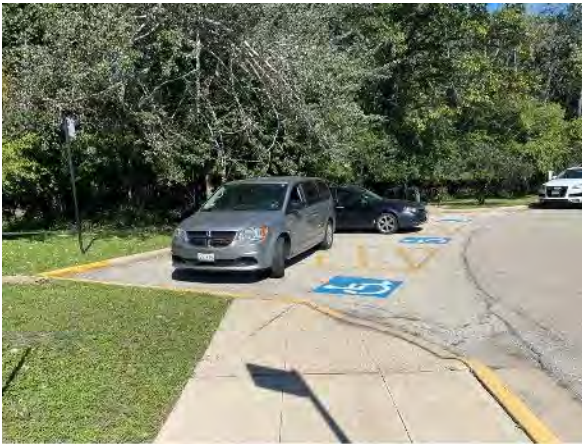
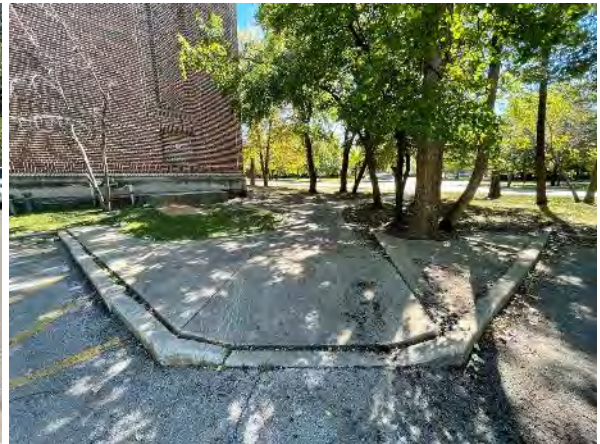
3.1.3.1 Curb Ramps from accessible parking stalls is non-conforming

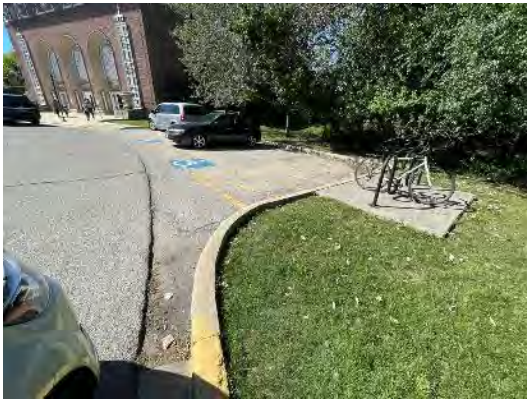
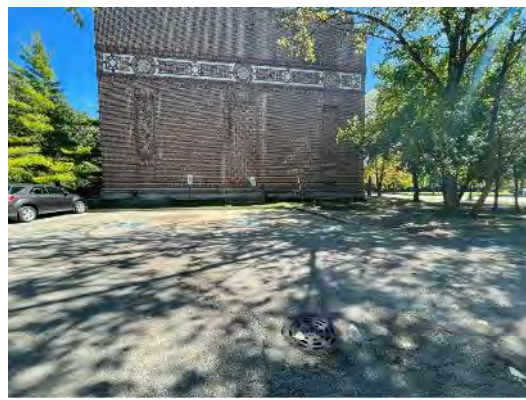
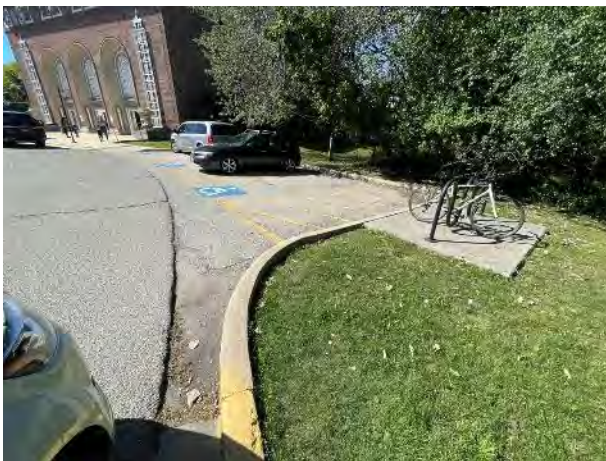
3.1.3.2 Accessible stalls are non-confirming for signage, striping, and potentially grading (a survey would be required).

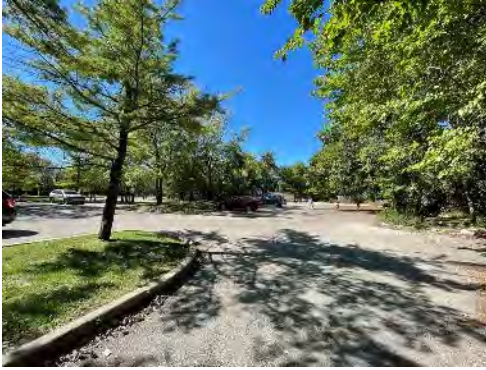
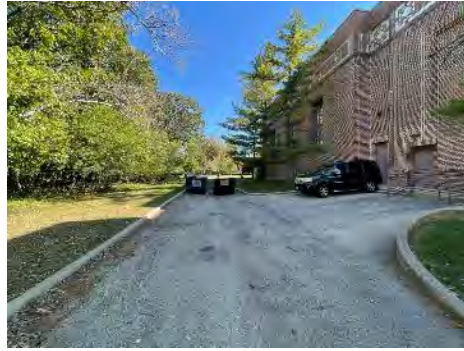
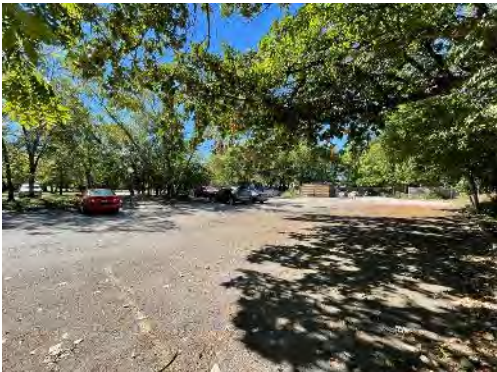
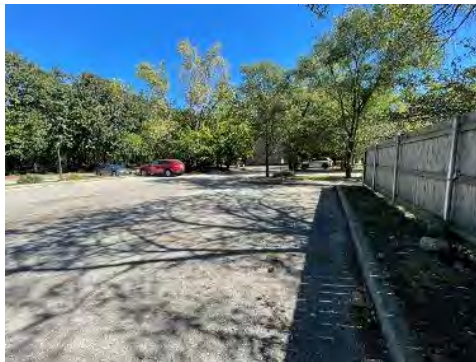
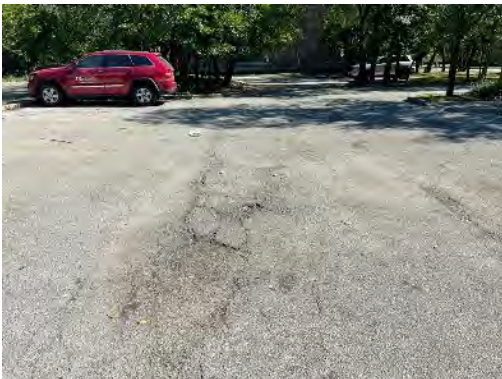
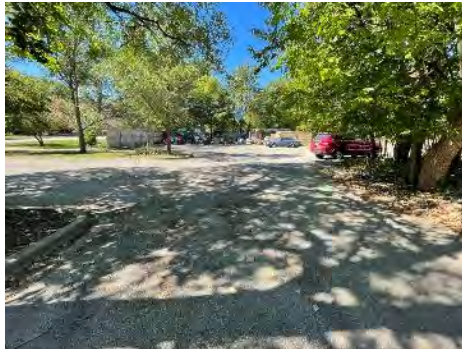
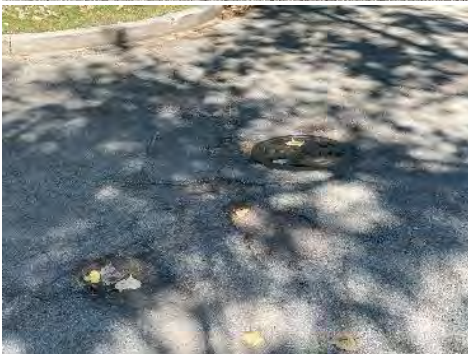
3.1.3.3 Parking Lot pavement indicates need to crack seal, sealcoat after replacing potholed areas with full-depth pavement

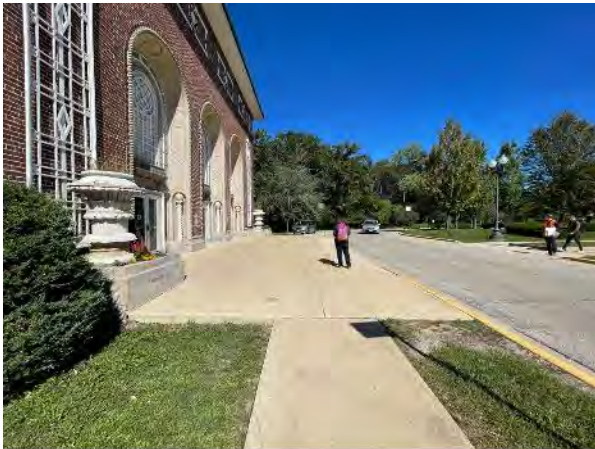
3.1.4.1 The southeastern landscape area has settled, exposing the side of the sidewalk

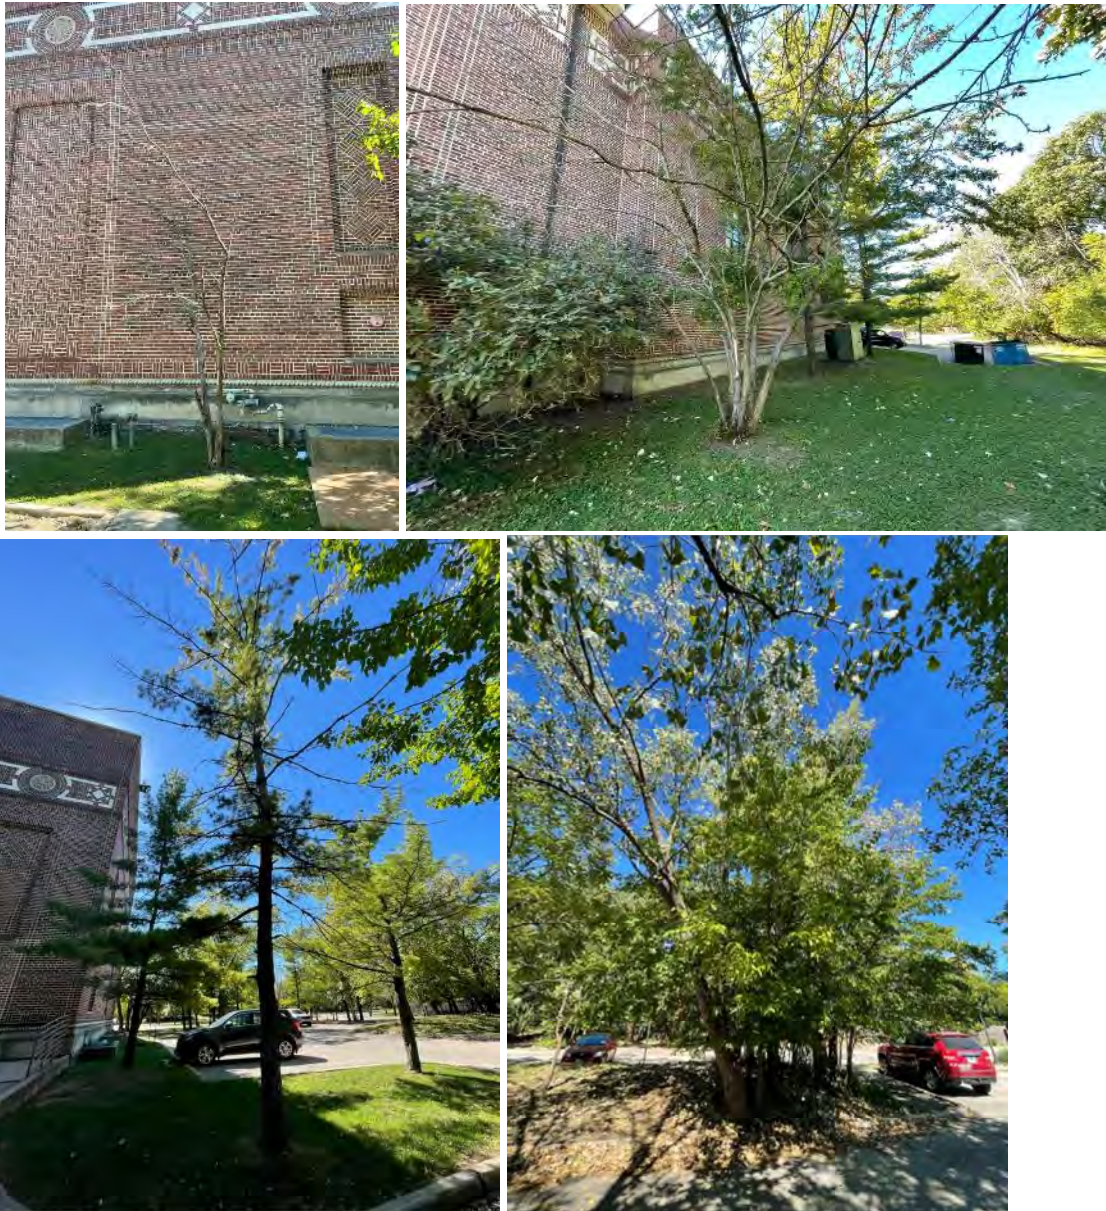
3.1.5.1 Remove dead trees and overgrowth in center island

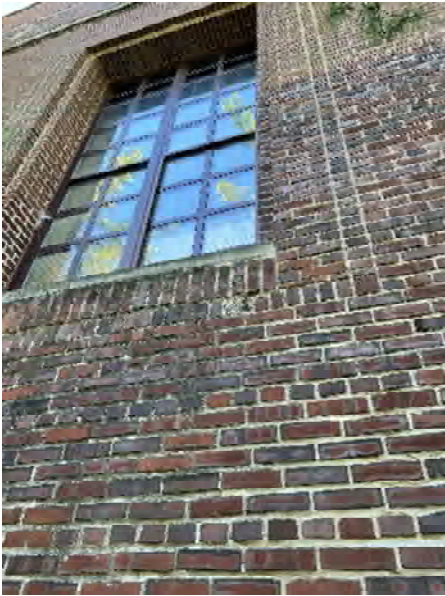
The exterior windows on the north and south facade, viewed from the ground due to their height and size, appear to be new in relation to the age of the building and in good condition. There is evidence of moisture penetration at the window sills but does not appear excessive.

3.2.4.1 Windows at North and South Façade. Windows are

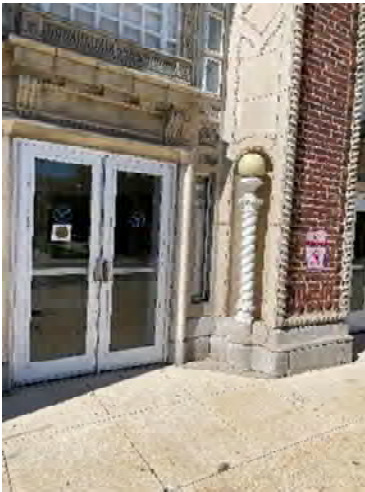
The exterior doors are in fair condition. On the East Façade the main entry doors are surrounded by decorative limestone, decorative metal and terracotta portals. The limestone elements appear in fair condition. Due to the width of existing doors, only the north main entry door is Accessible.

3.2.6.1 Exterior Non-Accessible Doors

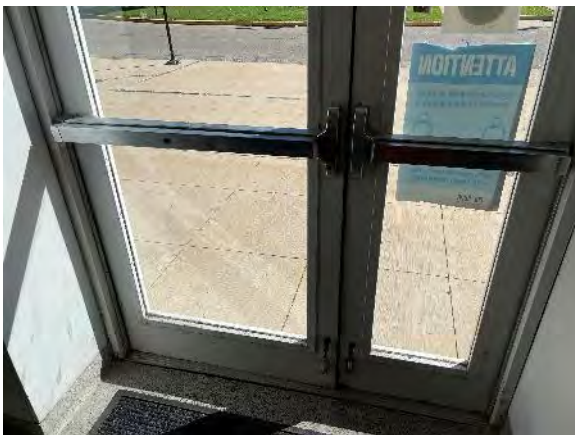
3.2.6.3 Exterior Doors uneven leaves

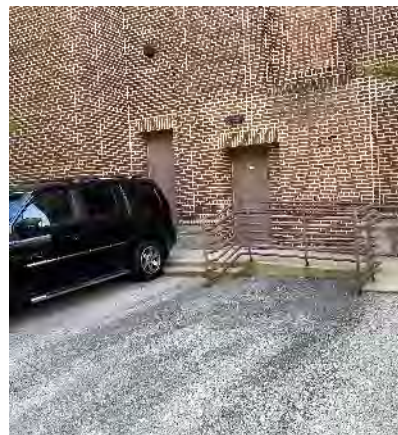
3.2.6.4 Exterior Egress Doors in fair condition

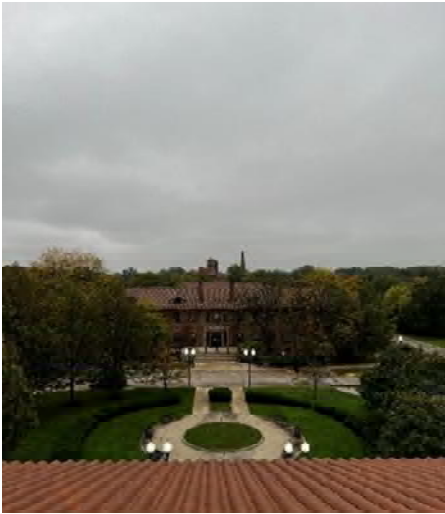
3.2.7.1 Clay tile roof above entry Vestibule

The existing roof consists of two types of roof systems. The gable portion above the main gymnasium space is a membrane roof assembly. The roof above the vestibule is a clay tile hip roof. Multi-wythe masonry parapets separate the roofs. Based on what could be observed the roof and parapets are in fair to poor condition. At the masonry parapets, sealant joints at the stone coping are separated, and there is

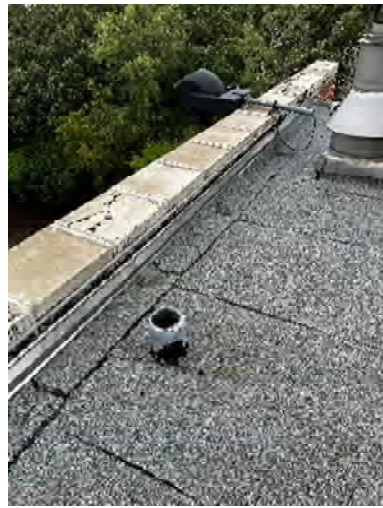
3.2.7.2 Masonry parapet at membrane roof

evidence of moisture damage on the masonry. Although not available at the time of this Preliminary Report, KOO's roofing consultant will be providing a full roof report including moisture survey and visual inspection of the clay tile roof.

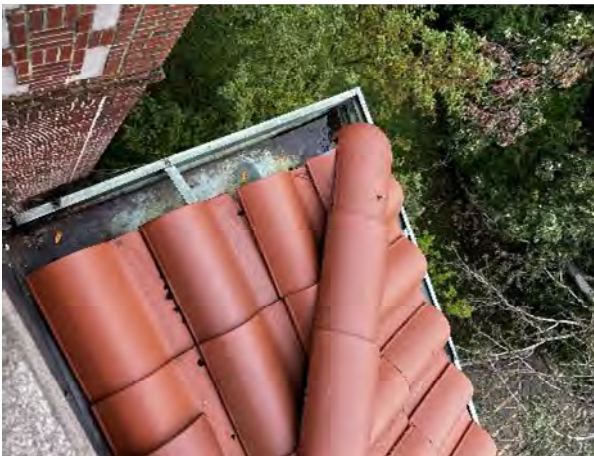
3.2.7.3 Clay tile Roof and Gutter

The existing soffit at the roof overhangs is in poor condition, as evidenced by peeling paint, debris build up and organic material growth. This appears due to improperly installed or damaged roofing and gutters installed at the sloped tile roof above.

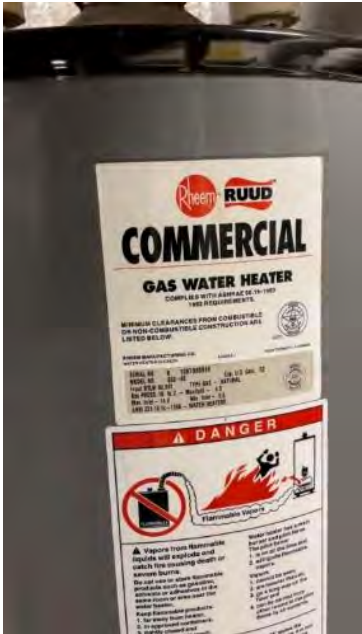
The building water service is located in the basement mechanical room. The building is served by a single gas fired 50 gallon water heater rated for 60 MBH which appears to have been installed in 2014. The water heater appears in reasonable working condition.

3.3.1.1 Water heater in basement.

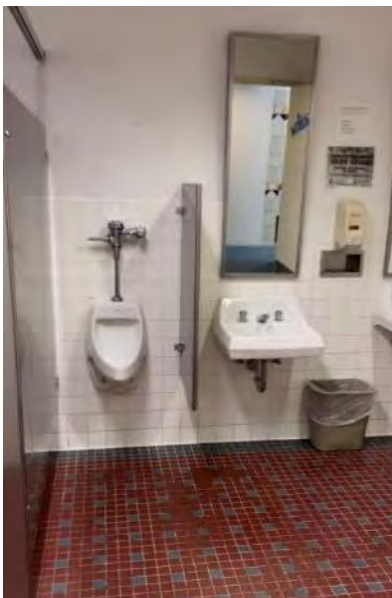
Plumbing fixtures in existing bathrooms appear relatively new and appear in reasonable working condition although a lavatory faucet was observed to be leaking in the first floor boys bathroom which should be repaired.

3.3.1.2 Existing bathroom fixtures

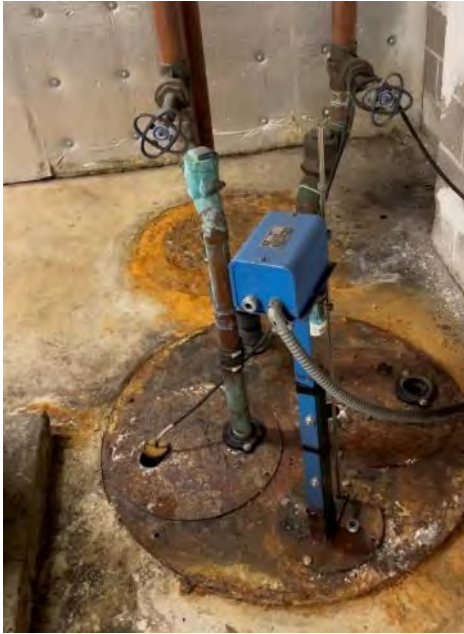
A sewage ejector is located in the basement and is piped for duplex pumps however only one pump is installed and piped. The building engineer noted the pump was recently replaced and is operating properly. A second sewage ejector pump should be installed and proper duplex pumping controls installed for system redundancy.

3.3.1.3 Existing basement sewage ejector

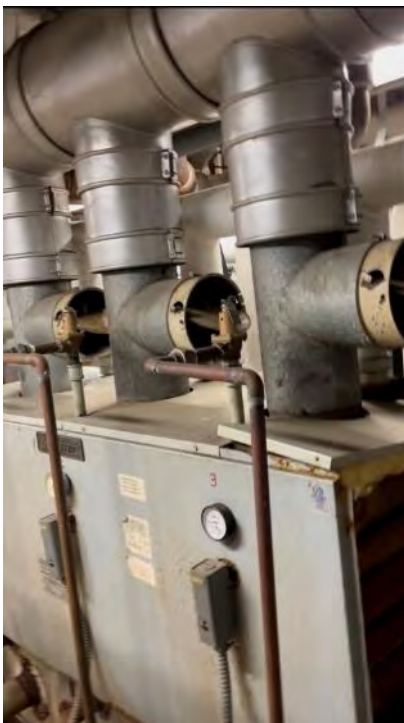
The building is heated via a three-burner hydronic boiler located in the basement. The unit is past its useful life and is in the process of being replaced with a new boiler which the building engineer noted is to be installed prior to this winter.

3.3.2.1 Existing basement boiler

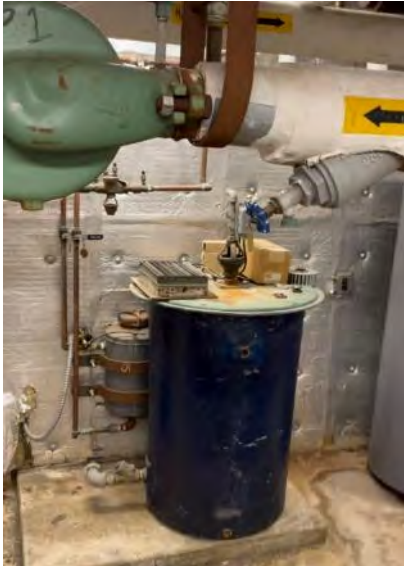
The building uses a primary/secondary pumping scheme for system pumping. System pumps appear to be in reasonable working condition and system piping was observed to be insulated throughout. System balancing should be checked upon replacement of the boilers for both the new boilers and terminal heating coils throughout the building. The system includes a glycol fill station which appears past its useful life and should be replaced with new as part of the boiler replacement.

3.3.2.2 Existing basement heating pump and glycol fill station.

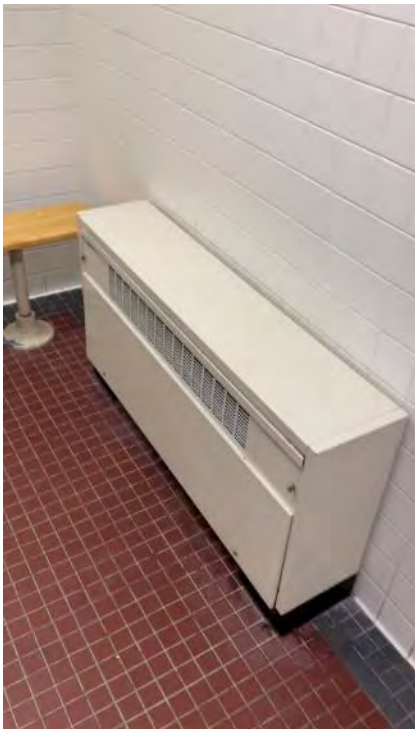
Hydronic radiators/cabinet heaters are located throughout perimeter spaces for zone level heating. Heaters appear to be in reasonable working condition.

3.3.2.3 Existing terminal cabinet unit heater

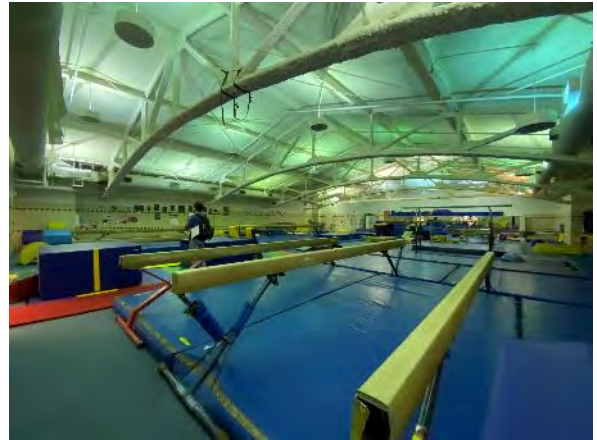
3.3.4.3.1 Lighting controls and lighting in the Gymnasium

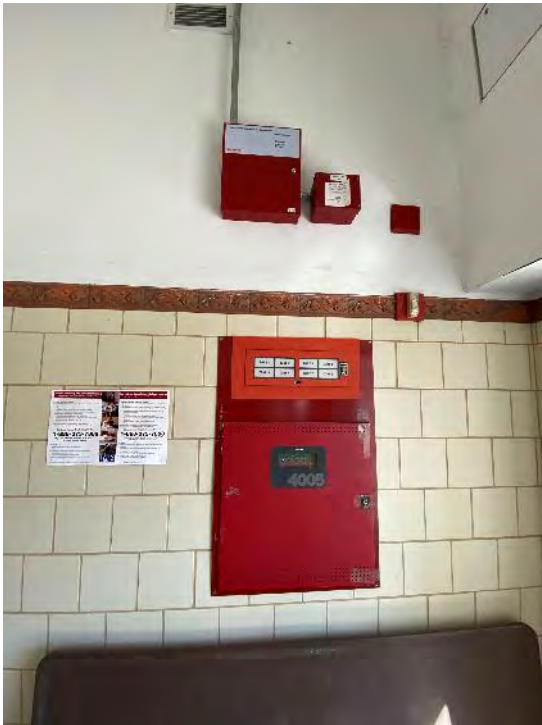
3.3.4.4.1 Simplex Panel at Vestibule

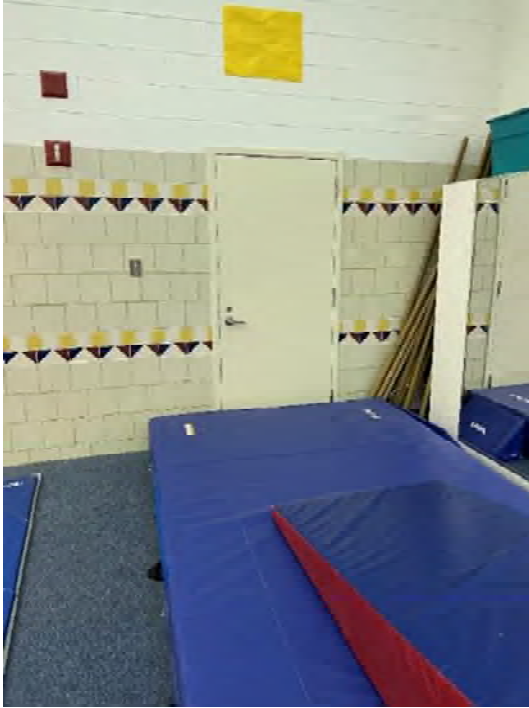
3.4.1.1.6 Level 1 and Level 2 Doors appear to typically painted hollow metal with ADA compliant hardware

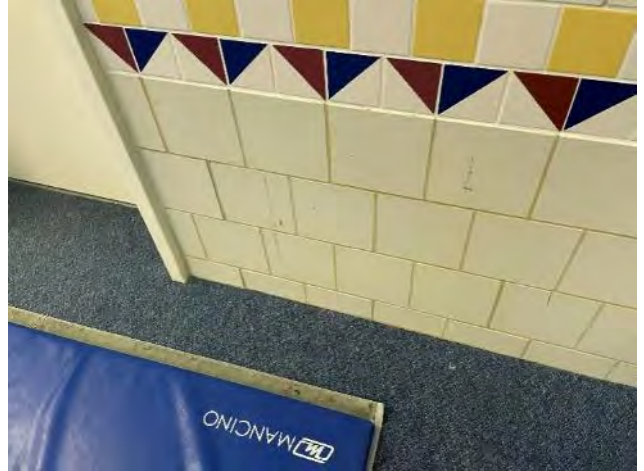
3.4.1.1.7 Similar Wall tiles layout and carpet is used throughout all the wall on second floor and first floor.

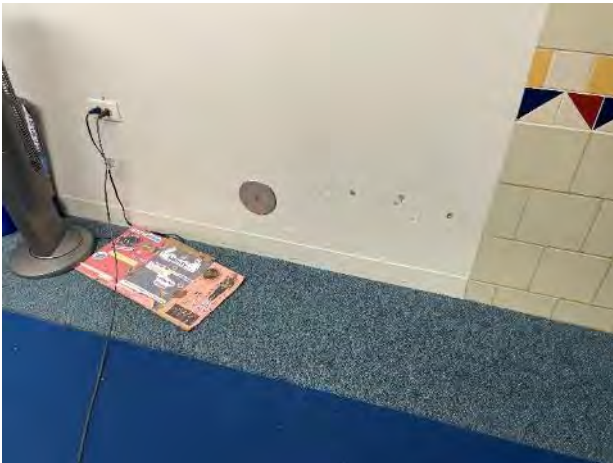
3.4.1.1.8 Dry wall and wall base matching color are used throughout back of house space on level 1 and 2 with the exception of restroom.

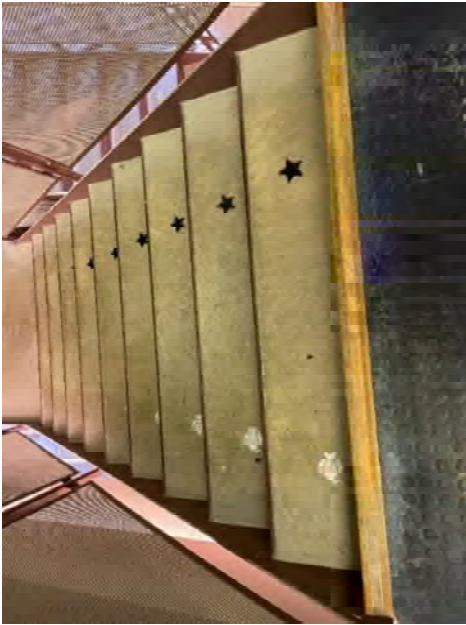
3.4.1.3.1 Stairs is in a good condition, and function well.
